NIST Response to the World Trade Center Disaster

**Federal Building and Fire Safety Investigation
of
the World Trade Center Disaster**

Part IIC – WTC 7 Collapse

April 5, 2005

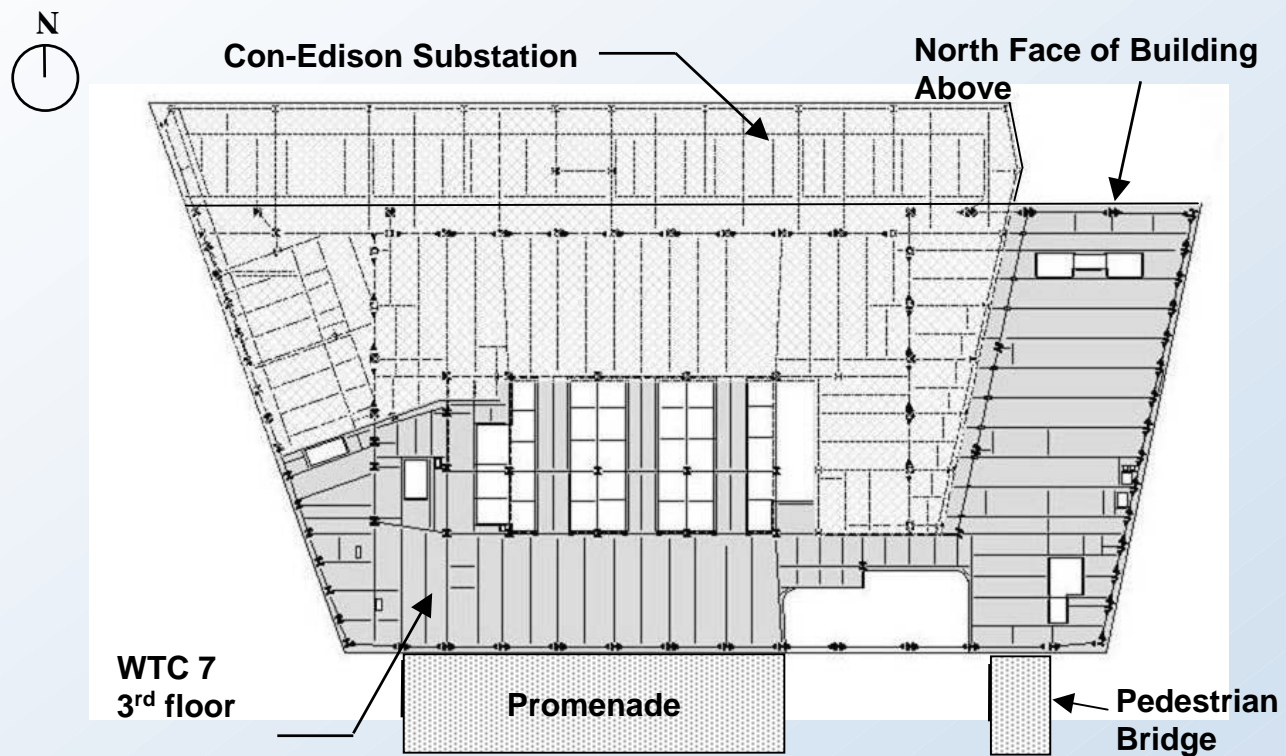
WTC 7 and Con Edison Substation

Below 7th floor, braced frame constructed over Con Ed substation

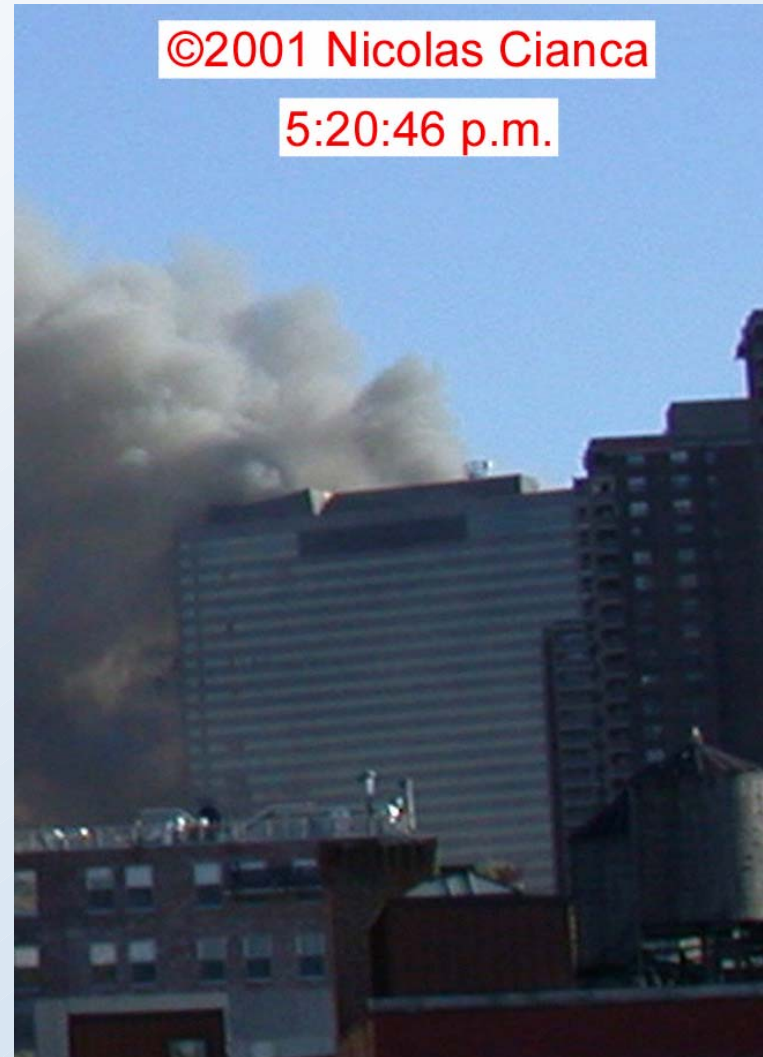
First Observation of Collapse

East Penthouse Kink
at Center of Roofline

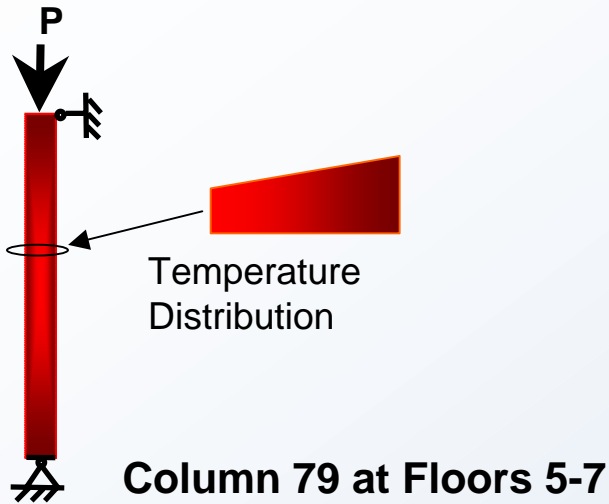
Initiating Event: Thermal-Structural Response of Critical Components

Possible Modes of Column Failure:

- Squashing (Yielding) of Column
- Cover Plate Weld Failure
- Failure of Column Splice

NIST continues to evaluate the factors that could have caused column 79, 80, or 81 to fail

- Massive size of columns 79, 80, and 81 appears to require severe fires and/or damaged fireproofing to initiate thermally-related failures

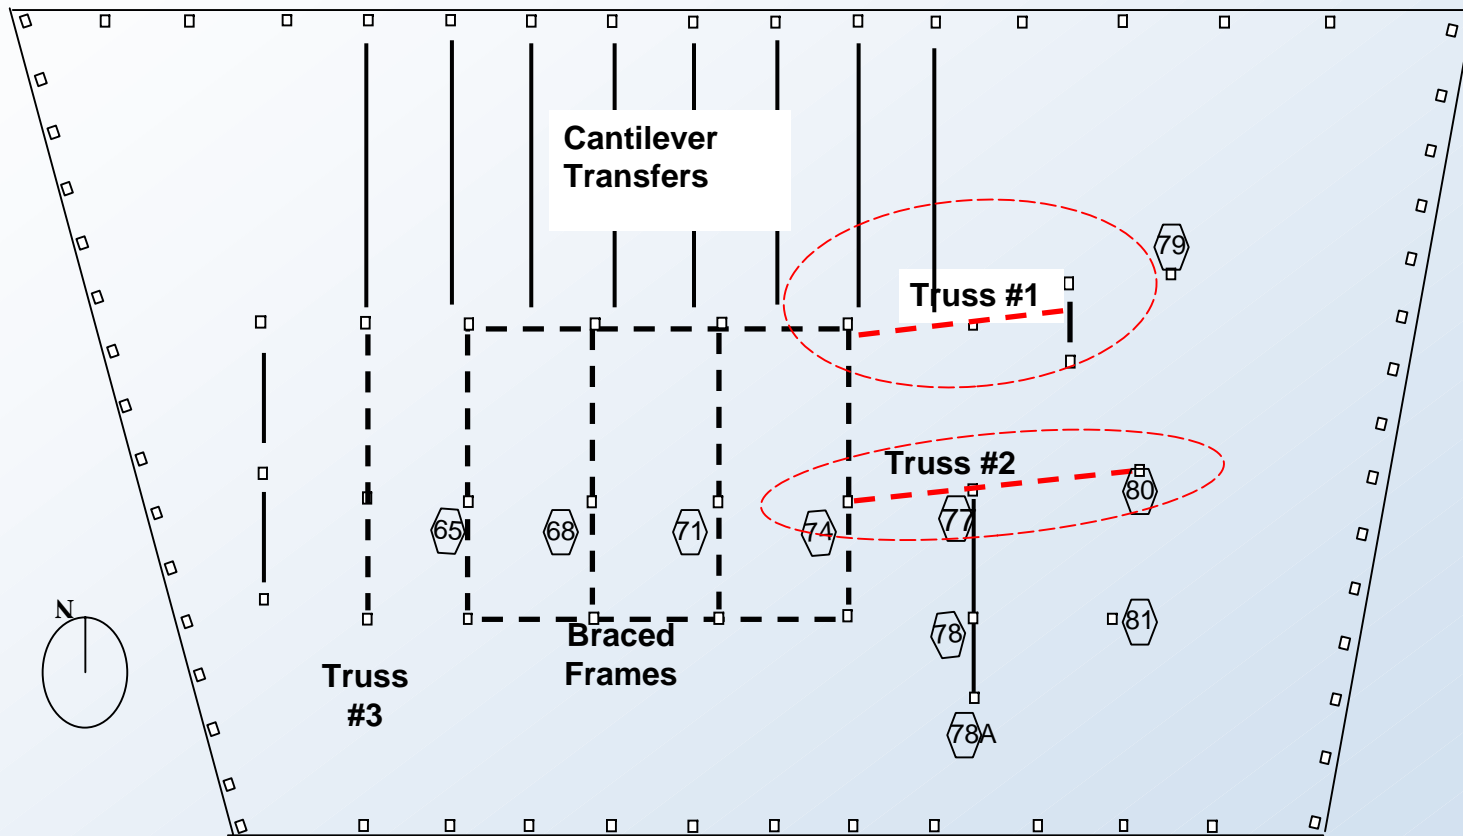
Truss #1 and Truss #2 Locations

- ❑ A vertical failure would pile debris on the east side of the building, damaging or severing transfer girders and trusses between floors 5 and 7.
- ❑ This secondary damage has been postulated to cause a horizontal progression of failure in the core columns at or near floors 5 and 7.
