NCST Investigation of the Champlain Towers South Collapse

Cross-Project Panel Theme 1: Timeline and Evidence Collection

*Judith Mitrani-Reiser, N. Emel Ganapati,
David Goodwin, Christopher Segura,
Jonathan Weigand, Kamel Saidi, and Jack Moehle*

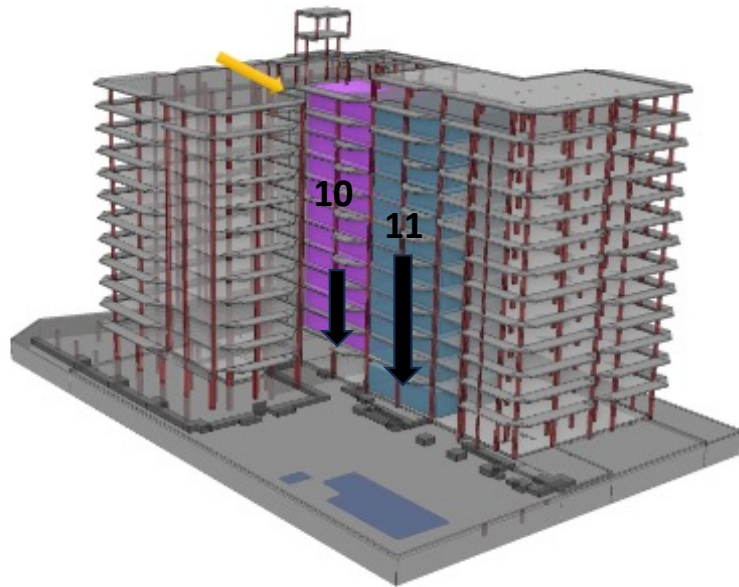
From a small glass window on the landing of an emergency exit

- The 11 stack units coming down “one by one” “like dominos”
- The 10 stack units start falling before the 11 stack units finished falling
- Almost felt like the units were “being dragged down”

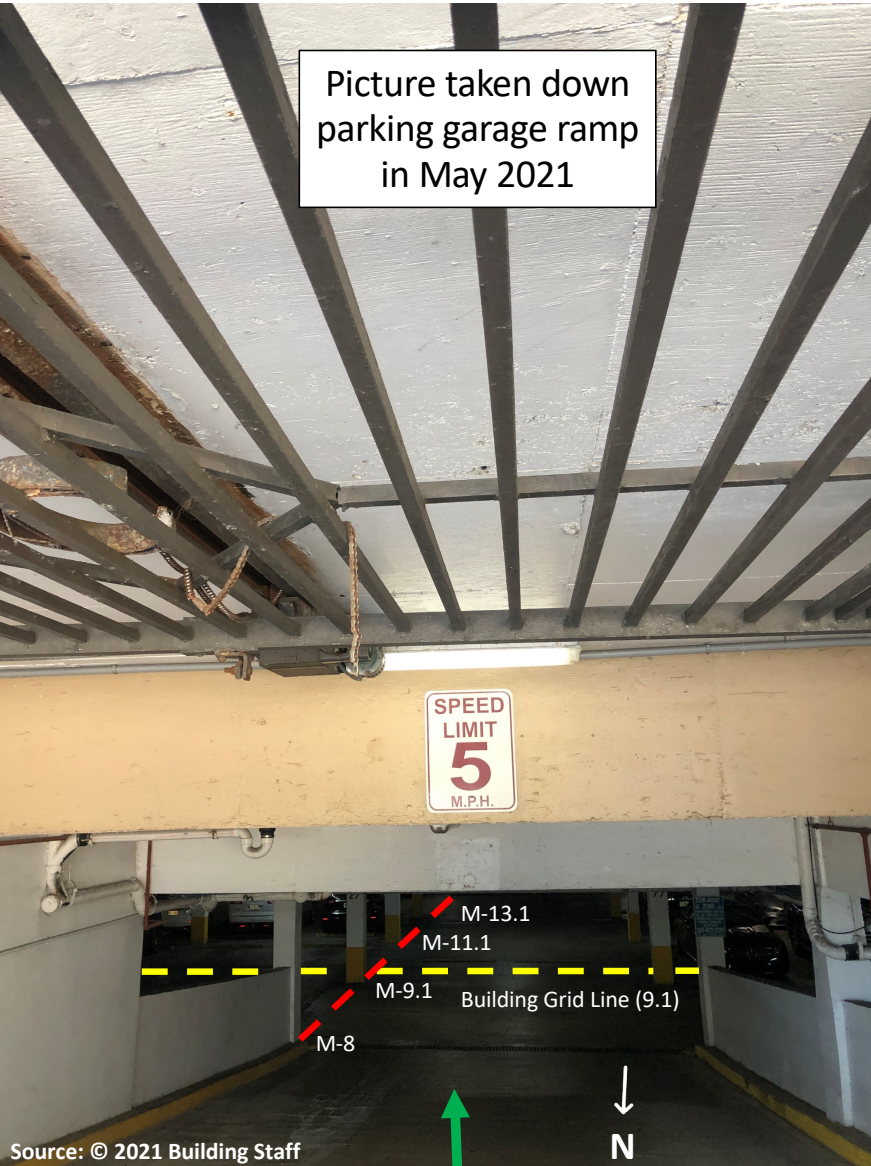
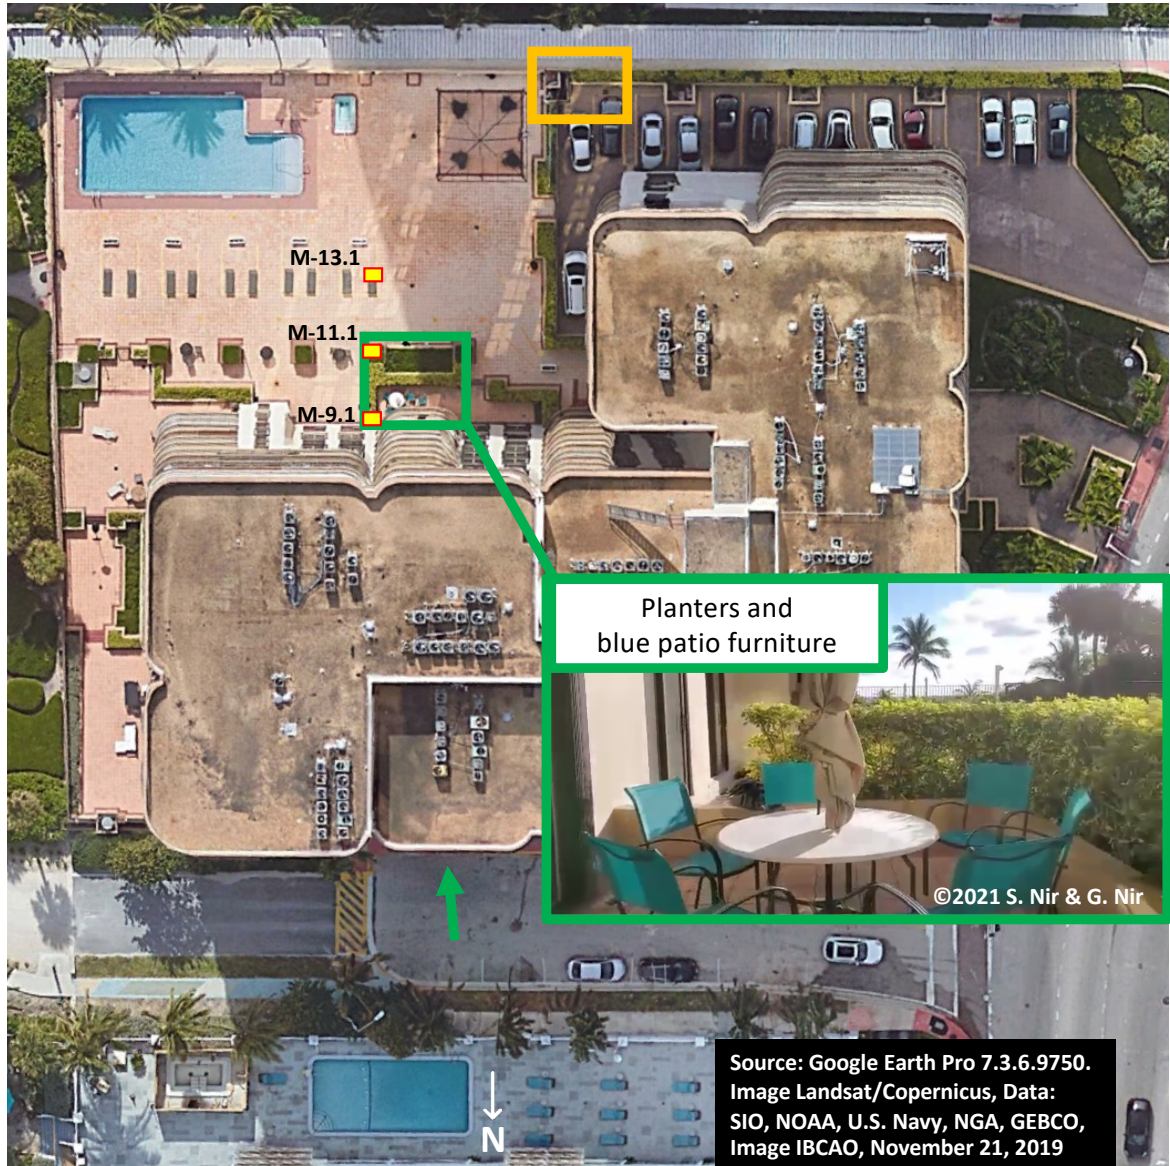
CTS Investigation: Parking Garage Ramp Footage

Key Point: North portion of pool deck slab collapsed into the basement (parking garage) prior to the global collapse of the eastern part of the tower

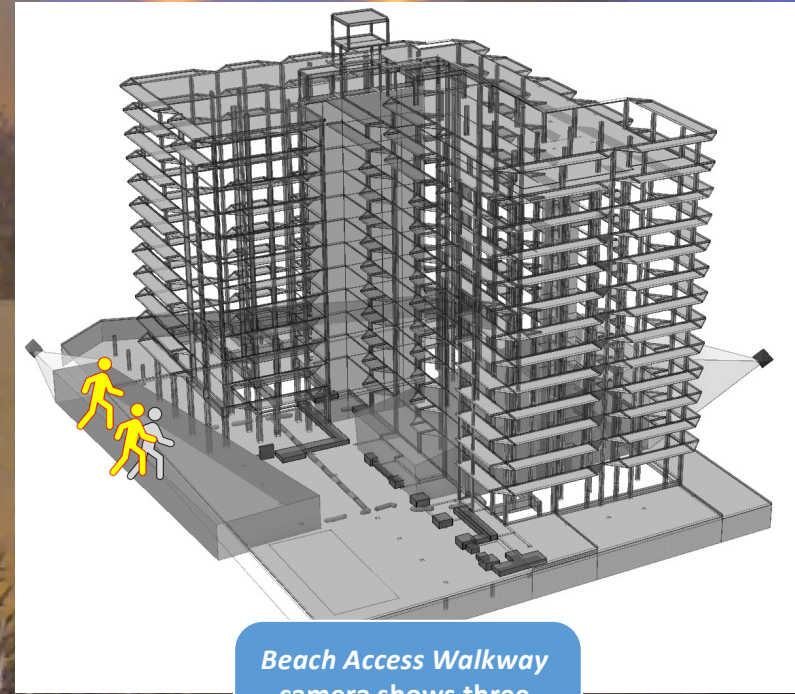
Beach Access Walkway
camera shows three
individuals on walkway,
observing damage.

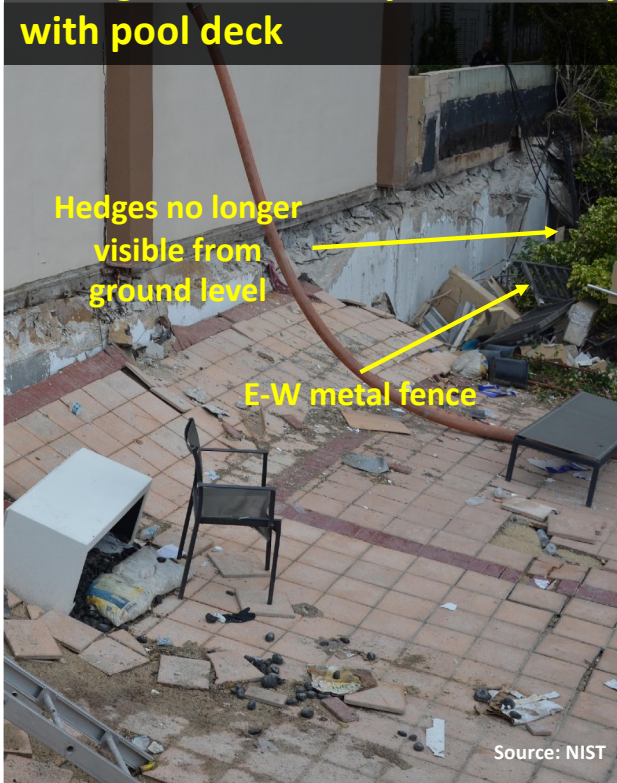
Observation 2: Portion of hedges and the metal fence are not visible in *Beach Access Walkway* footage because they had already collapsed with pool deck

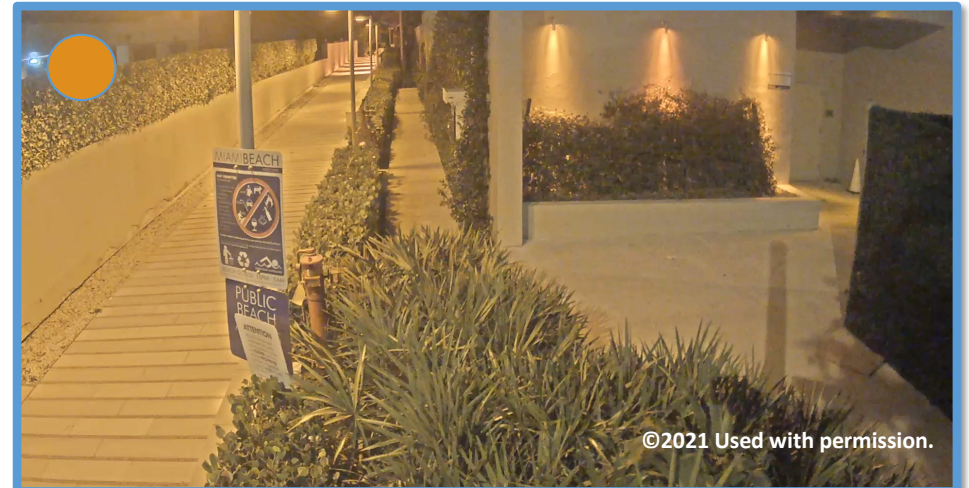
Observation 1: The Beach Access Walkway video captures moments just before, during, and after the tower collapses

Observation 2: Hedges and the metal fence are not visible in video because they had already collapsed with pool deck

Key Point: South portion of pool deck slab collapsed into the basement (parking garage) prior to the global collapse of the eastern part of the tower

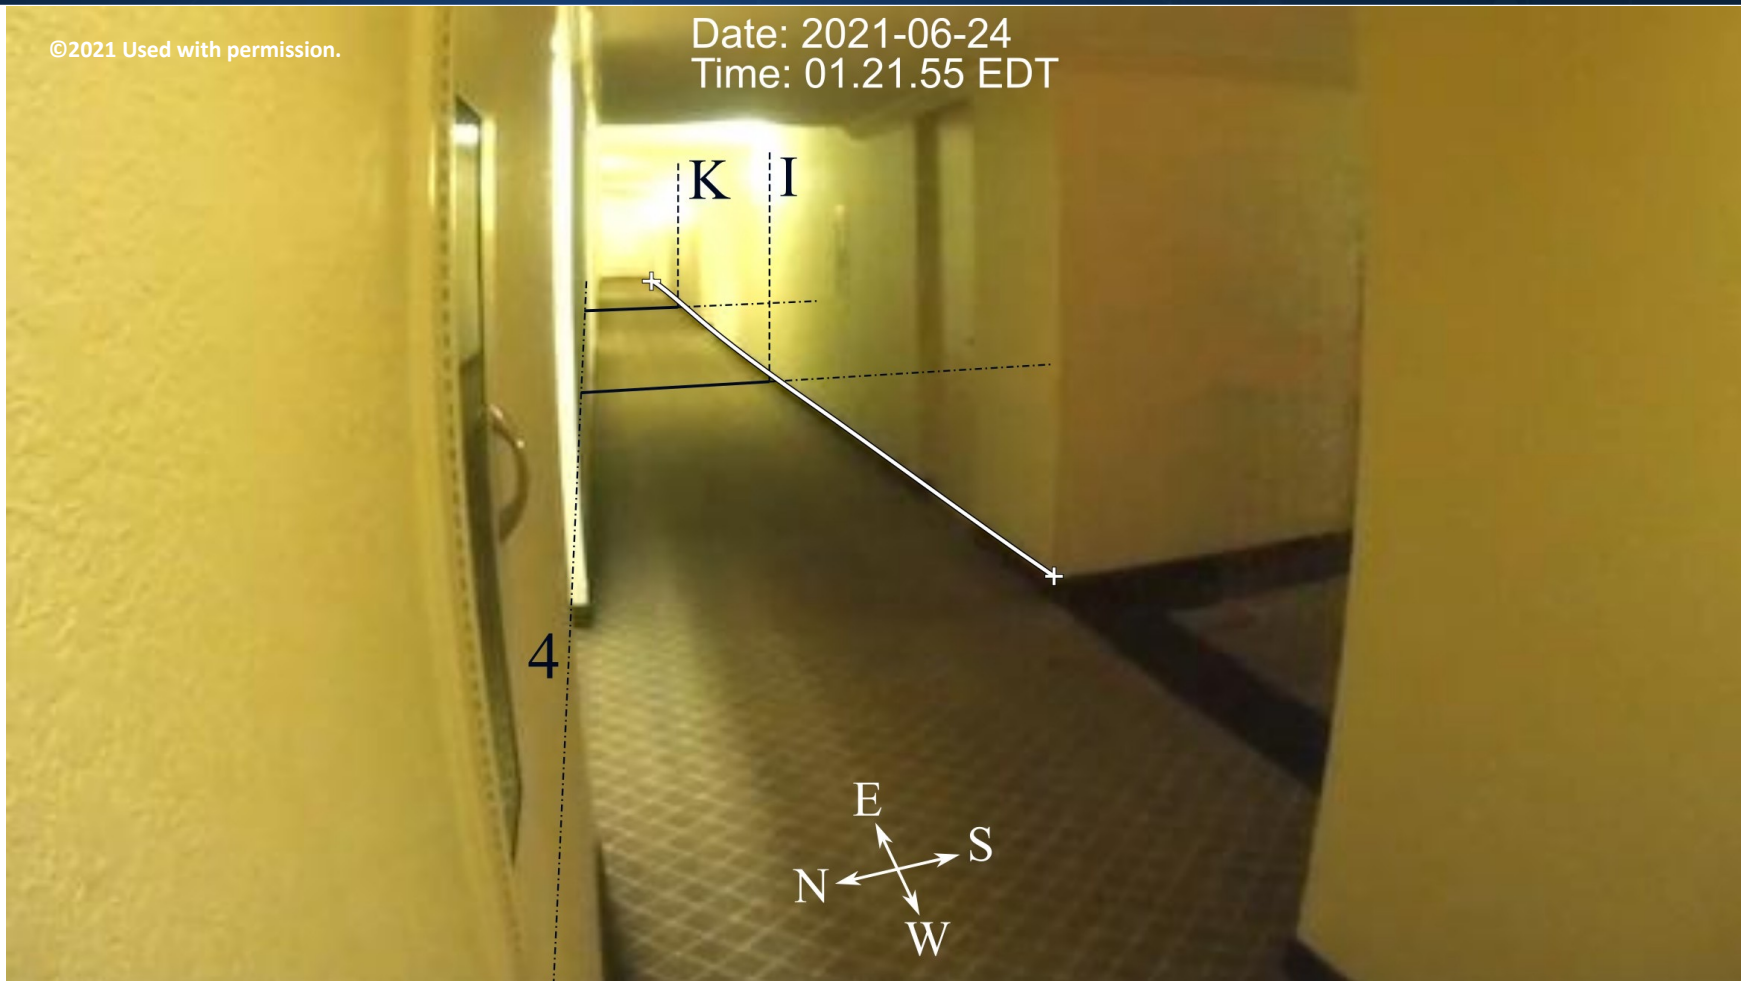
Date: 2021-06-24
Time: 01.21.55 EDT

Key Point: Prior to the tower collapse, severe deflections occurred in an upper story corridor of the CTS building near Grid Location K-4. These deflections were concentrated on the south side of the corridor near Grid Line K.

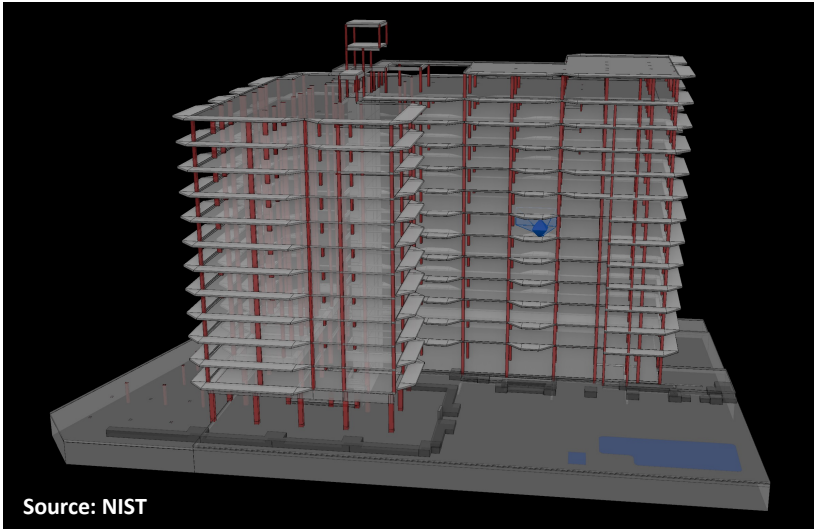
Material falling from above

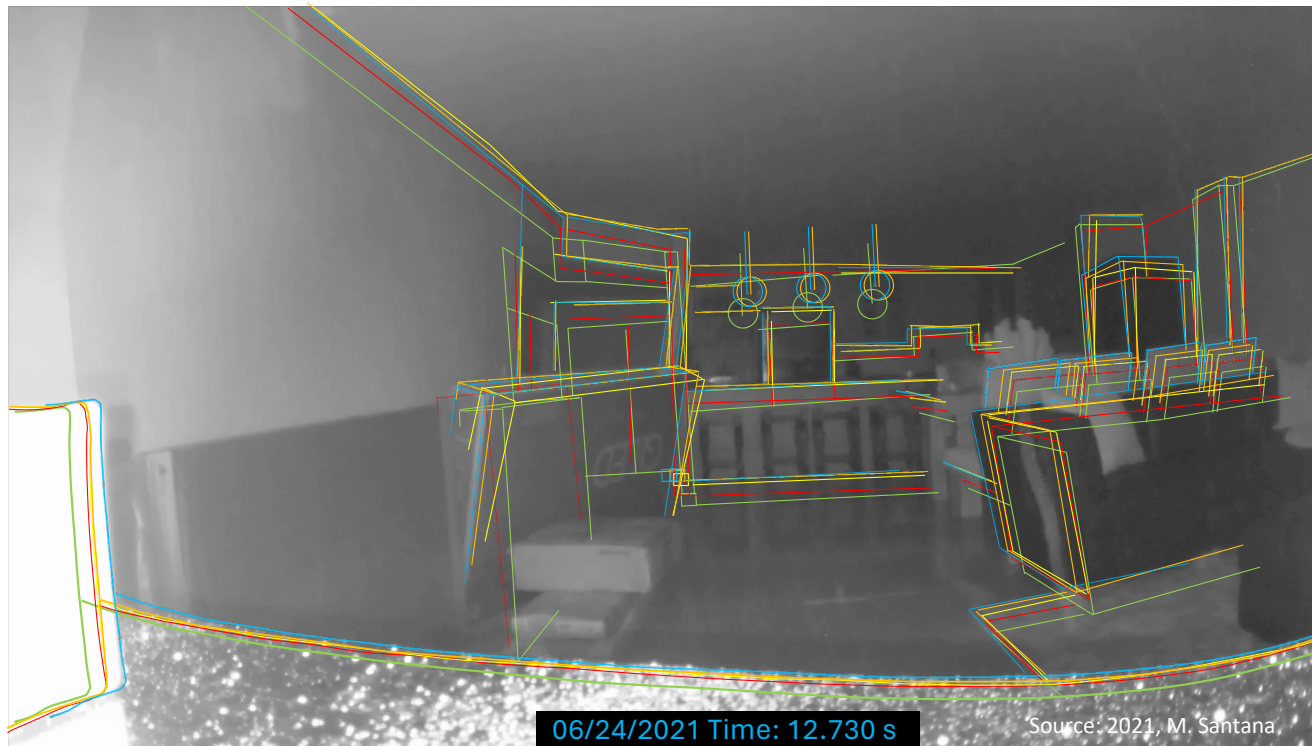
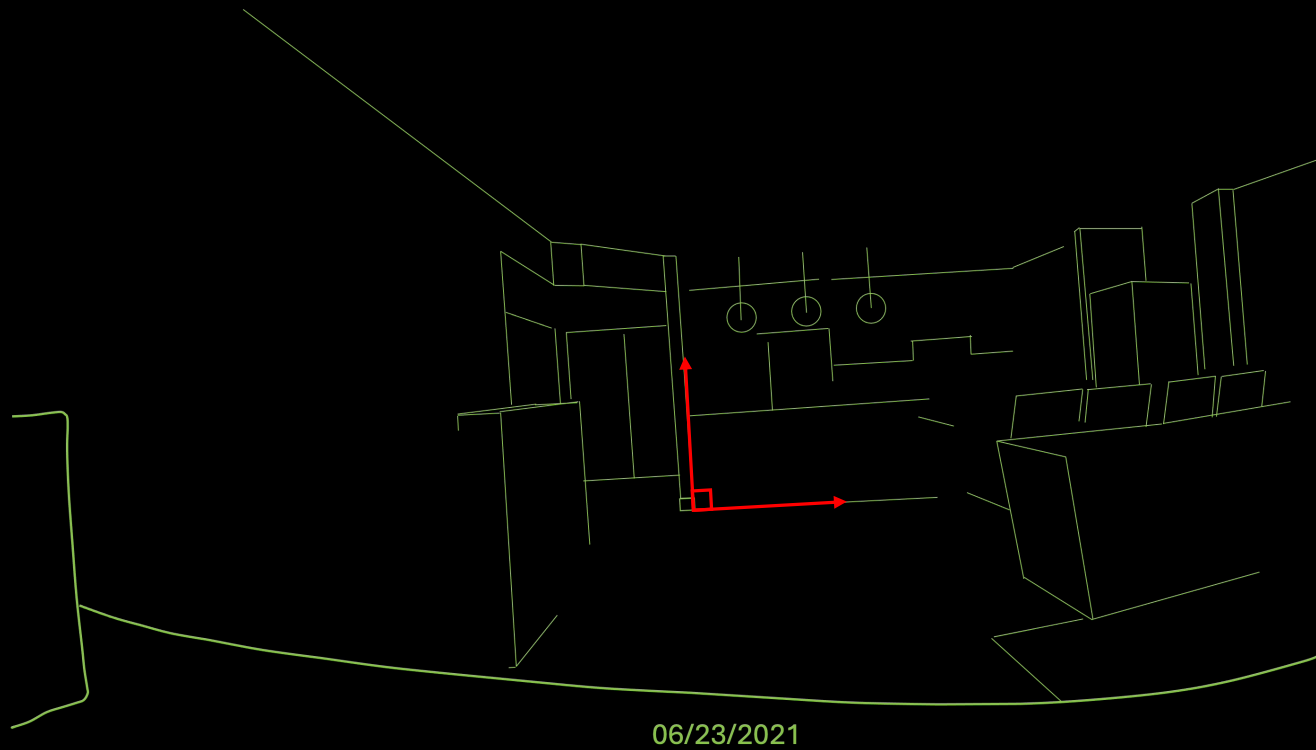
Tracking movement of objects in the 11 Stack Unit video

- Material seen falling in front of the camera may indicate distress from the floor above or the upper parts of the unit's walls
- Movements observed in the room are consistent with movements of Grid line 9.1
- Distortions in the kitchen partition wall may indicate greater vertical motion of Grid Line L relative to M
- No accurate timestamp yet

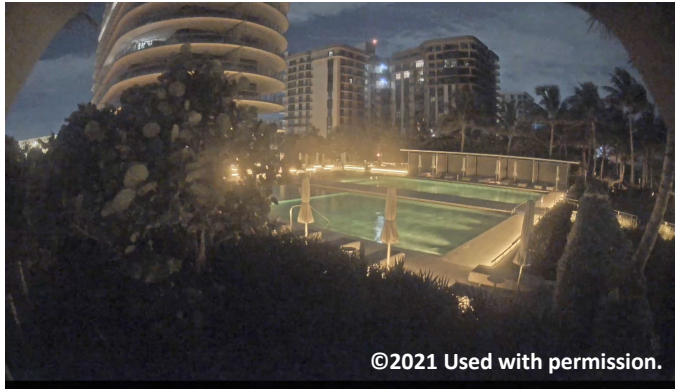
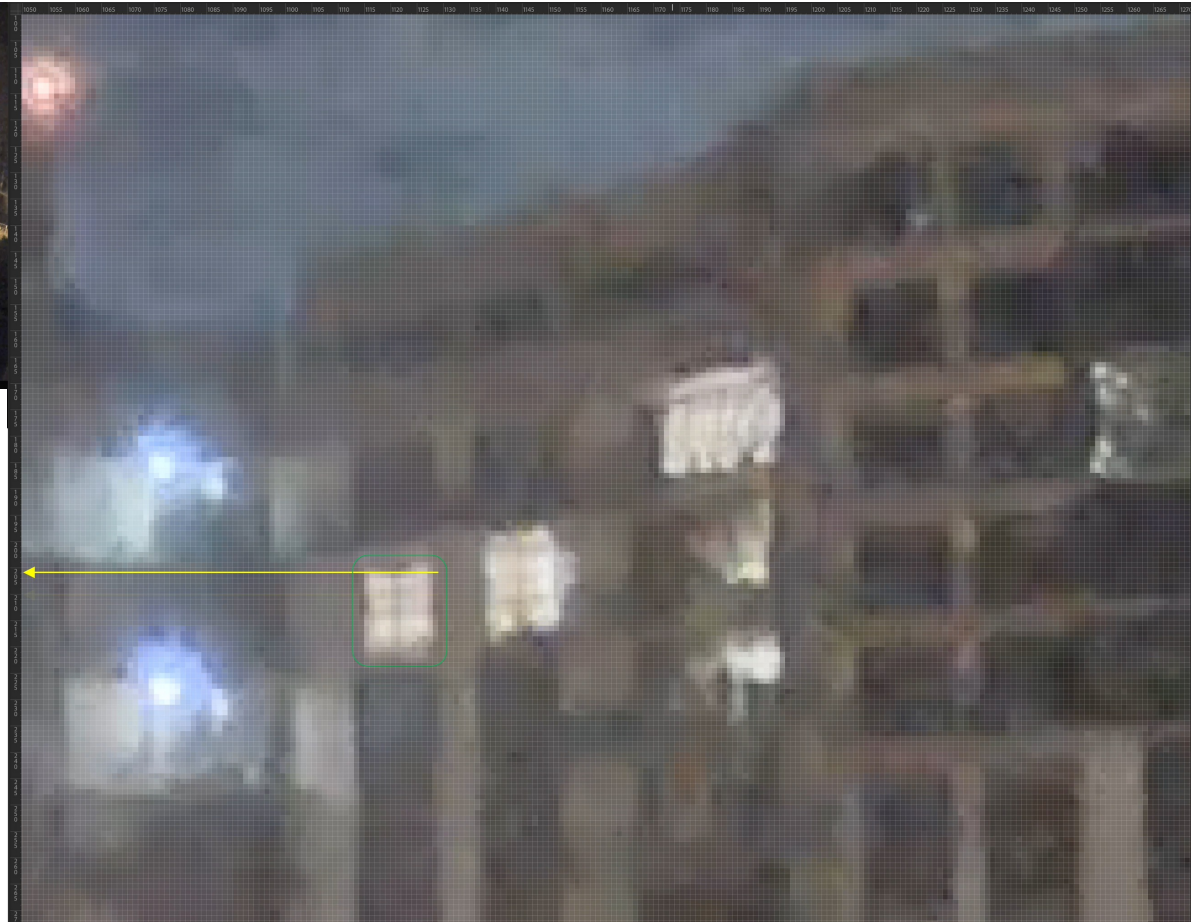
1:22:17.609 AM to 1:22:18.309 AM
6/24/2021

- On the façade of CTS, 1 image pixel \cong 4.5 in (or 0.113 m)

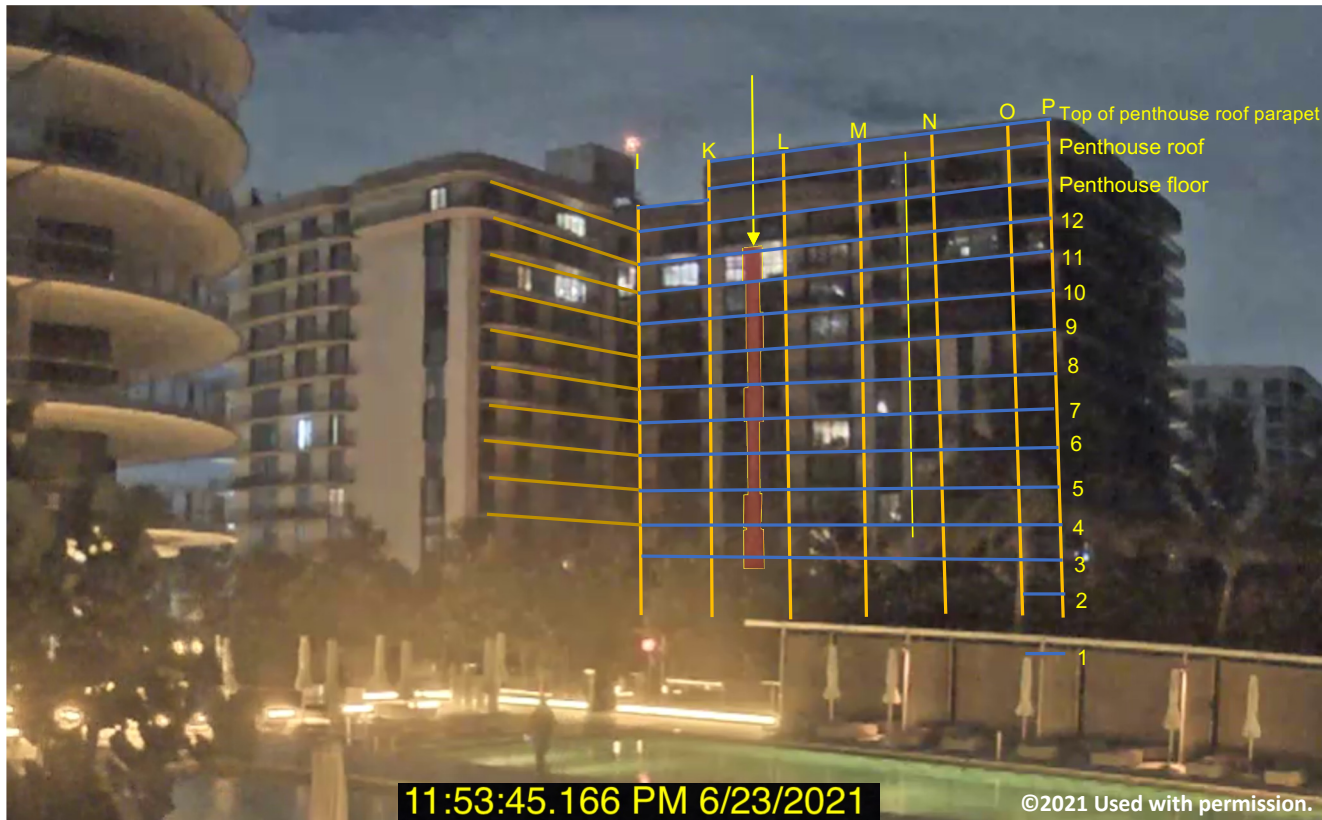
- The unique outline as seen approximately 1.5 hours before the collapse.
- The outline extends from the 3rd to the 11th floor.
- The outline is between Grid Lines K and L.

Unique façade shape
