NCST Investigation of the Champlain Towers South Collapse

Cross-Project Panel Theme 1: Timeline and Evidence Collection

*Judith Mitrani-Reiser, N. Emel Ganapati,
David Goodwin, Christopher Segura,
Jonathan Weigand, Kamel Saidi, and Jack Moehle*

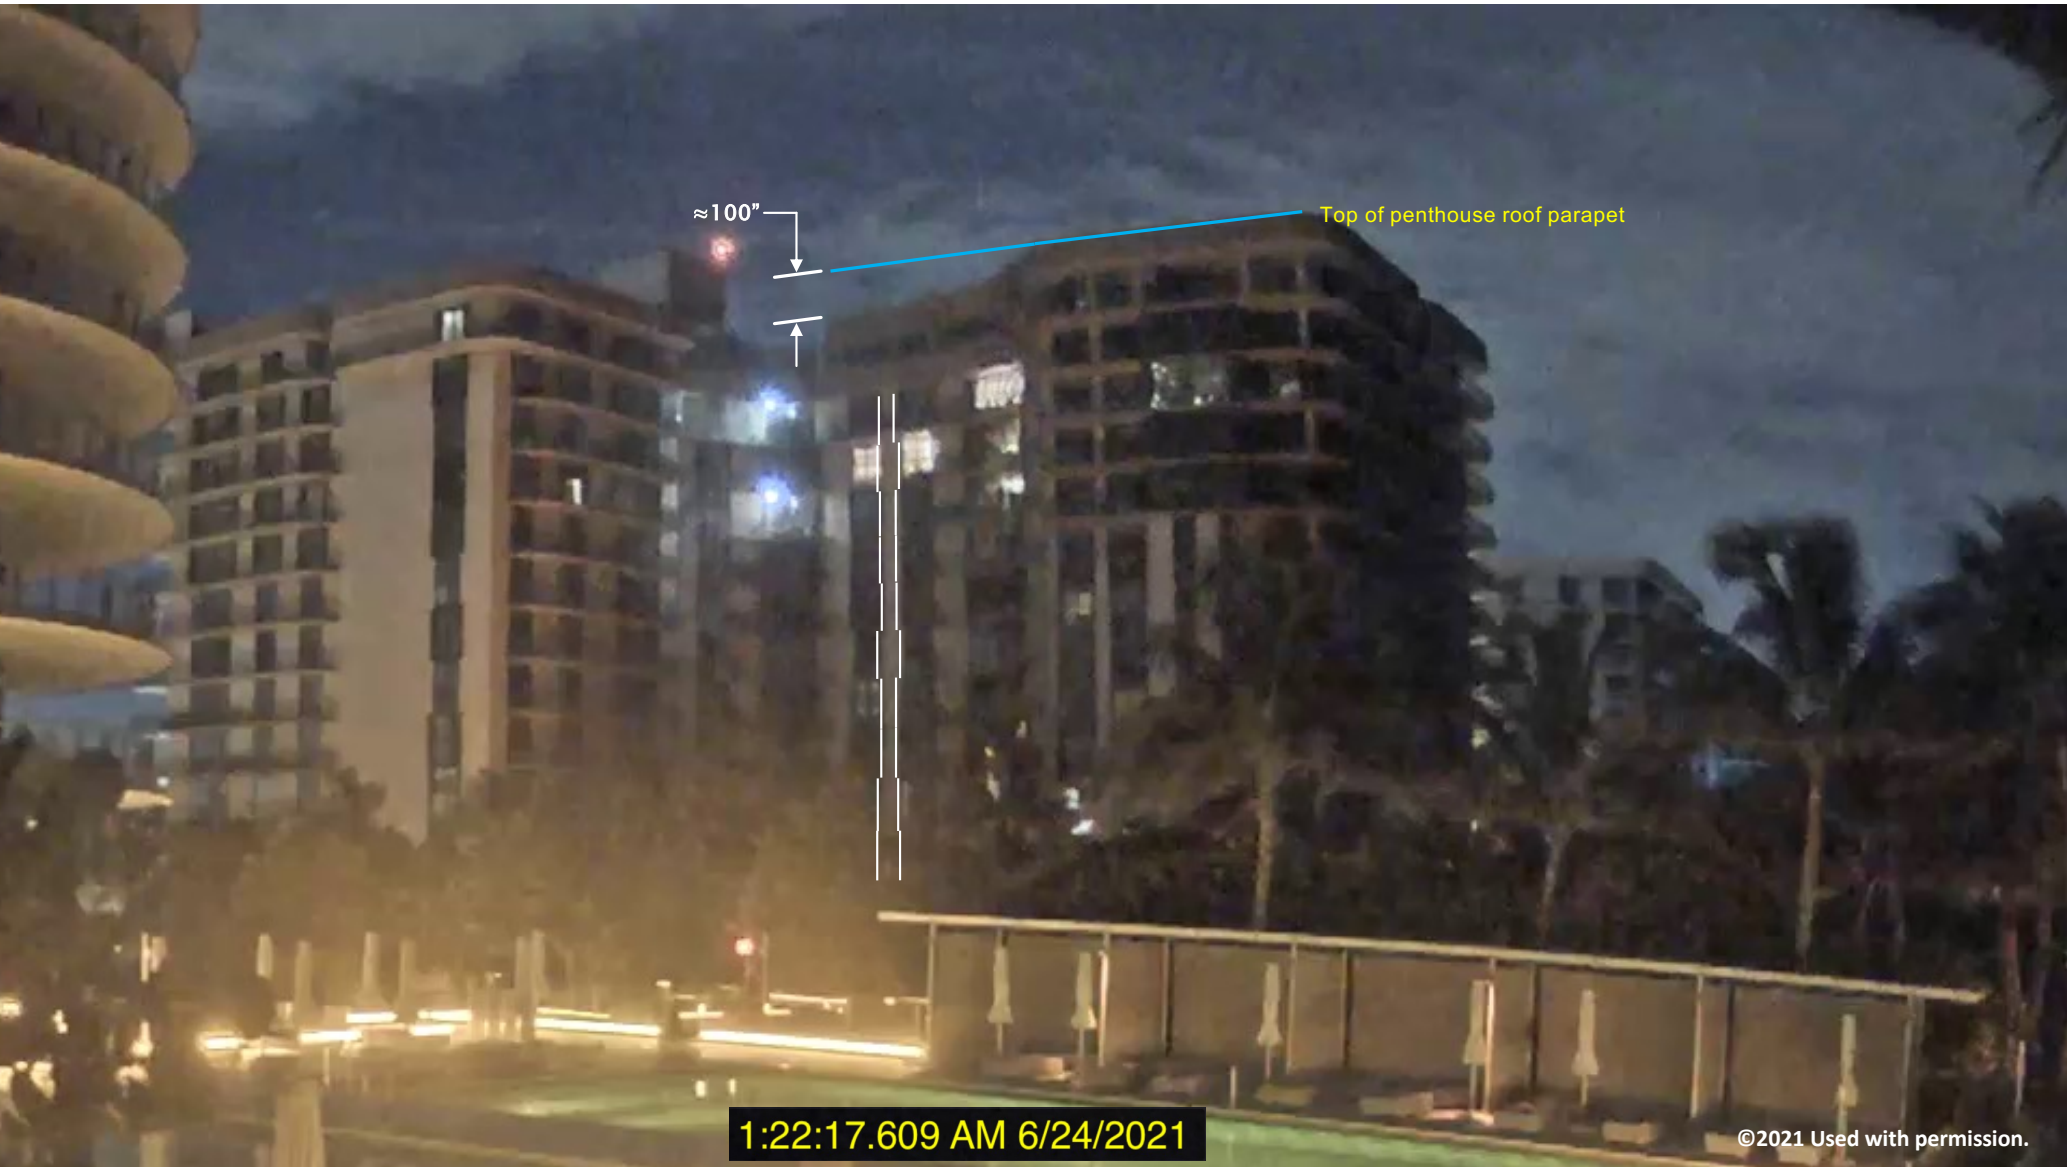
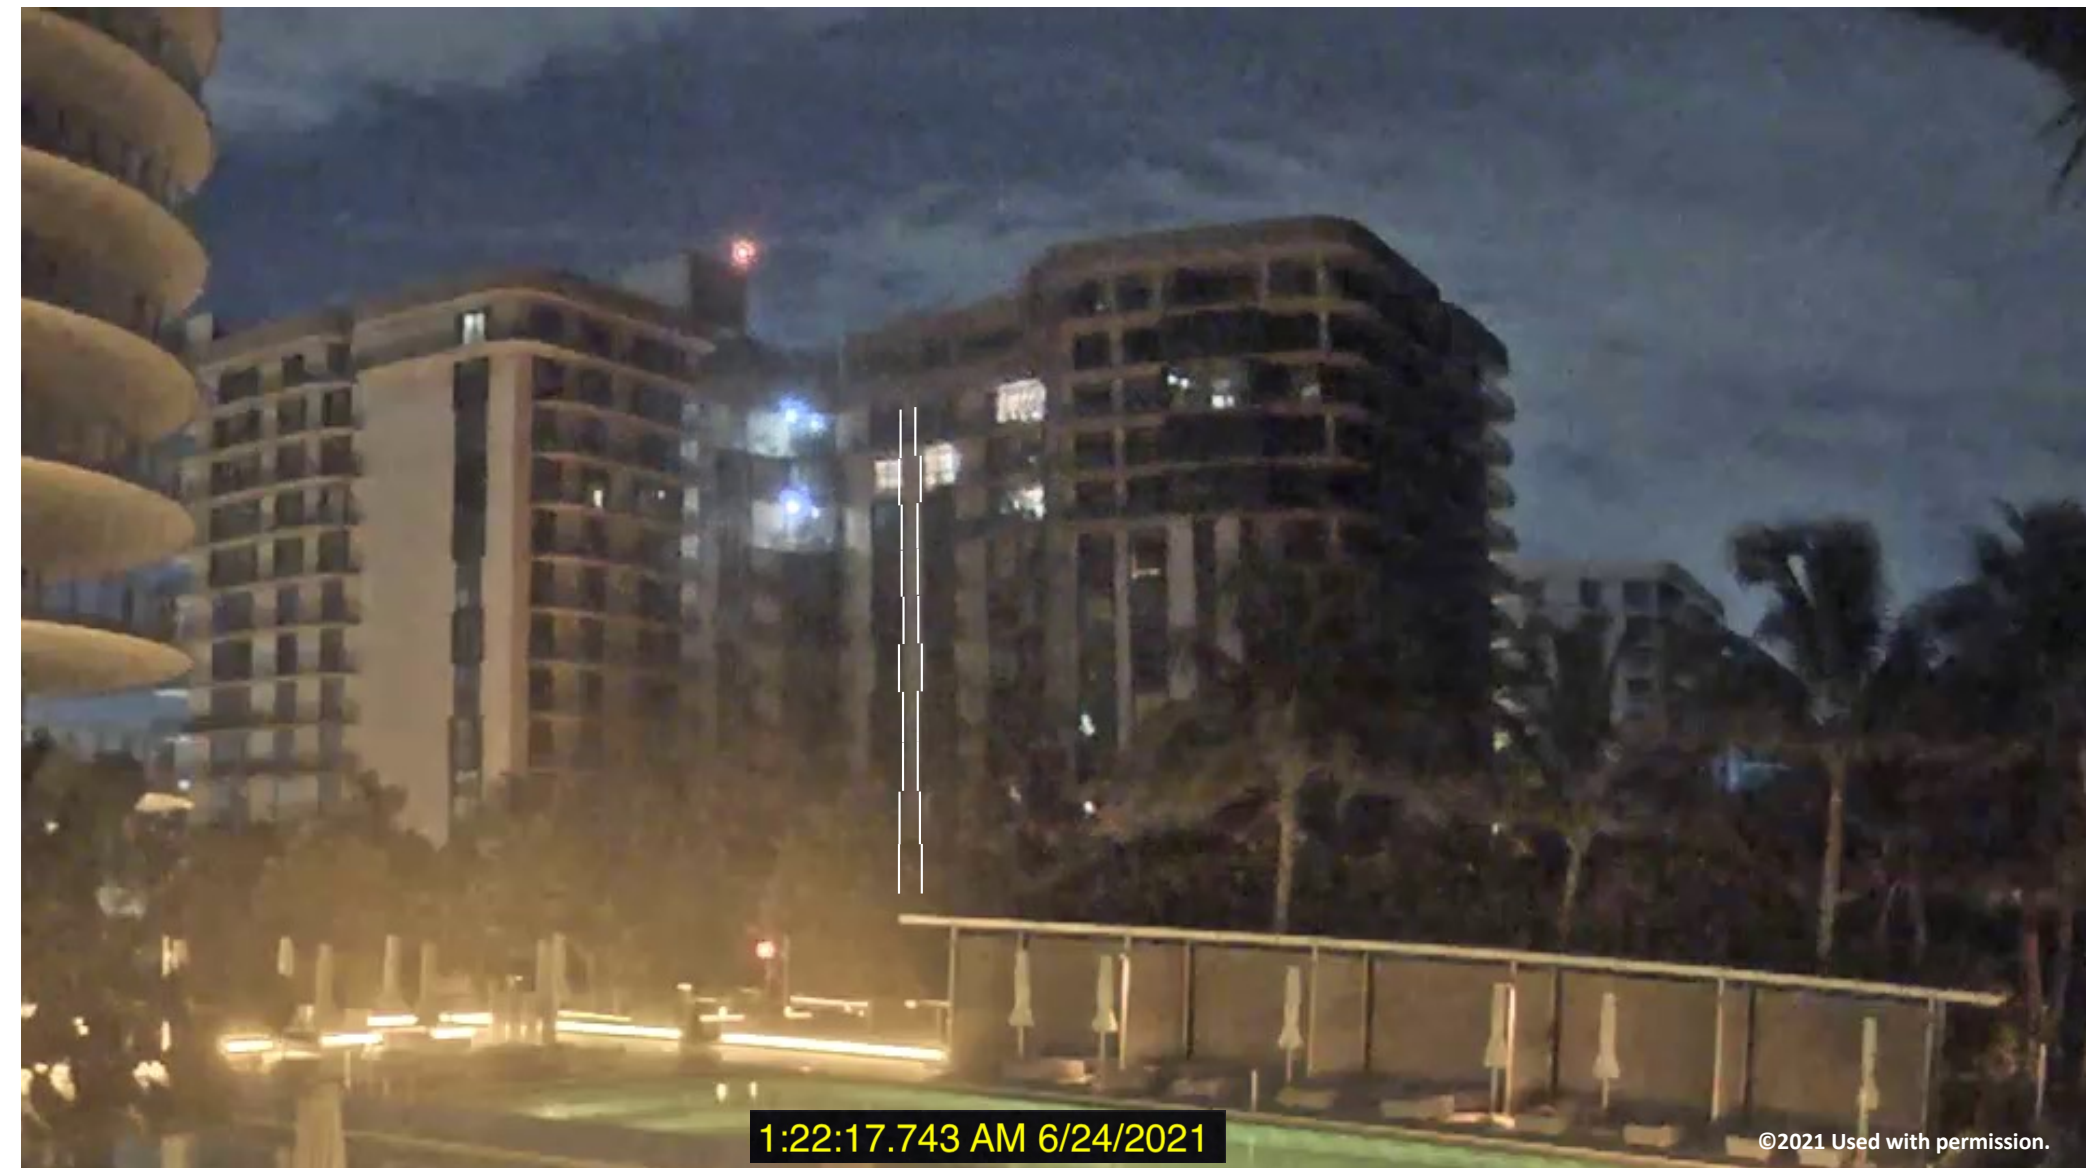
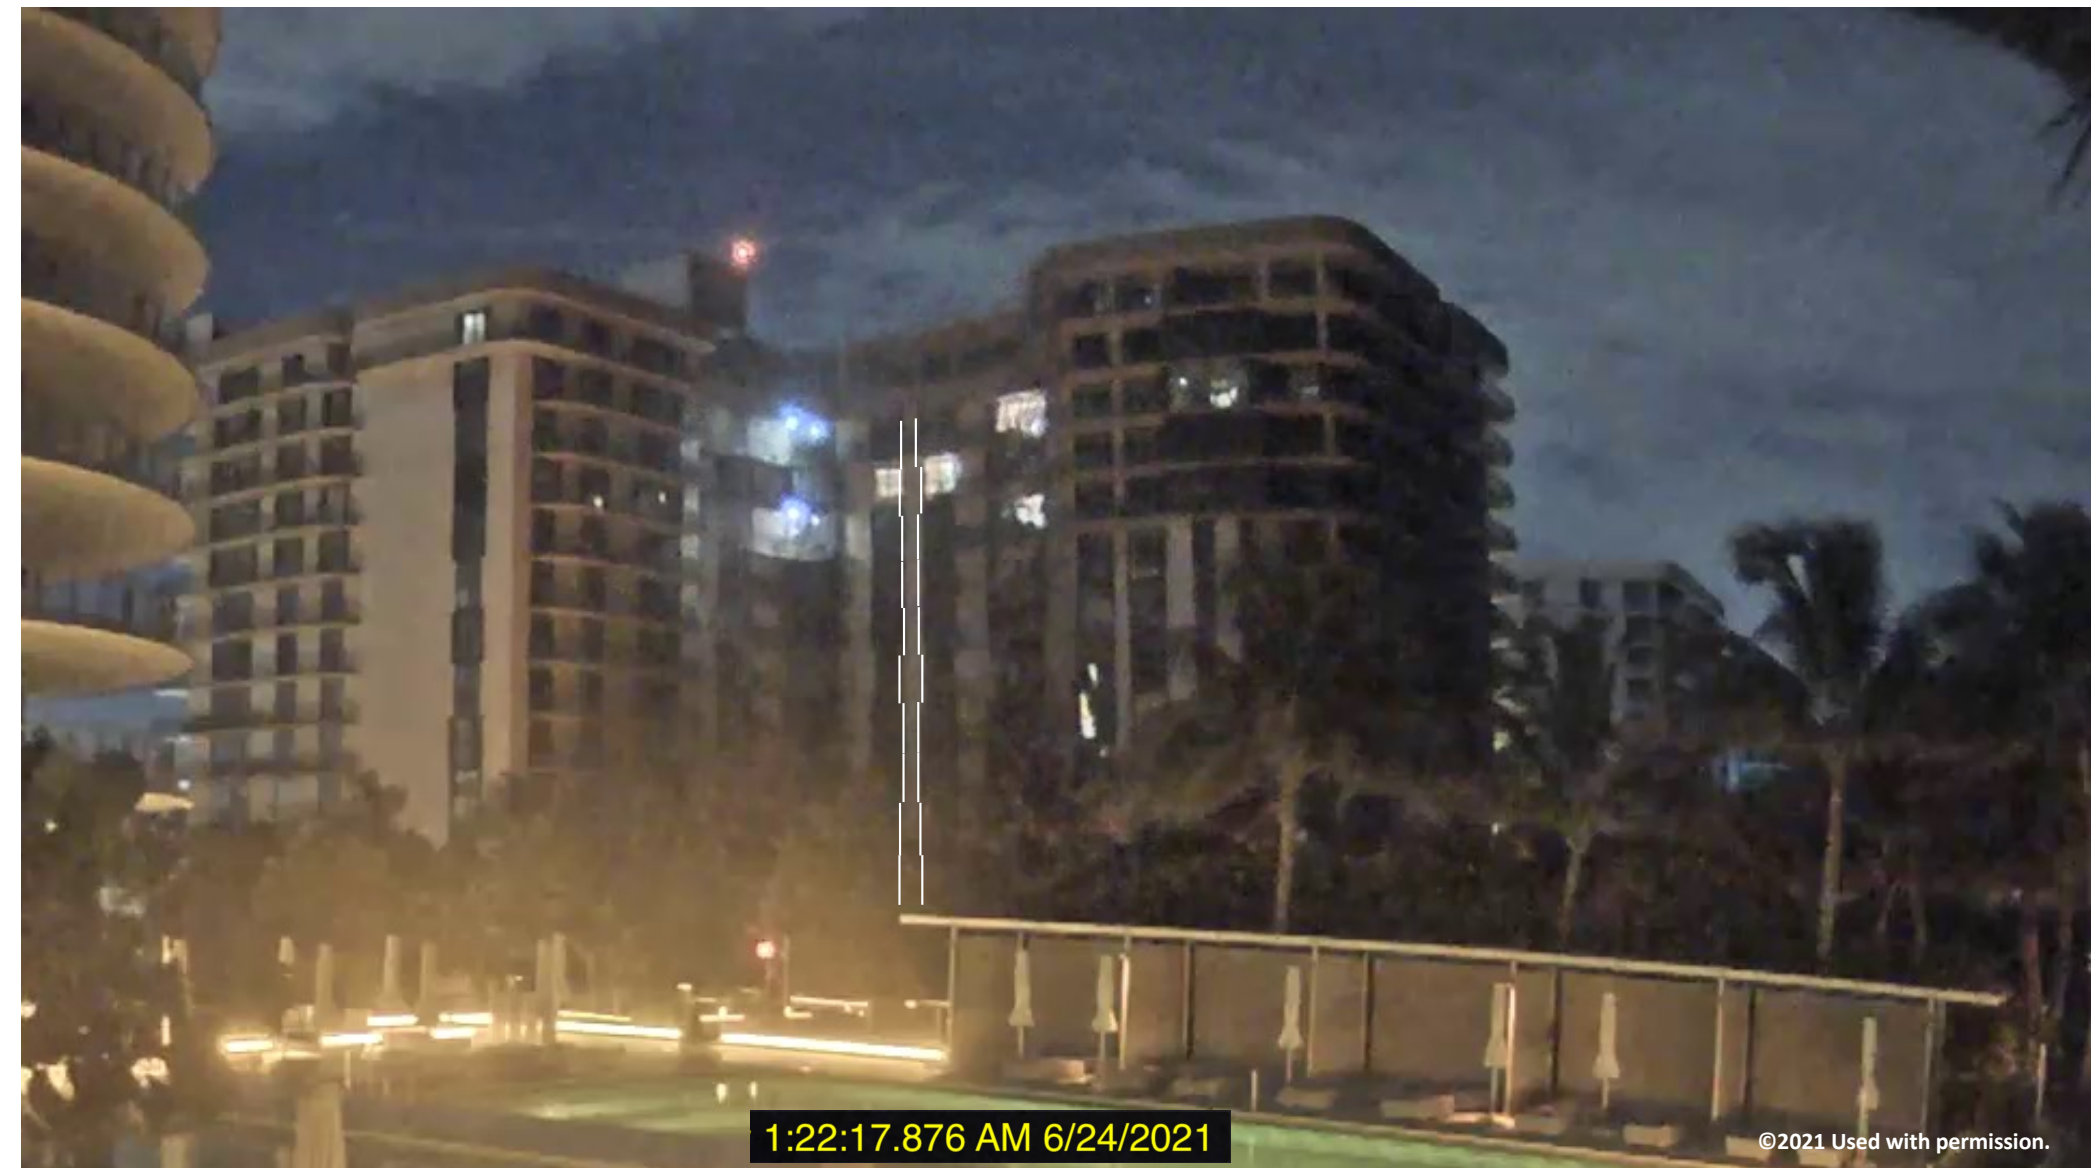
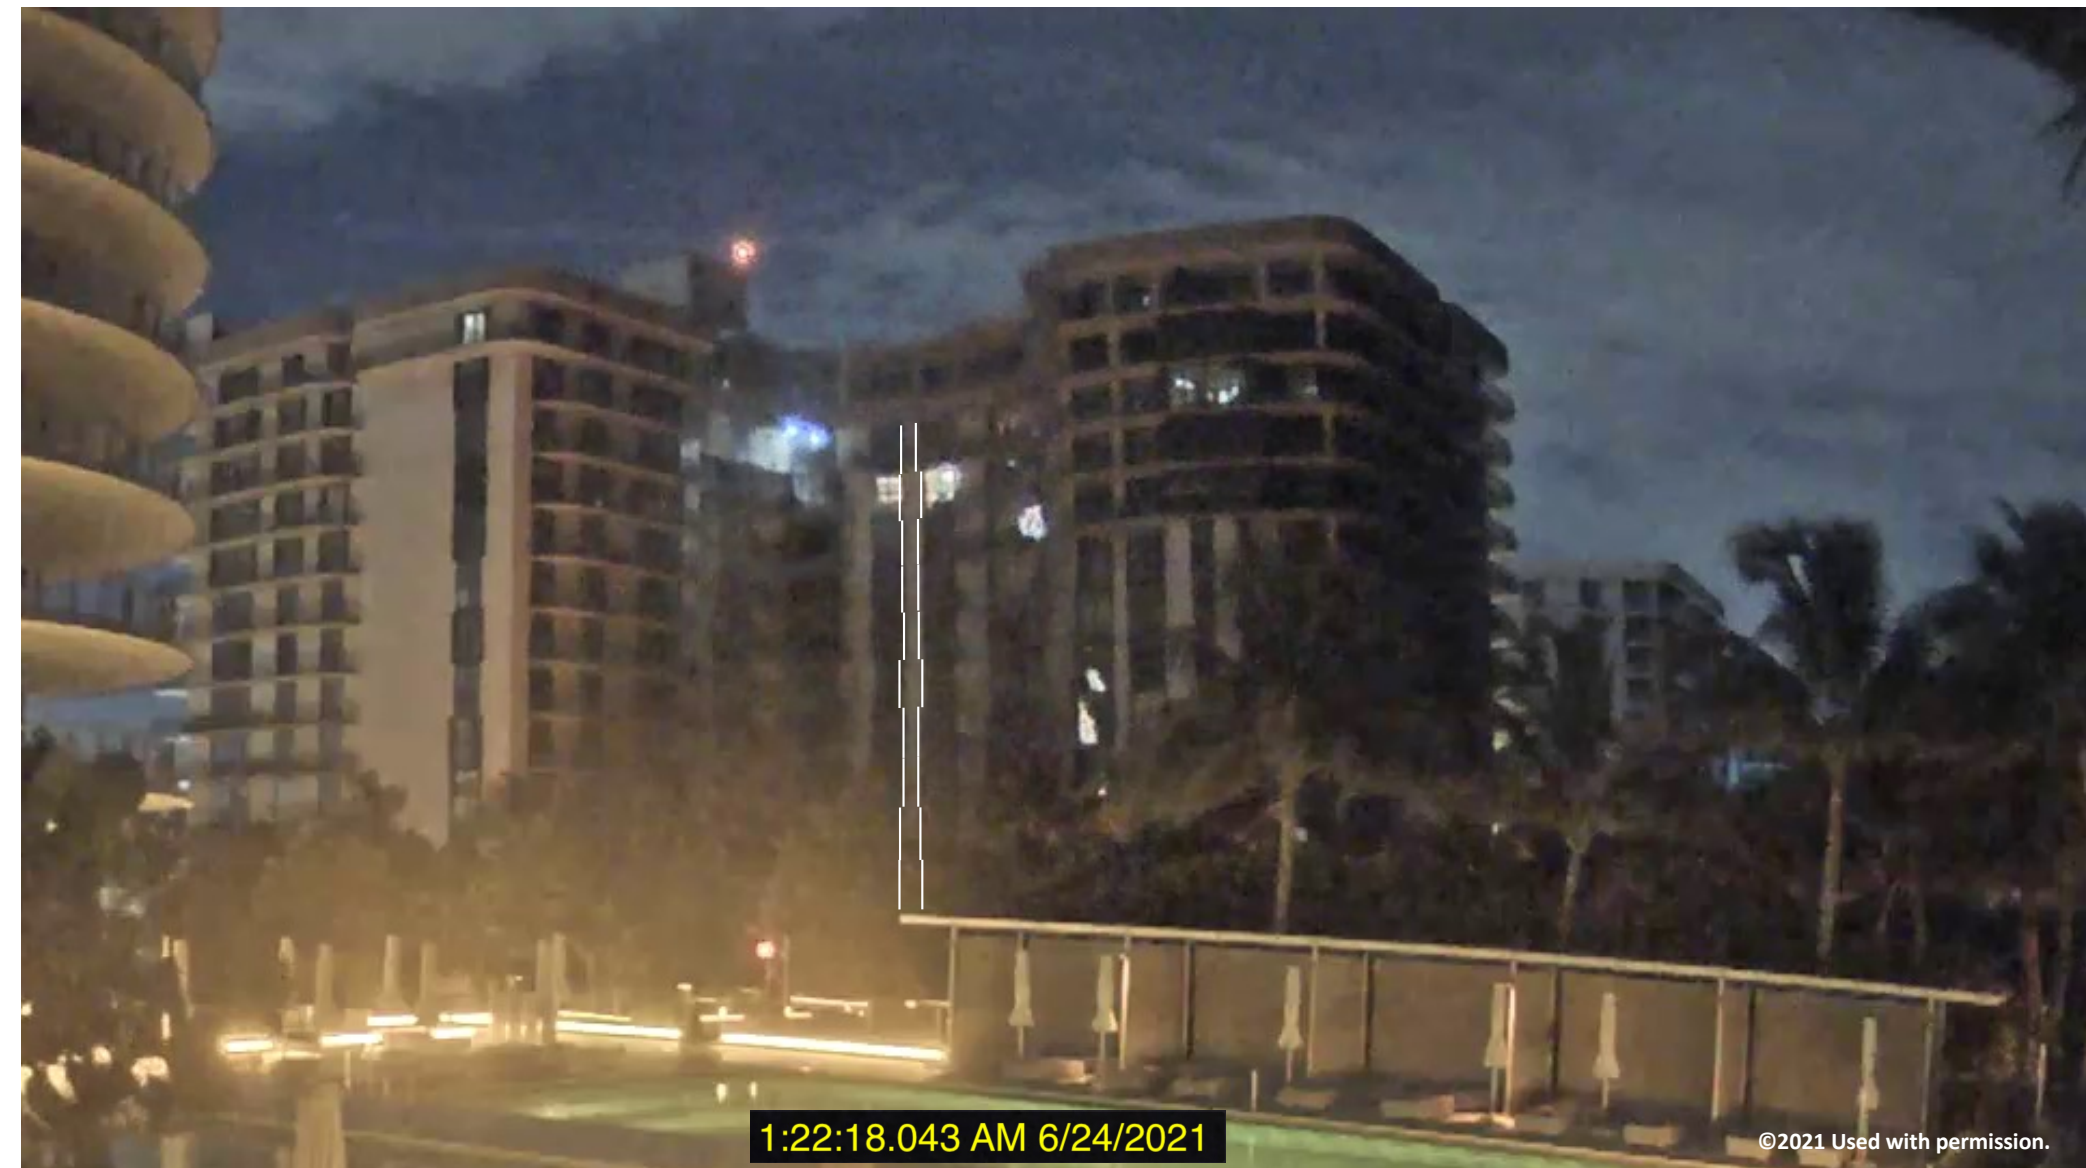
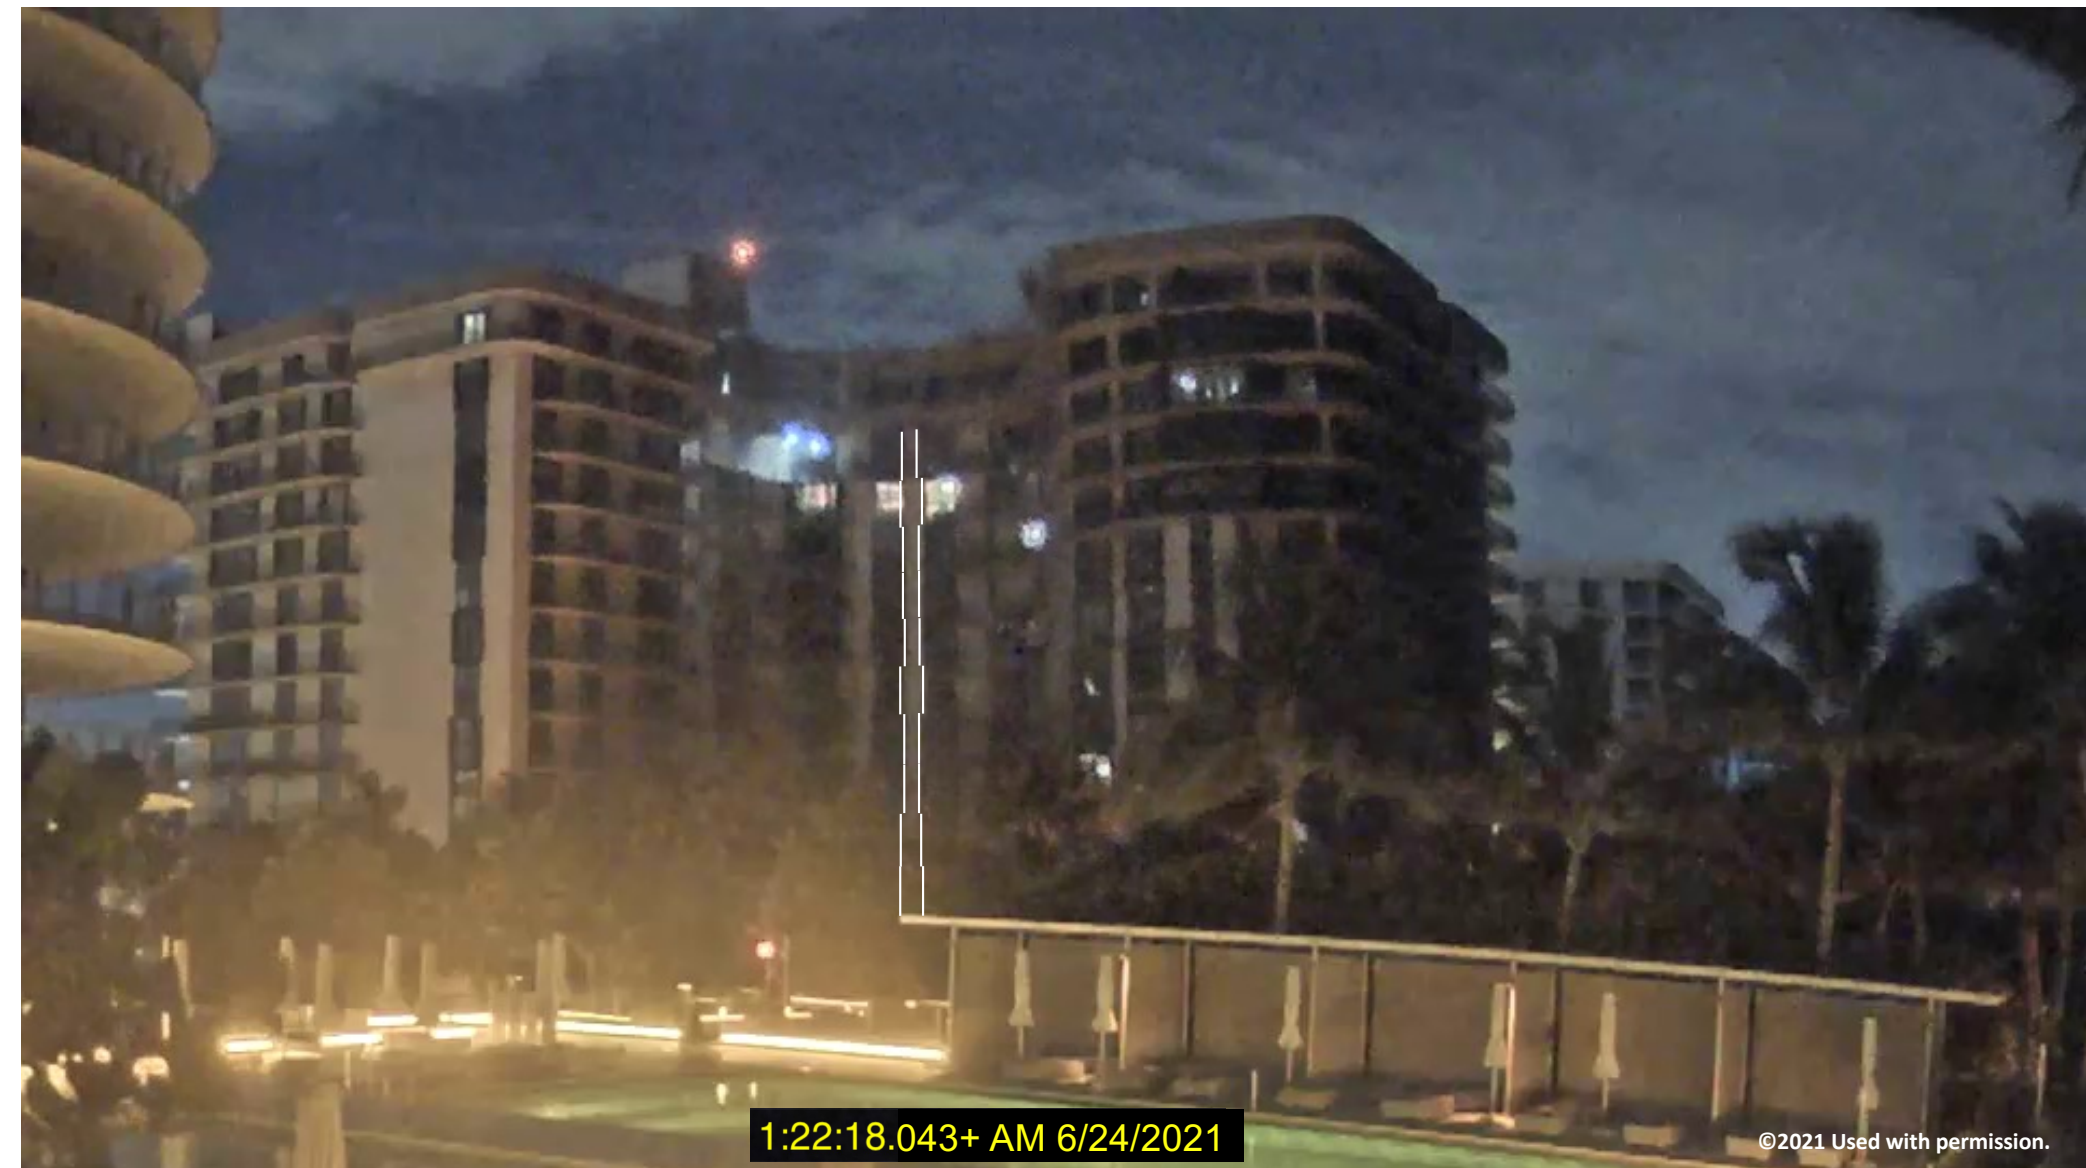
1. The unique façade shape moves uniformly downward, indicating that the failures that triggered the eastern part of the tower drop must have occurred below the 3rd floor.
