NCST Investigation of the Champlain Towers South Collapse

Cross-Project Panel Theme 1: Timeline and Evidence Collection

*Judith Mitrani-Reiser, N. Emel Ganapati,
David Goodwin, Christopher Segura,
Jonathan Weigand, Kamel Saidi, and Jack Moehle*

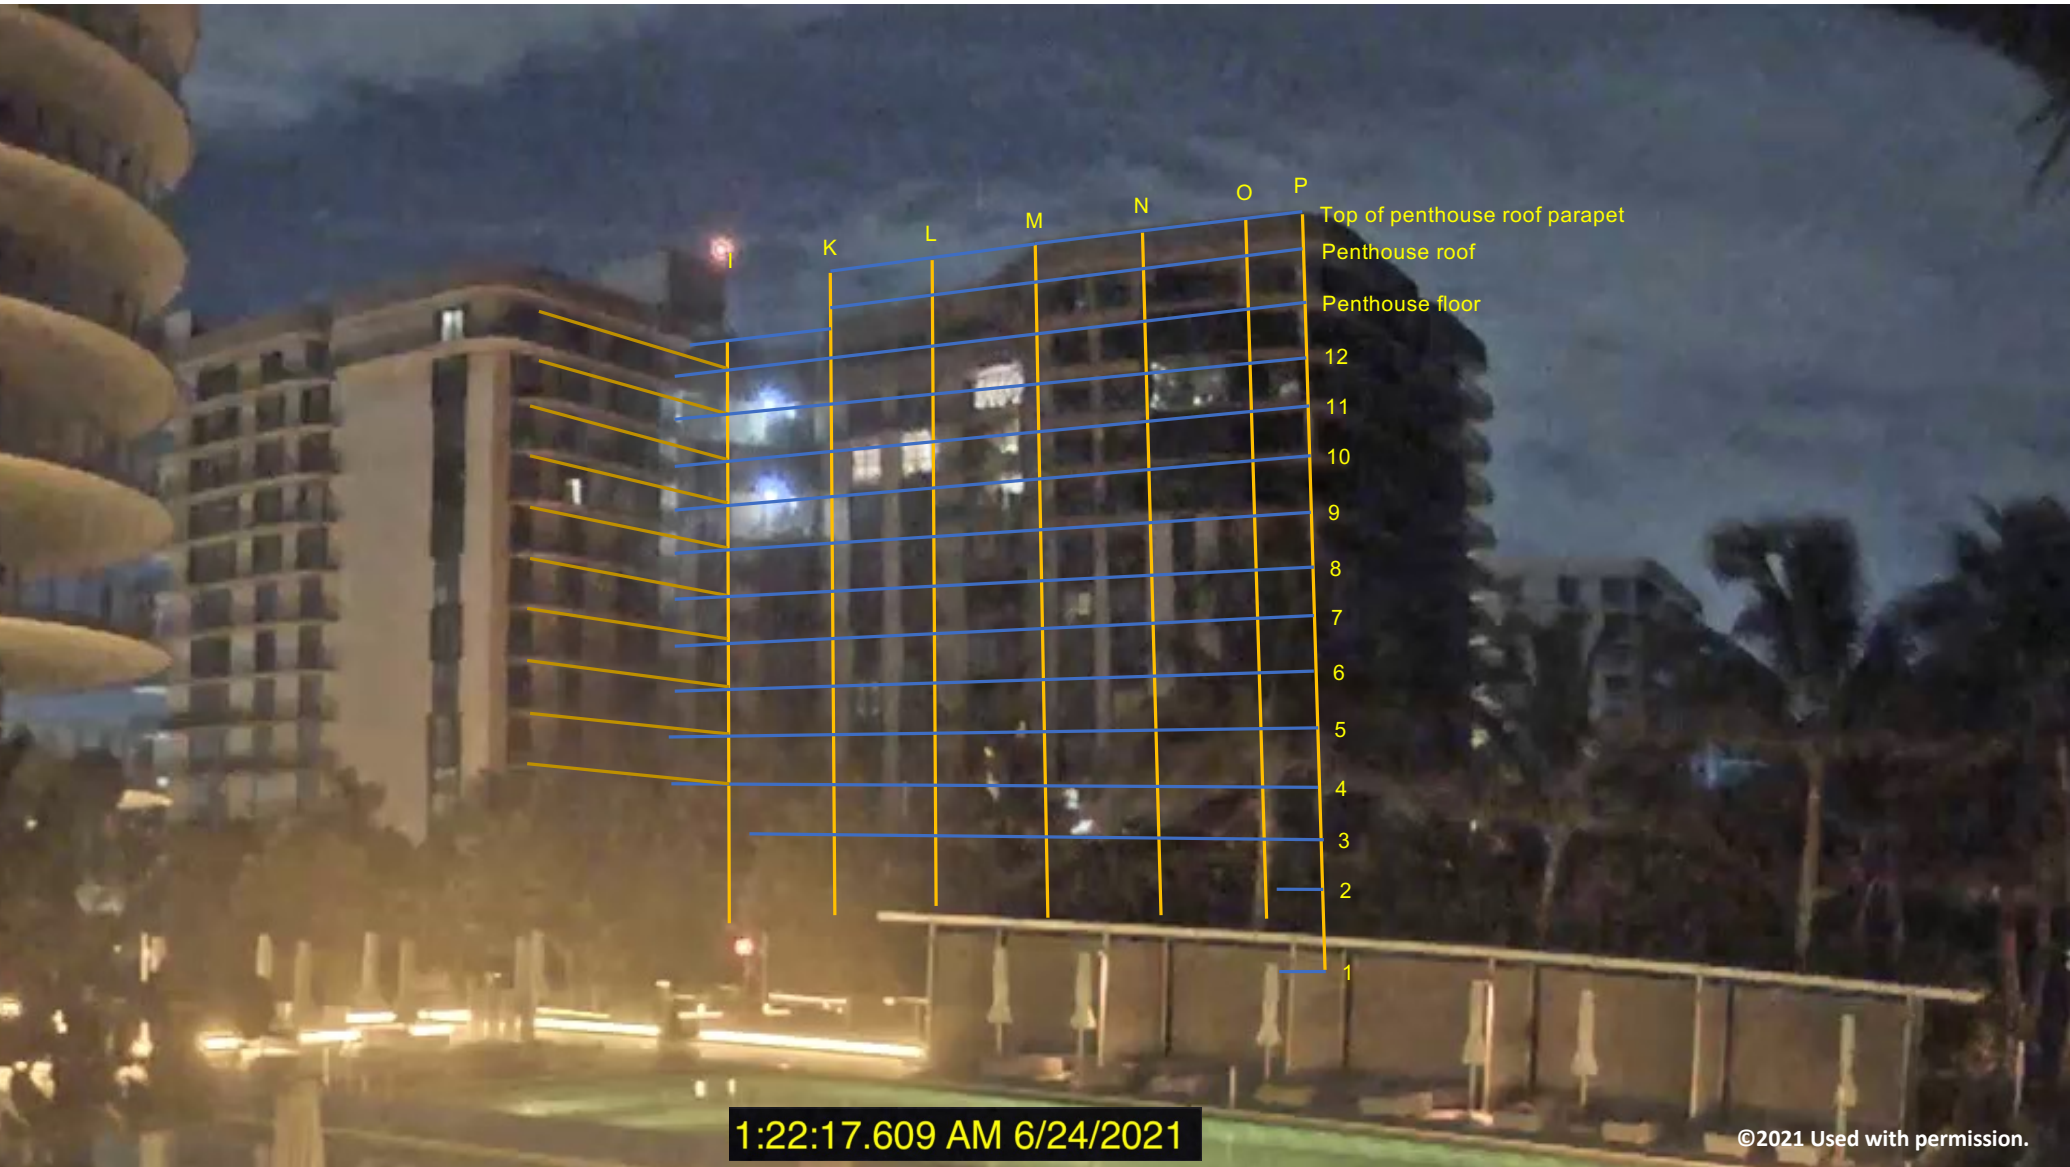
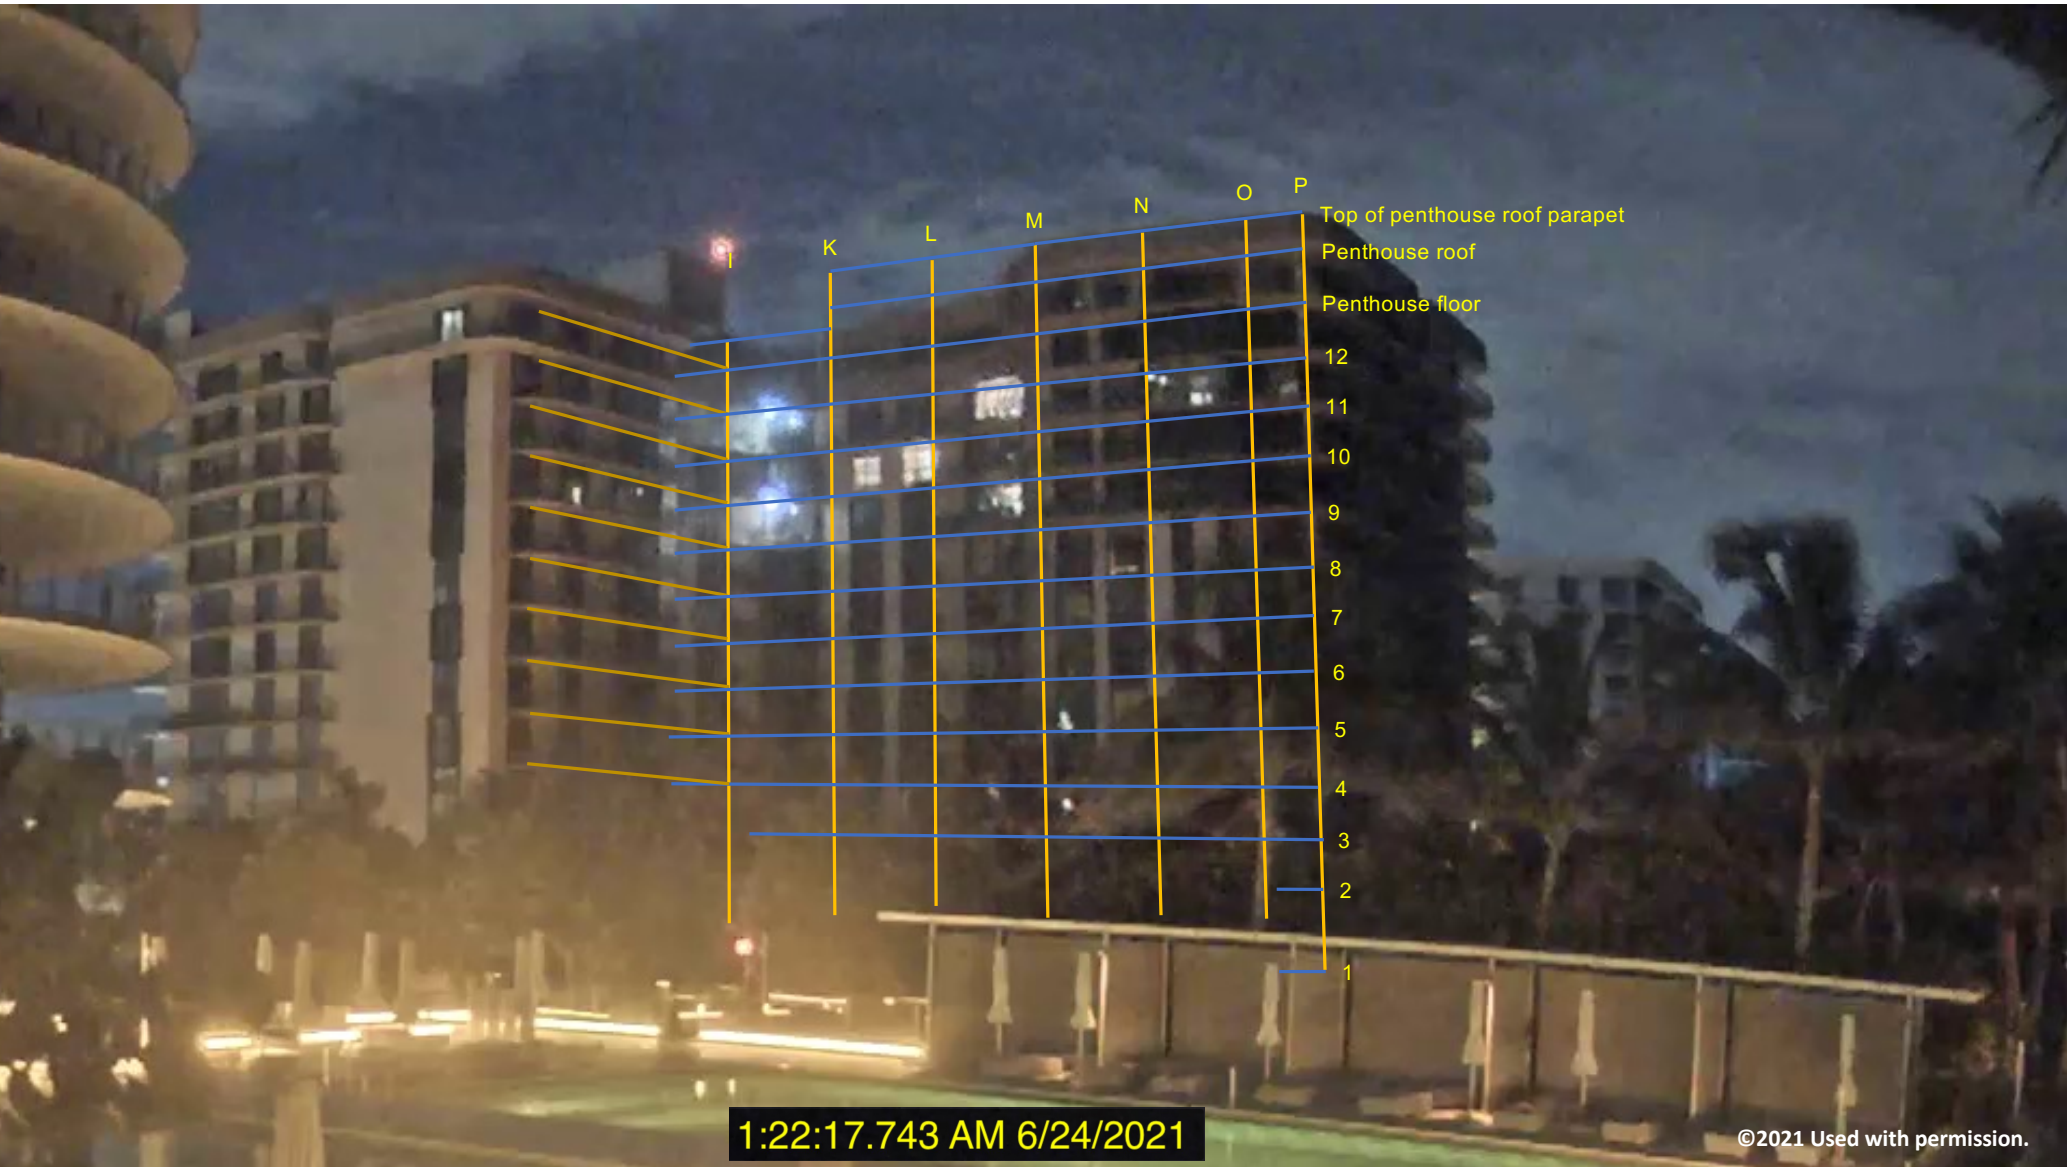
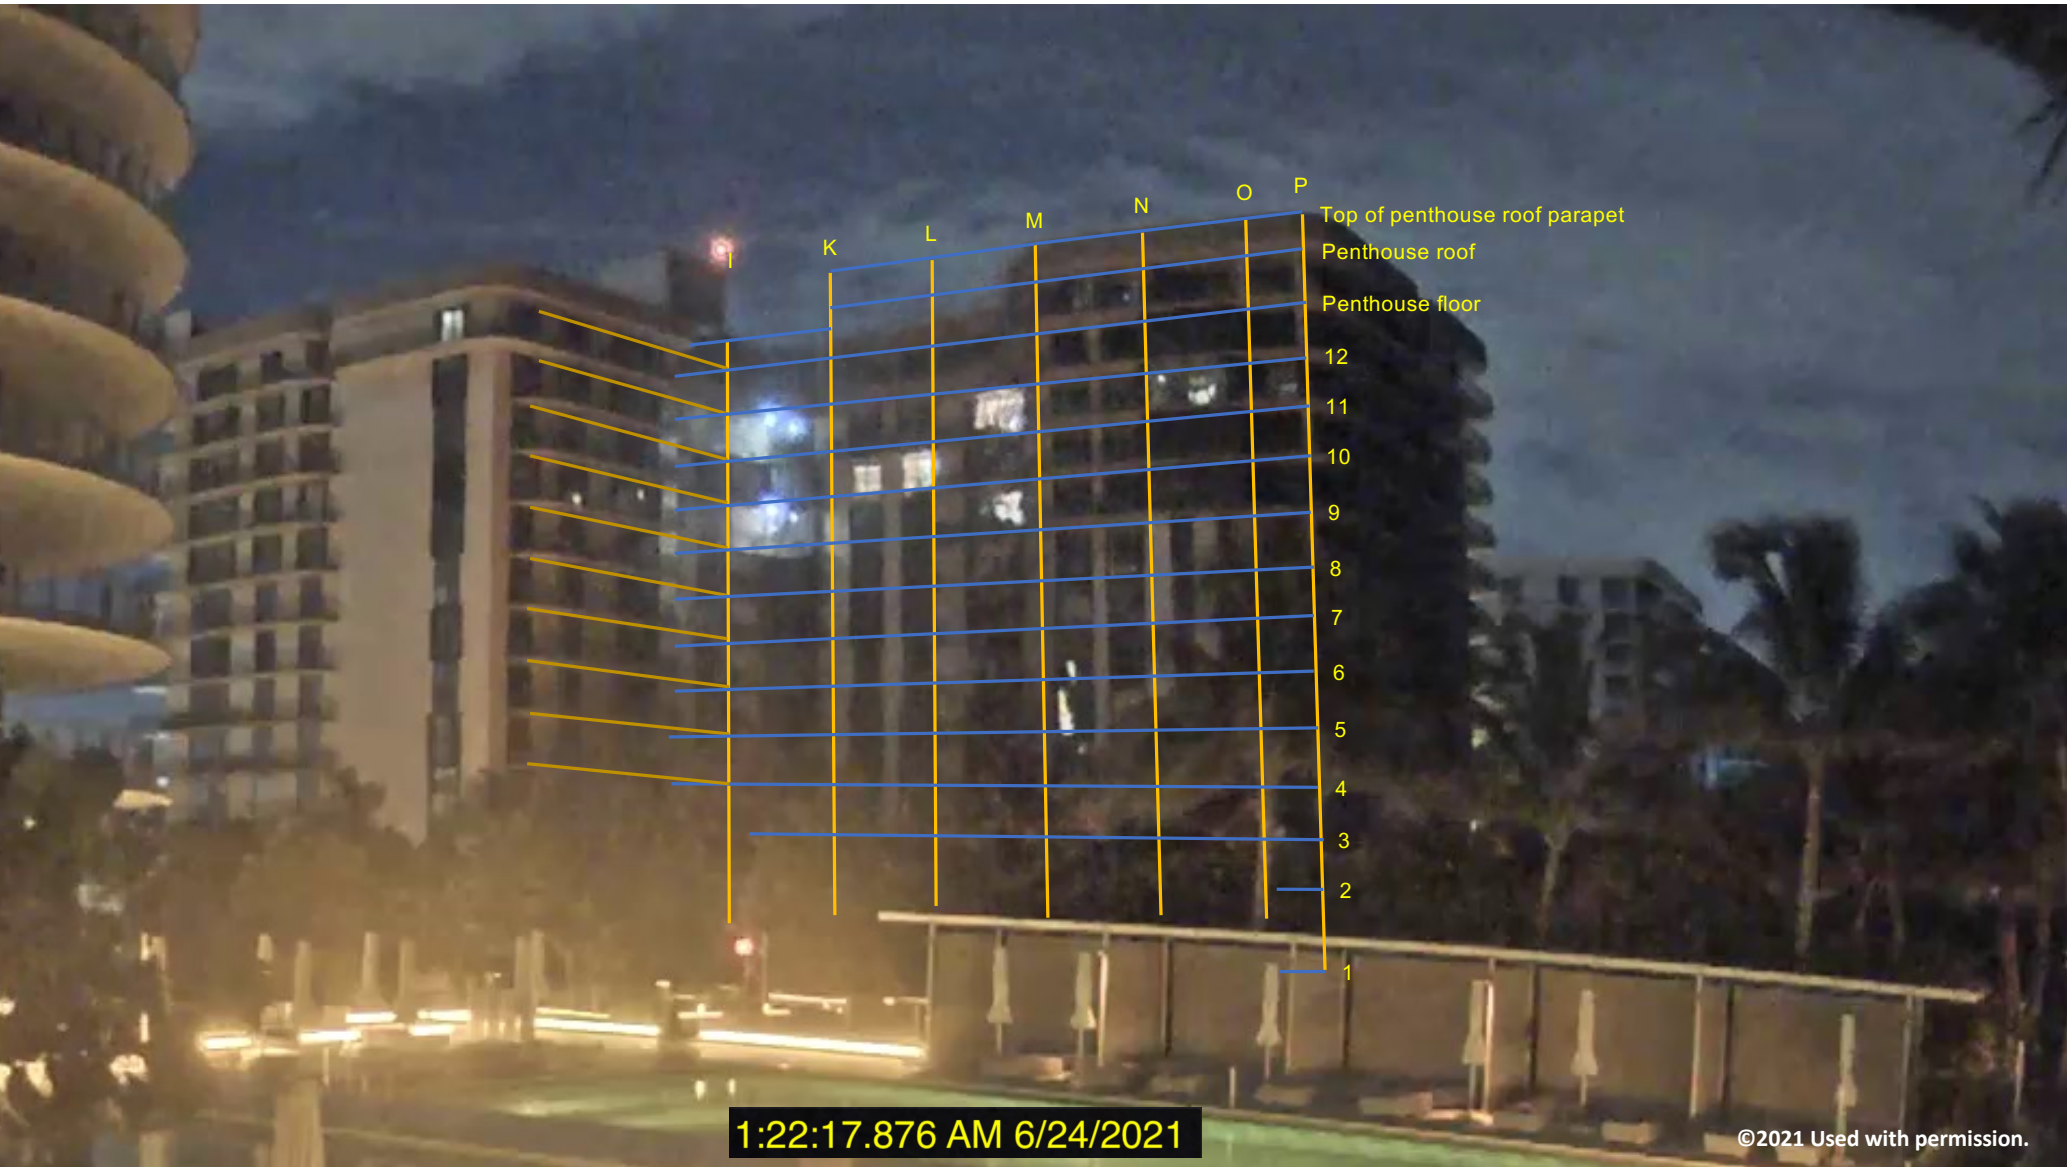
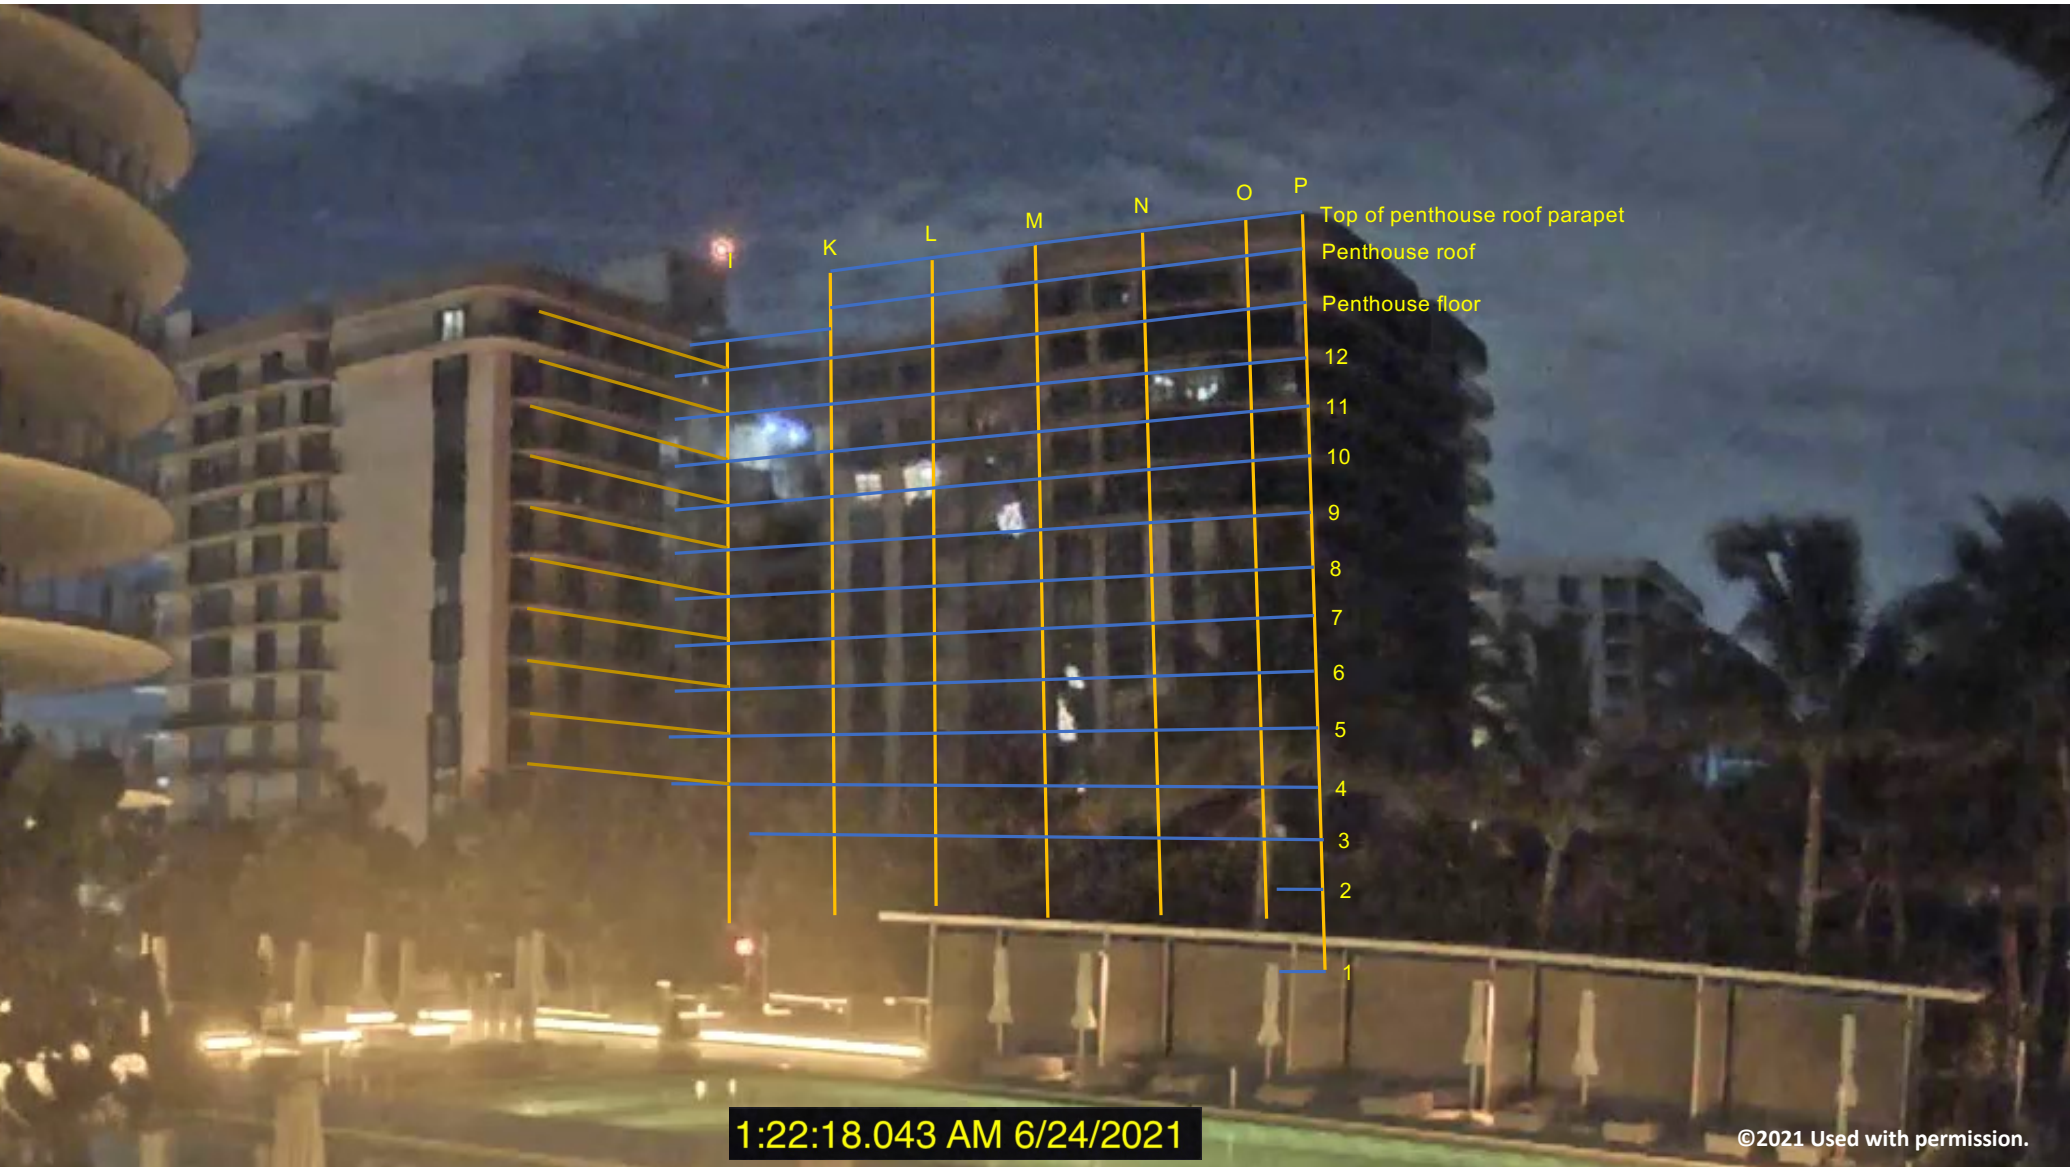
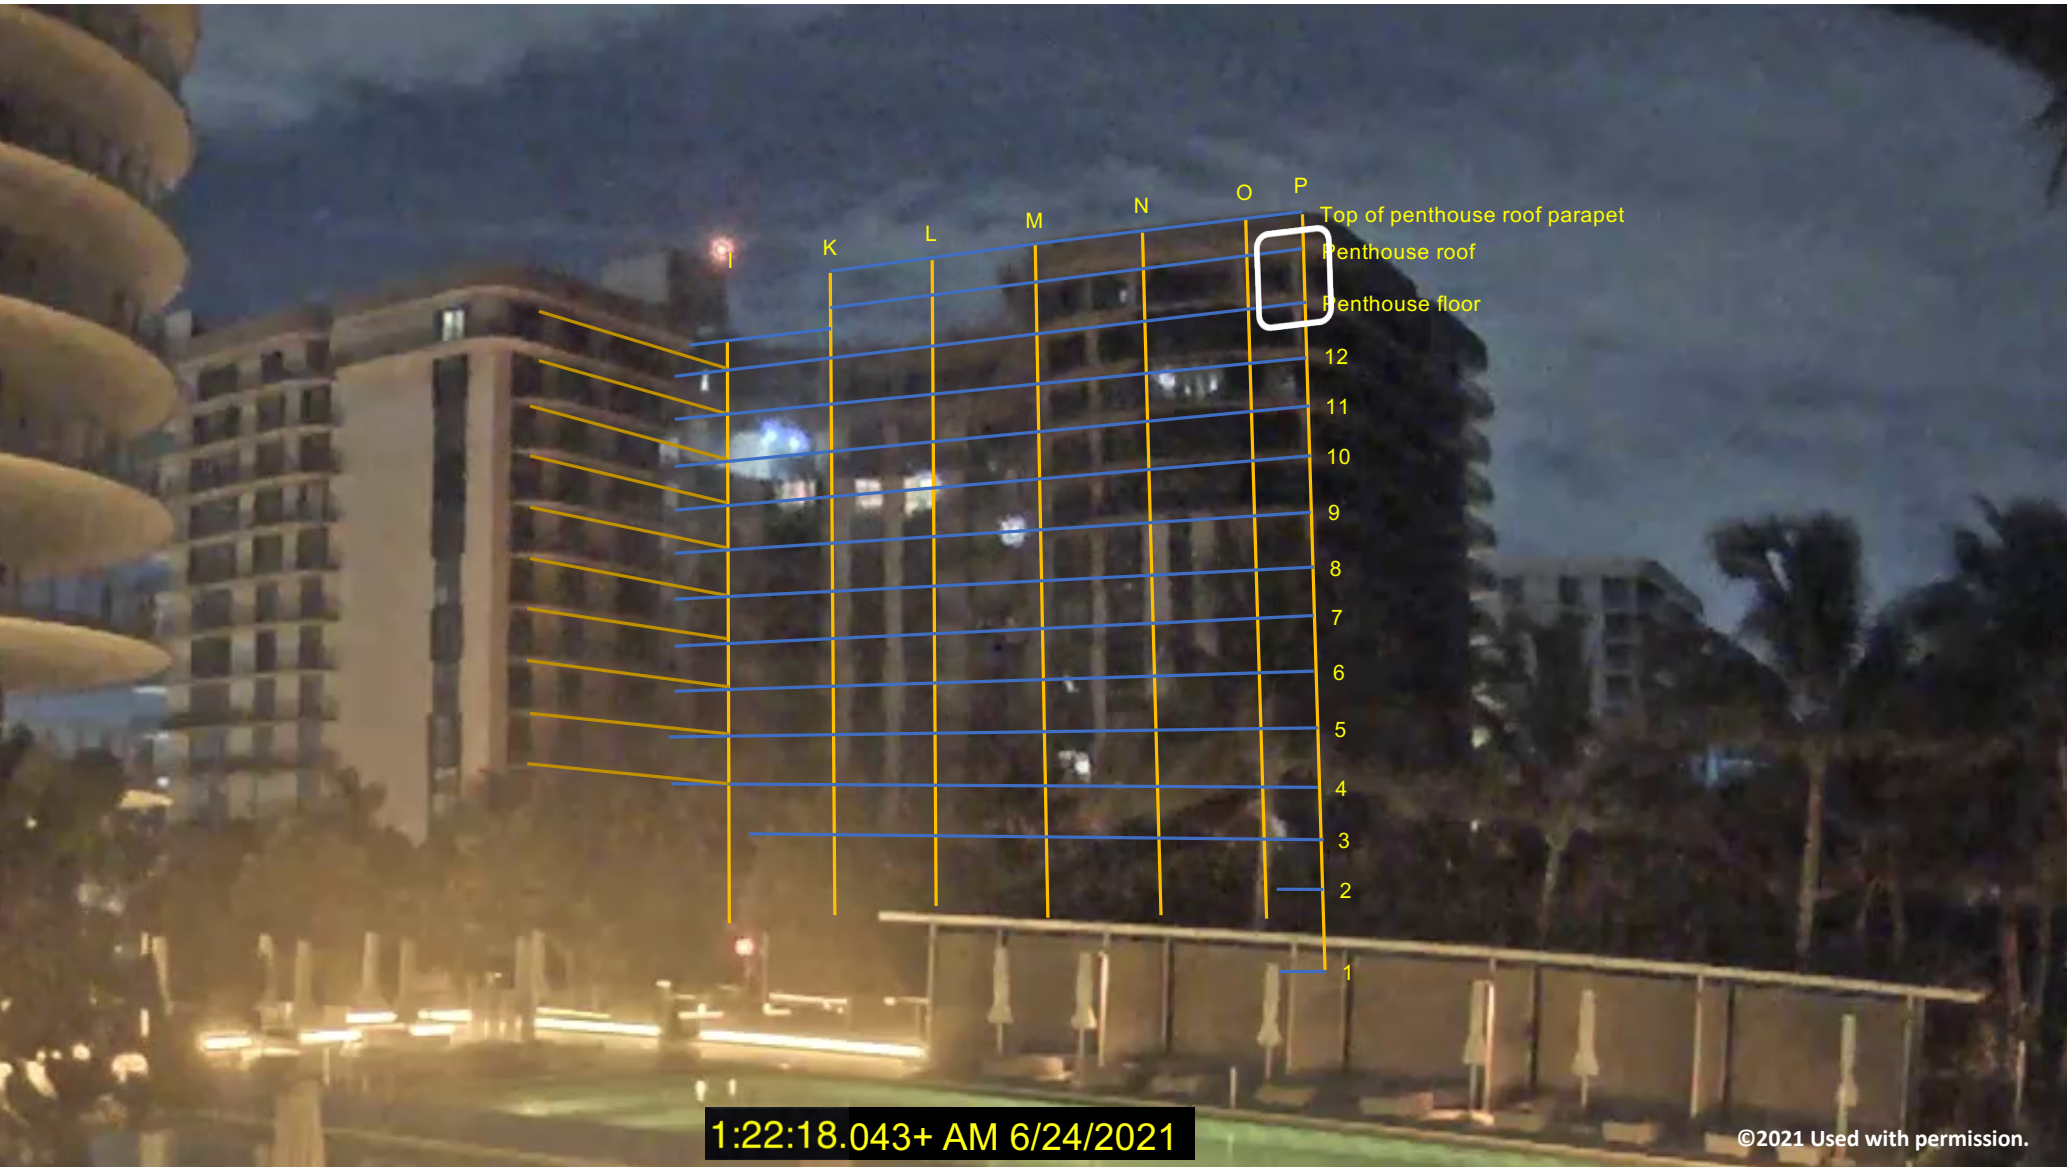
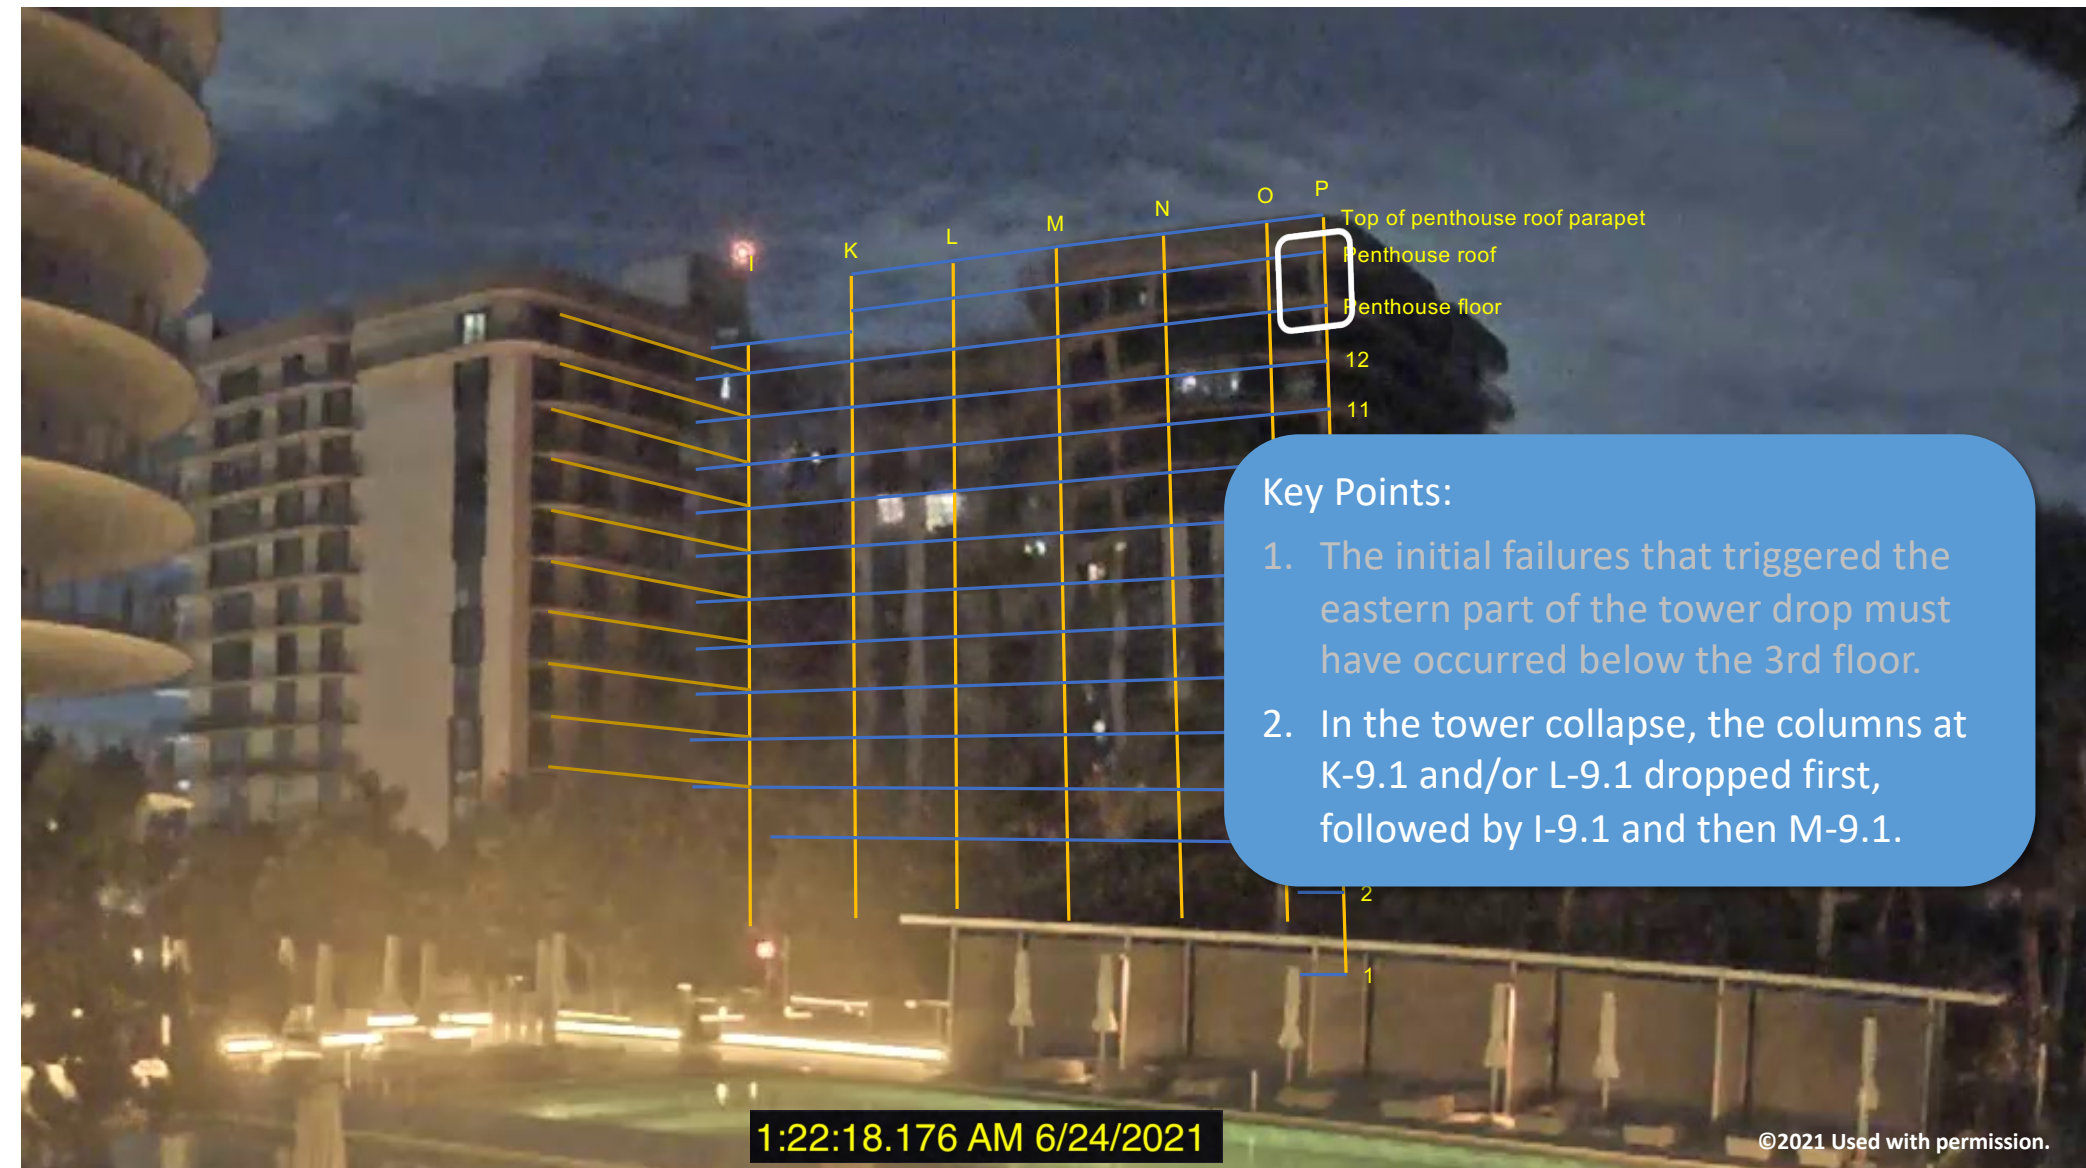
- 1. The initial failures that triggered the eastern part of the tower drop must have occurred below the 3rd floor.
- 2. In the tower collapse, the columns at K-9.1 and/or L-9.1 dropped first, followed by I-9.1 and then M-9.1.
