NCST Investigation of the Champlain Towers South Collapse

Cross-Project Panel Theme 1: Timeline and Evidence Collection

*Judith Mitrani-Reiser, N. Emel Ganapati,
David Goodwin, Christopher Segura,
Jonathan Weigand, Kamel Saidi, and Jack Moehle*

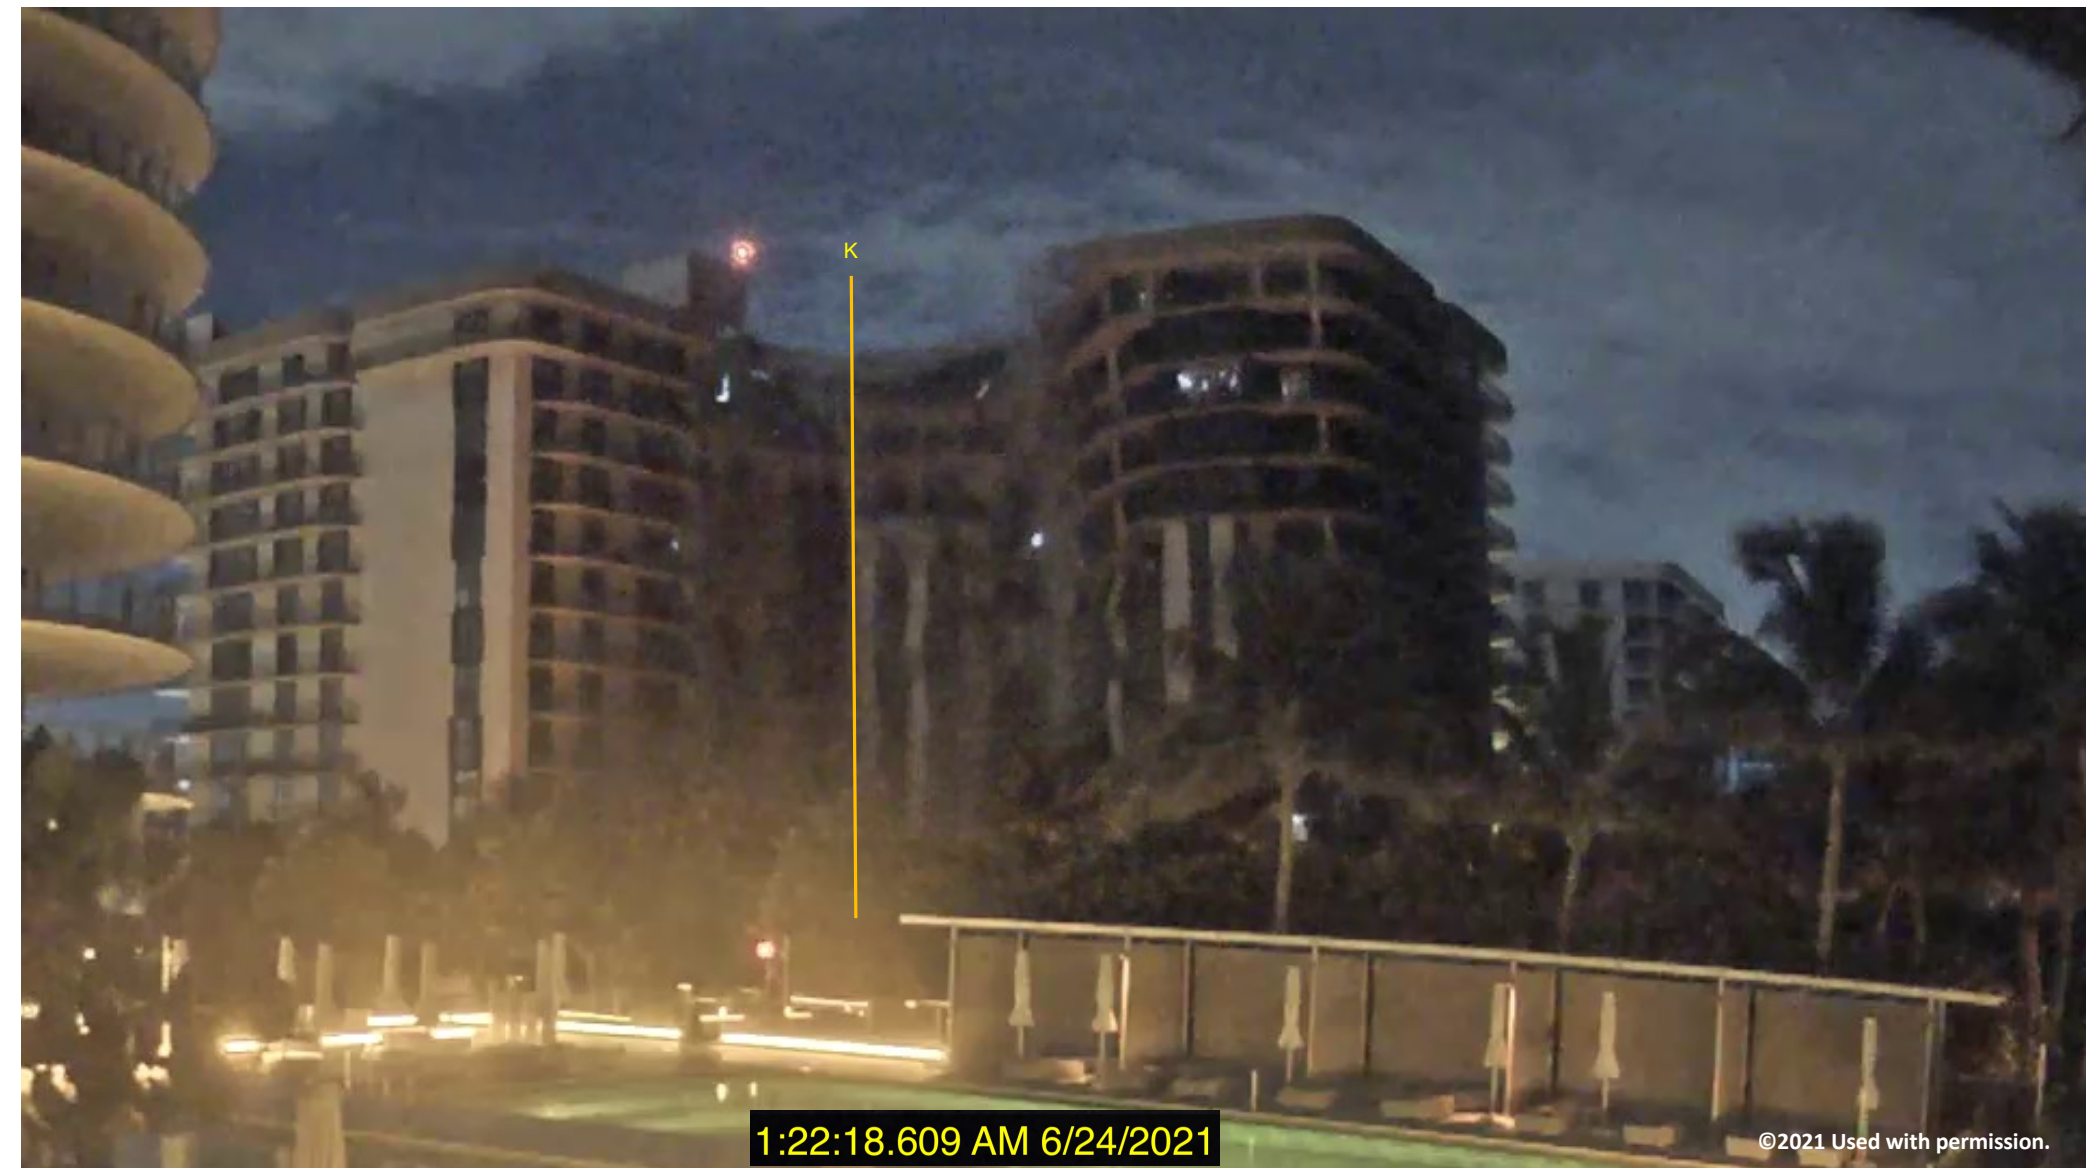
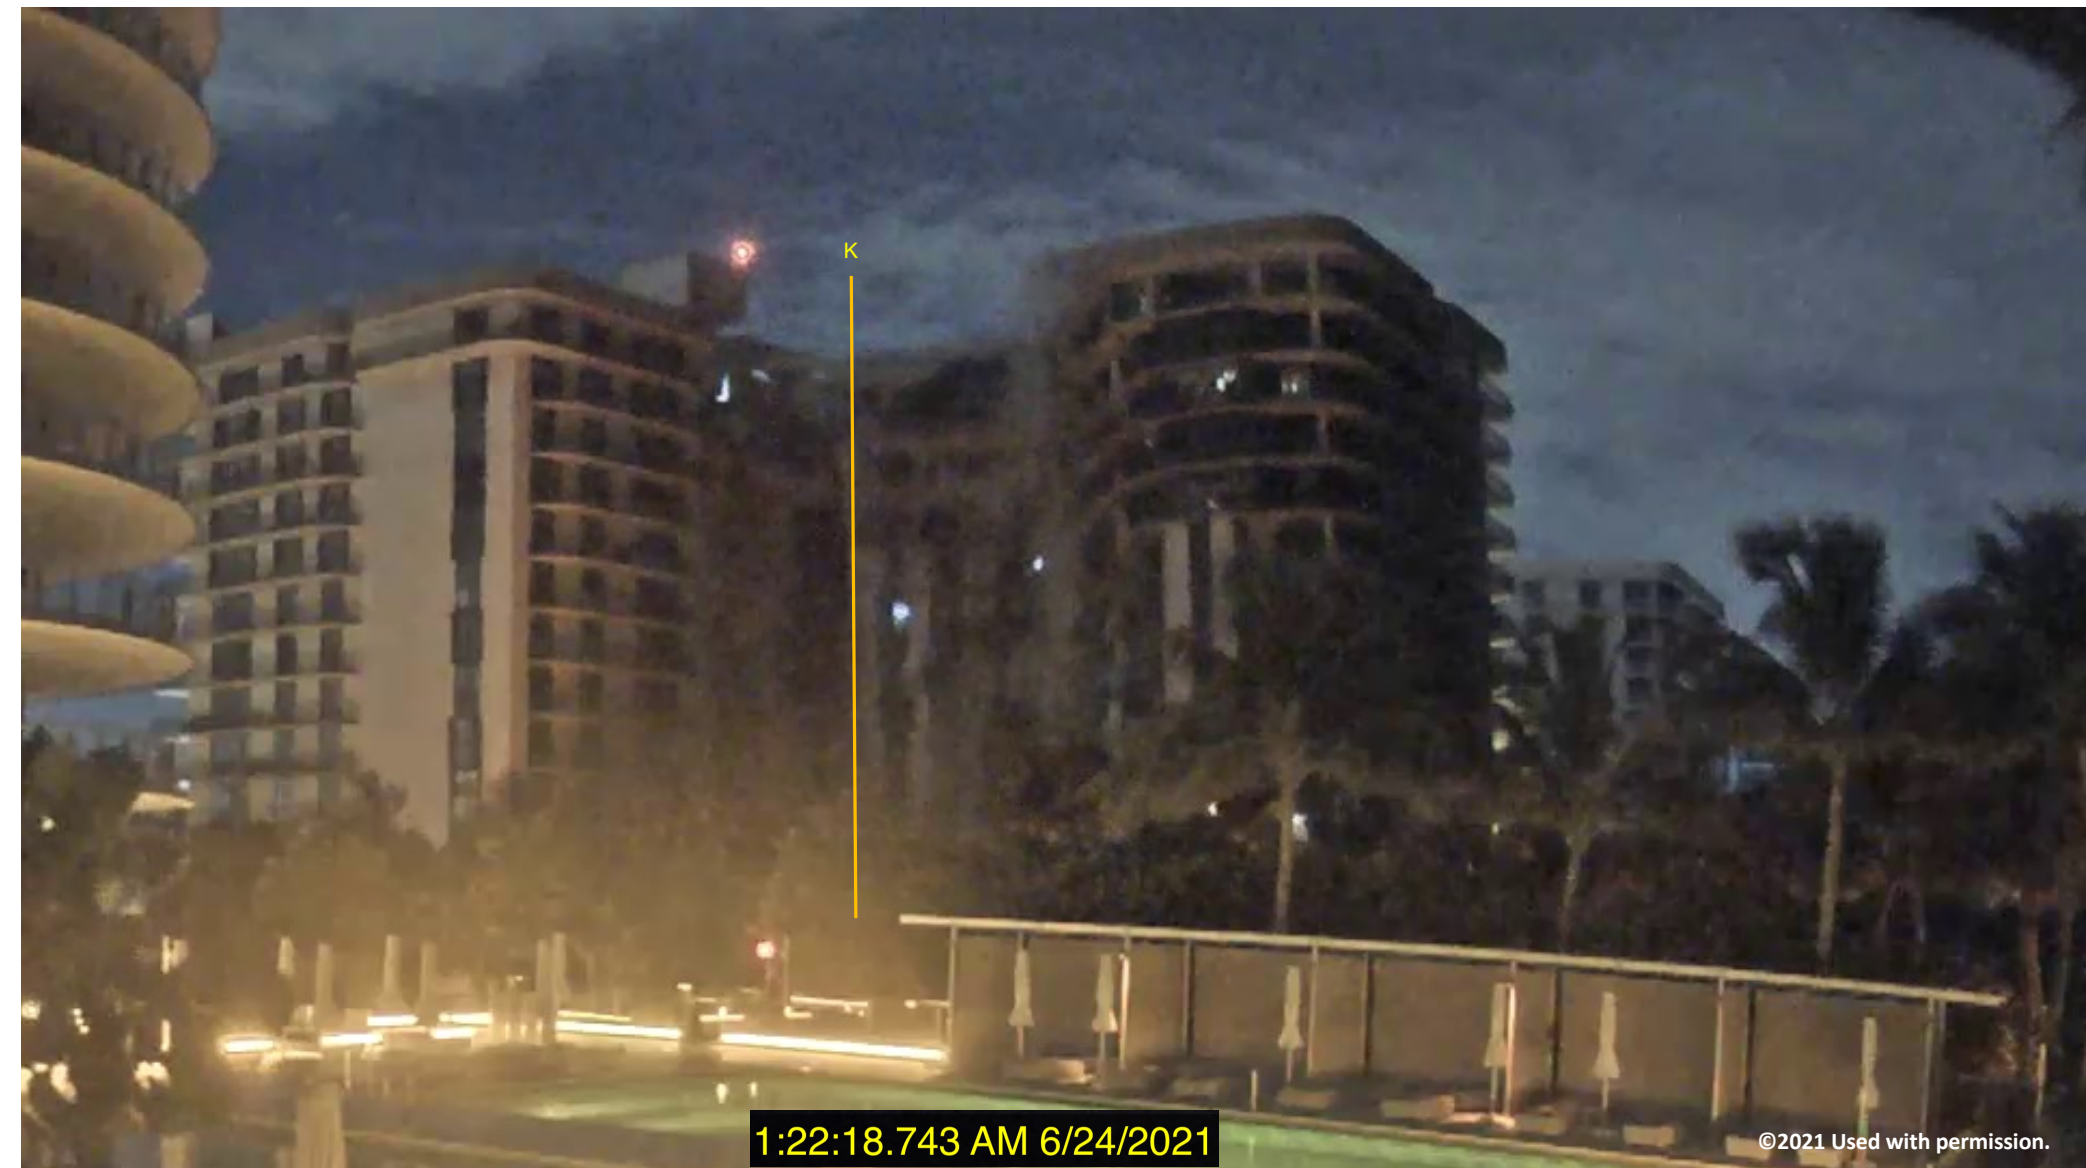
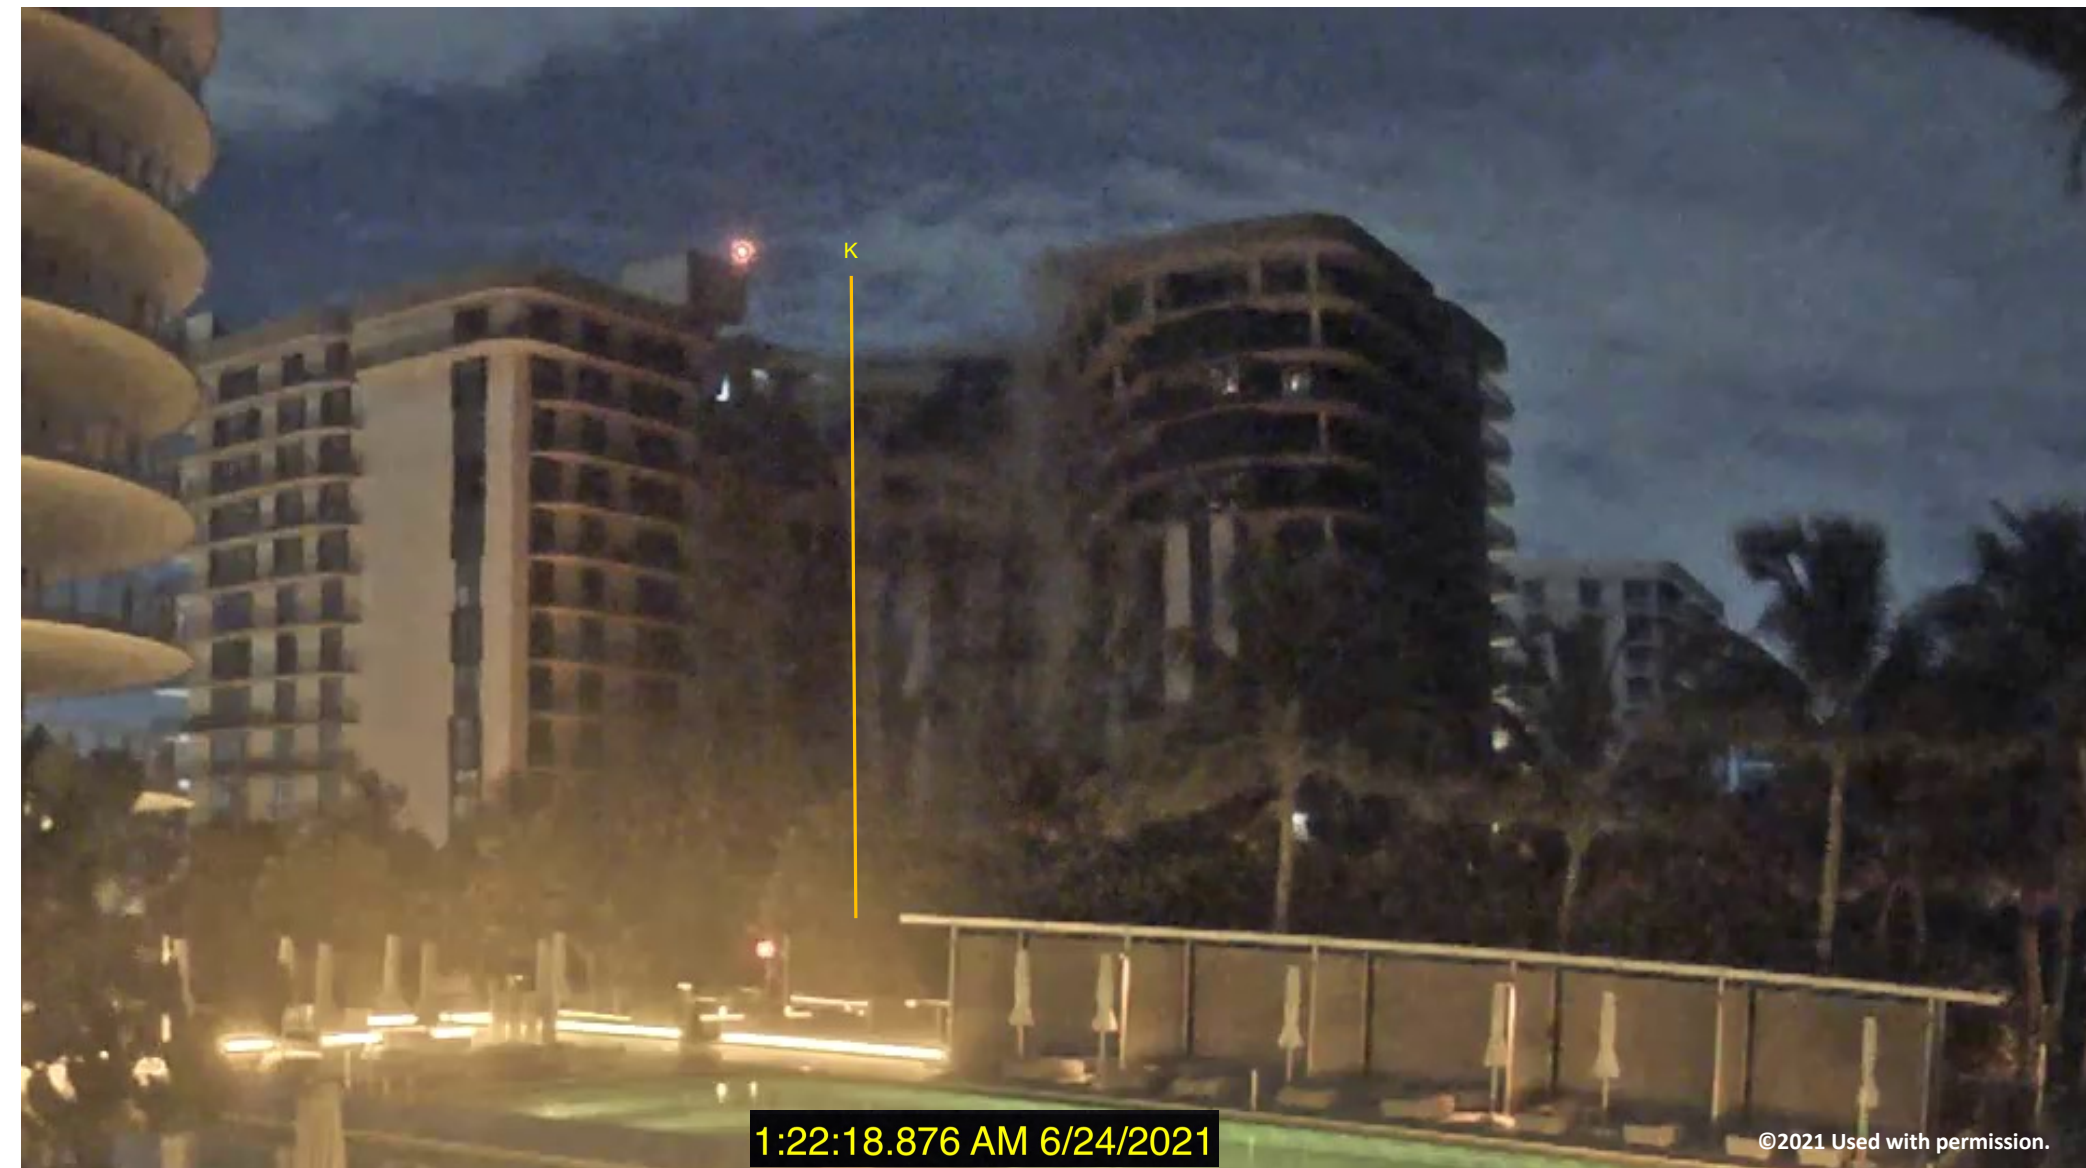
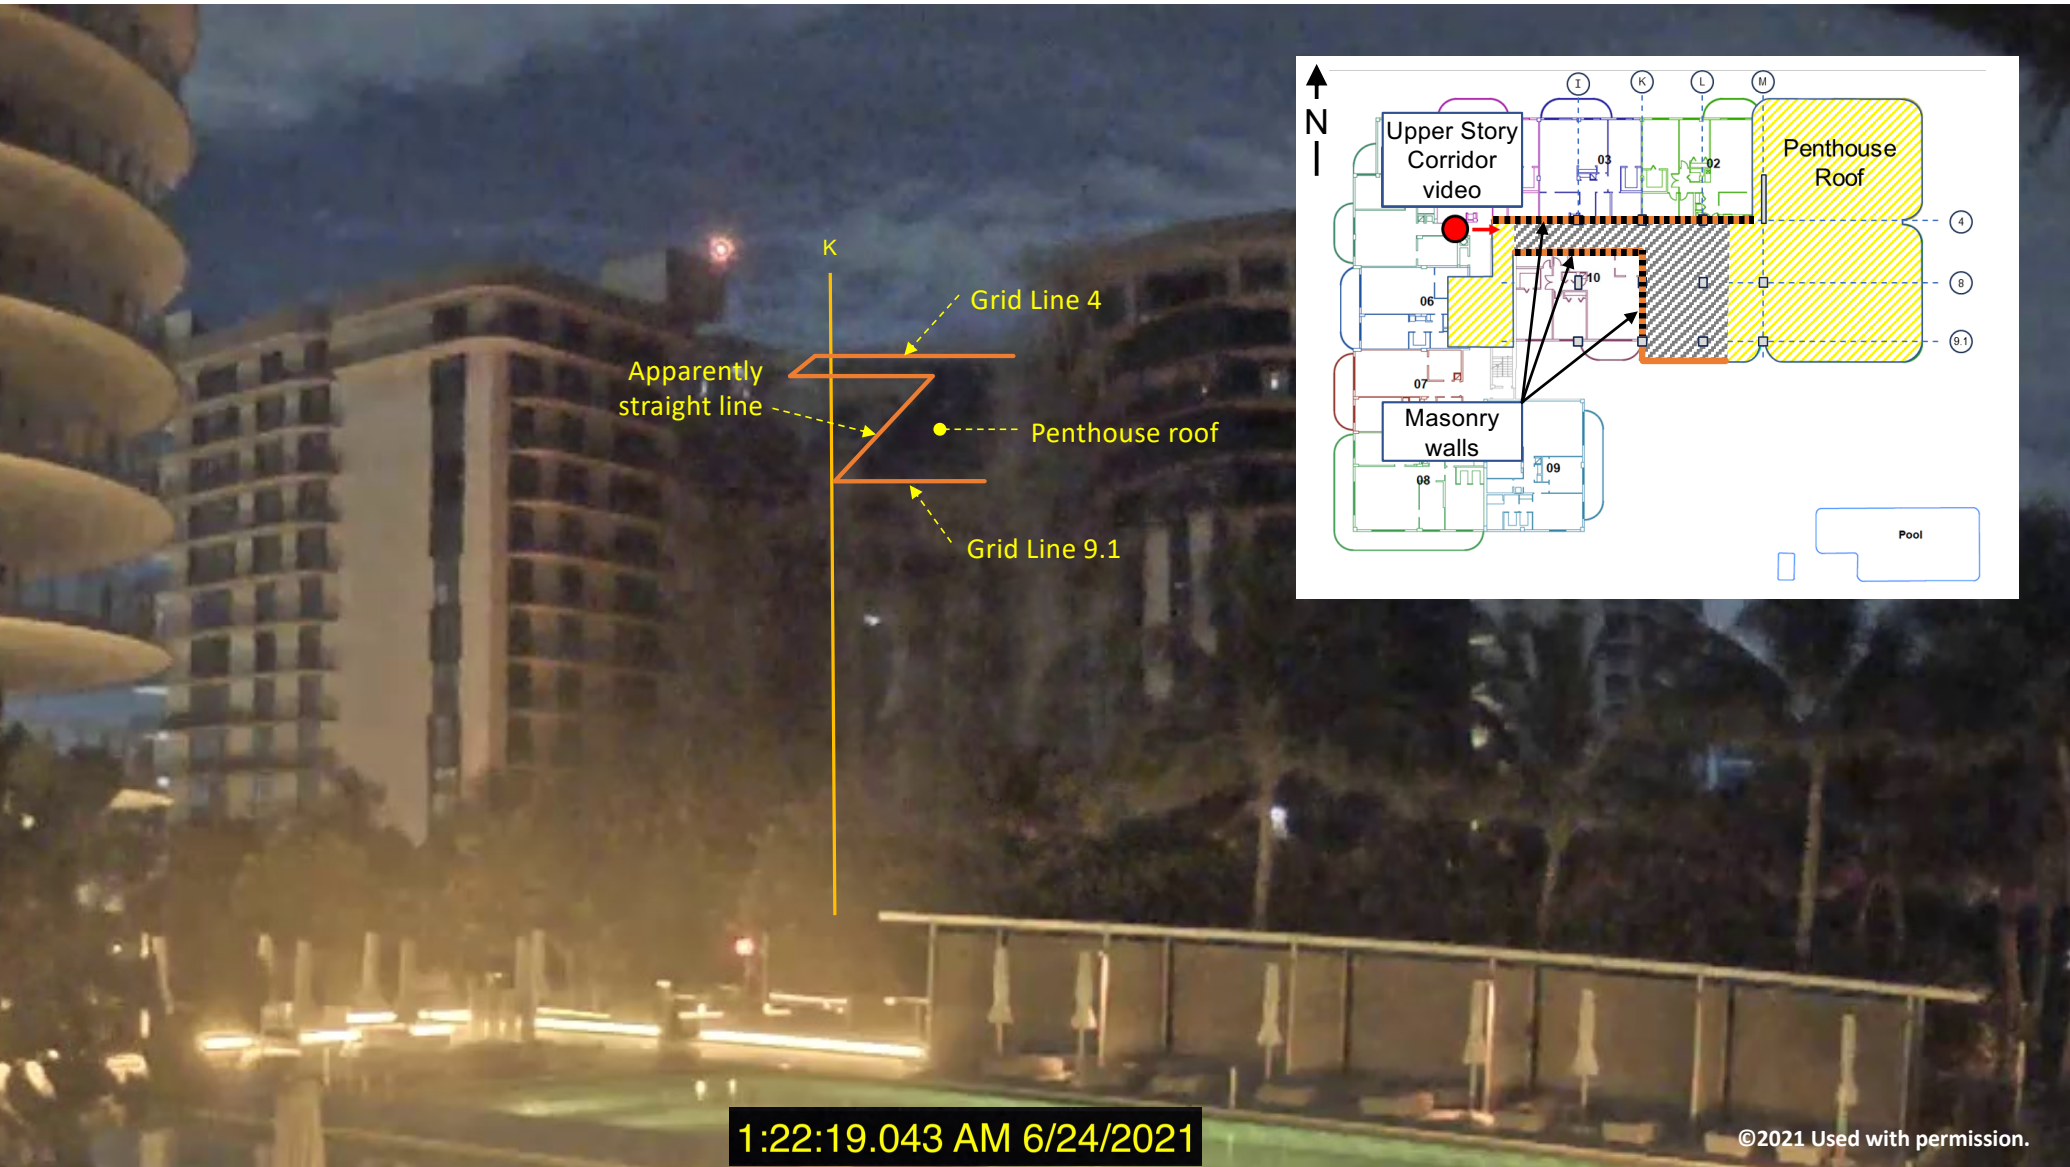
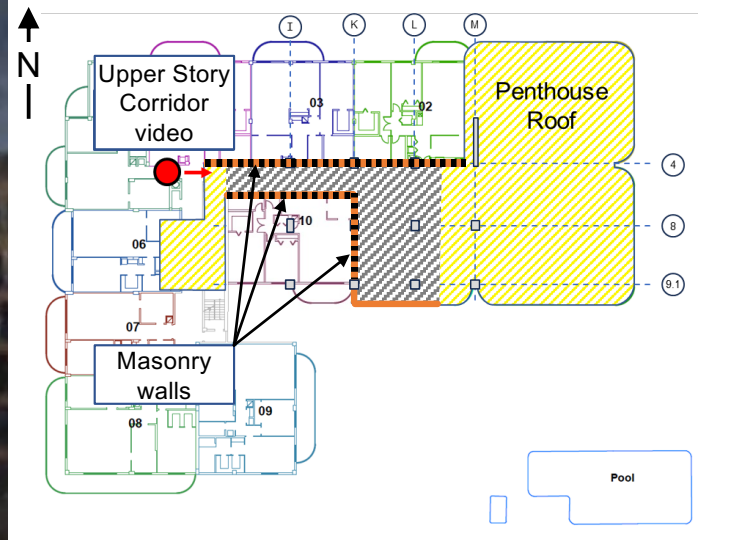
1. The initial failures that triggered the eastern part of the tower drop must have occurred below the 3rd floor.
2. In the tower collapse, the columns at K-9.1 and/or L-9.1 dropped first, followed by I-9.1 and then M-9.1.
3. As the columns on Grid Line 9.1 dropped, the collapse advanced northward.

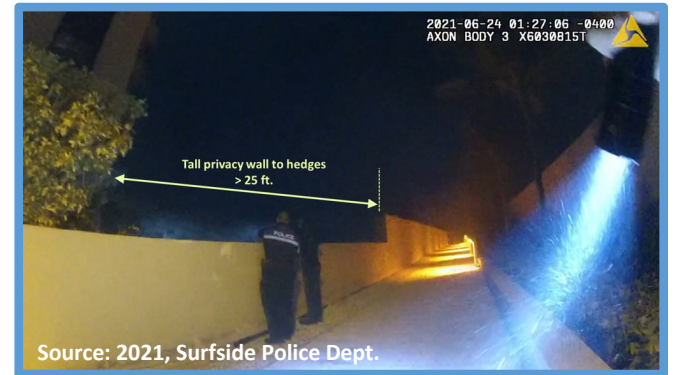
Beach Access Walkway Video
+
Police Body Camera Video

Beach Access Walkway camera shows three individuals on walkway, observing damage.

Body camera shows two individuals, observing damage.

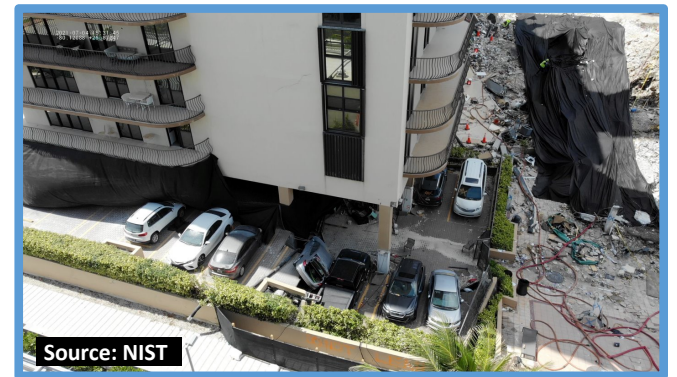
Eyewitness accounts

- Horizontal cracks across the stucco façade
- Windows/sliding doors on the 1st floor exploding
- “A huge cloud of dust” blowing from the garage– getting “bigger and bigger” until nothing can be seen

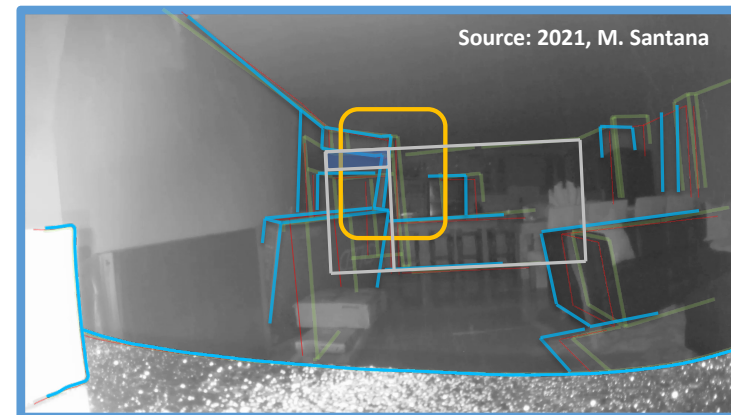
11 Stack Unit Video

- Material seen falling in front of the camera may indicate distress from the floor above or the upper parts of the unit's walls
- Movements observed in the room are consistent with movements of Grid line 9.1
- Distortions in the kitchen partition wall may indicate greater vertical motion of Grid Line L relative to M
- No accurate timestamp yet

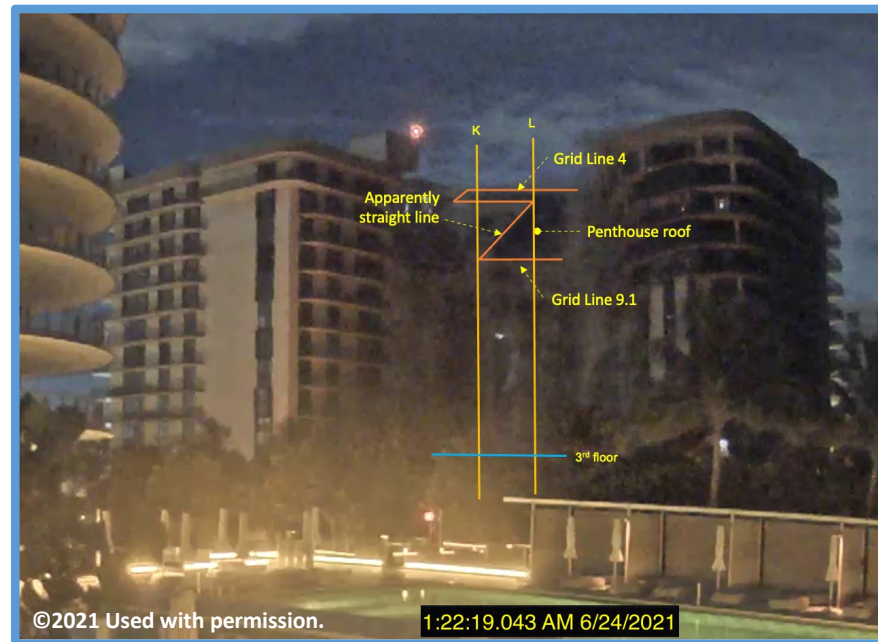
South Face Video

1. The unique façade shape moves uniformly downward, indicating that the failures that triggered the eastern part of the tower drop must have occurred below the 3rd floor.
