NCST Investigation of the Champlain Towers South Collapse

Cross-Project Panel Theme 3: Failure Hypotheses

CTS Investigation: Failure Hypotheses

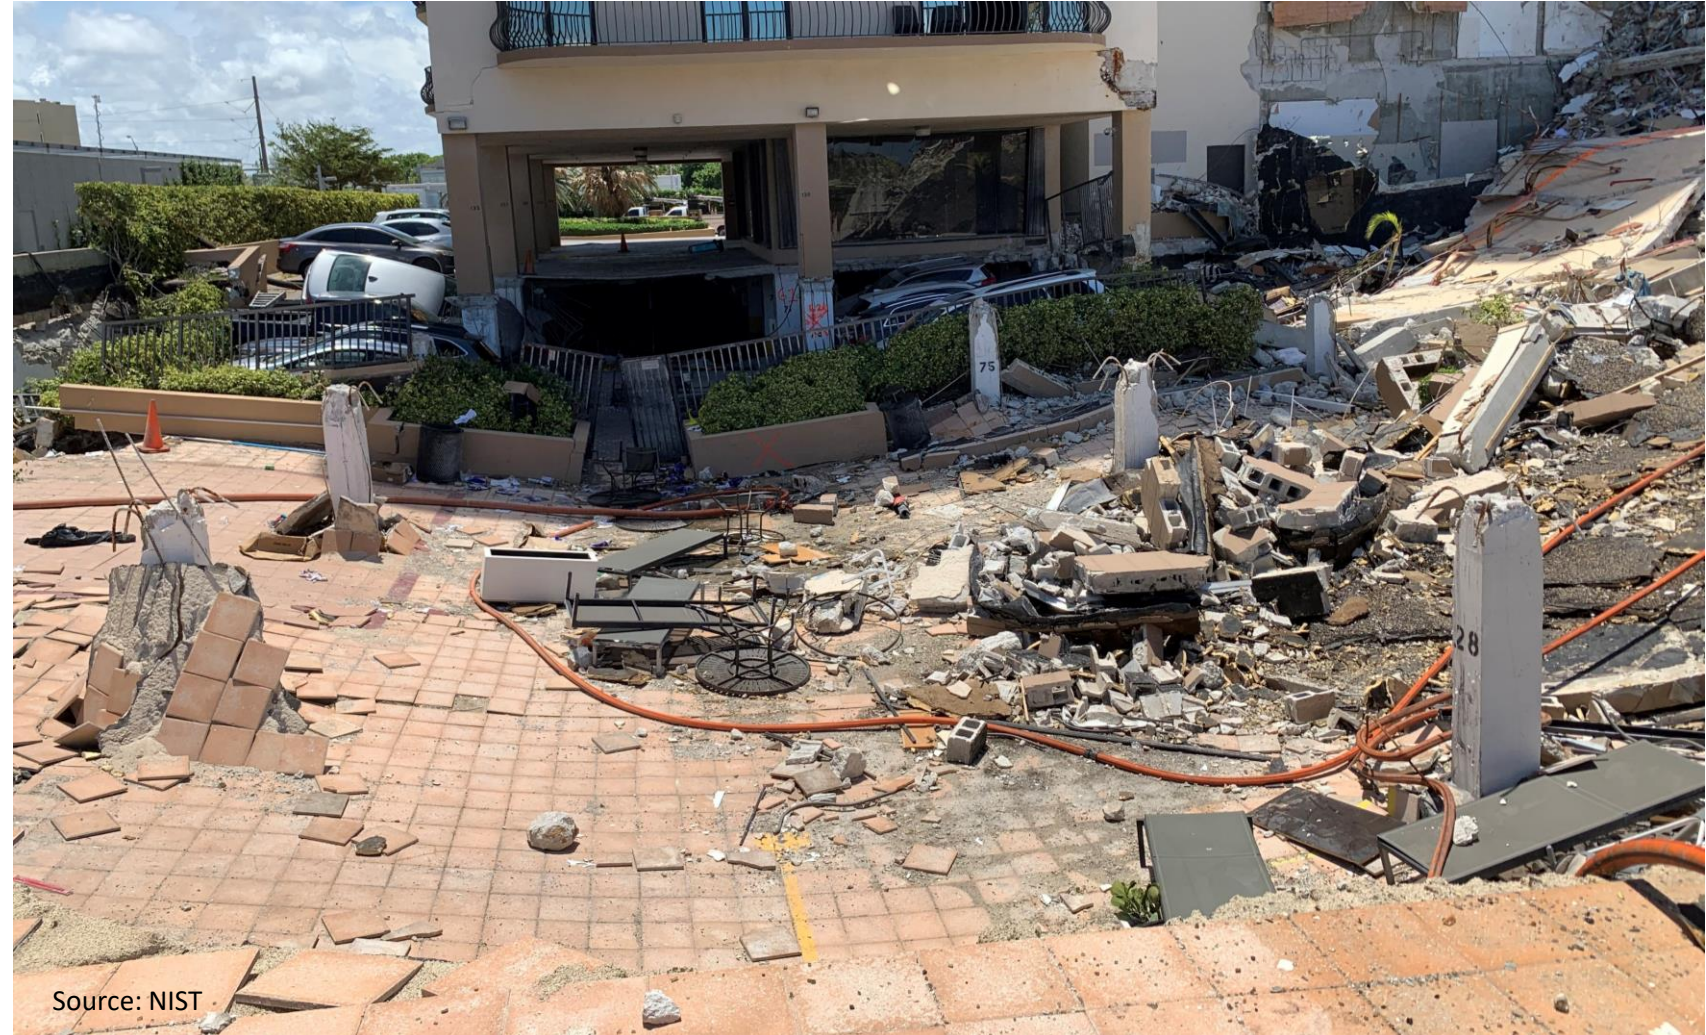
Description: Failure of the connection between slab and column, causing the slab around the column to drop. Failure may be preceded by cracking, large movements, and yielding or fracture of reinforcement in the slab. Such failure can initiate cascading failures through the entire slab.

Objective: To examine the likelihood that partial collapse of the CTS building initiated at a pool deck slab-to-column connection

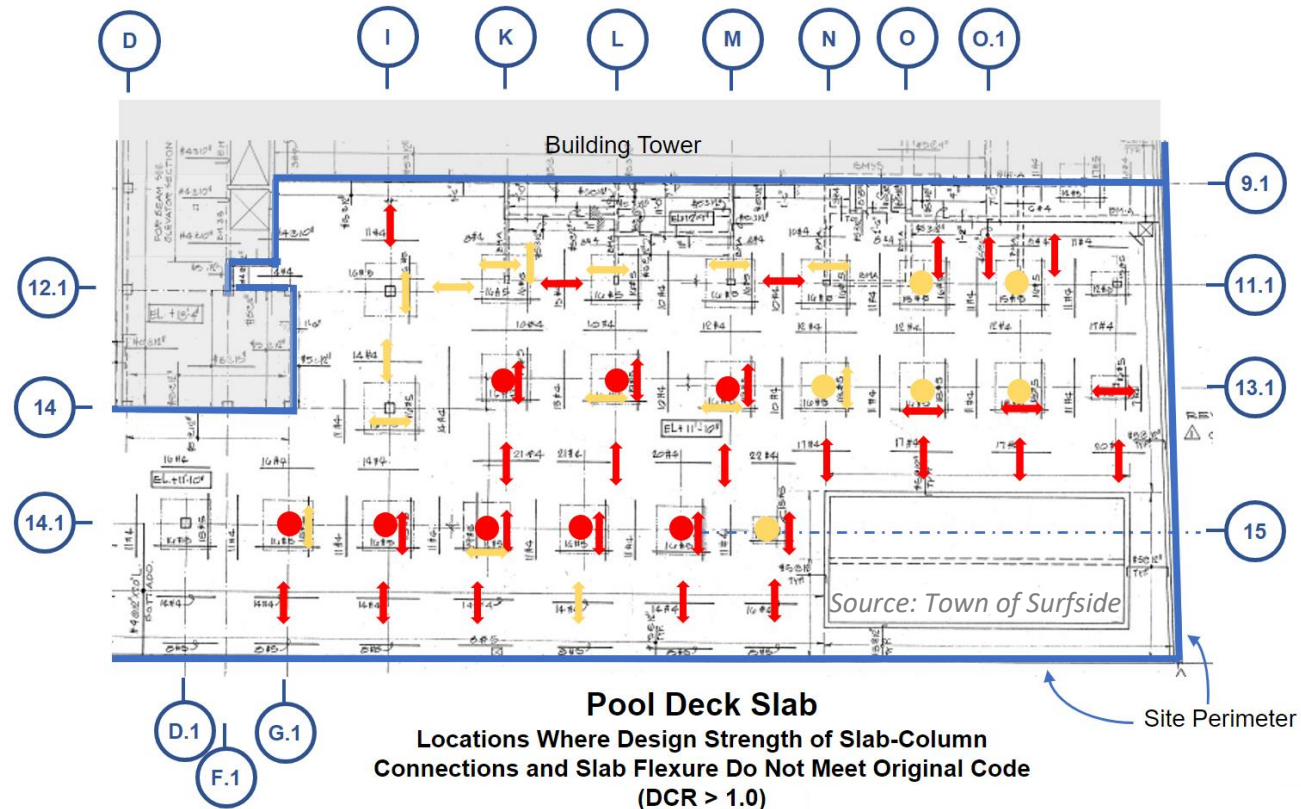
- *Design deficiencies in pool deck:* High DCRs (demand/capacity ratios) in connections, in particular, along Grid Lines 13.1 and 14.1
- *Deviations in pool deck construction from design documents:* Lower top bars, wider top bar spacing, 25 % of reinforcing bars not passing over columns
- *Added super-imposed dead loads:* Heavier planters, added fill and paving

- *Effects of corrosion*
 - Analysis shows that bottom reinforcement was highly stressed under dead loads, thus corrosion-induced loss of cross section could lead to failure/fracture of these bars.
 - Loss of or reduction in flexural capacity at midspan increases reinforcing bar stresses and strains in top bars over adjacent columns. Top bars are also susceptible to corrosion and could yield or fail.
 - This increases slab movements and crack width in the critical shear perimeter, eventually leading to a punching failure.
- *Possible concrete degradation*

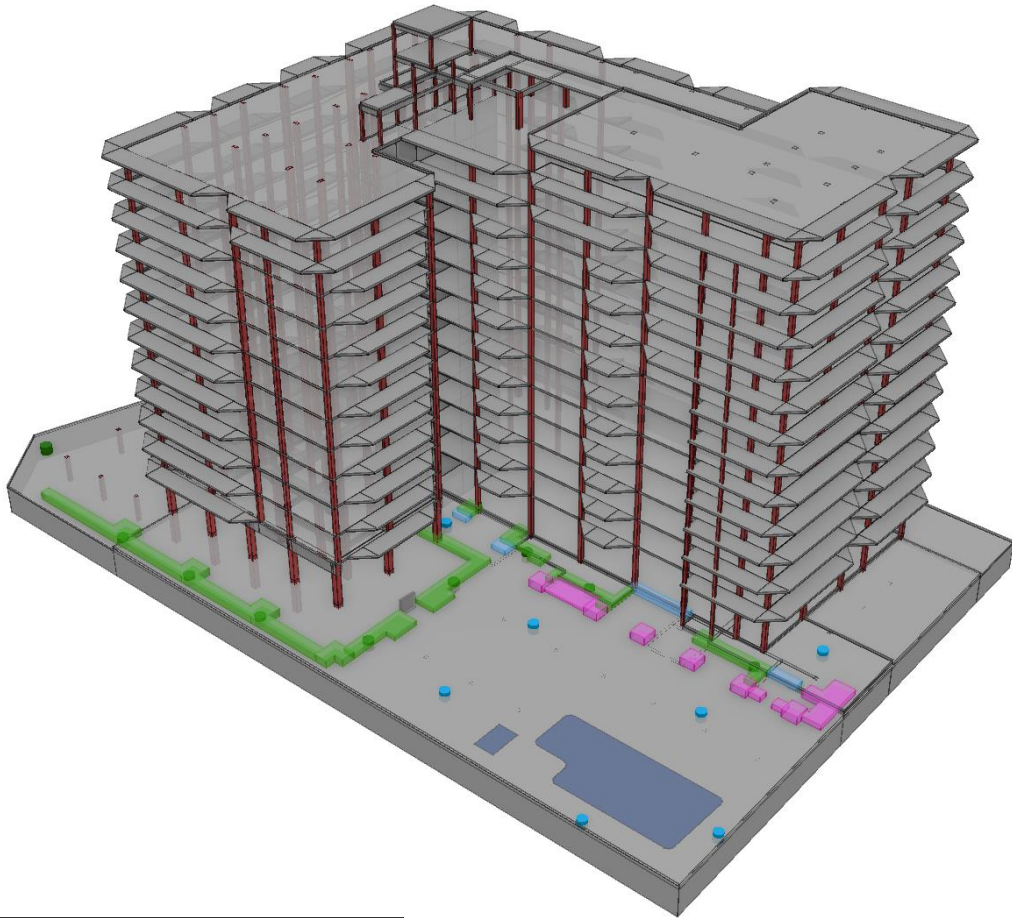
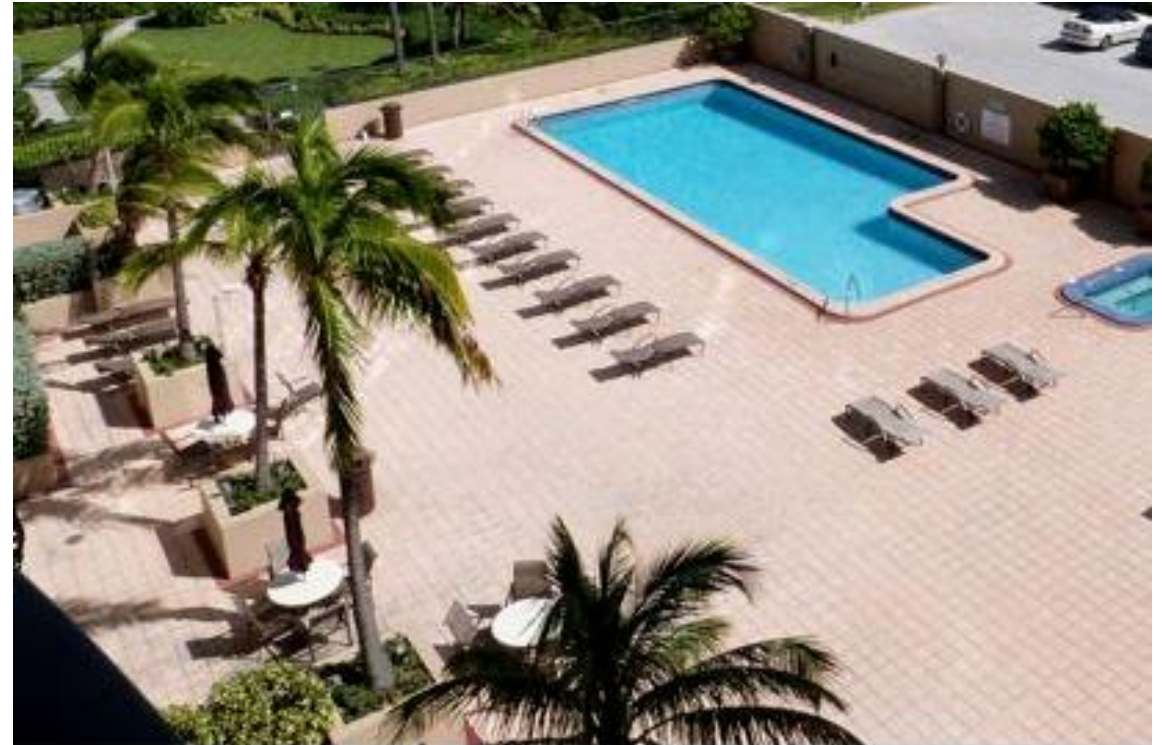
Planter Location Plan vs. Actual

Note: Palm trees not present at time of collapse

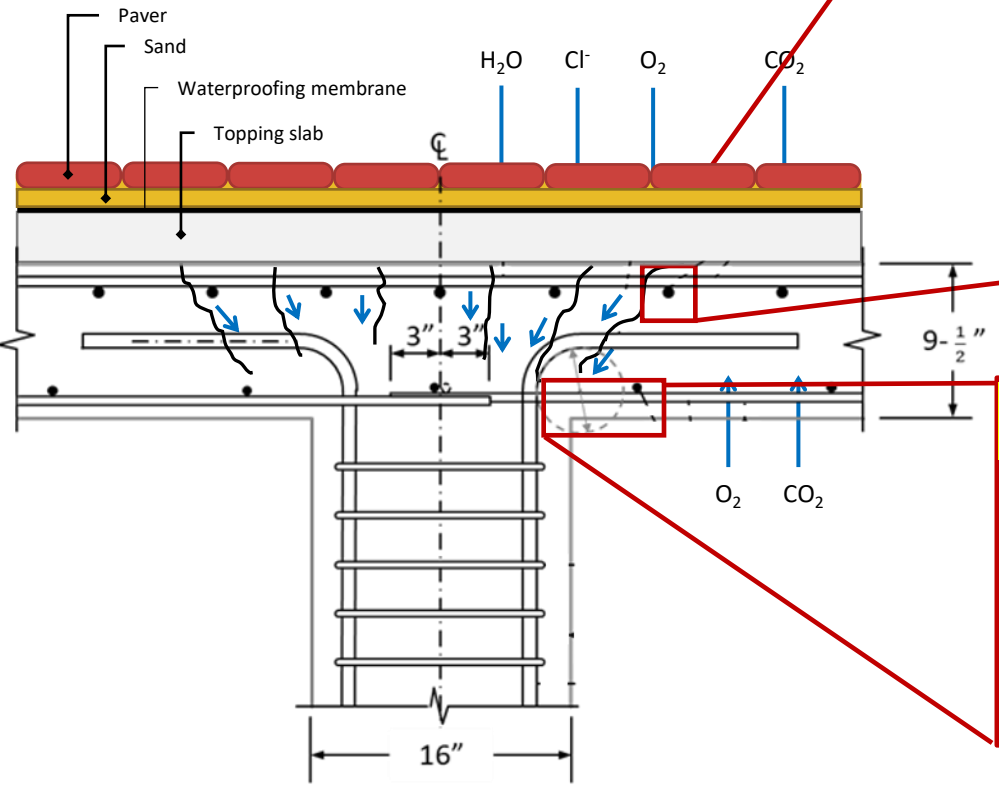
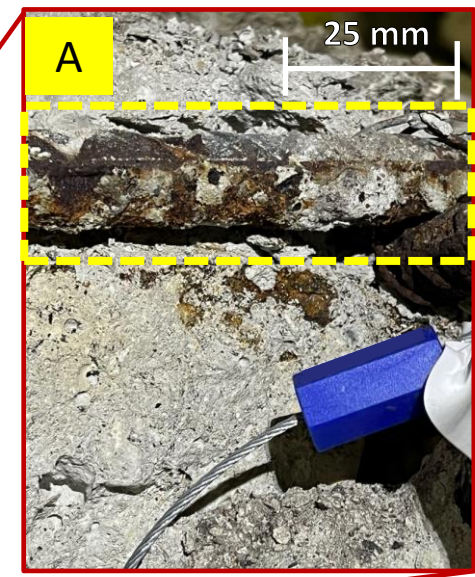
1. Cracking creates a “highway” for Cl^- , H_2O , and CO_2 to reach reinforcing bar causing corrosion
2. Concrete microstructure altered by the environment, changing mechanical properties

1. Reinforcing bar corrosion
 - Corroded reinforcement in slab (A)
 - Reinforcement before (B) and after (C) cleaning

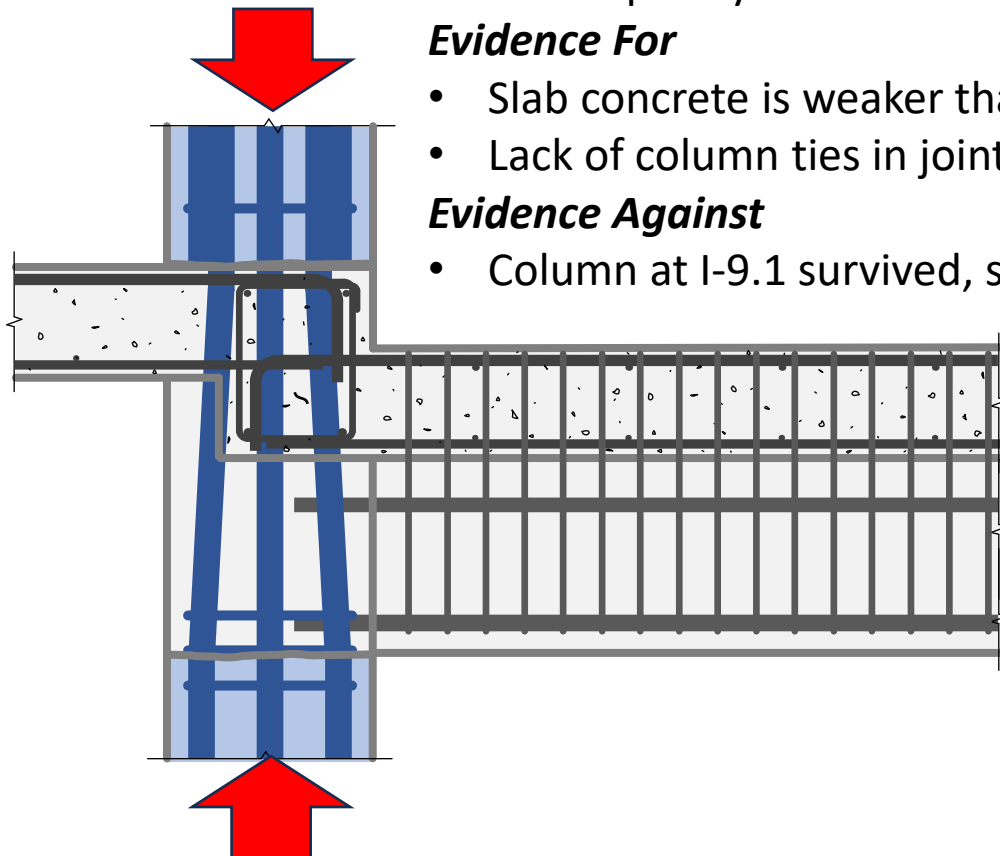
Failure Initiation Possibility #1: crushing in weak and poorly confined column/slab/beam joint:

- Slab concrete is weaker than column concrete
- Lack of column ties in joint

- Column at I-9.1 survived, similar load

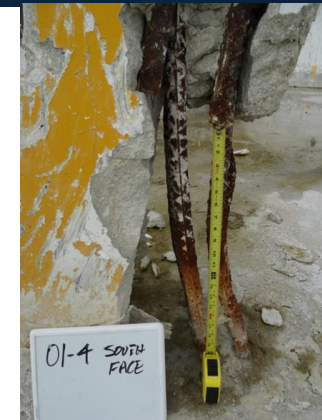
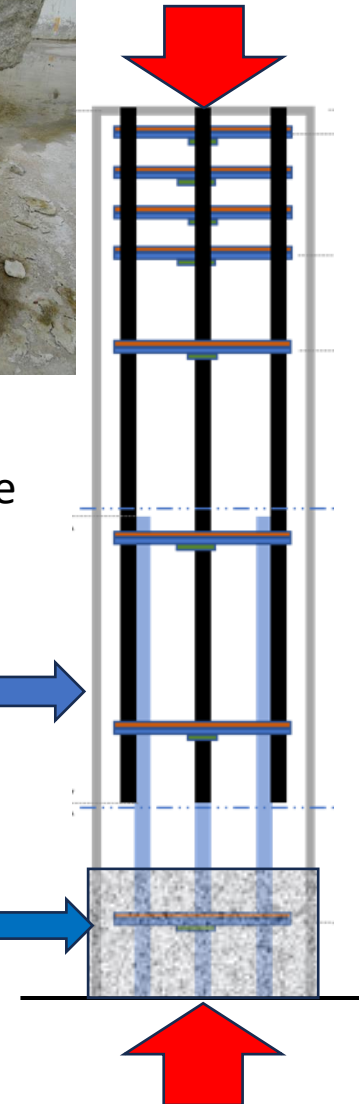
Possibility #2: partial failure at improper lap splice:

Evidence For: measurements

Evidence Against: survival of columns with short splices that permitted such measurements

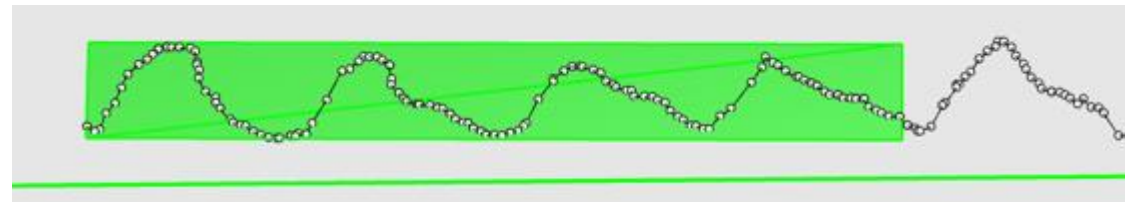
Collapse of pool deck slab initiates embedment failure of hooked bars from slab and beam at column, leading to loss of column capacity.

Image (at left) of similar condition at edge of portion that did not collapse. Image analysis of area in yellow box led to the profile (below) of concrete left after bars pulled out.

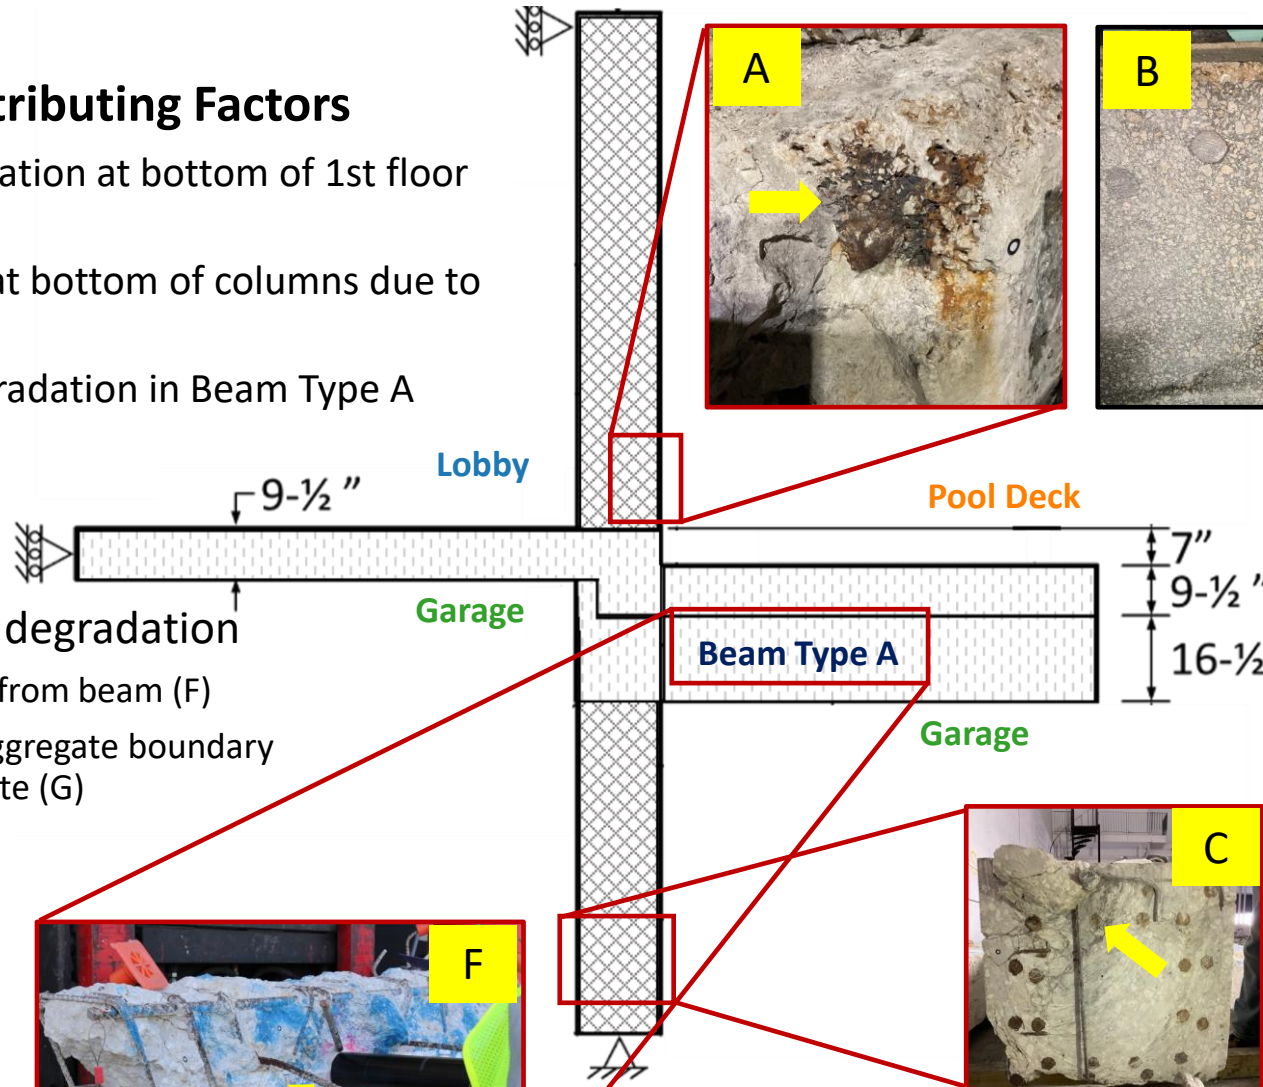
3. Beam Type A degradation

- Core extracted from beam (F)
- Porous paste aggregate boundary and altered paste (G)

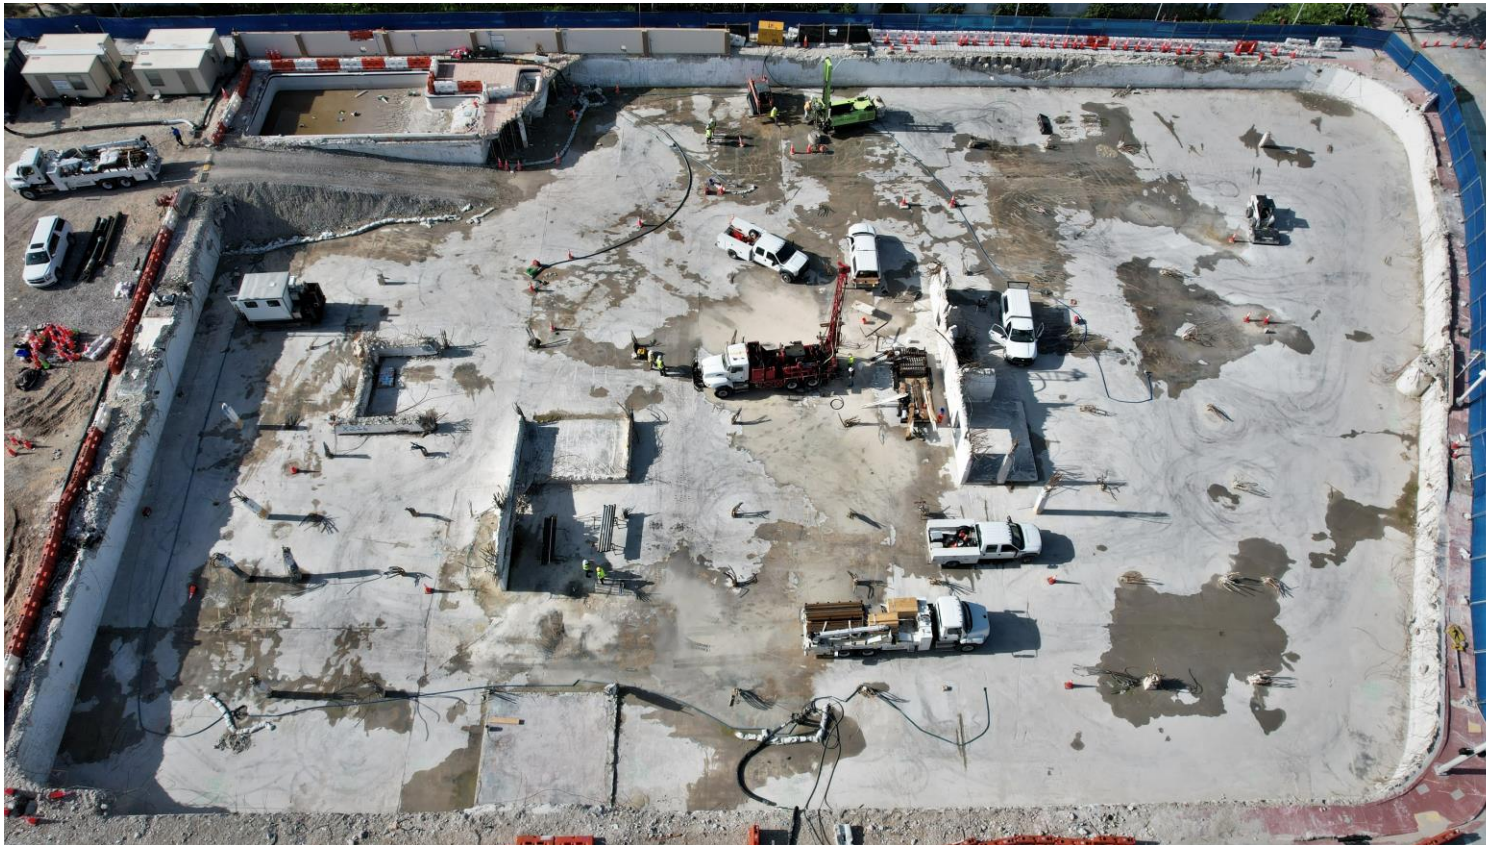
- 70 boreholes and cone penetrometer tests
- No evidence of large, persistent karstic voids

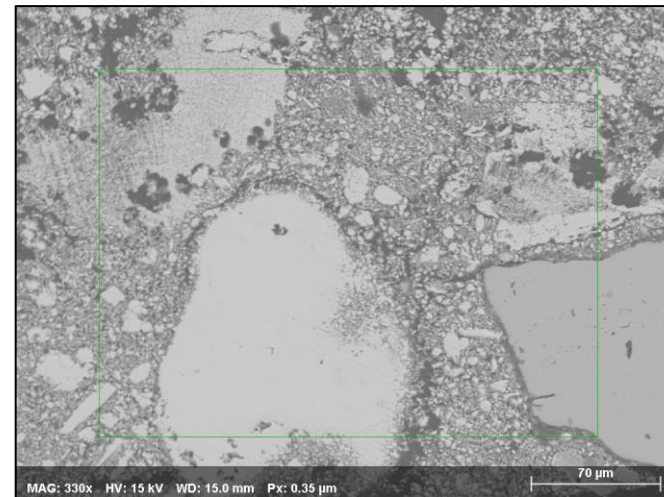
Sample depth range 25 ft-26 ft

- SEM: Scanning Electron Microscope
- EDS: X-ray (Energy Dispersive Spectrometer)
- SEM images and EDS / element maps confirm heterogeneity in composition and texture
- Large calcite / aragonite and quartz grains present
- While carbonate grains and matrix show signs of dissolution, presence of dissolution fronts and void space is limited
- **Intact quartz grain boundaries confirm insolubility (lack of potential to form large scale voids)**

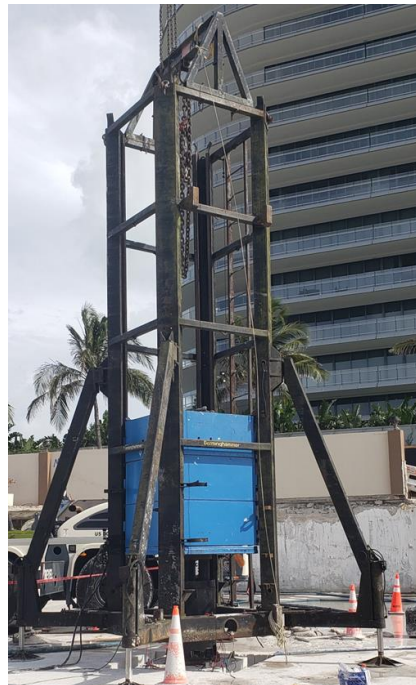
Site-Specific Pile Testing

Two pile load tests in pool deck area by NIST showed that these piles were able to adequately carry estimated design loads with limited deformations.

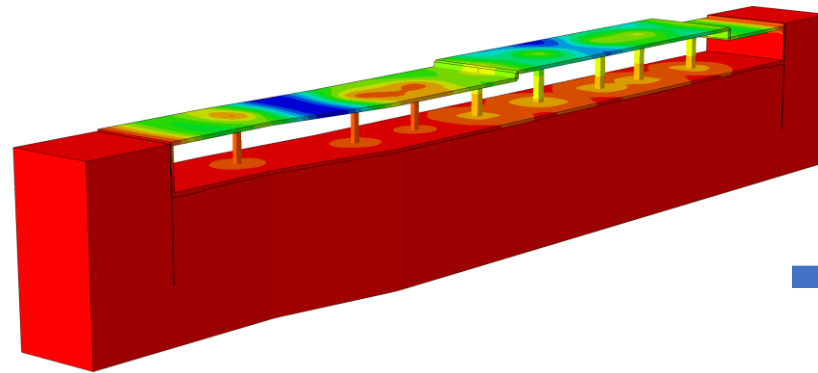
Pile Settlement Evaluation

Preliminary numerical analyses and calculations using empirical methods showed settlements within the range anticipated based on the site-specific pile load testing for the estimated structural loads.
