NCST Investigation of the Champlain Towers South Collapse

Concluding Remarks and Next Steps

Failure Sequence and Preliminary Data and Analyses

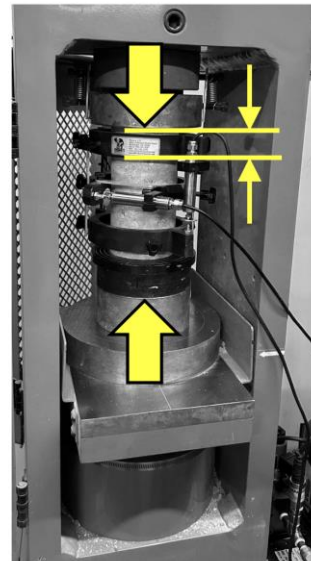
Concrete Compression Strength & Modulus of Elasticity (ASTM C39, C42, C469)

4. Extensive testing of the mechanical properties of concrete and steel is ongoing. Concrete strength test results to date are widely variable in some parts of the structure requiring additional analysis and testing.

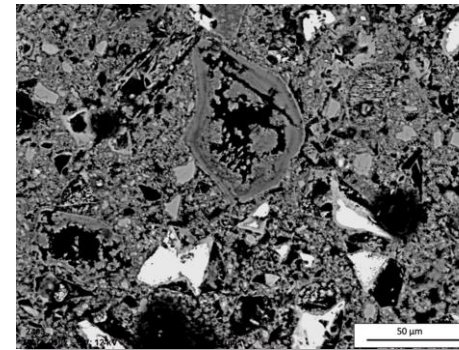
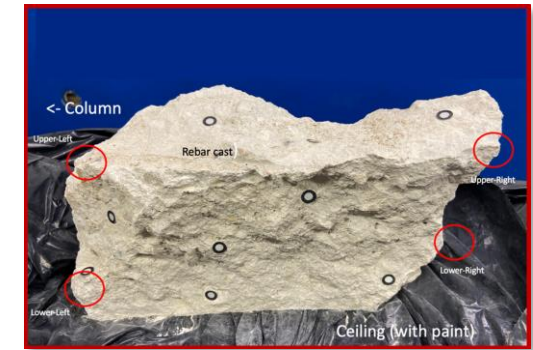
5. Study of degradative mechanisms in the concrete is ongoing.
