Summary of the Champlain Towers South NCST Investigation Progress

NCST Advisory Committee Meeting

September 9, 2025

Judith Mitrani-Reiser
Lead Investigator

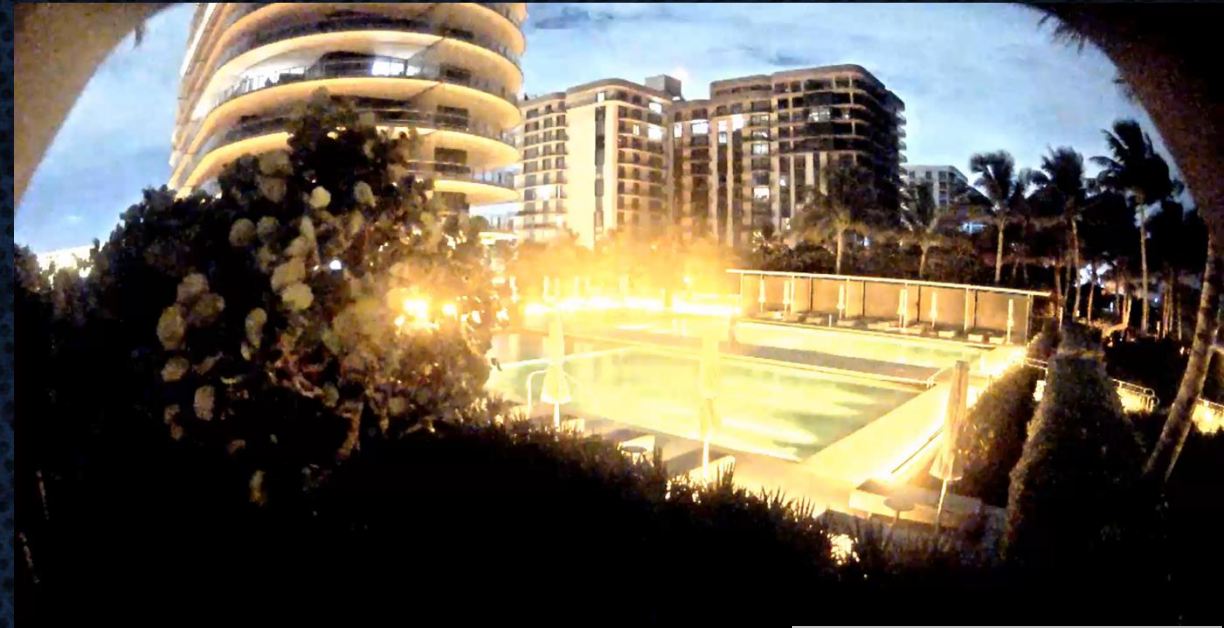
South Face Camera, Night of the Partial Collapse

- The pool deck collapsed more than four minutes before the general collapse of the tower.
- In the tower collapse, Grid Line 9.1 started to drop a second, or a bit more, before 1:22:17 am.
 - The columns on Grid Line K and/or L dropped first.
 - The initial column failures were low in the building.
- There were severe structural movements in the interior of the tower before the precipitous drop of the tower at Grid Line 9.1.

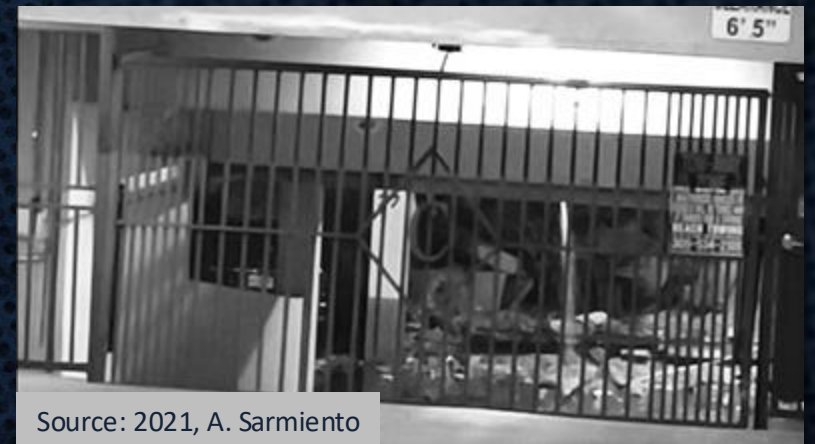
Where Did the Failure Initiate?

- Scenario I: In the Pool Deck
- Scenario II: In the Tower

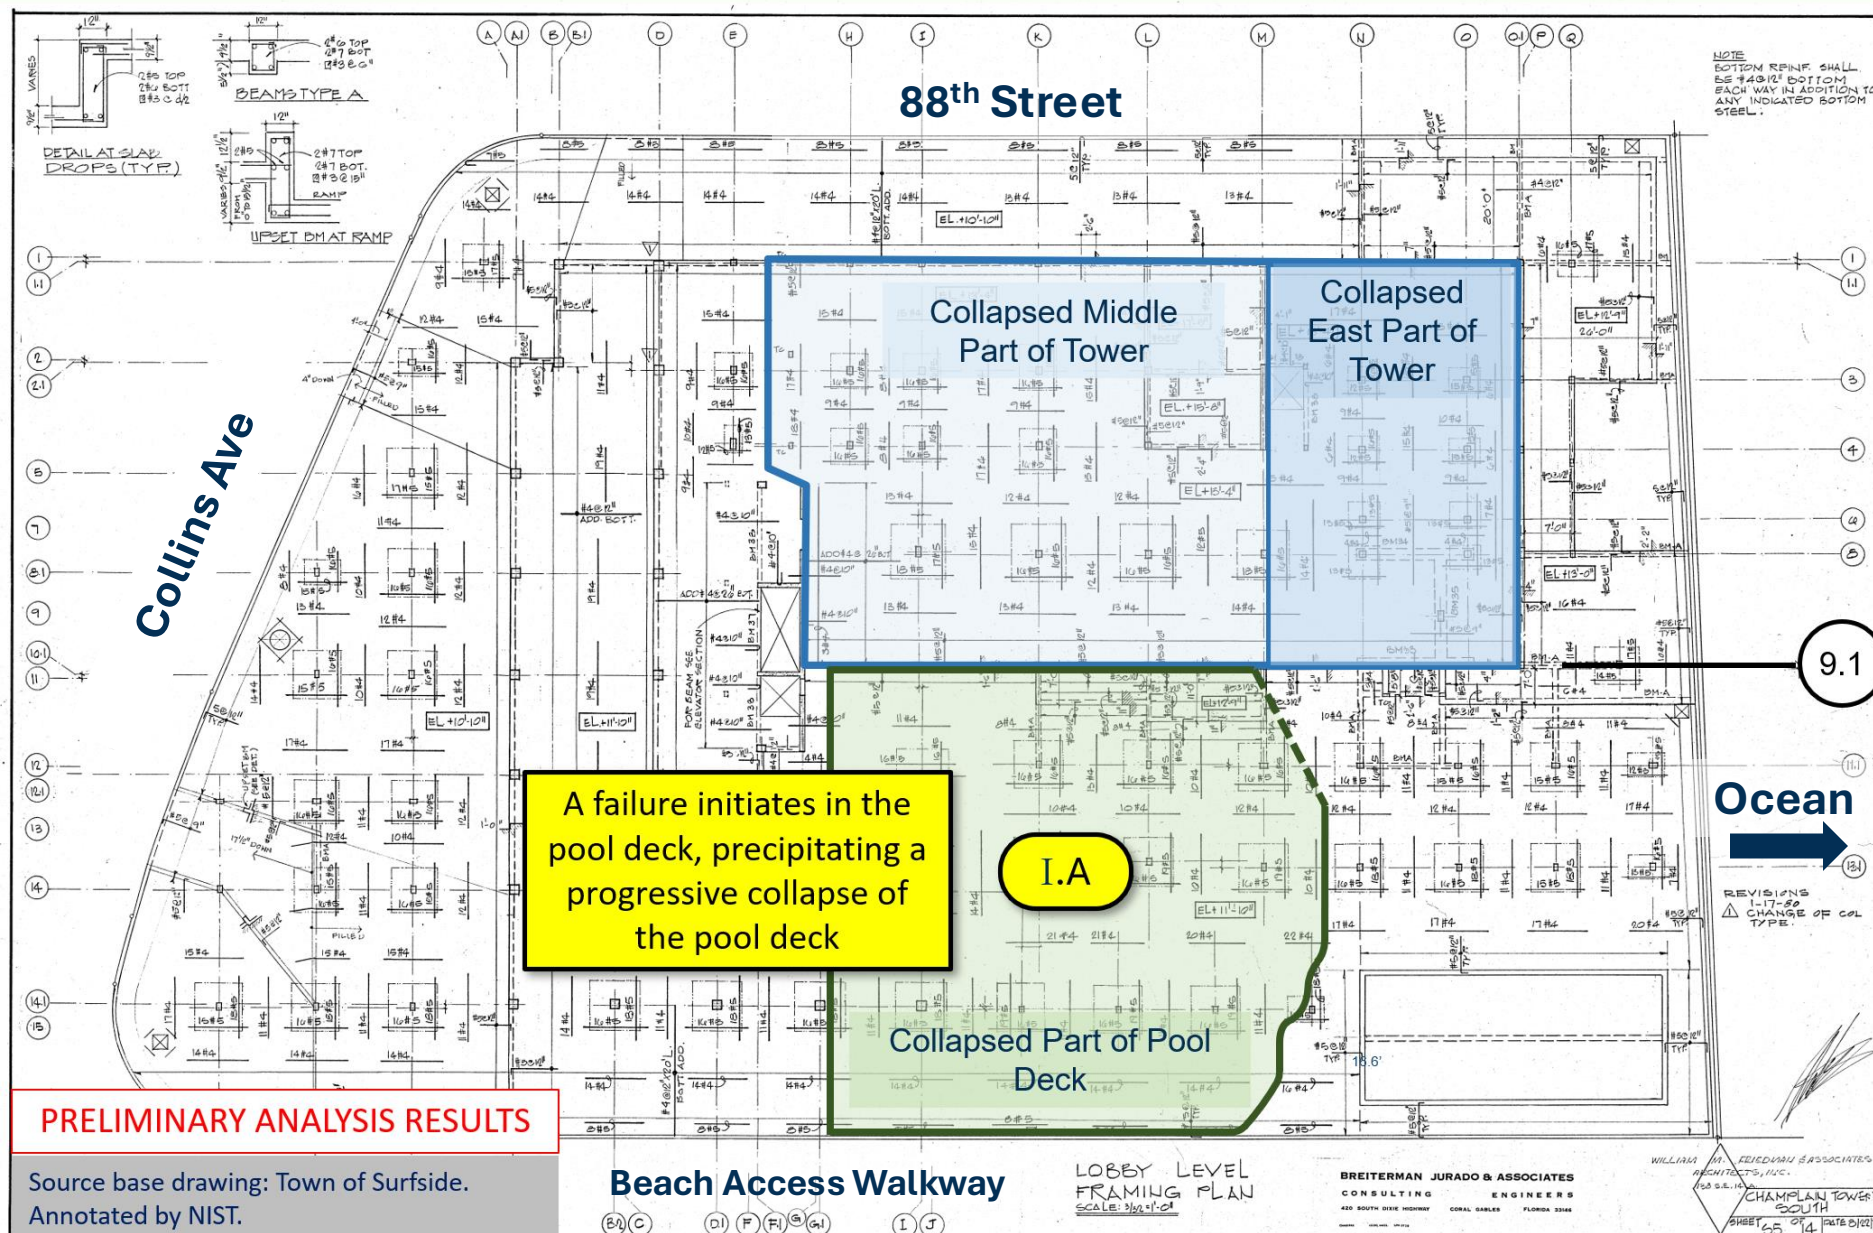
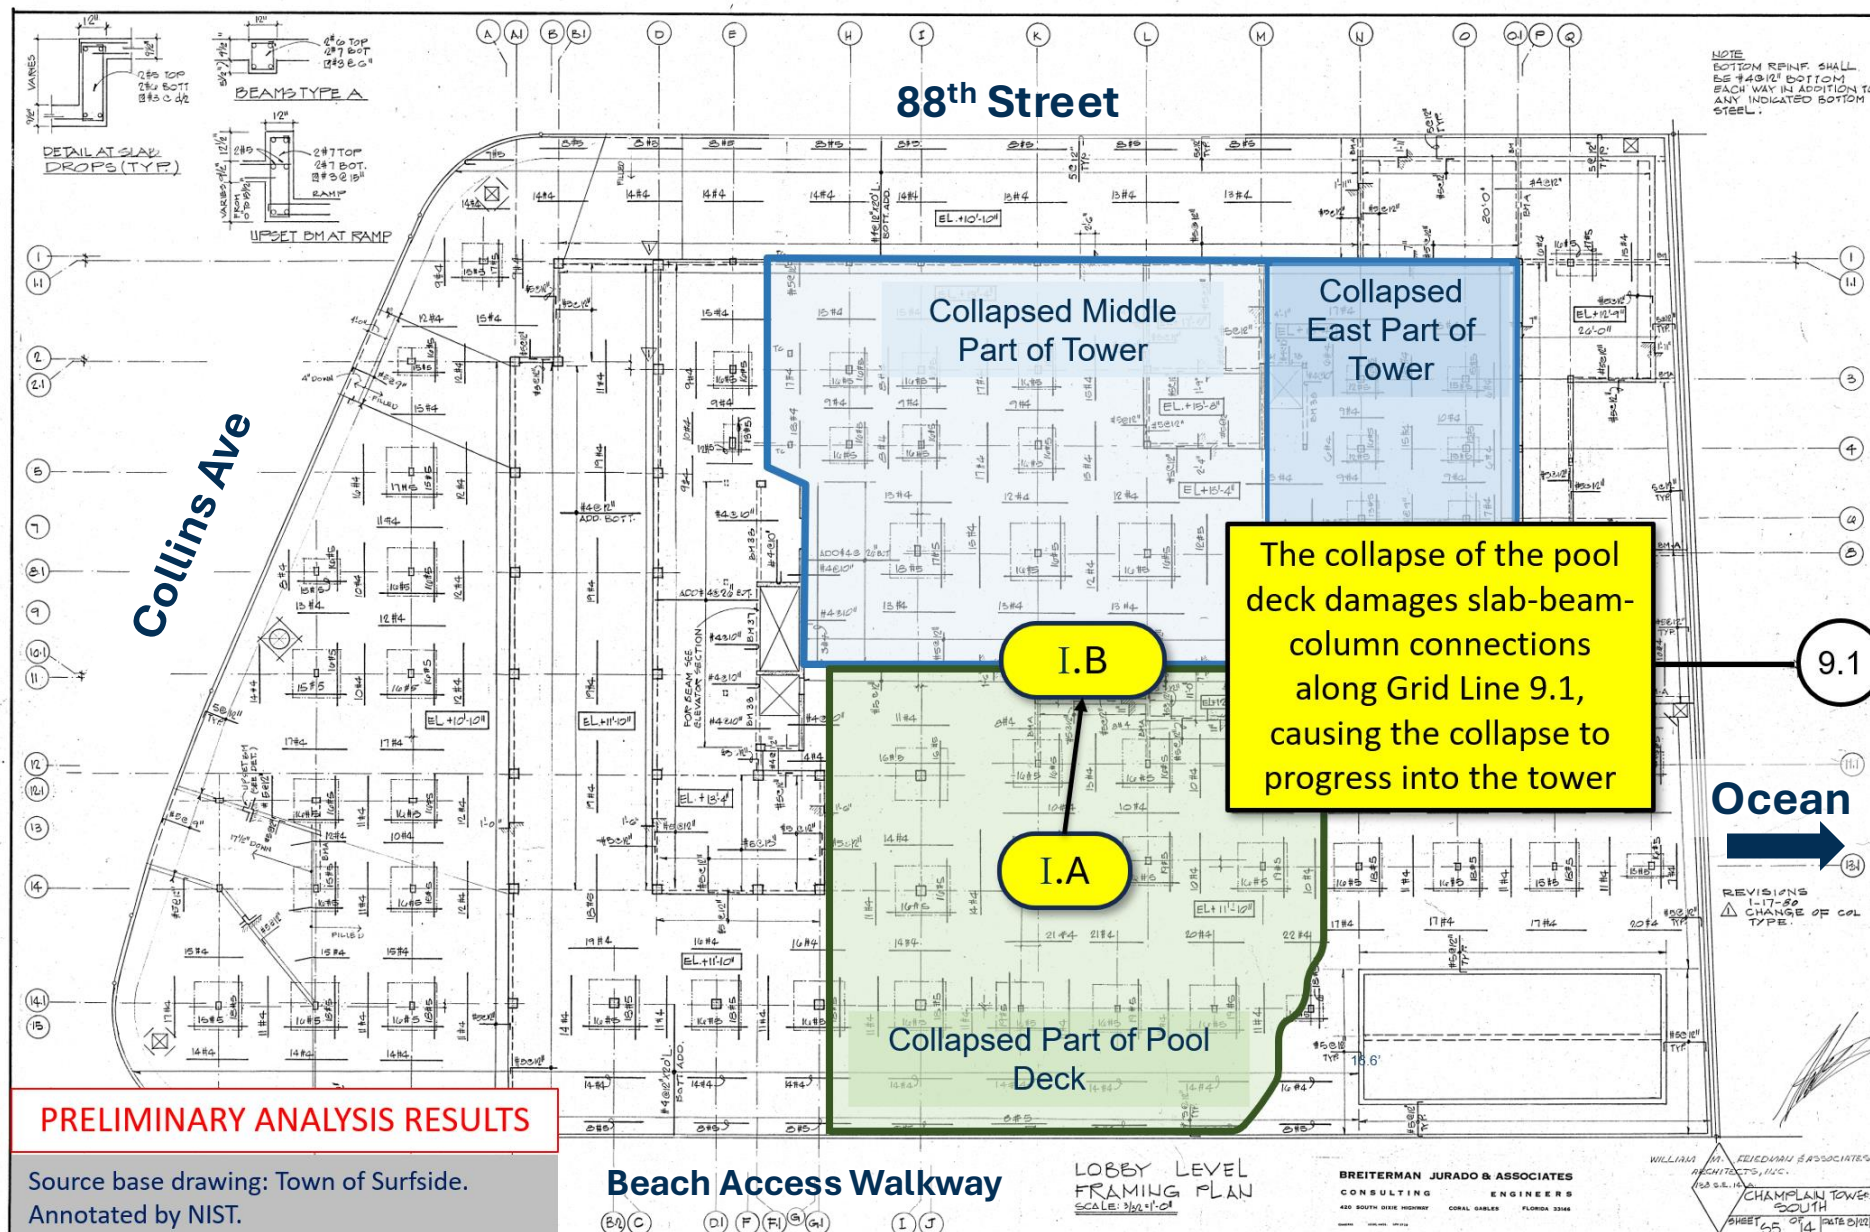
Scenario I: Failure Initiation in the Pool Deck

- Failure of a typical slab-column connection in the pool deck.
 - Design understrength, deviations in construction from requirements, loads added to the pool deck, and material degradation led to critically low margins of safety at the time of failure.
- Shortening of a lower-level column in the tower.
- Local crushing of a slab-beam-column joint at Level 1 on Grid Line 9.1.
 - Design understrength and construction deviations reduced the strength of the structural elements in these latter two initiating events. We continue to assess the impacts of material degradation.

Recent work indicates that it is **MORE LIKELY** that the failure started in a pool deck slab-column connection than we considered in June

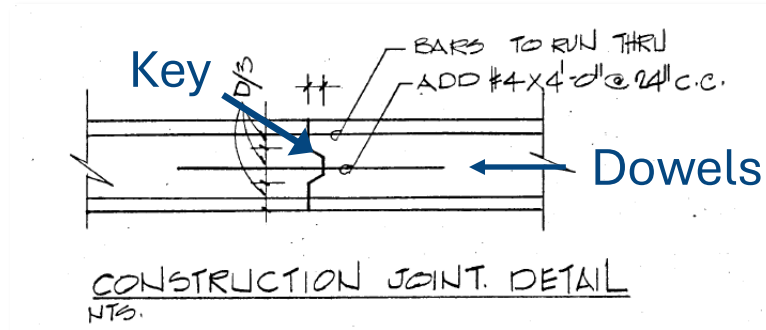
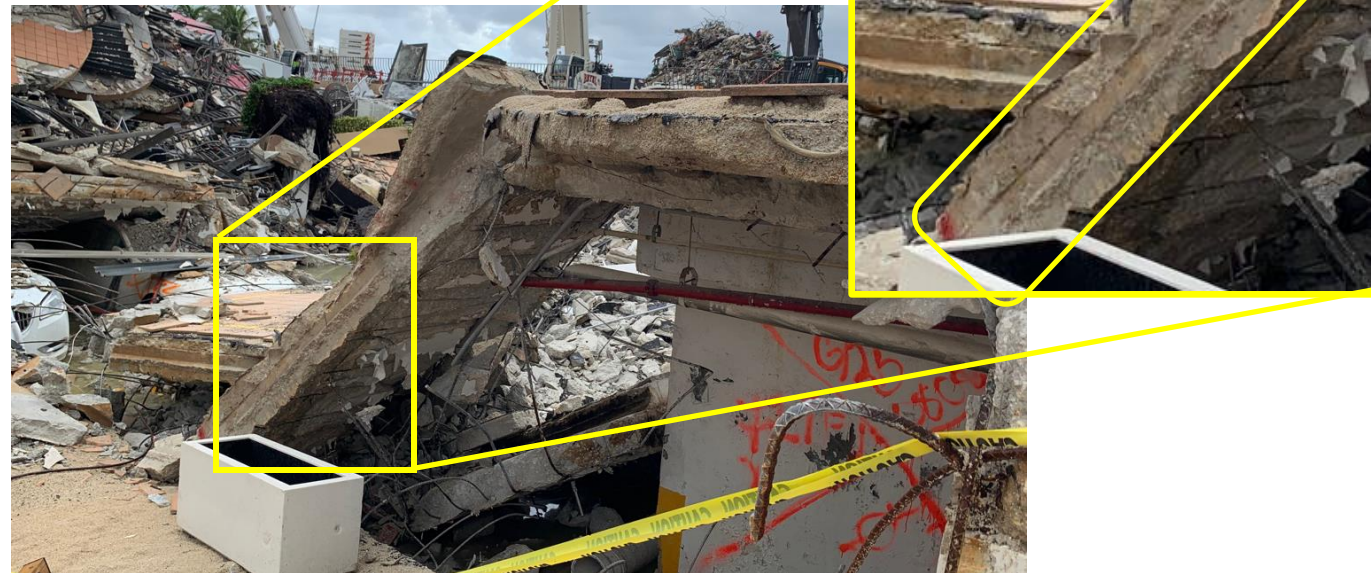
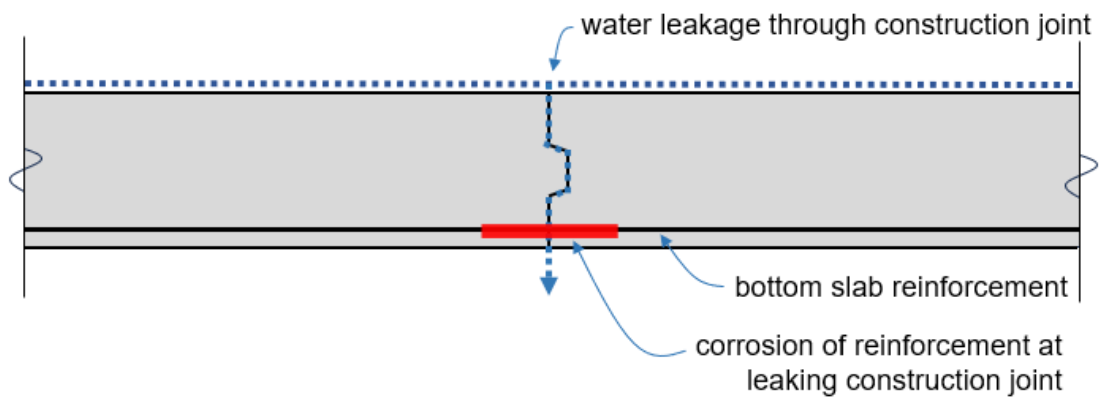
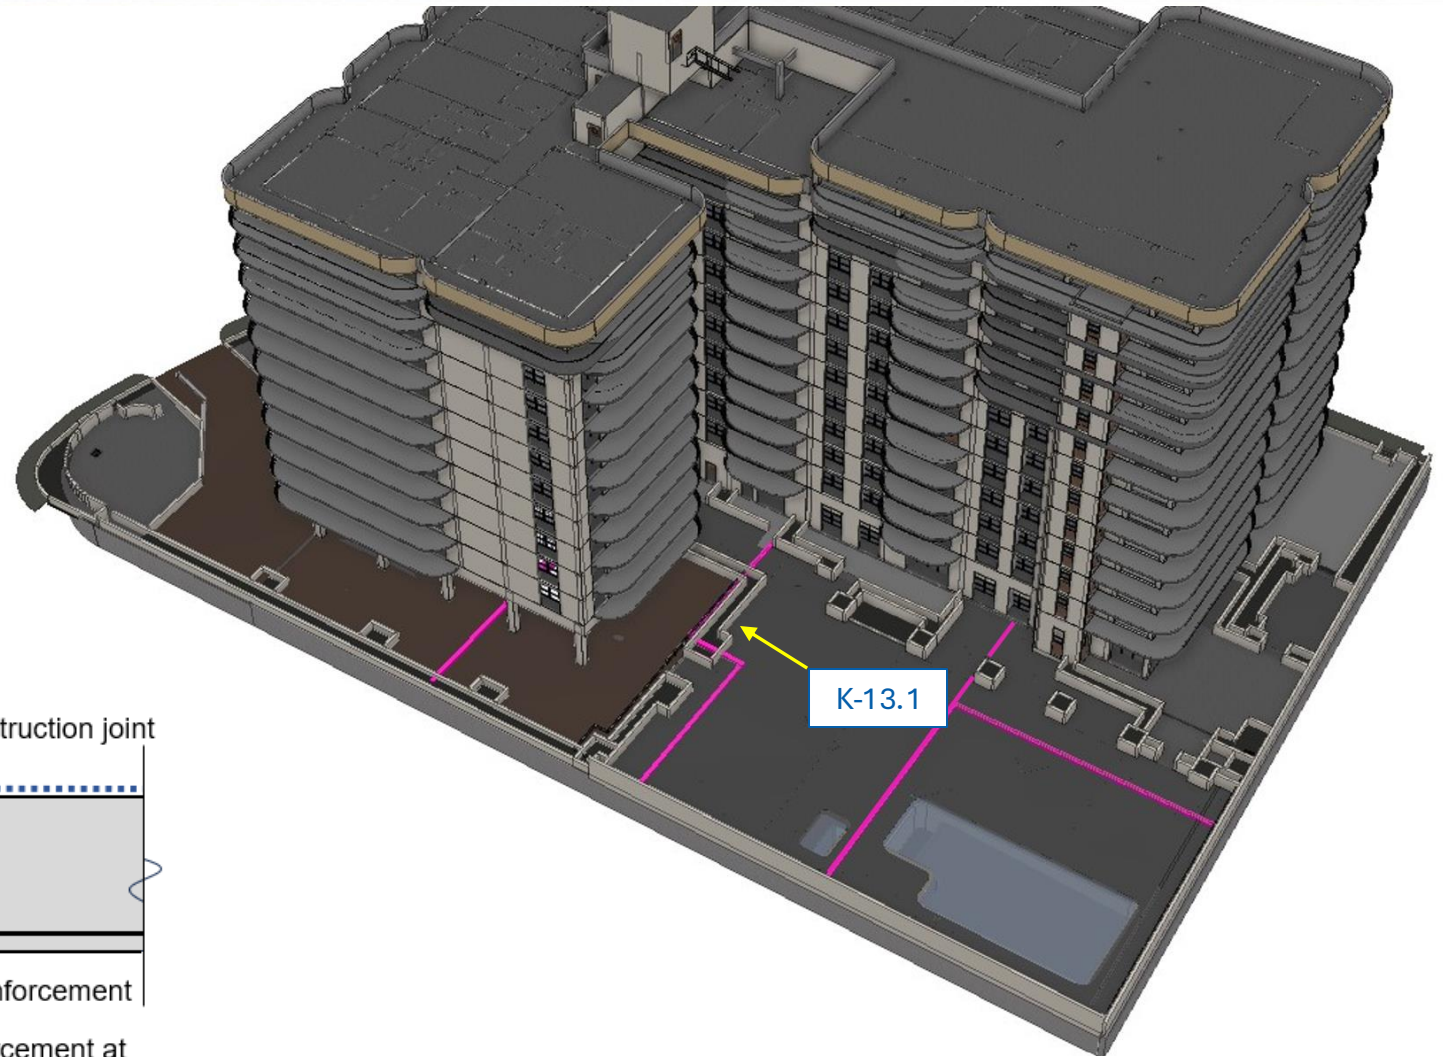
Pool Deck Slab-Column Connections Construction Joints in Slab

- Together, caused the bulk of the critically low margins of safety
- Existed from the time construction was complete – 40 years before the partial collapse

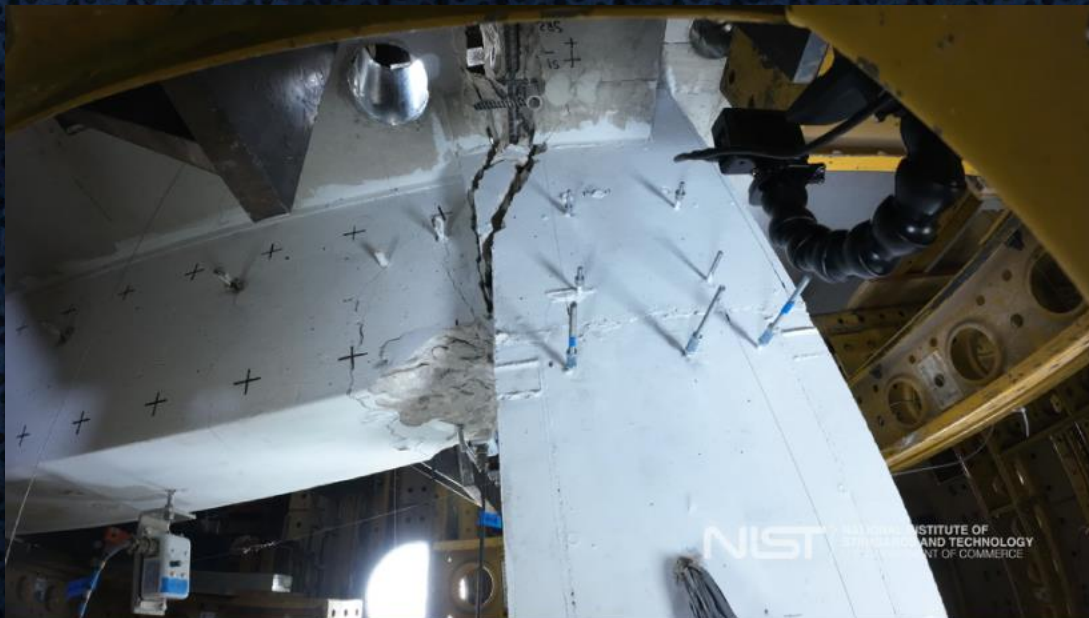
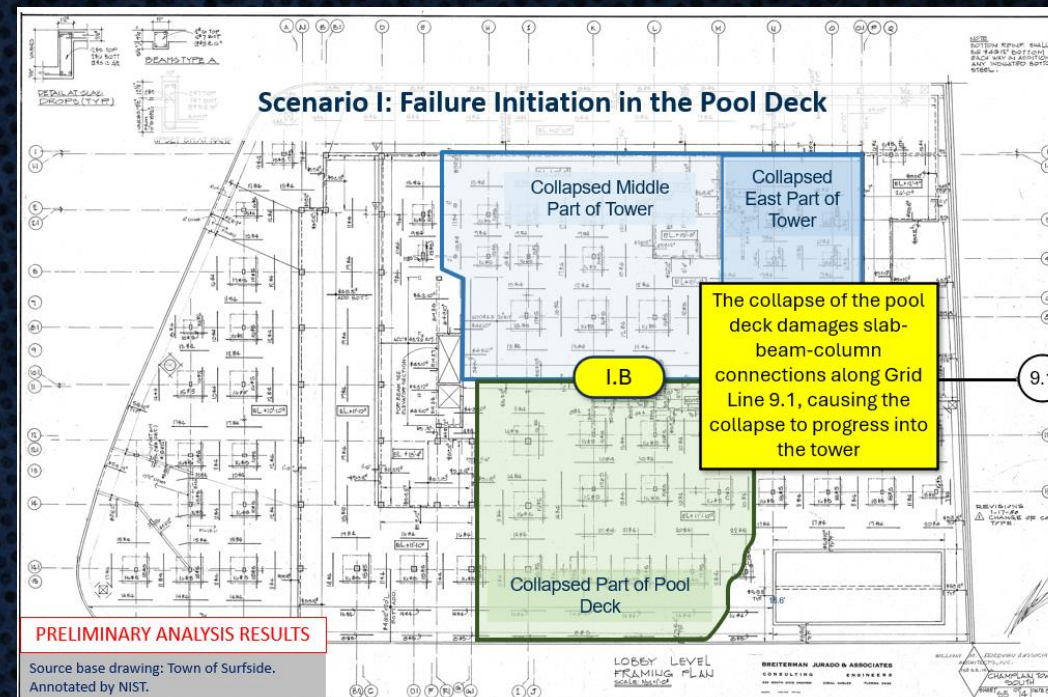
Recent work indicates it is **LESS LIKELY** that the failure started in a tower basement column than we considered in June

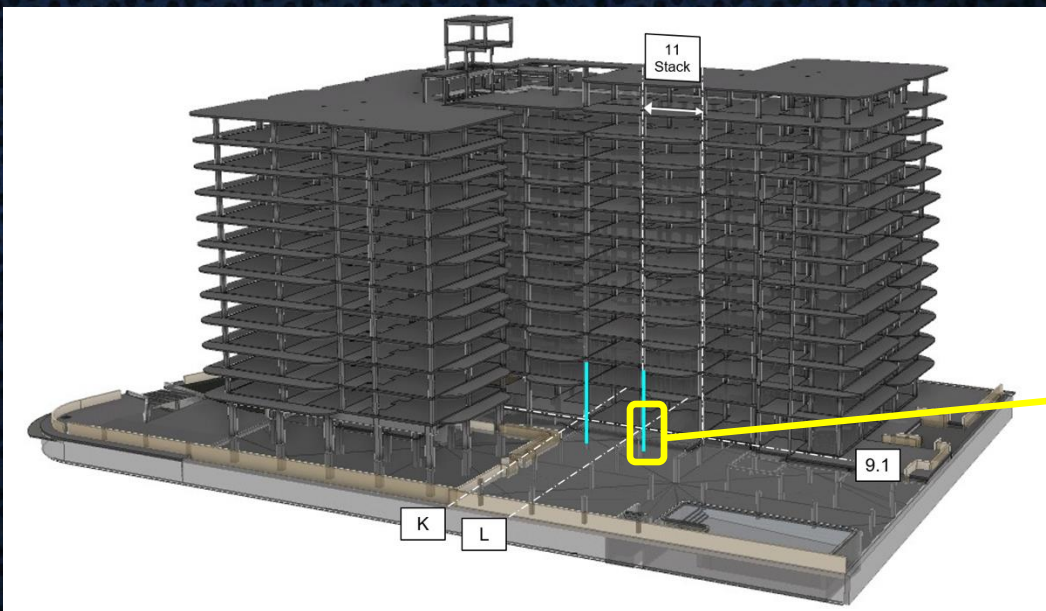
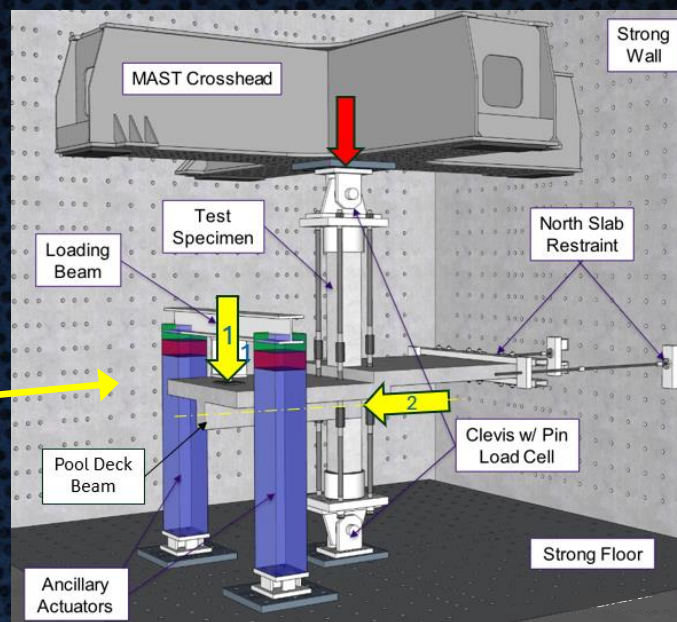
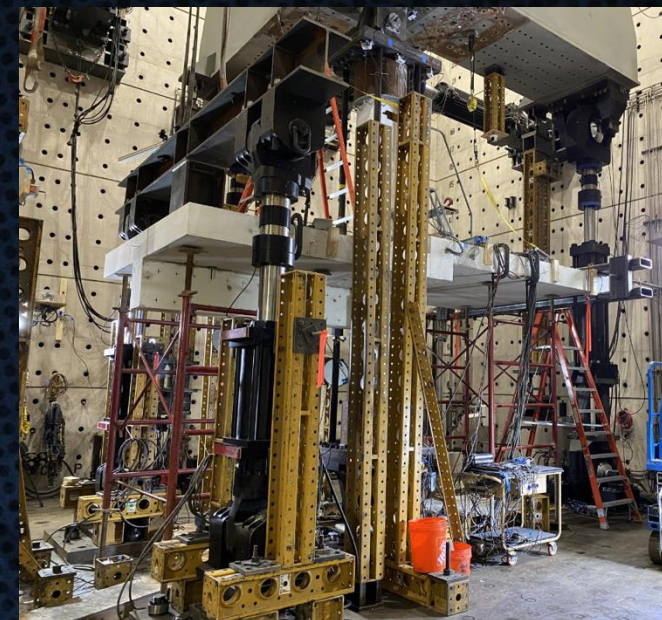
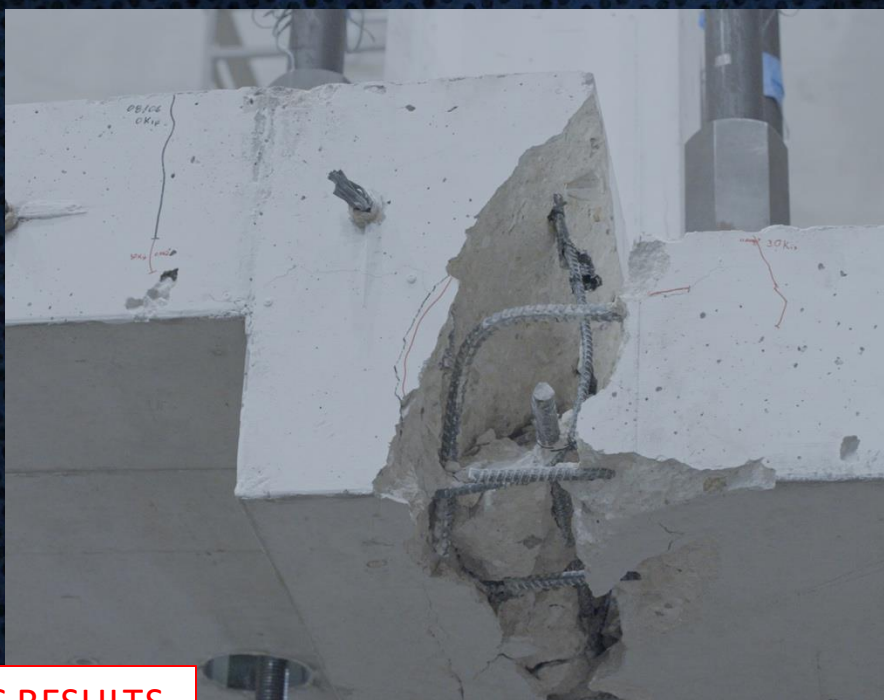
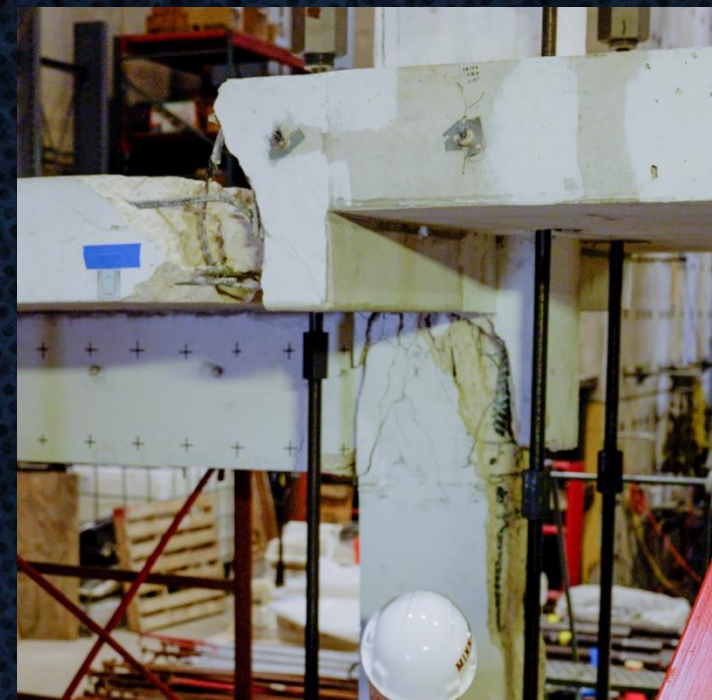
- The vulnerability of the structure where the pool deck met the tower allowed the collapse of the pool deck to progress into the tower.
- The poor resistance to progressive collapse allowed the collapse to spread through the east wing of the tower.

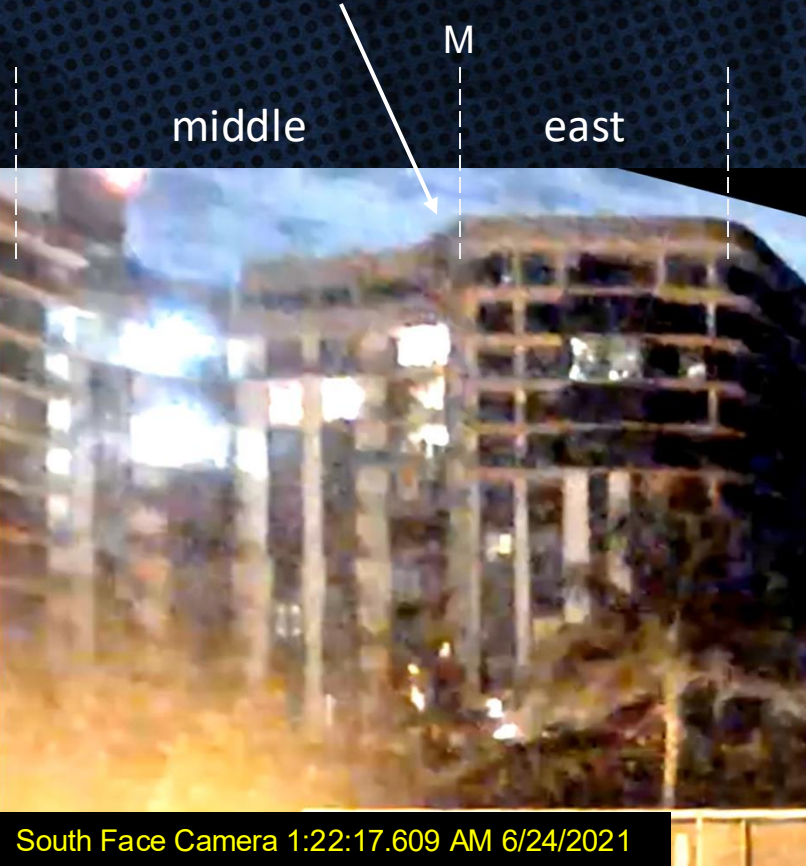
Collapsing middle part of tower is still connected to the east part at Grid Line M, which has not yet dropped

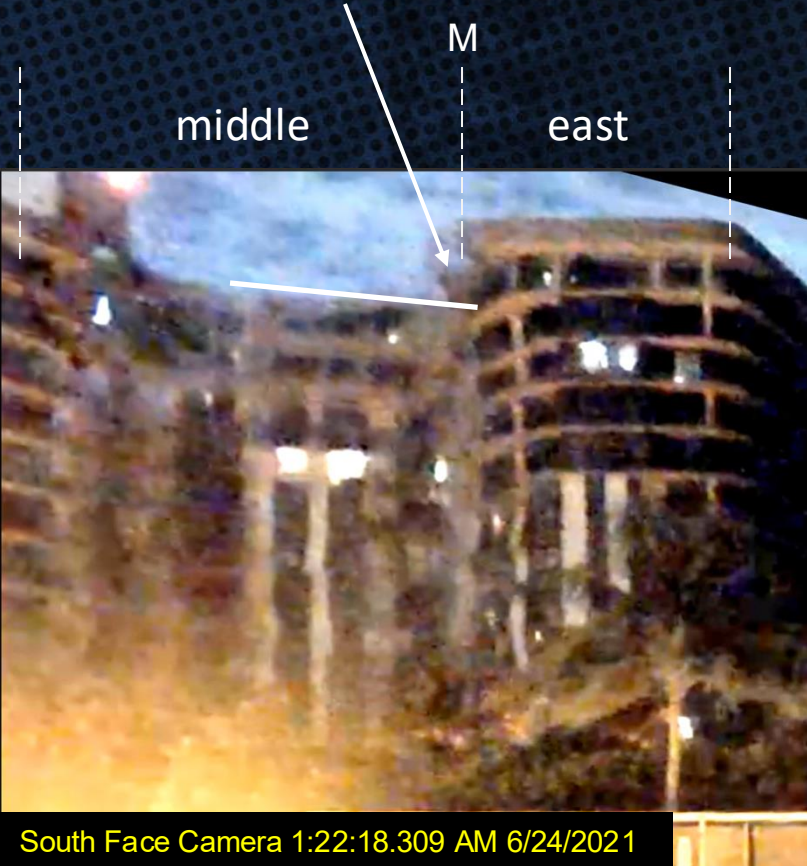
The middle part of tower has separated from the east part in this frame

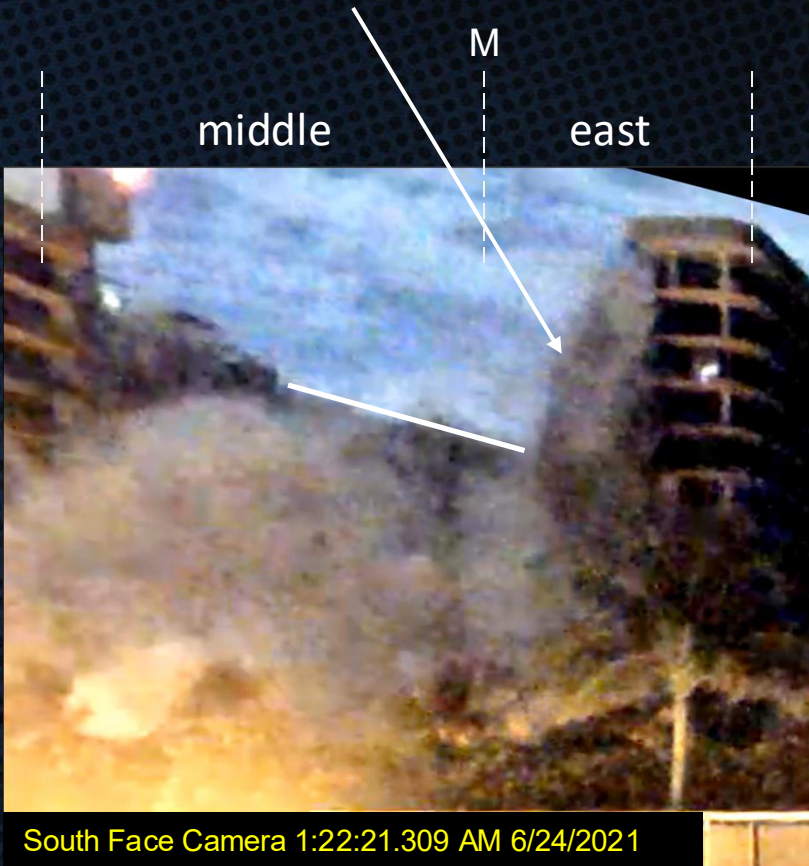
The collapse progresses into the east part of tower in this frame
