Lightning and Surge Protection of Photovoltaic Installations

Two Case Histories: Vulcano and Kythnos

François D. Martzloff
National Institute of Standards and Technology

NISTIR-89 - 4113

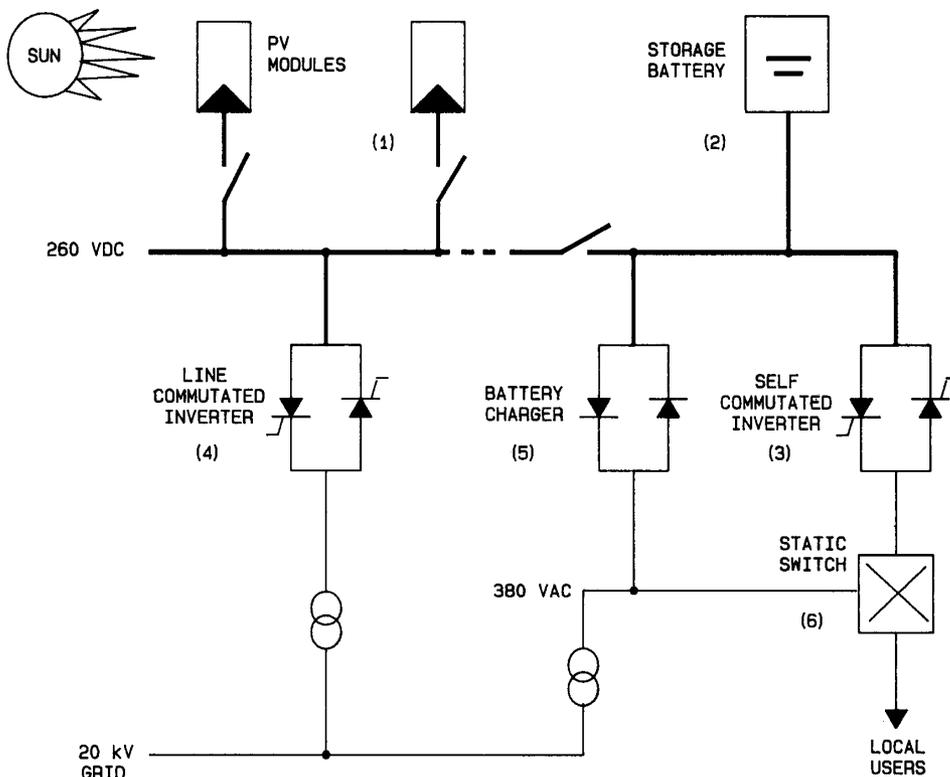
Figure 2-1. Block diagram of the Vulcano photovoltaic system

The Vulcano photovoltaic system (see Figure 2-1) includes the following major components: the array (1); a storage battery (2); one self-commutated, stand-alone inverter (3); one line-commutated inverter (4); a rectifier for charging the battery (5); and a static switch (6). More complete system diagrams by ENEL are given in Appendix A [1].

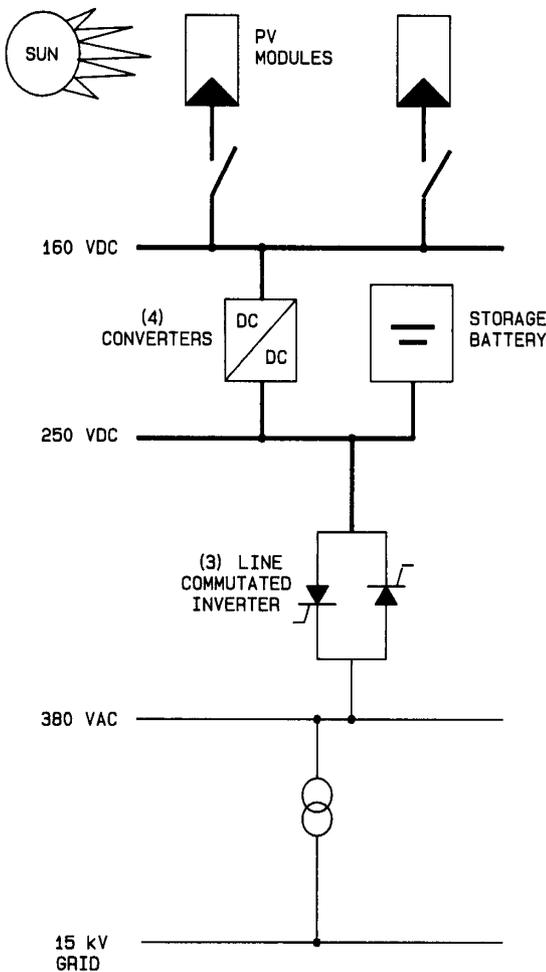
Figure 3-1. Block diagram of the Kythnos photovoltaic system

The installation was designed and implemented by Siemens, as one of the experimental facilities coordinated by the European Economic Community (Photograph 3-1). The plant has a nominal output capacity of 100 kW. Figure 3-1 shows a schematic of the system components. The modules are grouped in arrays formed by a series string of 20 modules, each producing a dc bus voltage of 160 V. Each of these 43 arrays is terminated in a junction box in the field, where two or three strings are connected in parallel to bring the dc power to the power conversion cabin (Photograph 3-2).

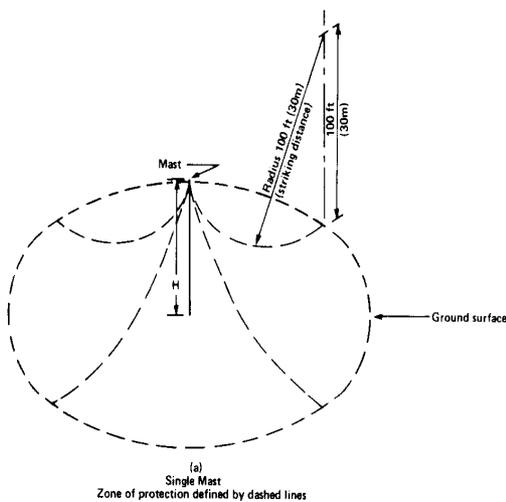
Figure 3-5. Rolling ball criterion
(Source: Reference [5])

Considering now the configuration of a vertical mast on the ground plane (Figure 3-5), rolling a ball on the ground until it touches the tip of the mast defines the limiting condition when the descending leader will terminate at the tip of the mast, thus leaving other points below the sphere uninvolved. Figure 3-6 shows
