Varistor versus Environment: Winning the Rematch

VARISTOR VERSUS ENVIRONMENT: WINNING THE REMATCH

Abstract — An unusual case of difficult application of surge protective devices was solved by field measurements with retrofit of protective devices suitable for the particular environment. On-site measurements indicated that capacitor switching transients were causing excessive current surges in the varistors and fuses protecting the input to a thyristor motor drive. Knowledge of the environment gained by the measurements allowed understanding of the problem and specification of matching surge protective devices.

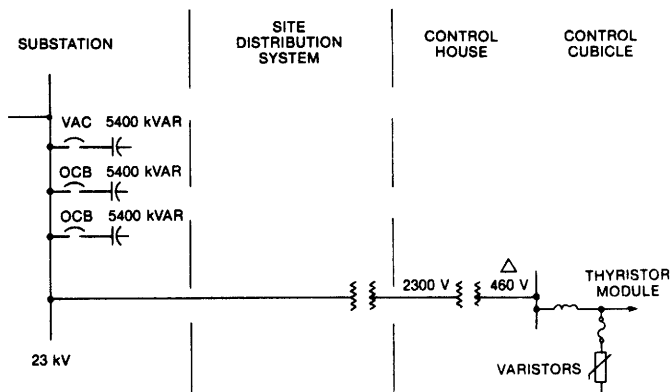
Figure 1. Simplified one-line diagram

Figure 1 is a simplified one-line diagram of the significant elements of the power system causing the varistor failures. The incoming 115 kV power is stepped down to 23 kV. Three banks of 5400 kVAR capacitors are connected to the 23 kV bus. Typical operating conditions involve two banks connected at all times, with the third bank switched on or off automatically to provide voltage regulation. Power distribution throughout the site is done at the 23 kV level.

The various drive systems which experienced the difficulty are supplied at 460 V by a 2300/460 V transformer in their control house. A substation close to the control house supplies the 2300 V power from the 23 kV distribution system.

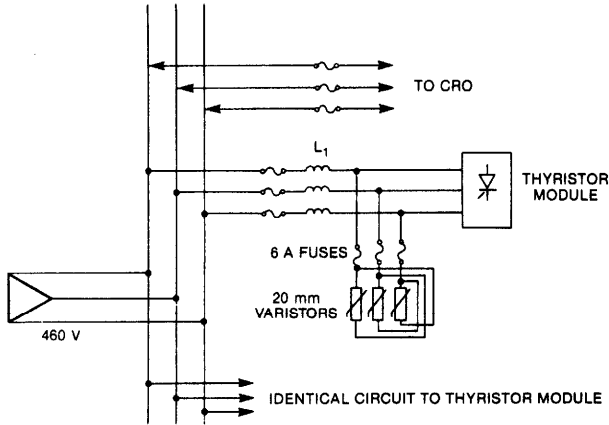
Figure 2.   Simplified three-phase schematic

Figure 2 is a simplified three-phase schematic of the power input. In the original circuit, the thyristor modules were protected by varistors at the power input of the 1250 hp drive, where the measurements were made. A 6 μH line inductance, L1, was inserted between the bus and the thyristor modules; 20 mm varistors rated 510 V were connected in a delta configuration, in series with a current-limiting fuse in each line. The varistor connection was about 80 cm long, introducing an estimated 1 μH inductance into each lead.

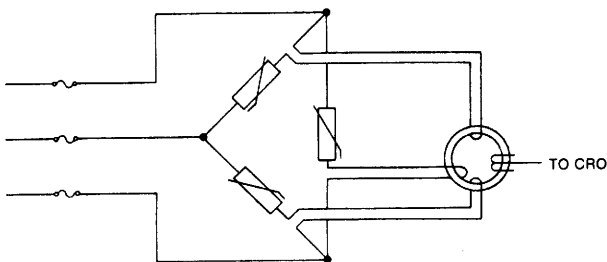
**Figure 3.   CT connection for recording
all three varistor currents**

Manual off-on switching of the 5400 kVAR capacitor bank at the 23 kV utility substation was the next step in the measurement procedures because the switching of a capacitor bank is always a prime suspect for producing transients. Measurements were performed with one oscilloscope monitoring the line voltage upstream of the line inductors (Figure 2) and another oscilloscope monitoring the sum of the currents in the three varistors (Figure 3).

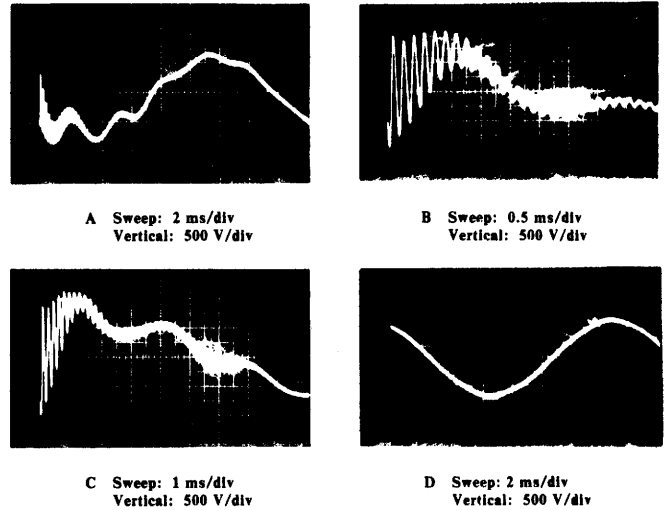
**Figure 4.   Capacitor switching transients
and steady-state voltage**

A typical total event recorded on one of the phases during a capacitor bank closing is shown in Figure 4A. A low-frequency oscillation with a period of 3 ms (330 Hz) and initial peak-to-peak amplitude of 450 V decayed in about 10 ms. The high-frequency oscillations are resolved in the recording of Figure 4B (recorded during a similar switching sequence). This high frequency has an initial peak-to-peak amplitude of 2000 V, decaying in about 5 ms. The period is 180 μs (5.5 kHz). A similar, third event is shown in Figure 4C. For scaling the amplitudes, the steady-state voltage is shown in Figure 4D.

Observe that, depending on the time of closing with respect to the 60 Hz voltage, the 5.5 kHz oscillation varies in amplitude; furthermore, the modulation by the 330 Hz oscillation pushes crests of the 5.5 kHz oscillation above the 1000 V level some time after the beginning of the trace, at a time when the 5.5 kHz amplitude is already lower, producing a burst of pulses above the 1000 V level.

The oscillograms of Figures 4 and 5 were selected as most severe from a series of 20 capacitor switching sequences. Some sequences could not even produce a current or voltage trigger; four sequences produced bursts with the central peak exceeding 120 A, two of these reaching 200 A peaks.

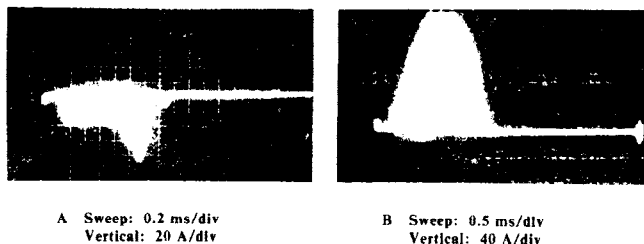
Figure 5. Current surge bursts during capacitor switching

The significance of this finding will be discussed next, with reference to Figure 5, which shows recordings of transient currents in all of the three varistors. The 510 V varistor has a nominal voltage at 1 mA [2] in the range of 735 V to 970 V. For a varistor with a nominal voltage in the middle of this range, a current in the order of tens to hundreds of amperes will flow if a voltage of 1000 V is applied to the varistor. Figure 5A shows a train of current pulses in the range of 10 to 40 A. In the burst of Figure 5B, the recorded current pulses range from 5 A to 200 A. The current and voltage traces are not simultaneous events because each of the two oscilloscopes was triggered by its internal circuit. The nearly symmetrical appearance of this burst can be compared to the symmetry of the voltage peaks exceeding the 1000 V level in Figure 4, the one correlating with the other.

Therefore, conclusive evidence was obtained that substantial current pulses were absorbed by the varistors during capacitor switching. The magnitude and duration of these pulses were excessive for the capability of a 20 mm disc; many similar drives installed elsewhere do not experience the failures encountered at that particular location.

These recordings establish the nature of the current surges that are conducted by the varistors, with an estimate of 10% reaching 200 A maximum crests and another 10% reaching 120 A crests, for all capacitor bank switching.

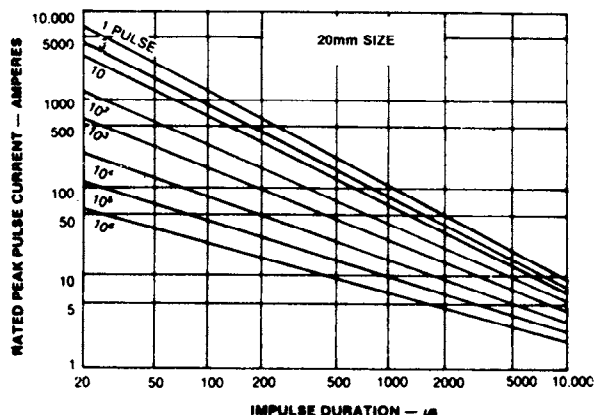
Published varistor specifications include the "pulse ratings," a family of curves that define, for each varistor type, the number of isolated pulses that a varistor can absorb until its "rating" is reached [4]. The curves show lines relating amplitude, duration, and total number of pulses. Figure 7 shows this family of curves for the original 20 mm varistor.

Figure 8 shows the same curves for a proposed 32 mm varistor. It should be noted that the pulse rating does not mean catastrophic failure of the varistor at the end of this rating, but only a 10% change in the varistor nominal voltage. Although some change is indicated, the varistor is quite capable of staying on line voltage and of clamping surges.

An obvious remedy would be to use a varistor with greater energy-handling capability. The 32 mm size offers such a possibility. Inspection of Figures 7 and 8 shows that the equivalent pulse of Figure 10 (800 μs and 100 A) corresponds to a permissible occurrence of 100 pulses for the 32 mm varistor, in contrast to the two for the 20 mm varistor. The improvement in the number of pulses is 50 times more pulses until *pulse rating* is reached. The improvement in the number of pulses until *varistor failure* occurs, however, is not necessarily 50 times more pulses. Because of the imprecision mentioned previously in the margin between end of pulse rating and ultimate failure, that margin is not necessarily the same for the two sizes, 20 mm and 32 mm, but it is reasonable to expect the same order of magnitude improvement in the ultimate failure as in the pulse rating. This expectation of a 50 times improvement would change the time between failures from the few days observed with the 20 mm size to perhaps one year with the 32 mm size, providing immediate relief and time to make further changes for the long term. Therefore, the change to a 32 mm size, connected at the same point of the circuit, was immediately implemented for that particular environment.

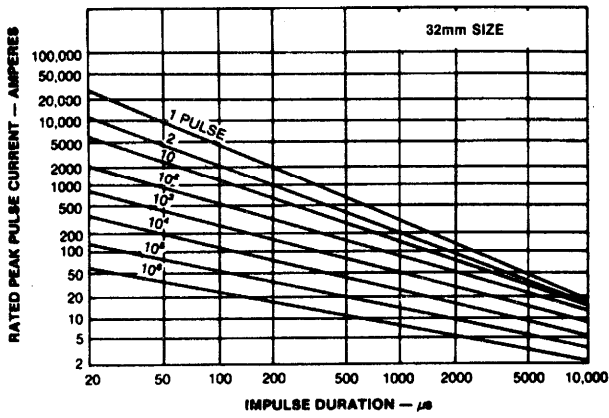
**Figure 7. Pulse ratings of 20 mm varistor [4]**

The equivalent pulse of Figure 10 can then be used to evaluate, from the pulse ratings of Figure 7, the number of high-amplitude switching transients that will consume 100% of the varistor pulse rating. Inspection of Figure 6 shows that for a 800 μs duration and 100 A amplitude, the pulse rating of the 20 mm varistor (6 kA rating at 8/20 μs) is reached with two such events. With a probability of about 10% that this highest switching transient would occur during random timing of the switching (the effect decreases rapidly for transients other than the highest) and with 2 to 4 switching operations each day, the pulse rating of the varistors could be reached with 20 operations, failure perhaps starting at 40 to 50 operations, or after about 10 days of exposure to that power system environment. This estimate is unavoidably imprecise because the pulse rating curves represent a conservative minimum; actual failures will occur only for amplitudes or numbers of pulses exceeding the rating by a large but imprecise margin to allow for manufacturing variations. However, the order of magnitude of this estimated time to failure is in accord with the observations made at that installation.

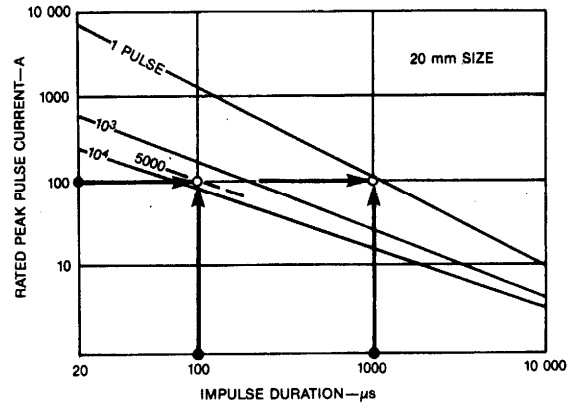
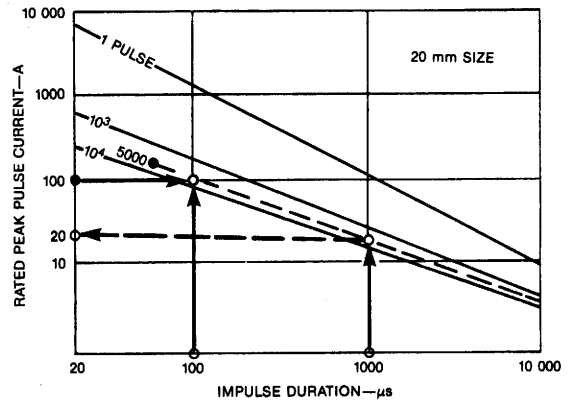
A careful examination of the pulse rating curves will show that the duration of the pulses has a strong influence on the number of permissible pulses. Furthermore, the relationship between the increased duration of the pulses and the decreased number of permissible pulses is not proportional. For instance, consider pulses of 100 A peak and 100 μs duration (Figure 9A): the curves show 5000 pulses allowed. Now increase the duration of the pulses to 1000 μs (a ten-fold increase), while keeping the amplitude at 100 A: the curves show the permissible number as one pulse only. Thus, the ten-fold increase in duration does not result in a ten-fold decrease in the number of permissible pulses; the reduction in that number is much greater than the inverse of the increase in duration. Conversely, taking a pulse duration of 1000 μs, and seeking the amplitude allowable for the same 5000 pulses, Figure 9B shows that the current is 20 A, which is five times less than the original 100 A, not ten times less. Therefore, it would be incorrect to treat the multiple pulses of Figure 5 as five separate short pulses; rather, one equivalent long pulse has to be defined.

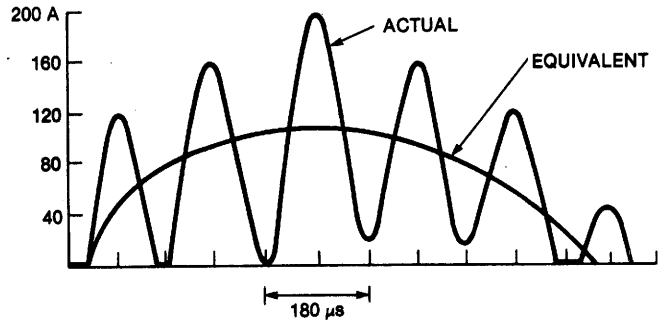
Figure 10.   Single-pulse equivalent pulse for multiple pulses

The five-pulse burst of Figure 5 has been redrawn in Figure 10 in order to plot an equivalent continuous pulse of approximately equal duration, with a crest such that the i·t integral of the burst and the i·t of the equivalent pulse are approximately the same. The use of i·t rather than the $i^2 \cdot t$ integral typically used for fuses or other linear loads is justified by the fact that heat deposited in the varistors is the significant parameter because the nominal voltage change process is temperature related; this heat is the product of the variable i and the nearly constant voltage across the nonlinear varistor during the burst.

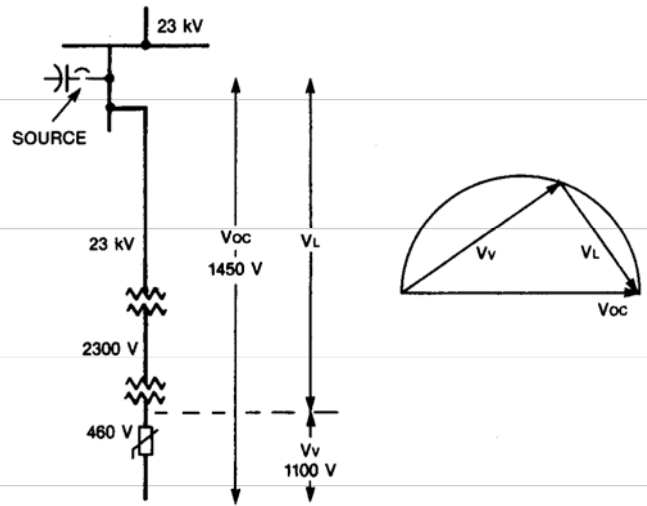
Figure 12. Open-circuit voltage and voltage drops in the system

1. From the actual measured voltages shown in Figure 12, we derive the voltage drop, V_L, in the 23 kV line and two step-down transformers:

Note that this 4.7 Ω impedance means that the 5.5 kHz switching transient, generated at a distance of about 3000 m (2 miles) from the point of measurement, and at the 23 kV level, can travel a long distance and pass through two step-down transformers with less attenuation than might be expected from the unsound but popular view that "surges cannot travel that far without substantial attenuation."

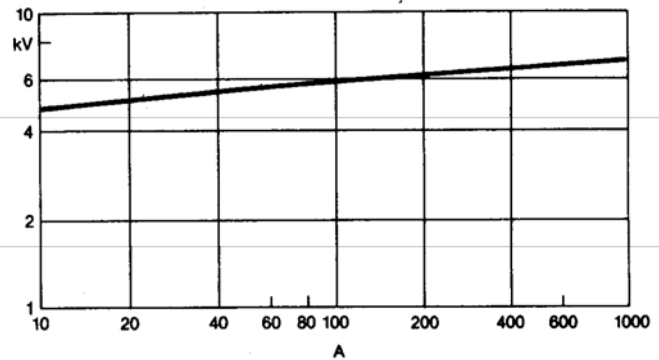
Figure 13. Minimum clamping voltage characteristic for 2300 V arrester

5. Thus, we can expect that the 2300 V arrester will experience current pulses occurring in bursts not exceeding 60 to 70 A, with durations similar to those found on the 460 V varistors, i.e., 5 to 7 pulses per train, or a total duration in the order of 1 ms. Information on arrester duty available from the manufacturer indicates that, for a pulse train of that duration and a crest of less than 100 A, no limitation of the number of pulses need be imposed on the arrester as long as enough time is allowed between pulses to permit cooling of the arrester.

Furthermore, the 5700 V clamping level predicted for the 2300 V surge arresters at 60 A would be reflected as a crest of 5700 V $\times$ 460/2300 = 1140 V on the 460 V side. The 510 V, 32 mm varistors, connected in series with the impedance of the 2300/460 V transformer, would then be exposed to this maximum

In general, the protection available from surge arresters tends to improve when the arresters are installed at higher circuit voltages. Thus, it is quite possible that arresters installed at the 2300 V primary of the 2300/460 transformer could provide a more effective clamping (and at the same time relieve some of the energy stress) than the varistors at the 460 V level. (It is of course implied that these would be the zinc-oxide type, gapless arresters.) The full benefit of these arresters depends on the configuration of the 2300 V system and its grounding (solidly grounded neutral in a wye system, resistance-grounded wye, or floating delta) when the arrestors are connected in the conventional line-to-ground mode. In a second phase of the retrofit described here, 2300 V arresters were installed at the transformer primary. A discussion of their expected performance, validated by the success of the retrofit, is given later on.
