EXPERIMENTAL TESTING OF ROOF TO WALL CONNECTIONS IN WOOD FRAME HOUSES

Michael A. Riley and Fahim Sadek

Building and Fire Research Laboratory
Gaithersburg, MD 20899-8611

April 2003

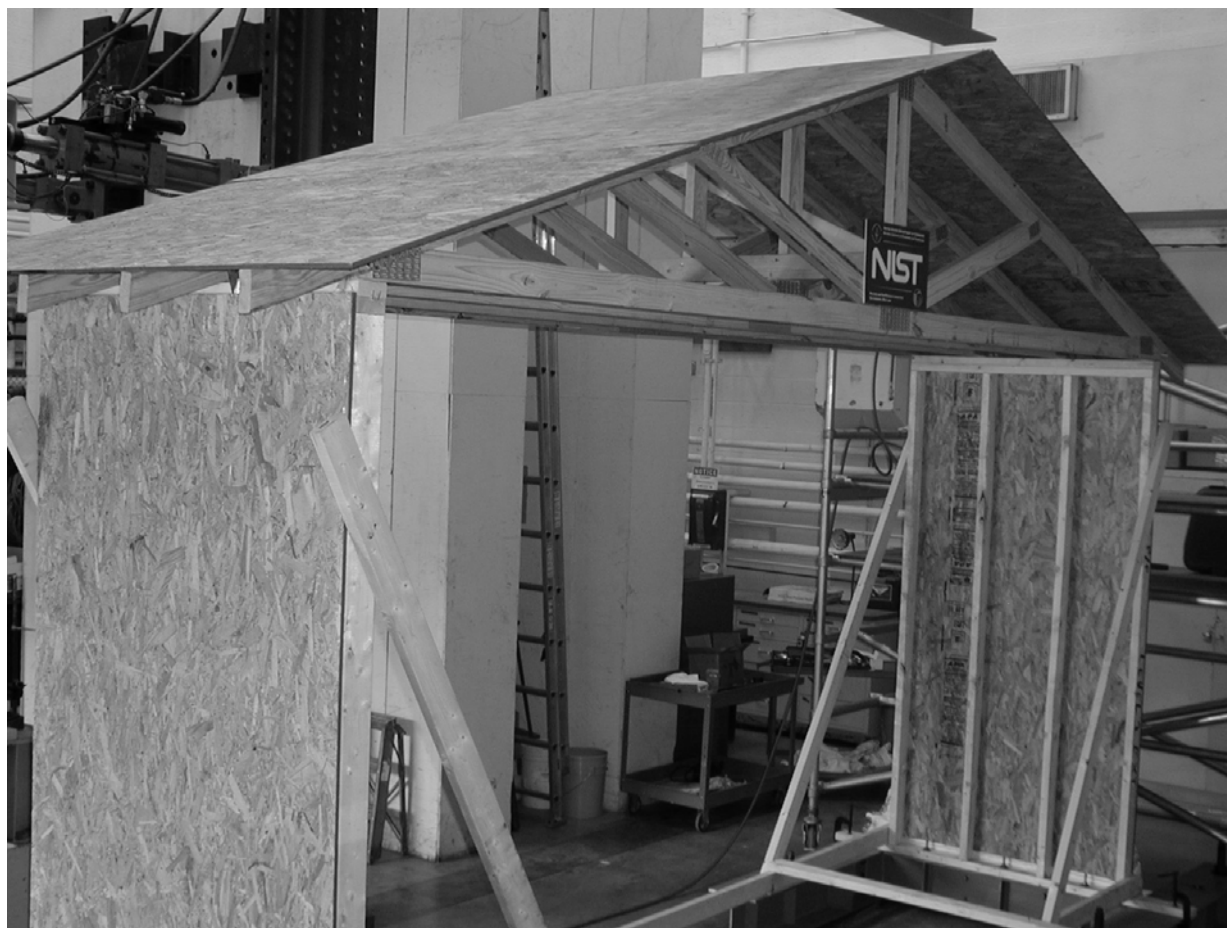
Figure 2.2. Typical test specimen before instrumentation.

The specimens represent a center cut through a simple wood-frame house. Each specimen consisted of two 1.22 m (4 ft) long by 2.47 m (8 ft 1.25 in) high shear walls that supported four roof trusses with spans of 4.88 m (16 ft). A sketch of a test specimen is shown in Figure 2.1, and a photo of one specimen is shown in Figure 2.2

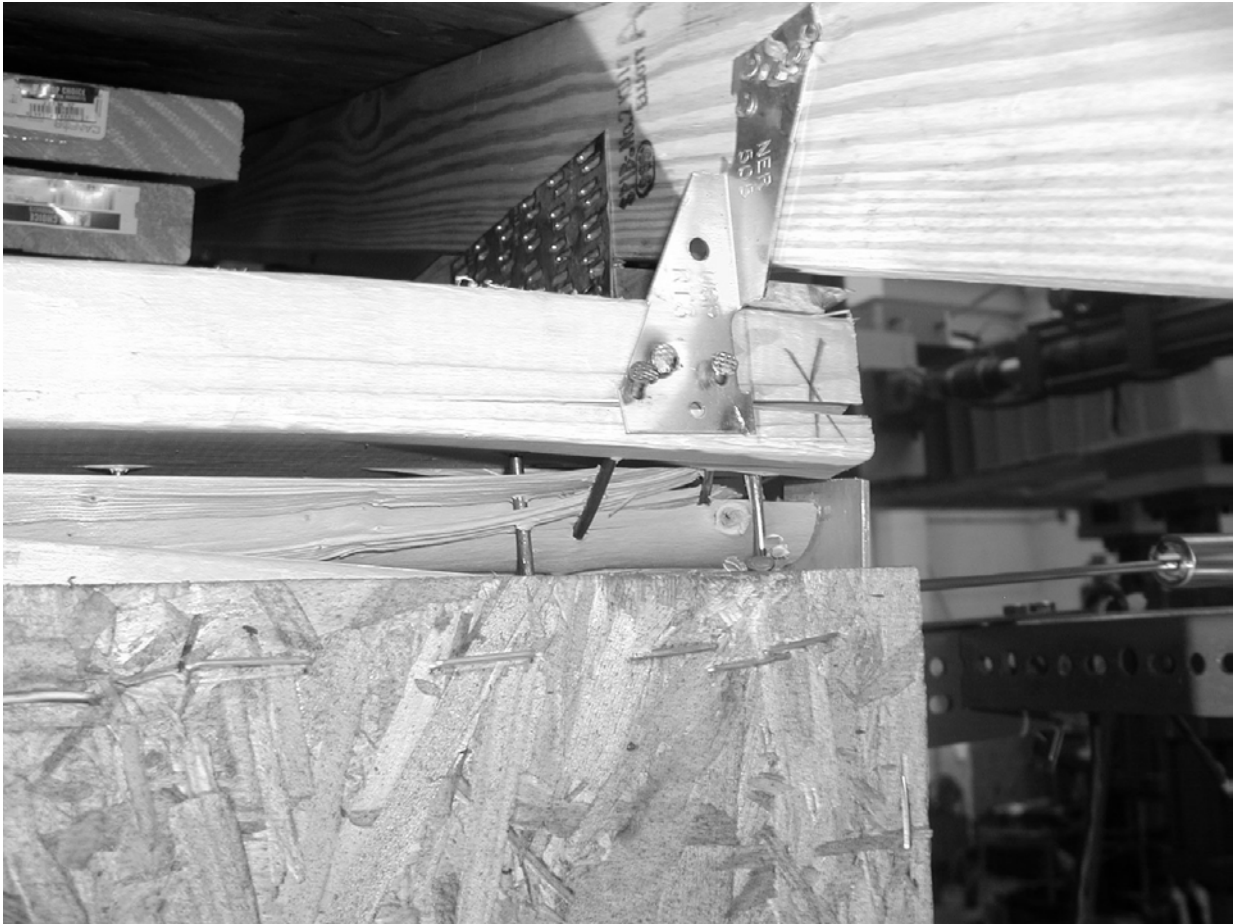
Figure 3.6. Failure of hurricane clip connection.

The specimen with the stronger hurricane clip connections was tested twice. The first failure occurred on the lightly instrumented side of the specimen, and consisted of the entire top plate pulling loose from the wall studs and cladding. The specimen was repaired and retested. During the second test, failure was observed on the other side in the walls' top plate, as can be seen in Figure 3.6. The hurricane clip remained attached to the upper member of the top plate and the truss, while the upper member of the top plate and a portion of the lower member separated from the rest of the wall. This failure mode clearly illustrated the improved strength of the hurricane clip connection.

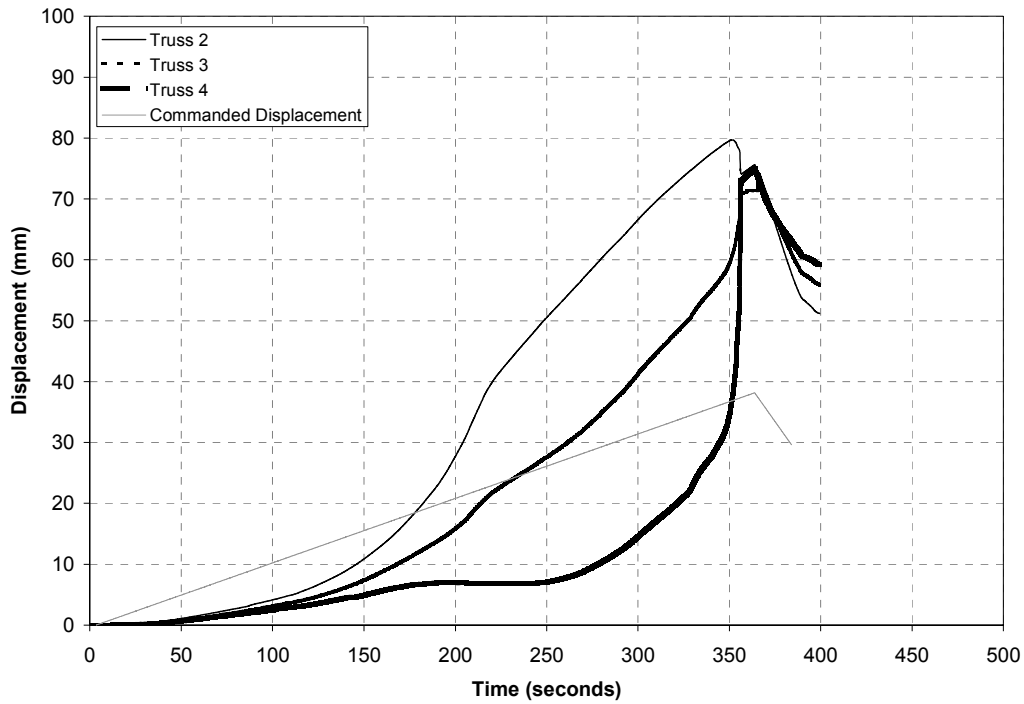
Figure 3.11. Connection deformation response of second test with hurricane clips.

The deformation that occurred at one of the inner truss connections during the first test is shown in Figure 3.9, while the deformation at three connections during the second test is shown in Figure 3.11. The corresponding load-deformation curves are shown in Figure 3.10 (first test) and Figure 3.12 (second test). As can be seen in these two figures, the hurricane clip connections showed good ductility, continuing to carry significant, but reduced, load at relatively large levels of deformation.

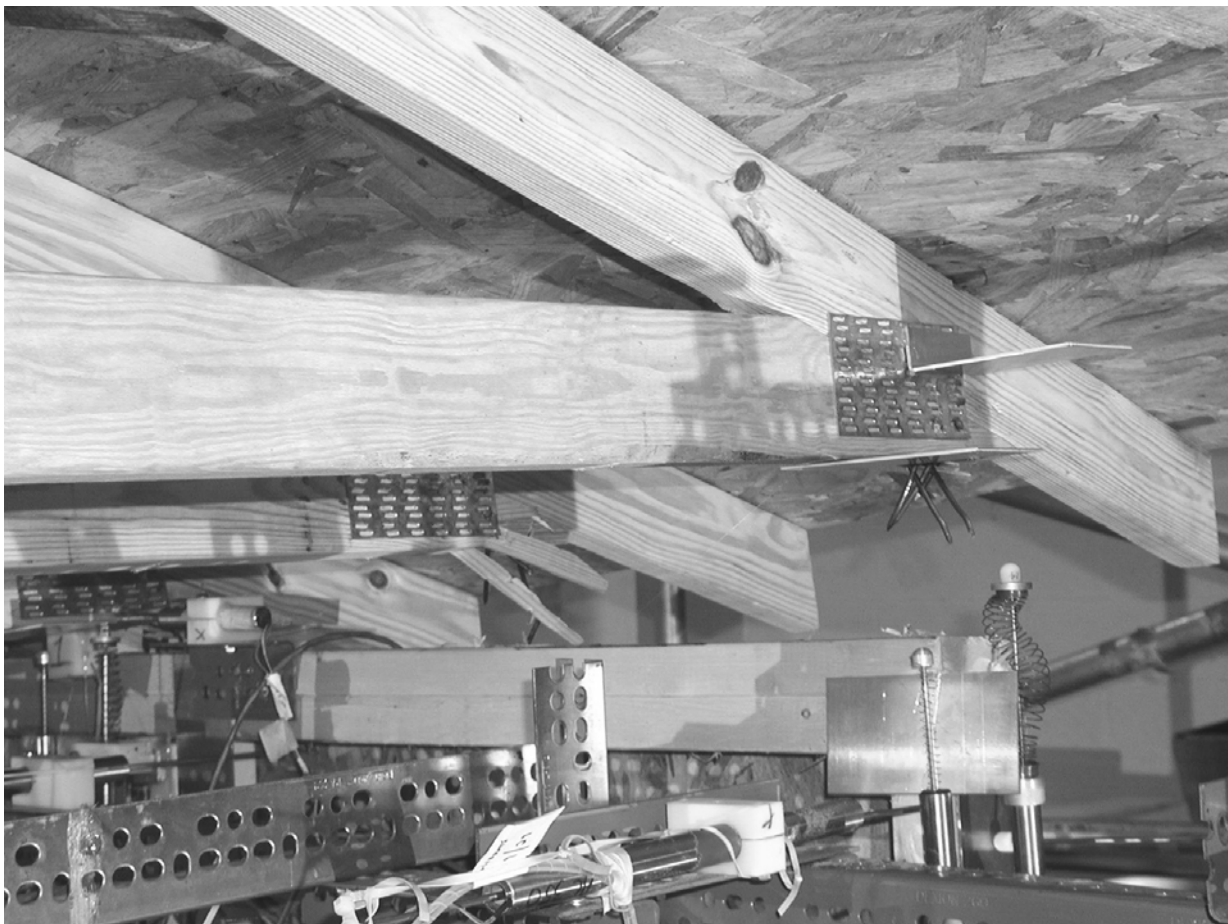
Figure 4.1. Failure of toe-nailed connection with lateral load.

For the specimen with toe-nailed connections, the lateral deformation was applied at a constant rate of 12.7 mm/min (0.50 in/min) for a period of about 330 s, as can be observed in Figure 4.2. The resulting load is shown in Figure 4.3. The specimen resisted the applied load with constantly decreasing stiffness, until about 270 s into the test. At this point, the tension, due to the overturning moments, in the connections at one end caused the outer truss to pull free of the top plate. This failure can be seen in Figure 4.1. As in the case of the uplift loading, the failure mode can be characterized as nail withdrawal from the top plate. This failure resulted in the wood splitting in the bottom chord of one inner truss, but little damage to the wood of the outer truss.

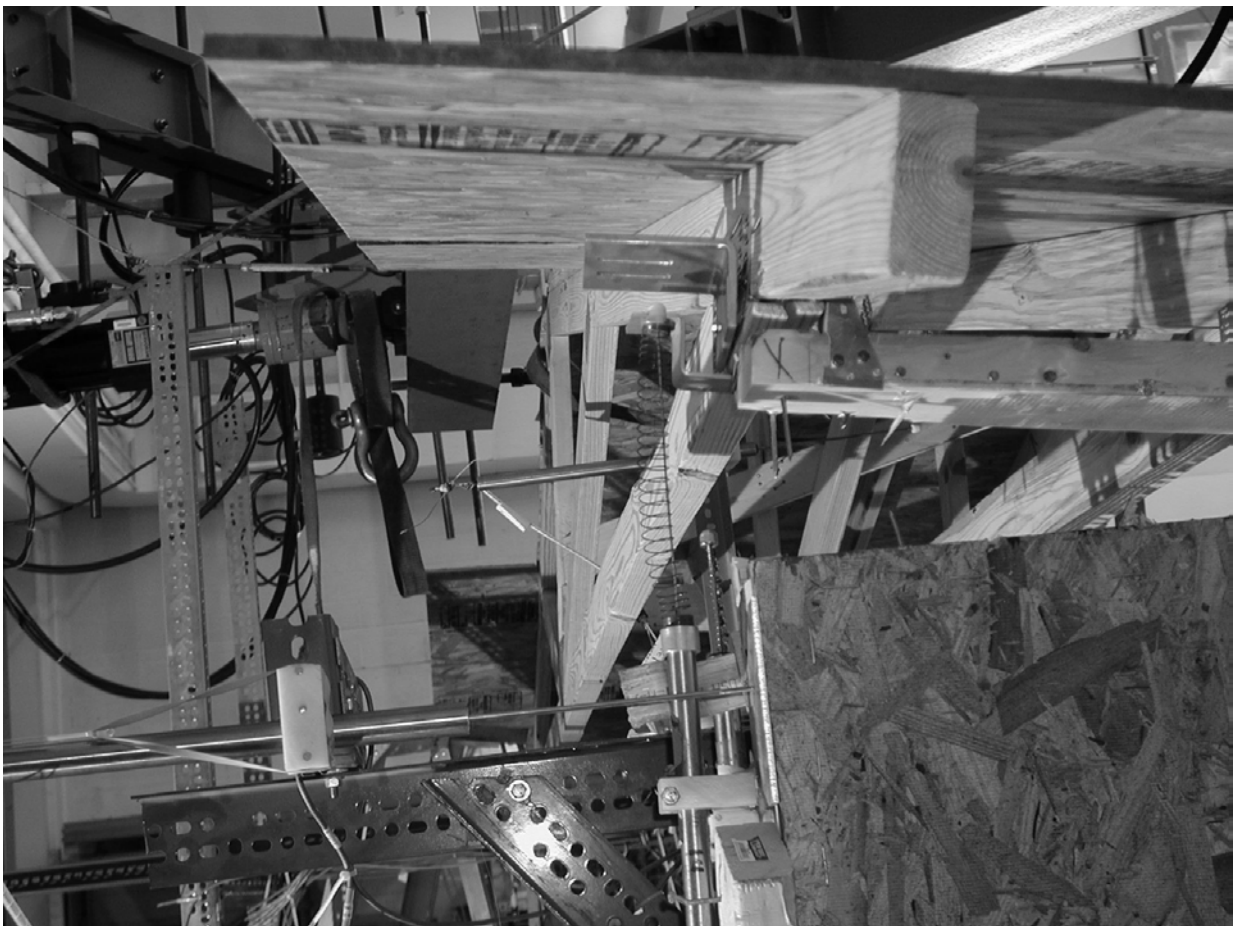
Figure 4.10. Failure of hurricane clip connection with lateral load.

For the specimen with hurricane clips, the lateral deformation was applied at a constant rate of 25.4 mm/min (1.0 in/min) for a period of about 250 s, as can be observed in Figure 4.11. The load that resulted is shown in Figure 4.12. The specimen resisted the applied load with a near constant stiffness, until about 170 s into the test. At this point, the outer truss pulled free of the top plate. As in the case of the toe-nailed connections, the tension due to the overturning moments appeared to play a major role in the failure, which can be seen in Figure 4.10. Also as in the prior test, the failure mode can be characterized as nail withdrawal from the top plate.

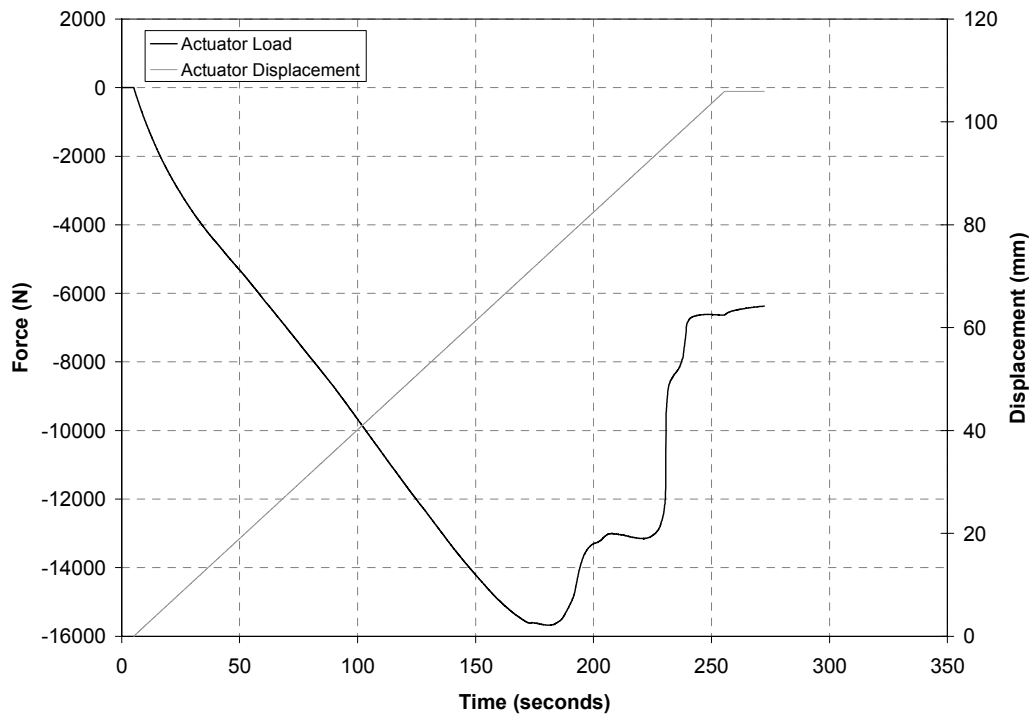
Figure 4.12. Lateral load applied to specimen with hurricane clips

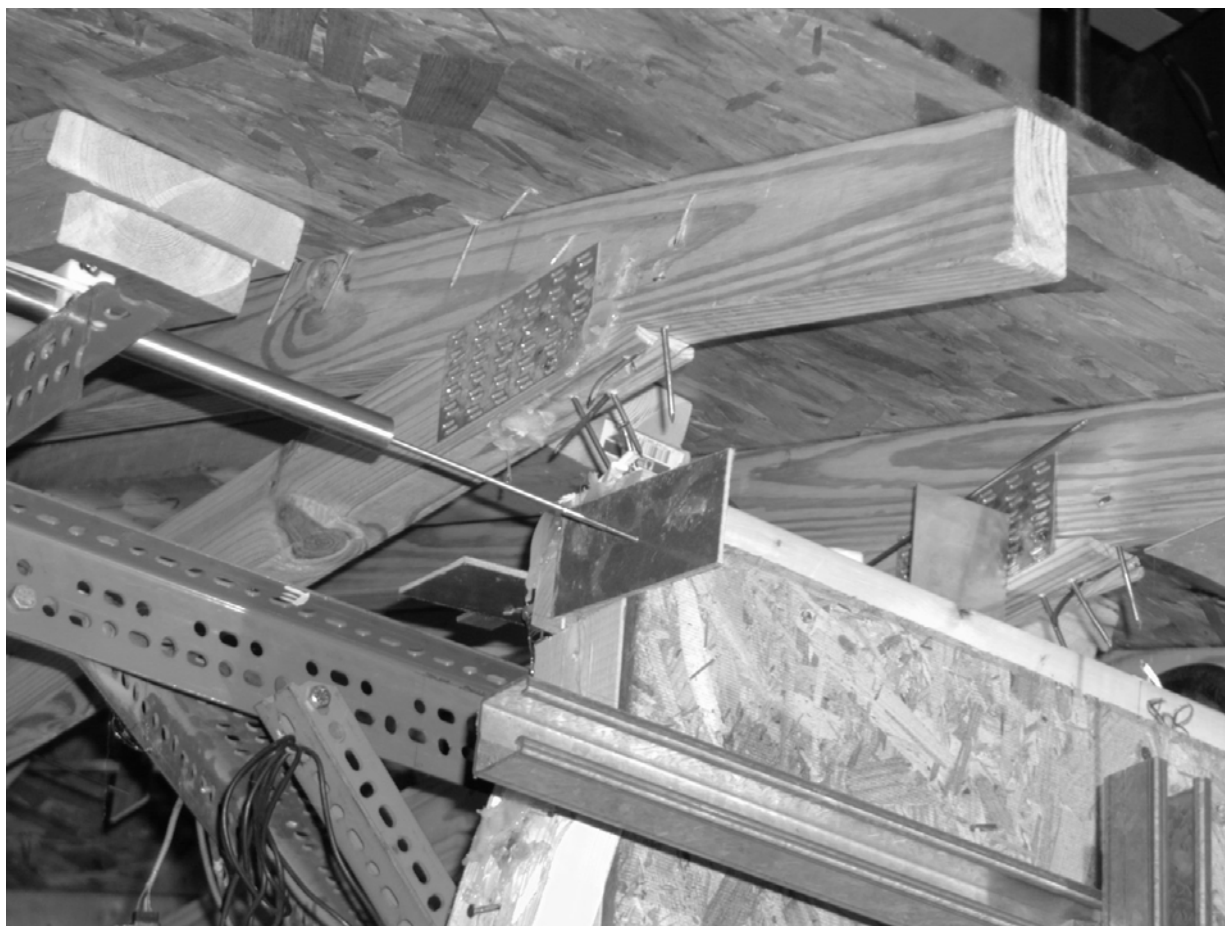
Figure 6.1. Failure of toe-nailed connection with combined load.
