Maintaining Structural Integrity

- **Stephen S. Szoke, P.E.**
- **Director of Codes and Standards**
- **Portland Cement Association**
- **5420 Old Orchard Road**
- **Skokie, IL 60077**
- **847-972-9078**

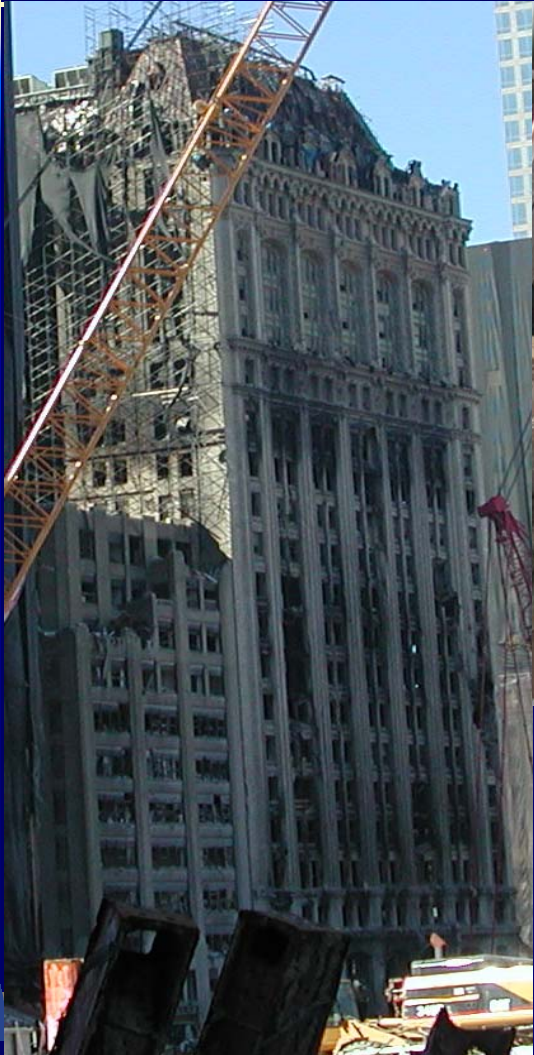
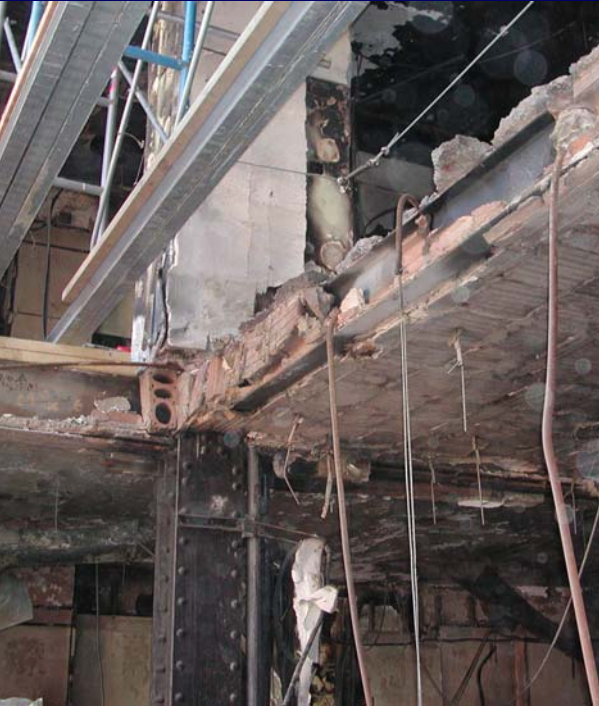
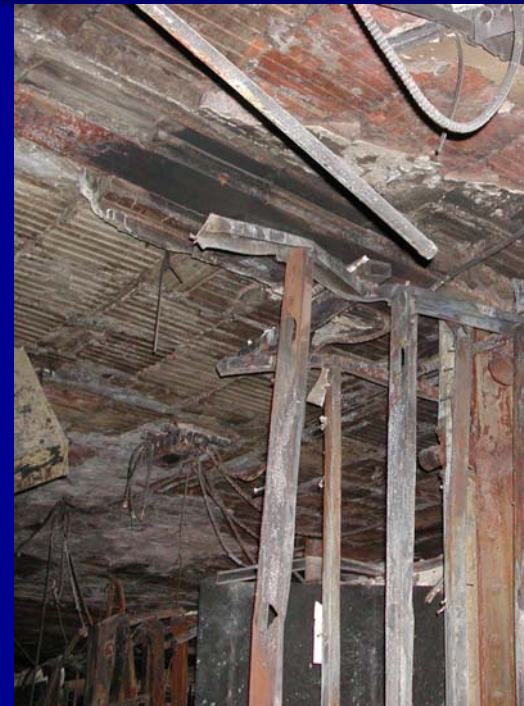
FEMA/ASCE on 90 West

"Older, early century fireproofing methods of concrete-, brick-, and terra cotta tile-encased steel frame performed well, even after 90+ years, and protected the 90 West Street building from extensive structural damage." "This type of construction, with terra cotta tiles providing fire protection...resulted in highly compartmentalized building, which may have helped slow the spread of fire..."

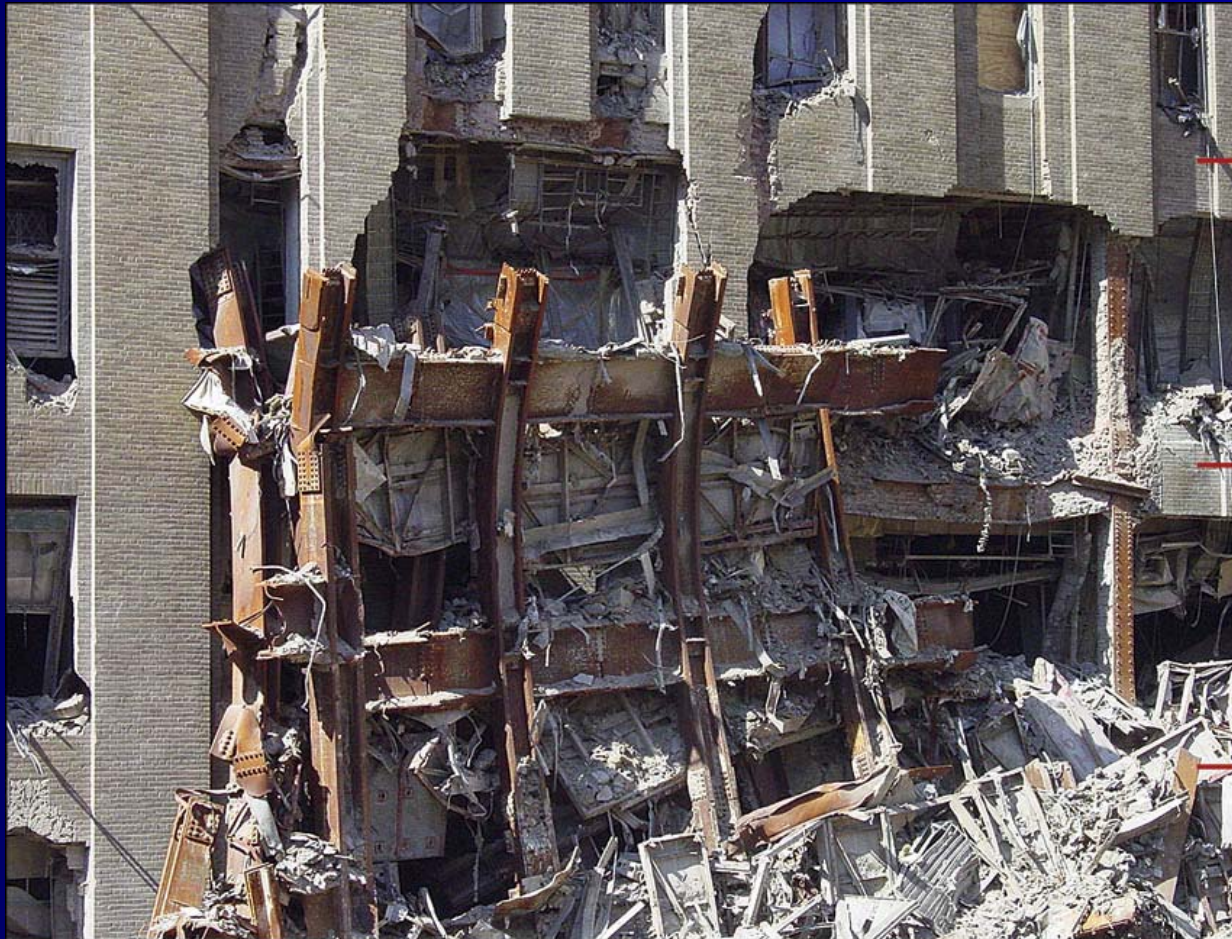
FEMA/ASCE on Verizon

"In general, the Verizon building performed well, especially given its close proximity to WTC 7... Several factors may have contributed to the performance of the Verizon building. The thick masonry walls, brick-encased columns, cinder-concrete encased beams and girders probably absorbed much of the energy of the impacts while also providing additional stiffness and strength to the building frame."
