# NIST Technology Showcase

## FutureScan

Next-Generation Pipe Penetrating Radar for  
Sewer and Water Infrastructure Inspection

Project NANB9H9009

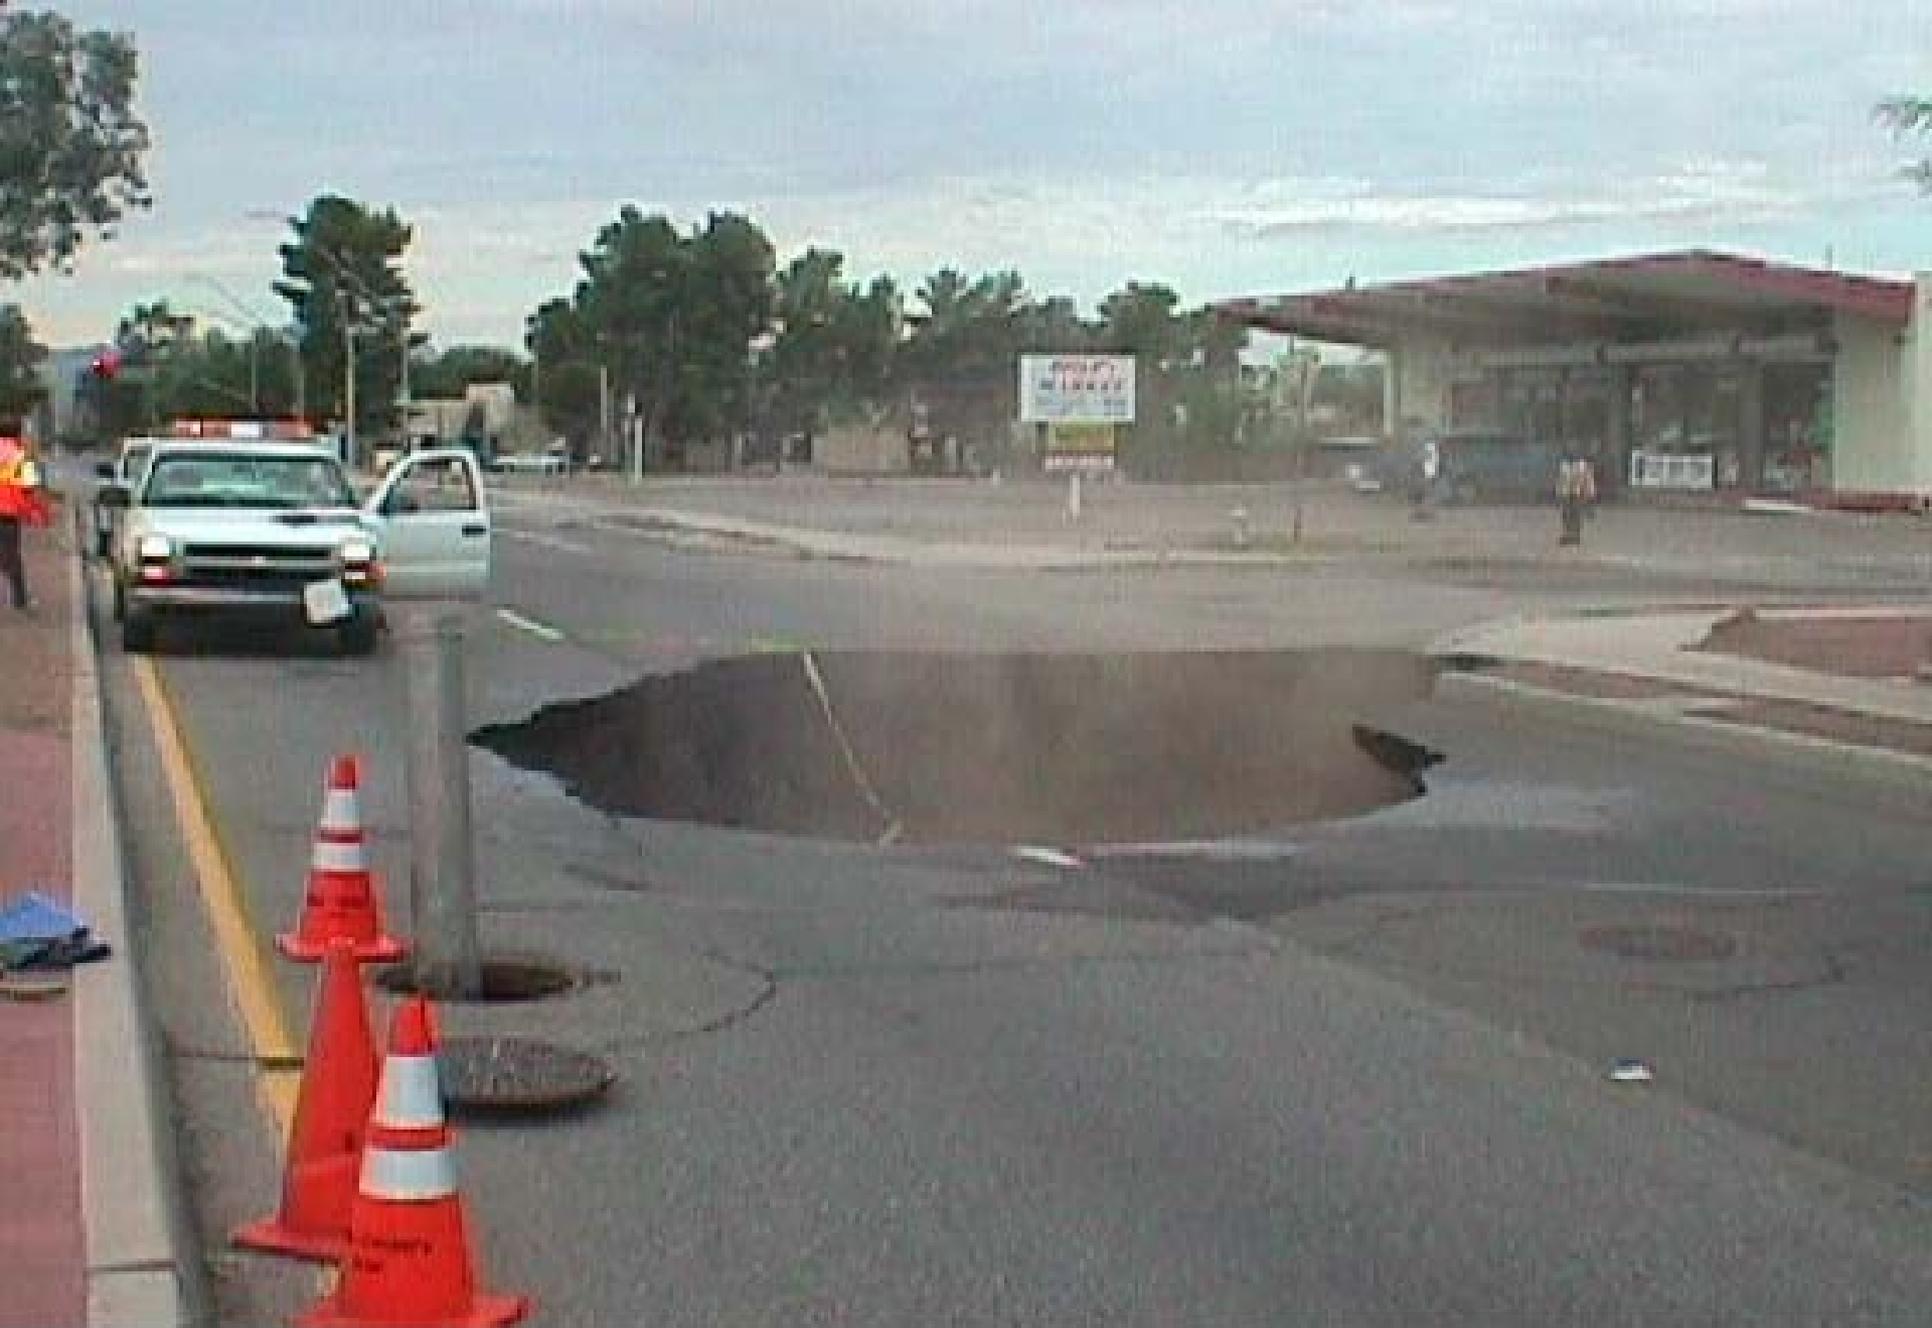
***An Example of a Catastrophic Void***

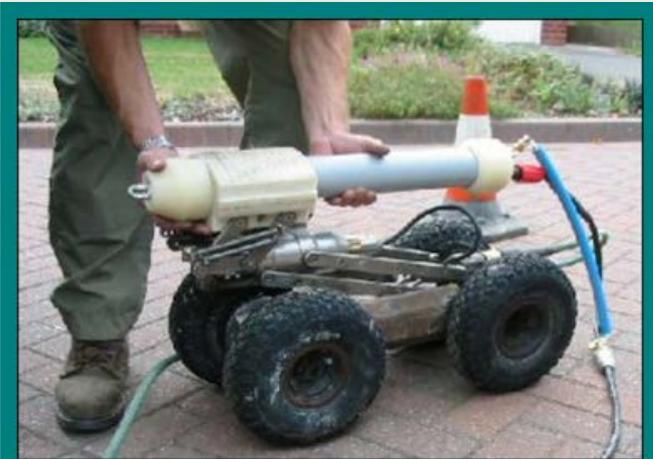
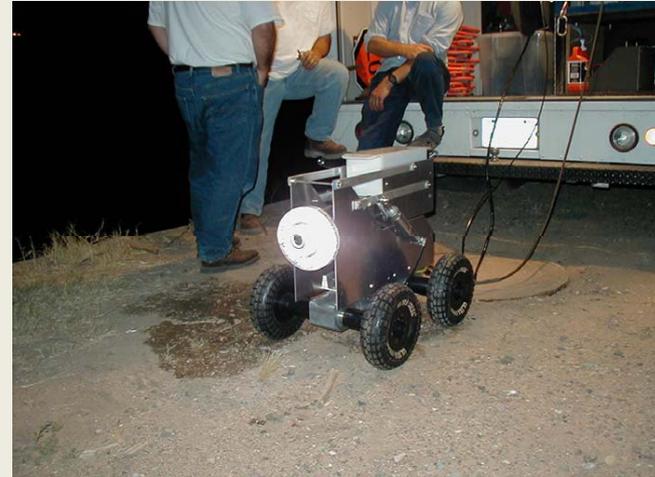
# Early Examples of In-Pipe GPR

- Borehole GPR unit looks for debris under I-5 (1998)
- Arizona Public Utility modified surface GPR mounted on standard transporter to detect voids behind a PVC liner (2004)
- Requires expert operators and Data Interpreters
- No common platform or User Interface
- Utilizes existing GPR technology—low resolution

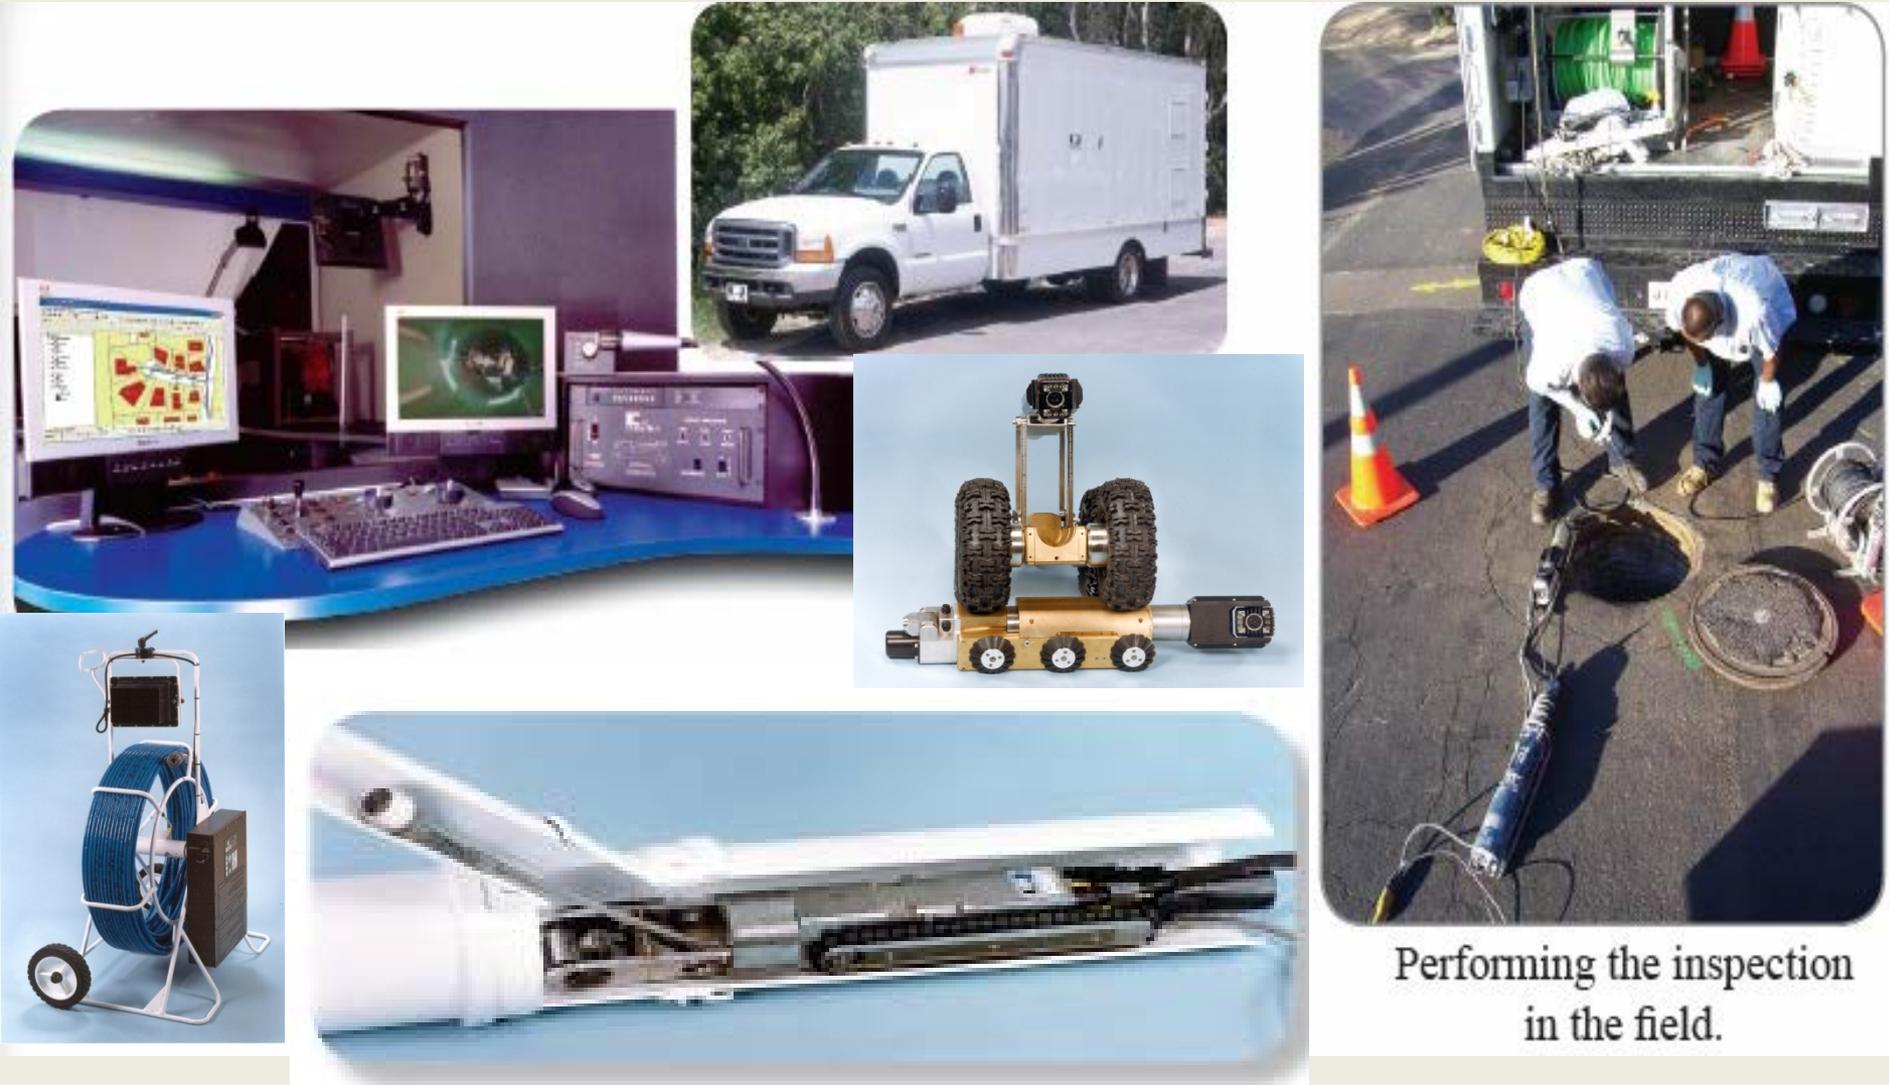
Performing the inspection  
in the field.

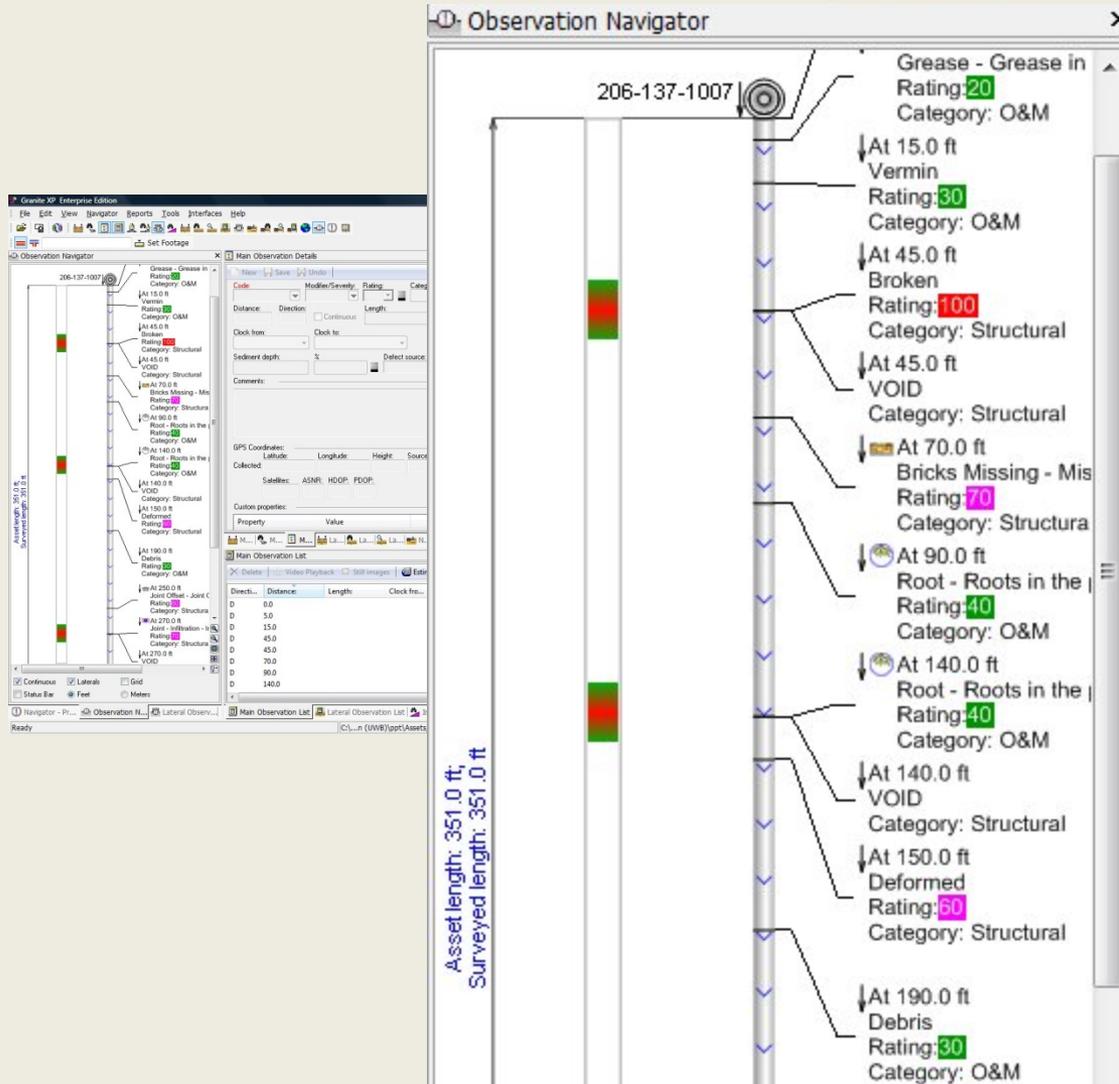
# Pipe-Run Report View

- Color real-time indication
- VOID observations are added automatically for each detected void
- Voids are available in all reports, including the pipe-run one

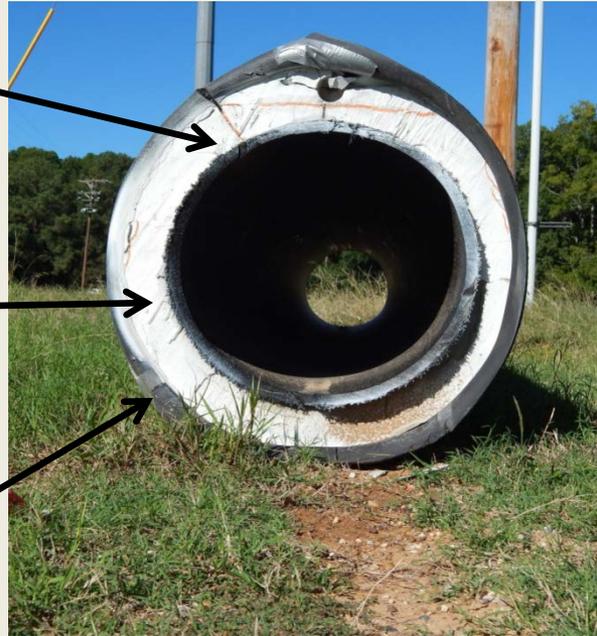
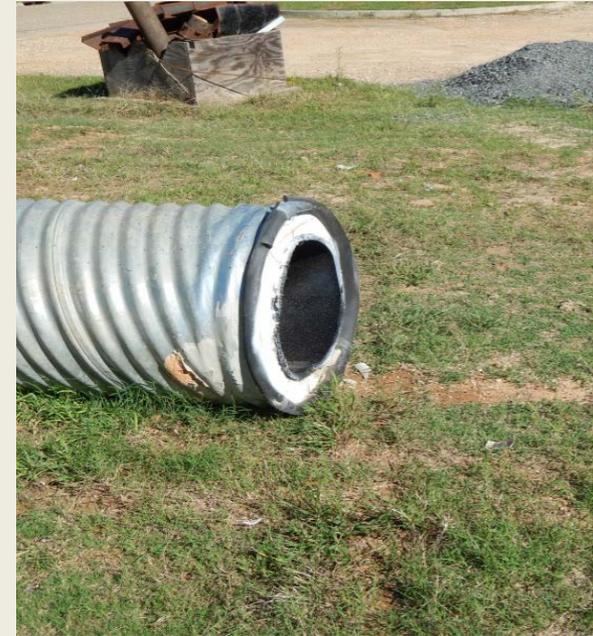
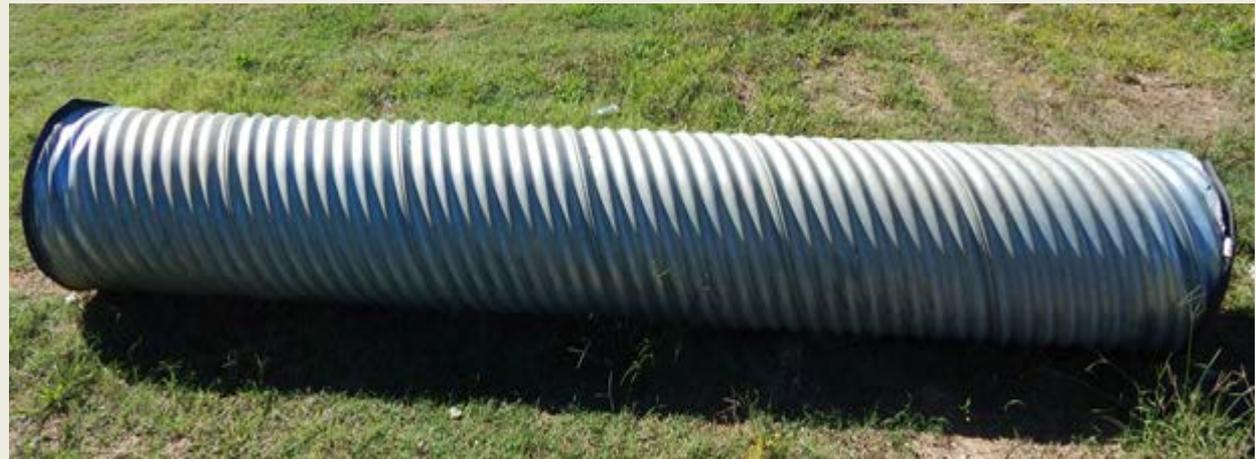
# Delamination Measurement—LTU Test Setup

1 inch HDPE

3 inches Grout

Corrugated Metal Pipe

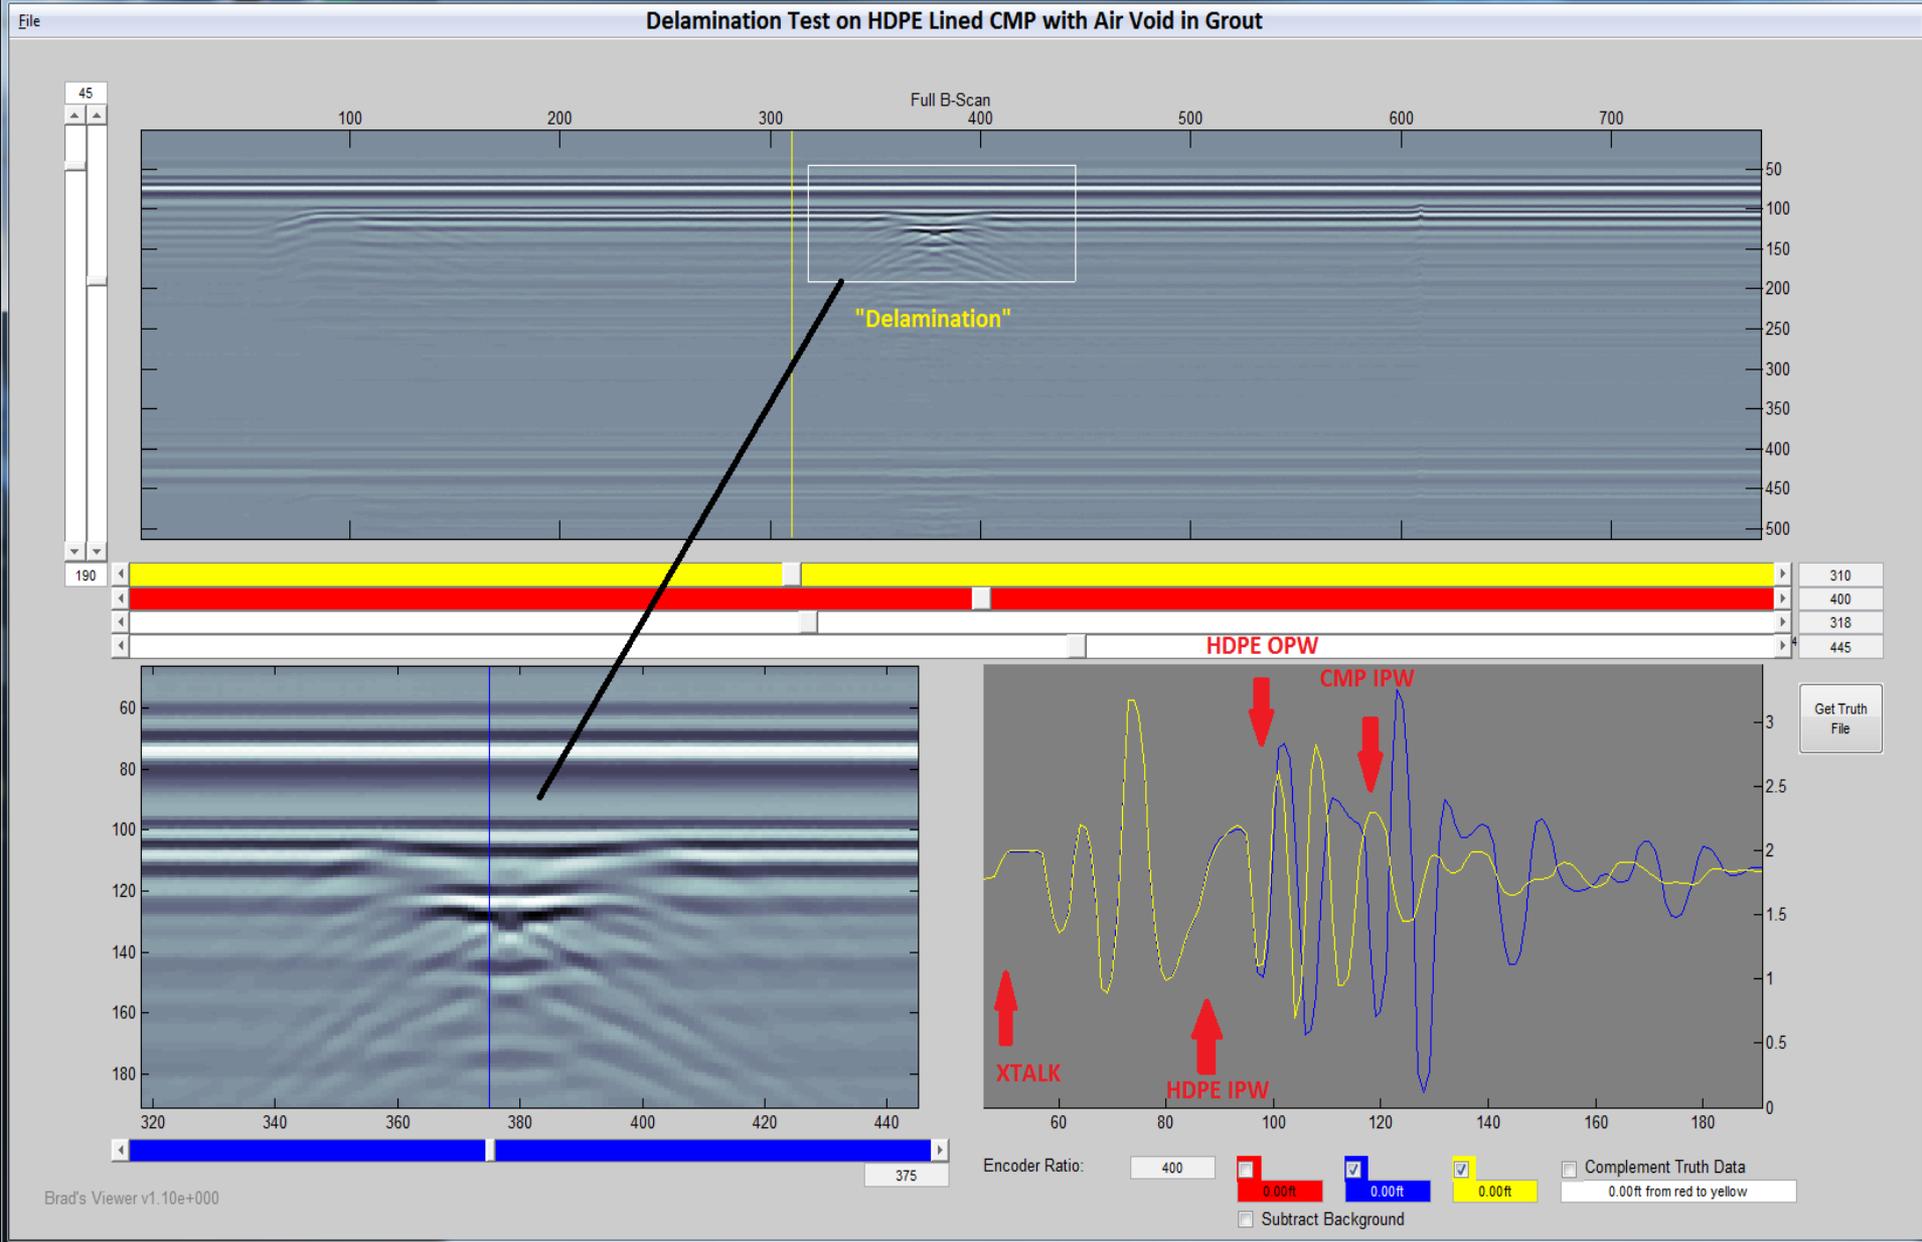
# Delamination Measurement—LTU Setup

Figure 1: D:\Dropbox\FutureScan team\Recorded Data Files\Louisiana Data\LTU Data\LTU-Ruston Data\SouthCampus data\2013-10-18 Itu PCCP delamination test\10 18 2013 12 03 PM.hdf

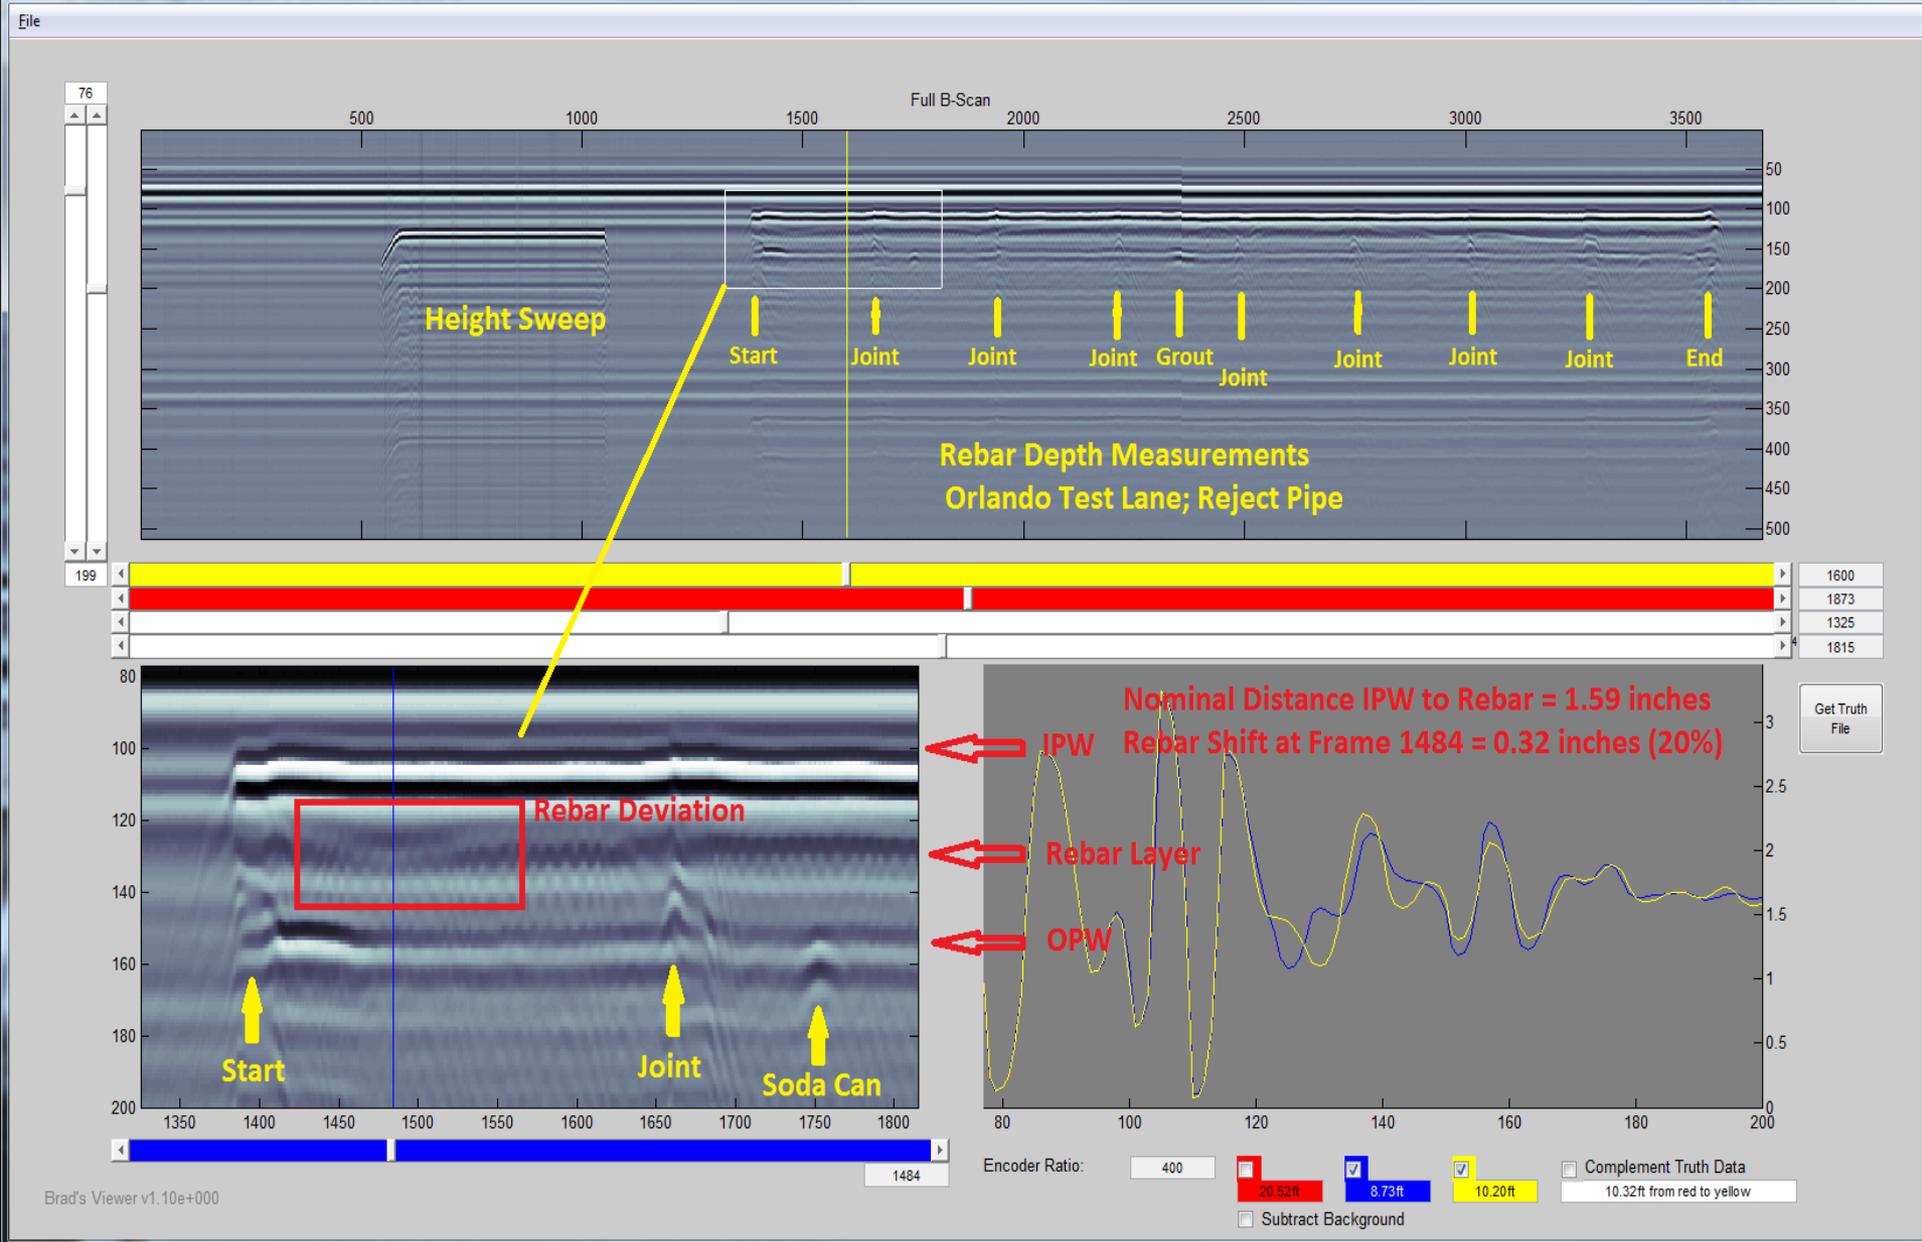
# Rebar Characterization

Figure 1: D:\Dropbox\FutureScan team\Recorded Data Files\Orlando Data\2013-06-08 rx gain tests.media\UWB\6 8 2013 9 00 AM.hdf

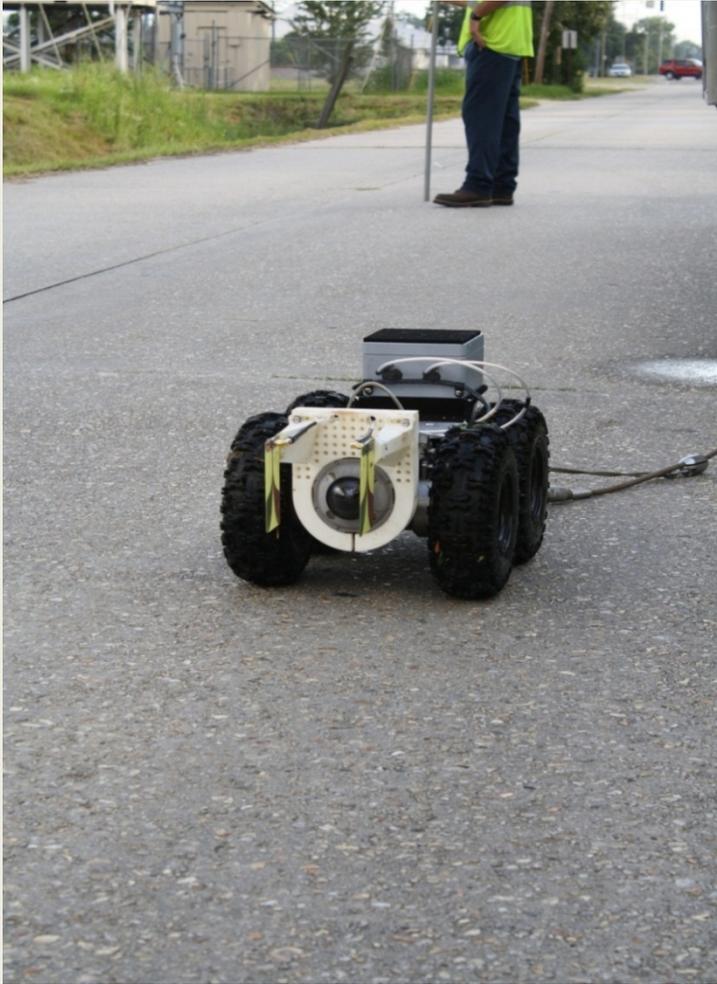
*FutureScan Unit Conducting a Pavement Surface Scan*

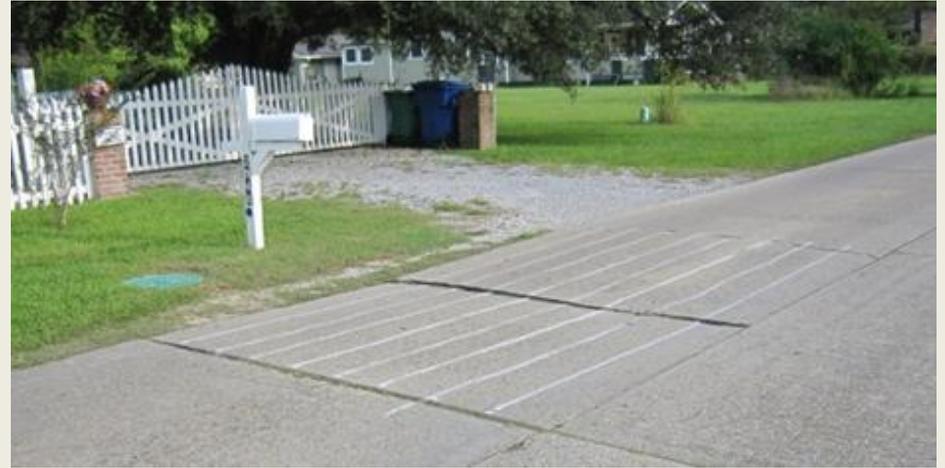
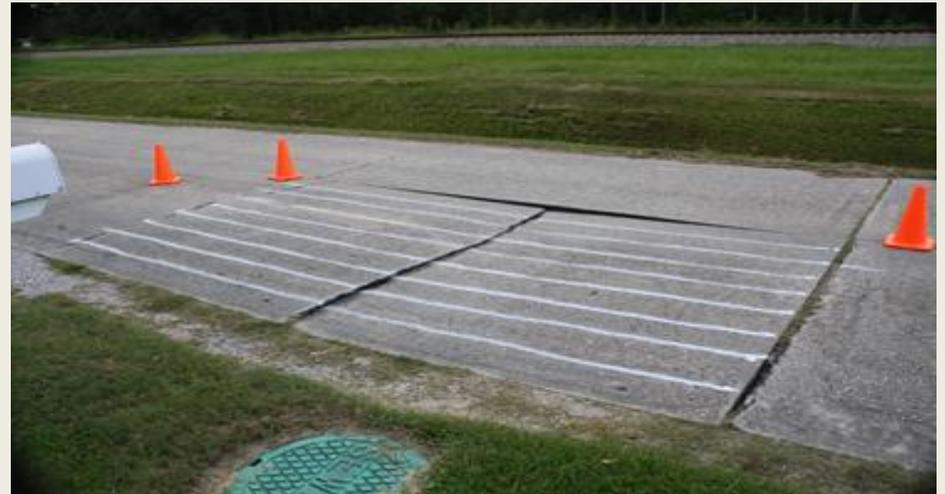
*Leakage into adjacent brick-lined sewer created void under roadway, cracking of the concrete plate*

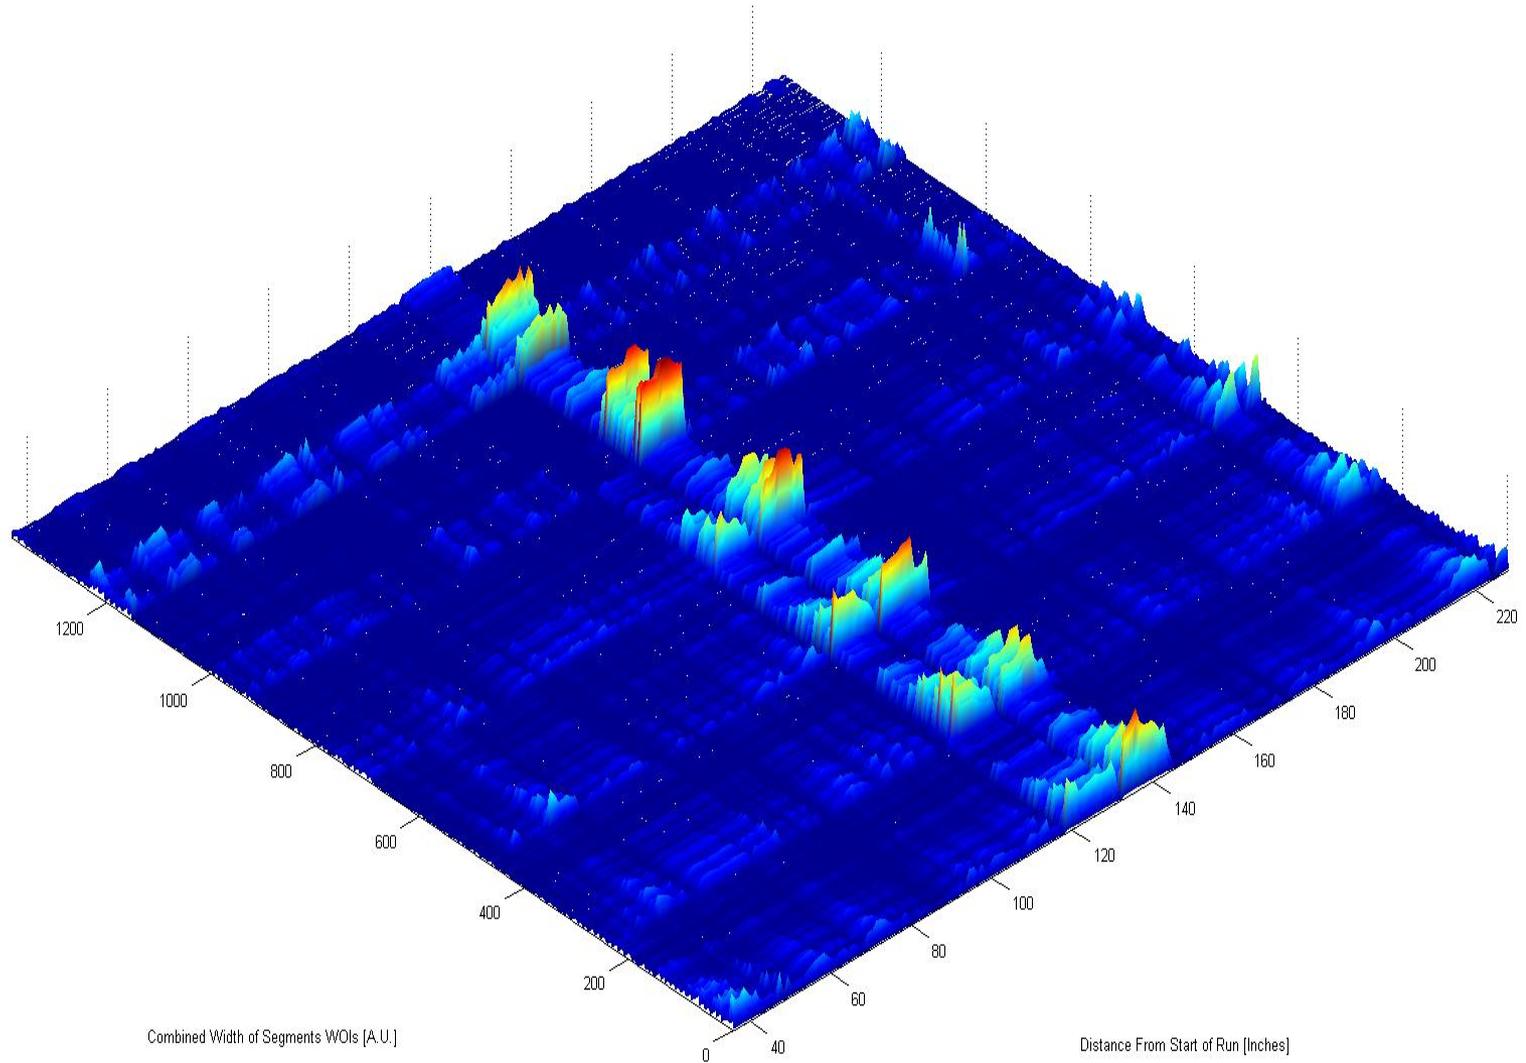
# 3-D Image of Surface Scan--2948 Front Street

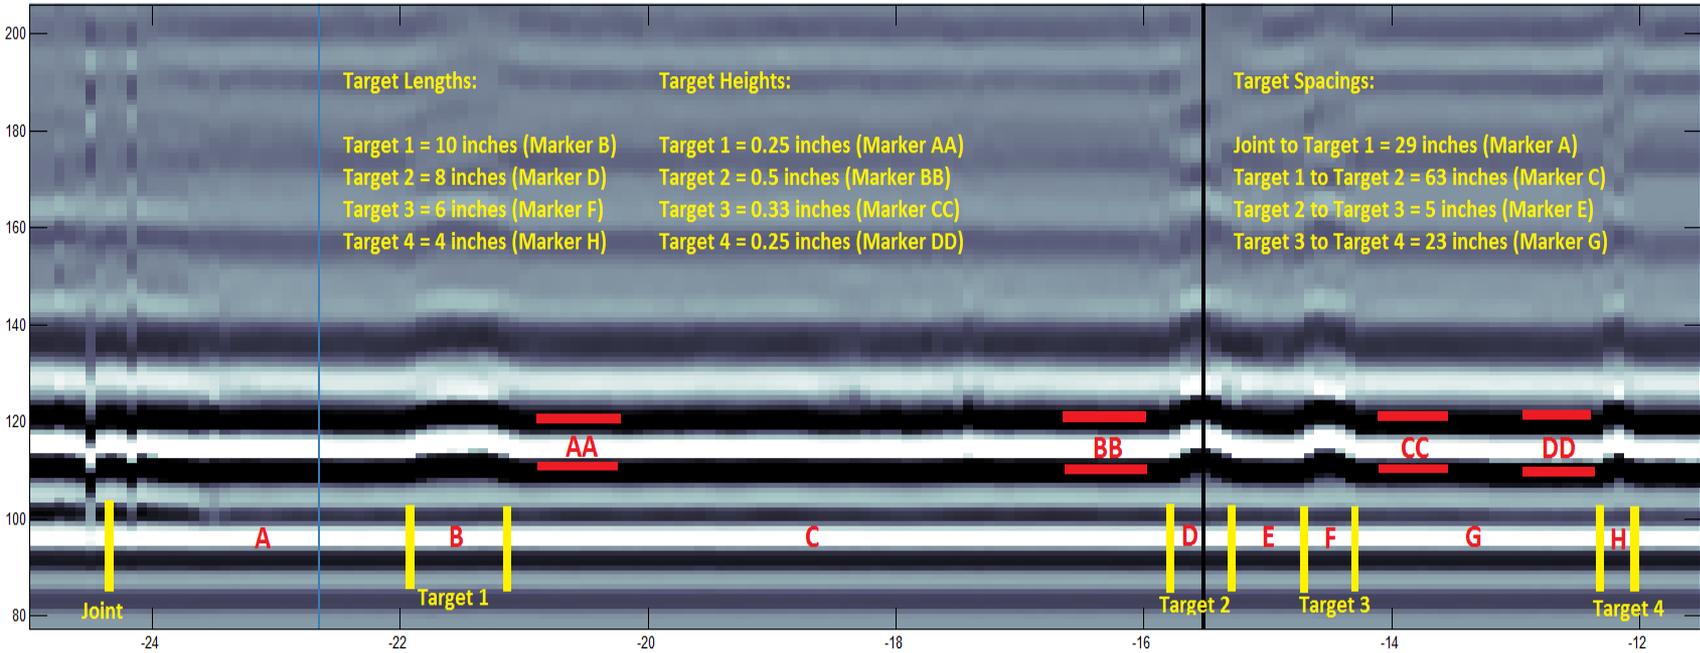
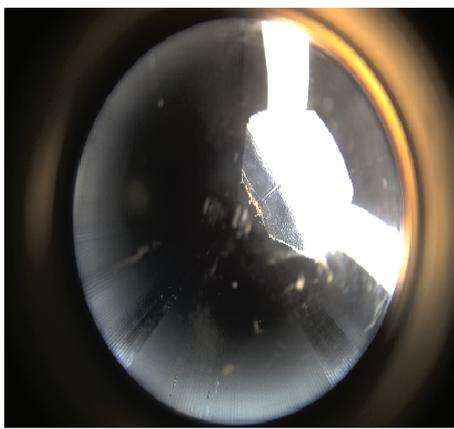
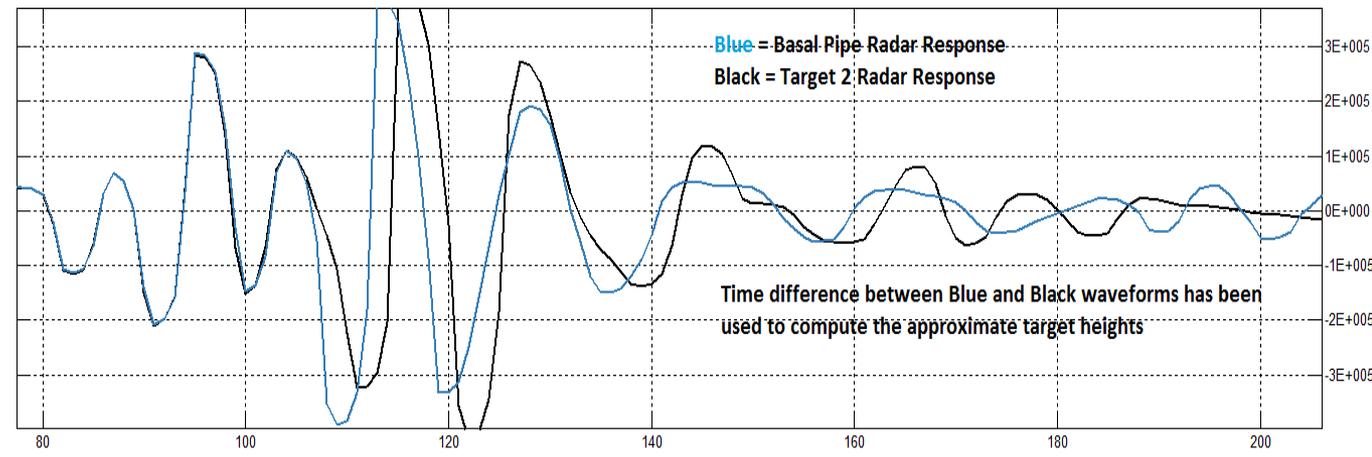
# FutureScan Void Detection—Virginia DOT

CUES GUI - 2013-10-30 VDOT Burnt Chimney----10\_30\_2013 11\_04 AM.gnet

GPR B-Scan | -15.50 ft | 38.6 Scans/sec Average | 42.6 Scans/sec Last 10 Frames

A-Scan Viewer | Black Max = 4.03926e+005 | Black Min = -4.14472e+005 | Black Peak-to-Peak = 8.18398e+005

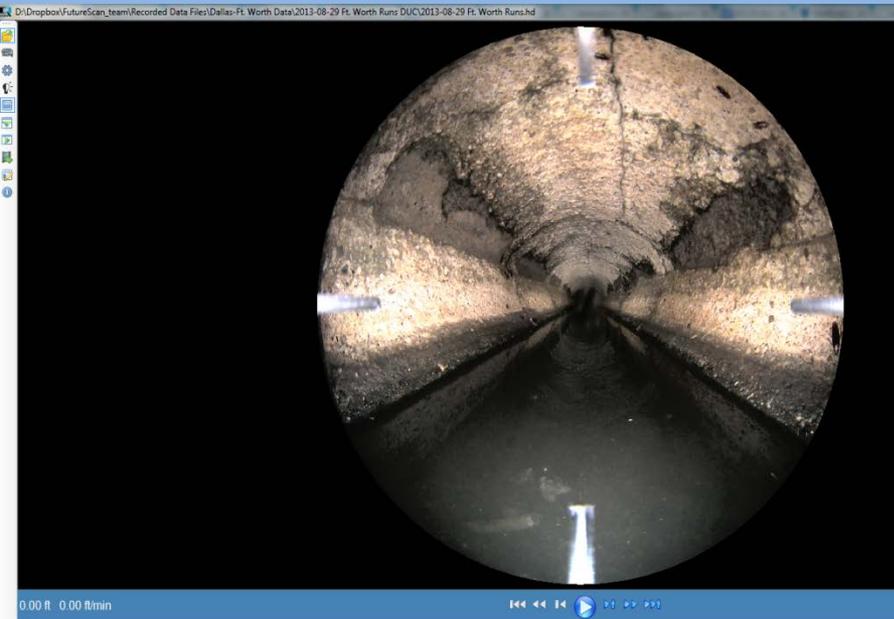
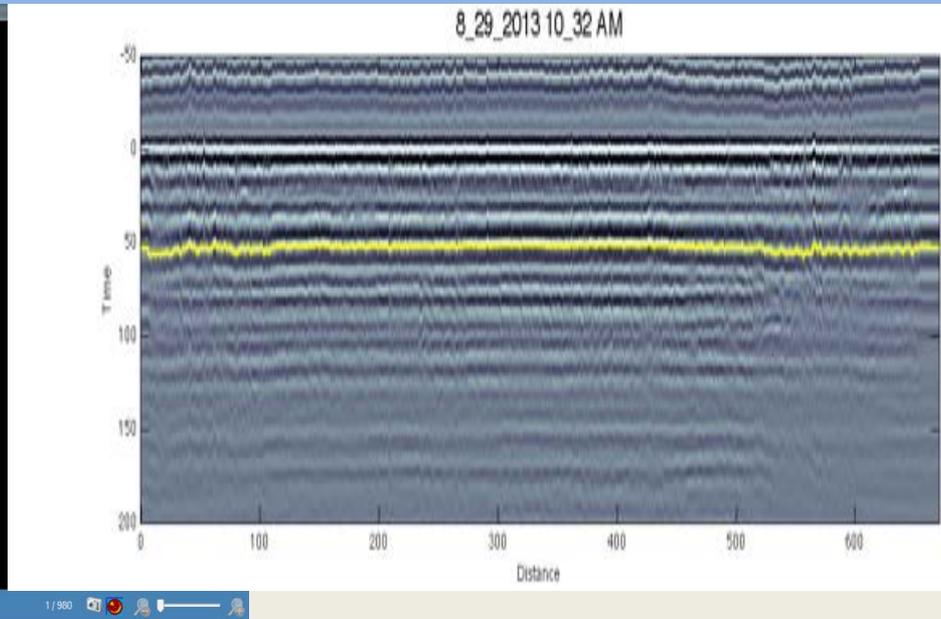
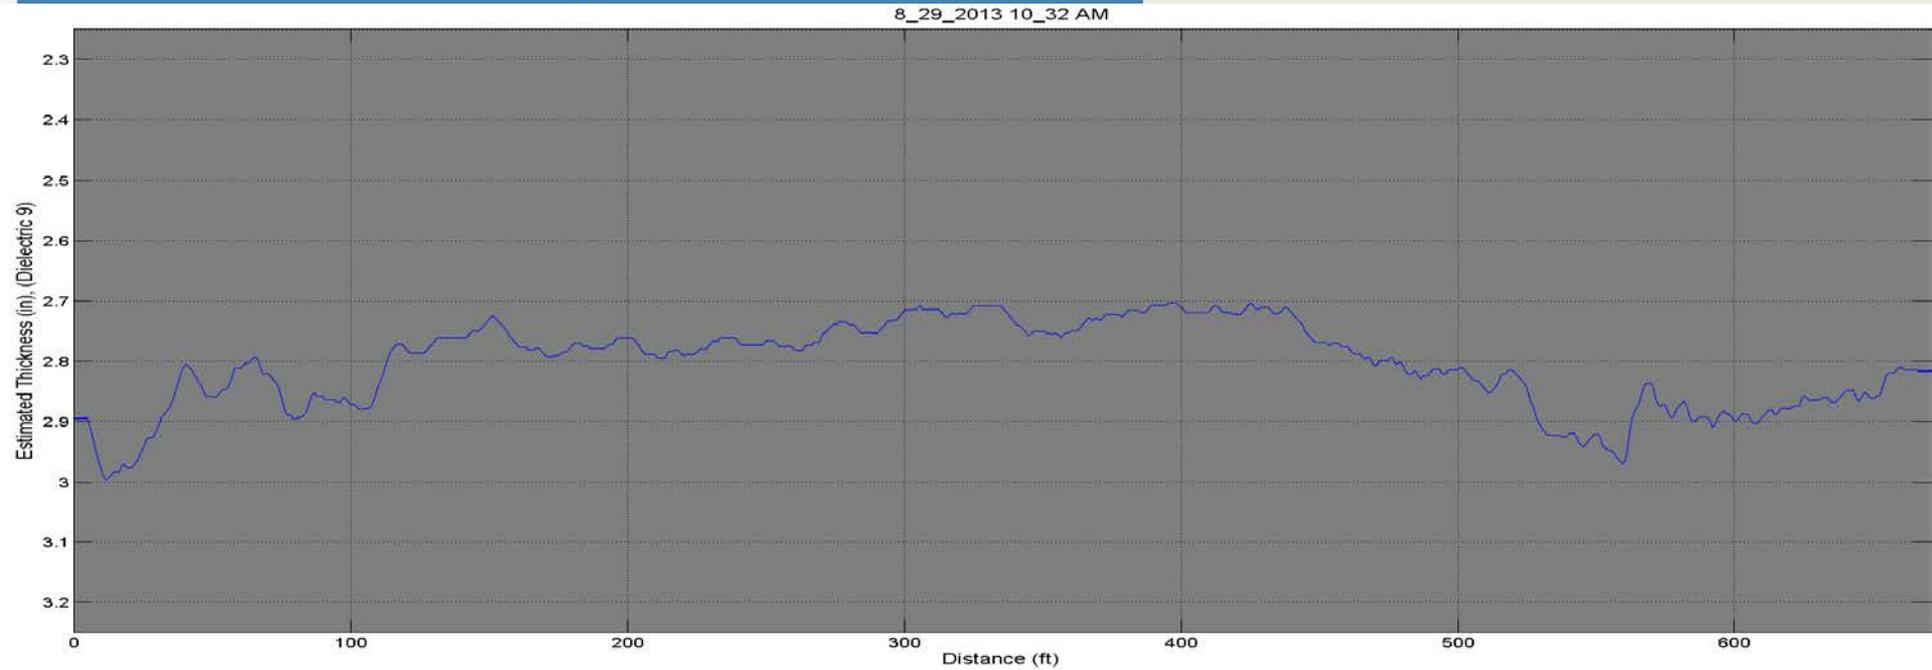
**Ft. Worth Pipe Wall Thickness Measurement  
24" deteriorated RC Sewer line**

# Pipe Wall Thickness Measurement—Ft. Worth

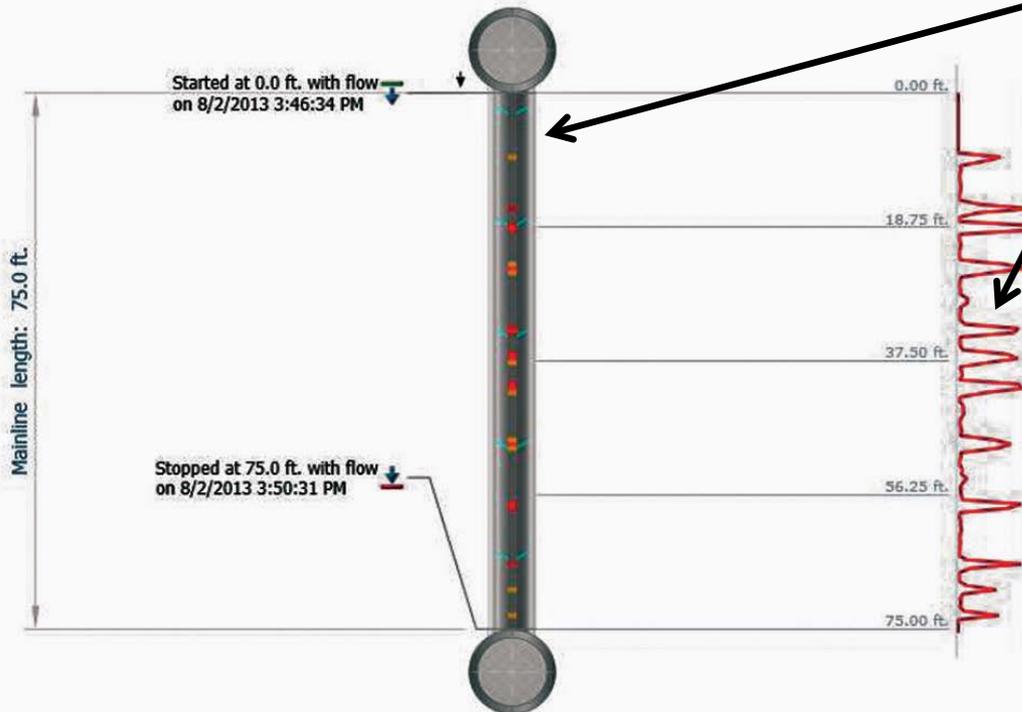
## Standard Analysis

### Void and Anomaly Detection:

Algorithms “tuned” to find differences (i.e. Anomalies) at the Outer Pipe Wall

Results Visualization in Two Formats:

“Heat-Map” of variations, with severity displayed via colorization, and

Confidence Value (CV) StripChart, with values ranging from 0 (no variation) to 1.0 (significant variation)
