COMPARISON TESTING IN A SIMULATED DATA PROCESSING/ TELECOMMUNICATIONS FACILITY: FM-200[®] AND AUTOMATIC SPRINKLER SYSTEMS

Mark L. Robin and Eric W. Forssell
Hughes Associates, Inc.
5415 Hillside Lane
West Lafayette, IN 47906
Ph: 765-583-0718; Fax: 765-583-2066
mrobin@haifire.com

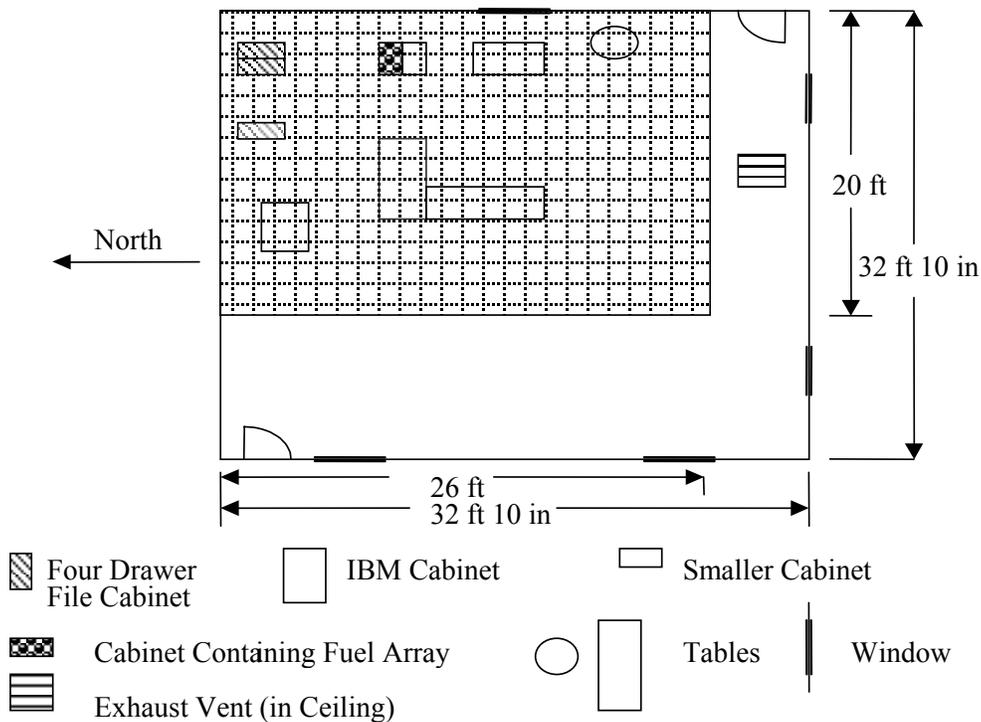
The test enclosure is shown schematically in Figure 1. The test enclosure was designed, constructed and outfitted to simulate a typical data processing or telecommunications facility. The tests were performed in a 32.8 ft x 32.8 ft x 12 ft enclosure equipped with a 1.5 ft deep subfloor and a suspended ceiling located 2 ft below the drywall ceiling. The chamber was constructed from 0.5 inch gypsum wallboard over a metal stud frame. Access to the room is accomplished via two 2.9 ft x 6.6 ft doors, one at the southern end of the east wall and the other at the northern end of the west wall. Both doors open at the level of the raised subfloor. The enclosure has five 46 inch x 70 inch windows made of 3/16 inch polycarbonate, reinforced with two sets of horizontal braces made from 5/8 inch plywood. Three smaller windows, nominal 1 ft x 1 ft, are located along the southern and western walls.

An area 20 ft x 26 ft was covered with additional floor tiles on top of the plastic covering. The cabinet containing the fuel array was placed upon these tiles. In addition to the cabinet containing the fuel array, three other data processing equipment cabinets were arranged on the partial layer of floor tiles. These cabinets had been gutted prior to placement in the chamber and were not operational. Three file cabinets, two tables and chairs, and a non-operating PC were also arranged in this area.

Figure 1. Test Enclosure

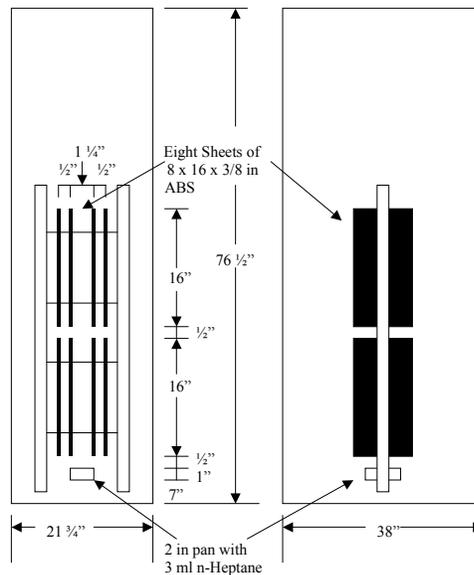
The test fire set-up is shown schematically in Figure 2, and consisted of eight 8 inch x 16 inch x 0.375 inch sheets of Acrylonitrile-Butadiene-Styrene (ABS), arranged vertically in two rows of four sheets each. The plastic sheet array was placed inside a cabinet equipped with metal mesh doors with the sheets oriented parallel to the solid metal walls of the cabinet.

The ABS plastic array was ignited by 3 ml of n-heptane in a 2 inch square pan located 0.5 inches below the array. This fire set-up is similar to that adopted by Underwriters Laboratories, Inc in their standard on Halocarbon Clean Agent Extinguishing System Units, UL 2166 [1].

Figure 2. Fuel Array

Heat release data for the fuel array were obtained by burning the fuel array under a 10 ft x 10 ft hood equipped and instrumented to determine heat release rates based upon oxygen consumption. This hood and heat release rate determination is similar to that described in NFPA 265 for the determination of the heat release rate and fire growth contributions of wall coverings [2].

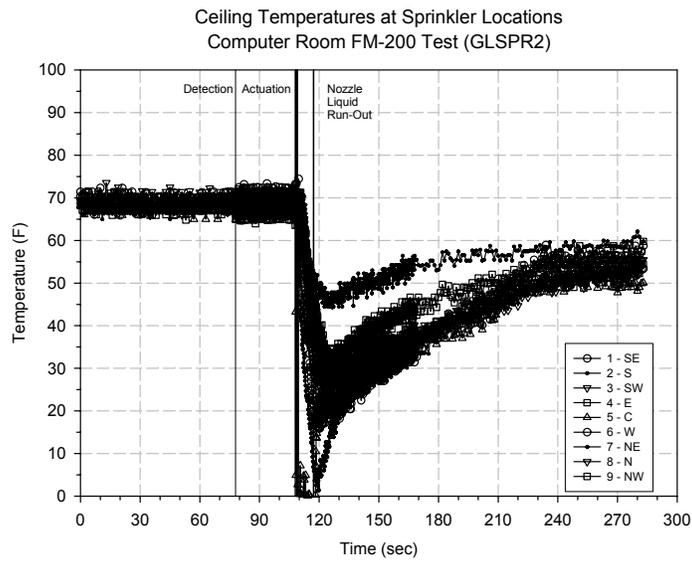
Figure 3. Ceiling Temperatures at Sprinkler Heads: FM-200 System Test

As can be seen from Figure 3, the ceiling temperatures at the sprinkler locations never reached more than 75 °F. Figure 4 shows that the maximum ceiling temperature observed in the enclosure was less than 85 °F.

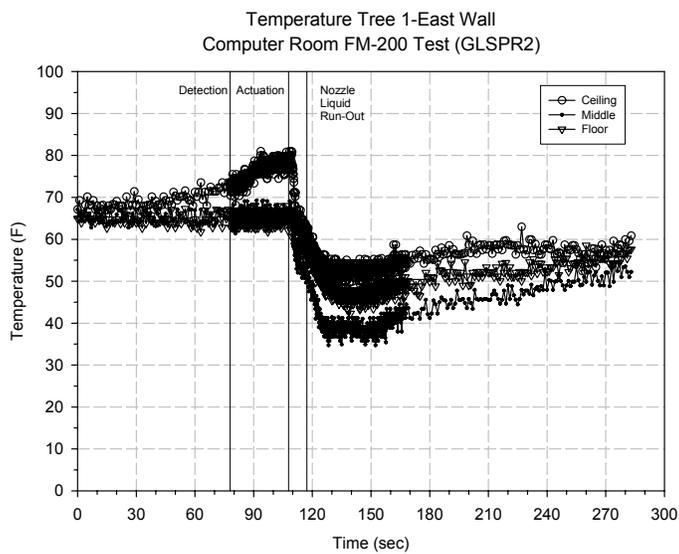
Figure 4. Enclosure Temperatures During FM-200 System Test

In the FM-200[®] test, the AnaLASER air sampling smoke detection system went into full alarm at 78 seconds after fuel ignition, and the FM-200[®] system was actuated 30 seconds later; from Figure 4, the fire size at the time of activation of the system can be estimated to be approximately 25 kW. The fire was observed to be completely extinguished 17 seconds after system actuation.

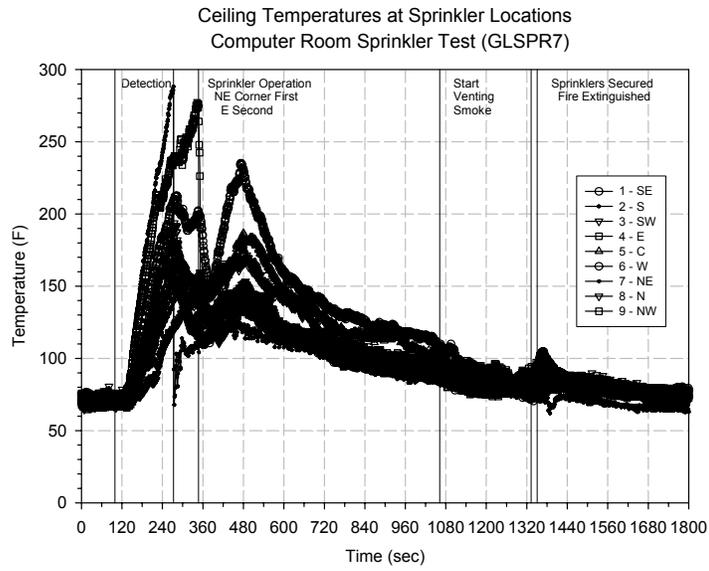
Figure 5. Ceiling Temperatures at Sprinkler Heads: Preaction System

As seen in Figures 5 and 6, at all locations with the exception of the southwest sprinkler, ceiling temperatures at the time of system actuation were above the 155 °F temperature rating of the sprinkler heads. However, only the northeast and east sprinkler locations got hot enough and remained hot for a sufficient time to cause activation. The east wall thermocouple tree was closest to the fire, and the ceiling level thermocouple on this tree peaked at a temperature of 560 °F at 480 seconds after ignition.

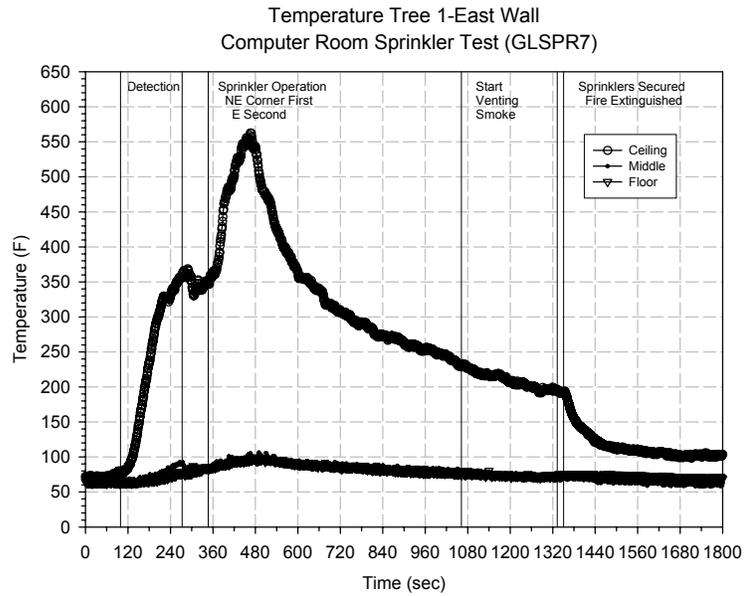
Figure 6. Enclosure Temperatures During Preaction System Test

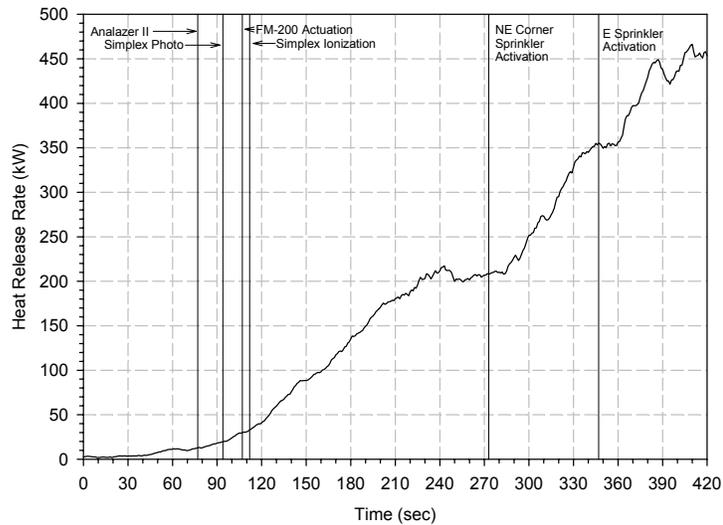
Fire Size of ABS Array used in GLCC Sprinkler Comparison Tests

Figure 7. Comparison of FM-200 and Preaction Systems

The test results obtained during this study clearly demonstrate the vast differences in protection provided by gaseous clean agent and automatic sprinkler systems. Both systems, designed and installed in accordance with the appropriate NFPA standards, performed exactly as expected based upon the primary design objective of the systems. Table 1 and Figure 7 provide a comparison of the test results.

Table 2 summarizes the characteristics of gaseous clean agent and automatic sprinkler systems. The fundamental objective of the two systems is vastly different. The primary objective of an automatic sprinkler system is fire *control*: confining of the fire to the room of origin and controlling the ceiling temperatures to prevent structural damage and/or collapse. This is vastly different from the primary objective of a clean agent system, which is rapid fire *extinguishment*. Figure 7 presents a graphical illustration of the difference between the two systems with respect to the heat release rate over time.
