Camp Incident Damage Inspection Report CABTU 016737

November 26th, 2018

The scope of this report is focused on the Camp Incident (CABTU 016737) that began on November 8th, 2018 in the County of Butte California.

The intent of the report is to provide an evaluation of fire damage to structures within the incident perimeter. This report attempts to include all habitable, commercial, utility and miscellaneous structures with a footprint greater than 120 square feet throughout the incident area. The report may evaluate or identify fire damage to infrastructure, mobile equipment, or other miscellaneous parcel improvements as determined.

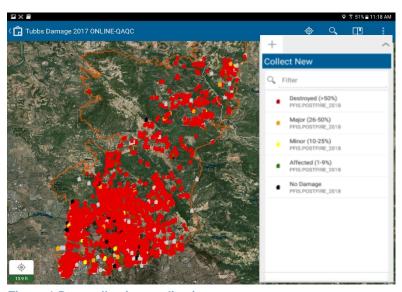
Figure 1 Data collection application

Wherever possible, all characteristics were collected that could allow for analysis of the fires impact to the structure. These included vegetation clearance, roof construction, eaves, vent screens, window panes, exterior siding, decks, patio covers, car ports, fences, topography, and aspect. Relative comments by the inspection team were also included. Additionally, a photo was taken of each damaged and destroyed structure and included in the damage inspection report.
