NIST GCR 06-885

FIRE INDUCED VIBRATION MONITORING FOR BUILDING COLLAPSE. FINAL REPORT

Final Report

Award No. 60NANB2D0124 Contract Period – August 1, 2002 – July 31, 2005

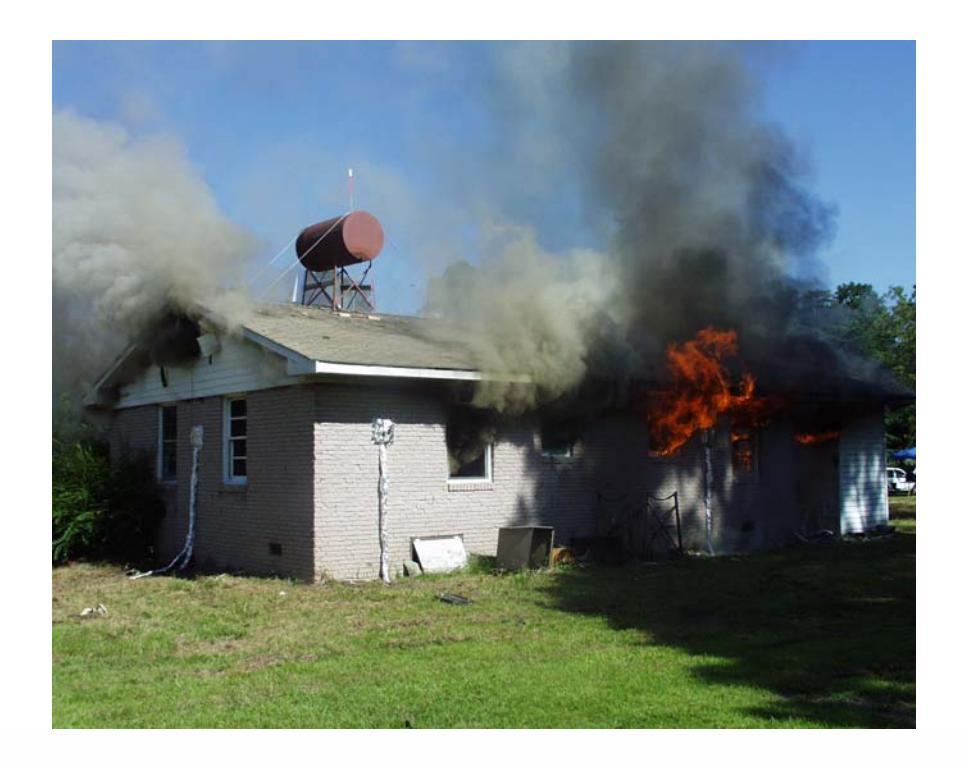
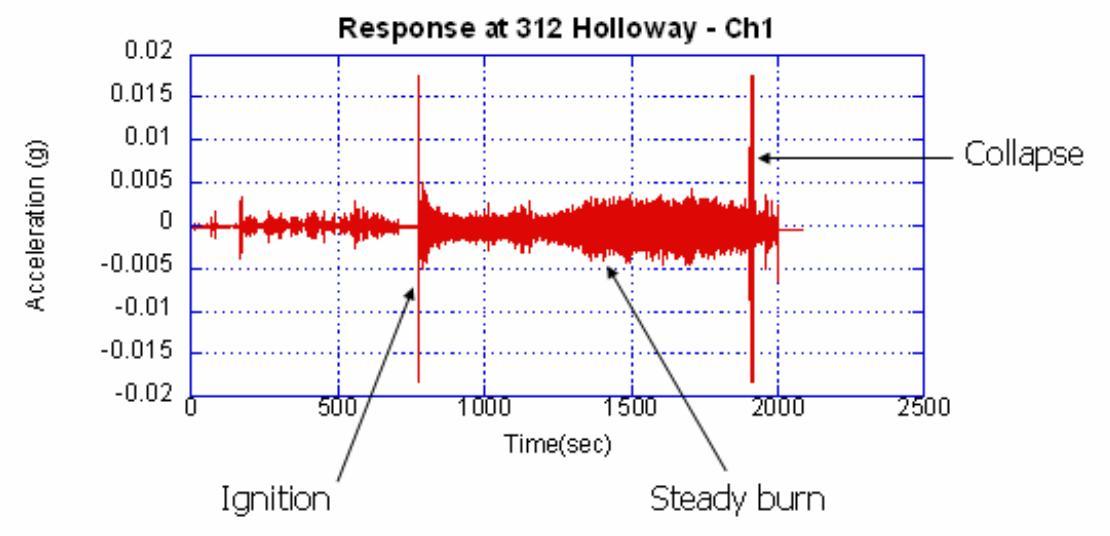
Figure 1 - Fire-induced monitoring of a wood frame structure.

The measured response was acquired on the exterior wall (left most wall as shown in Figure 1) and captures ignition, steady burn and collapse of the tank through the roof. The measured behavior was analyzed after the test, and a response index (shown in Figure 2) based on response variance was developed.

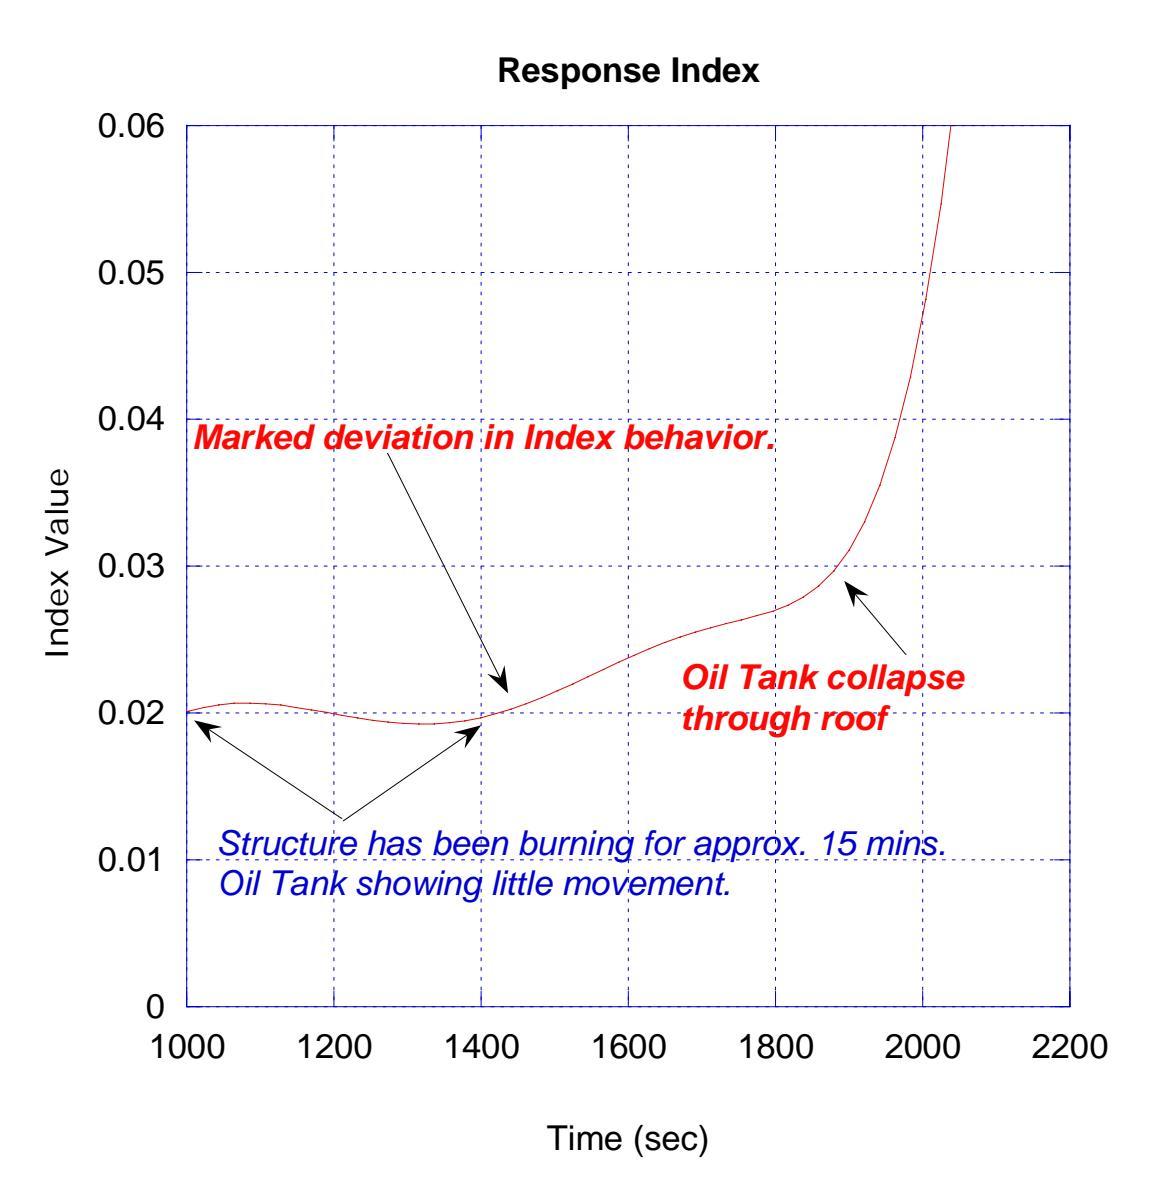
Figure 2 - Collapse index behavior for a burning wood frame structure.

The behavior of the index correlates well with visual evidence obtained during the burn, which clearly shows when the oil tank collapsed through the roof. The marked deviation after 1400 sec occurs approximately 8 minutes prior to collapse and provides a measure of early warning.

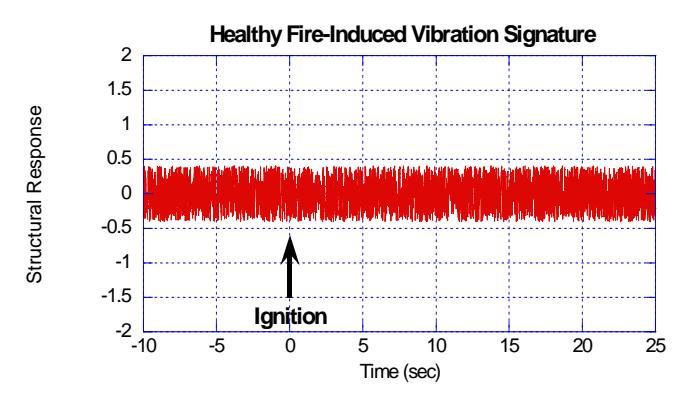
Figure 3 - Sample (idealized) fire-induced vibration response.

For the purposes of illustration, consider the signal shown in Figure 3. The signal is not an actual field measurement, but was constructed in a manner consistent with observed responses from a burning structure both prior to and after ignition at t=0 seconds. The response is random-like and does not indicate significant deviations in amplitude

or character after ignition. The signal exhibits "healthy" fire-induced behavior in the sense that the structure is not in danger of imminent collapse (since the response after ignition does not appear to differ with the pre-ignition response).

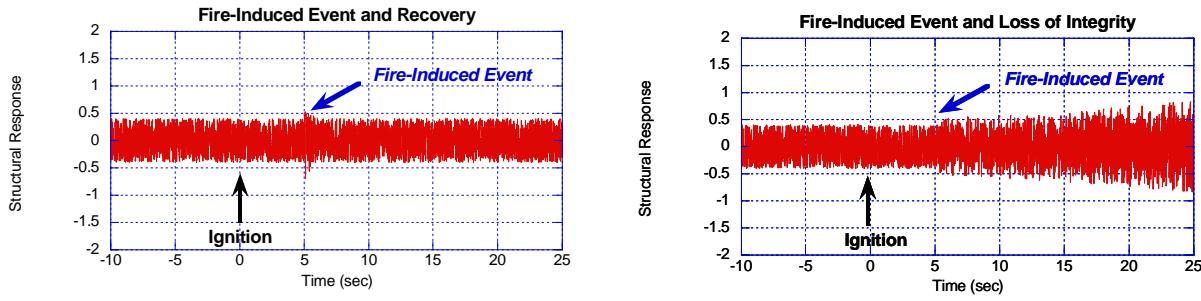
Figure 4 - Fire-induced response in a healthy (left) and weakening (right) structure

The signals in Figure 4 (variations of the signal in Figure 3) illustrate the occurrence of a fire-induced event near 5 seconds and the structure's probable response to that event. In Figure 4 (left), the response appears to be (largely) unaffected by the event, indicating that no significant structural change has occurred. On the other hand, Figure 4 (right) indicates growing response behavior following the event that could be indicative of weakening structural conditions.

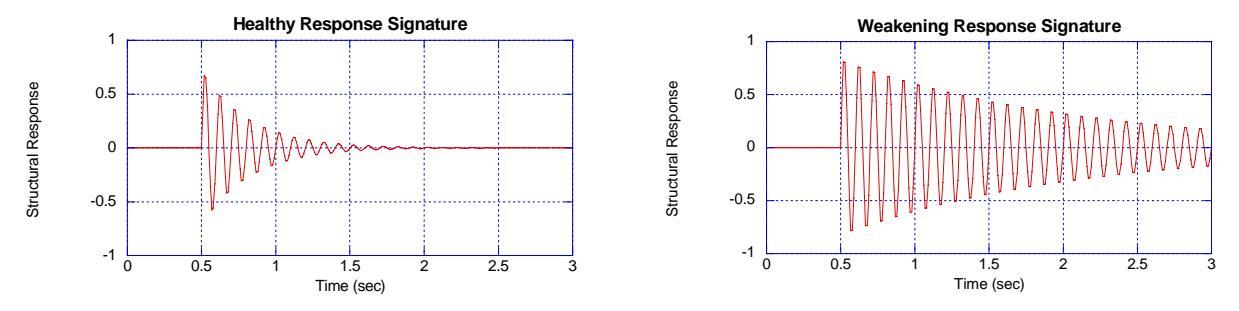
Figure 5 - Sample transient signatures for healthy (left) and weakening (right) burning structures.

If such an analysis technique were available, transient signatures (i.e. signals) could be derived from measured responses to provide indications of changes in structural stability. For example, if a signature of the type shown in Figure 5 (left) were obtained from a burning structure, the decay rate would reflect the structure's ability to dissipate energy, and the return to pre-event response levels after a short time would reflect the continuing stability in the structure. If, on the other hand, a signature of the type shown in Figure 5 (right) were obtained from a burning structure, the slower decay rate would reflect the structure's inability to "quickly" dissipate energy within the weakening structure.

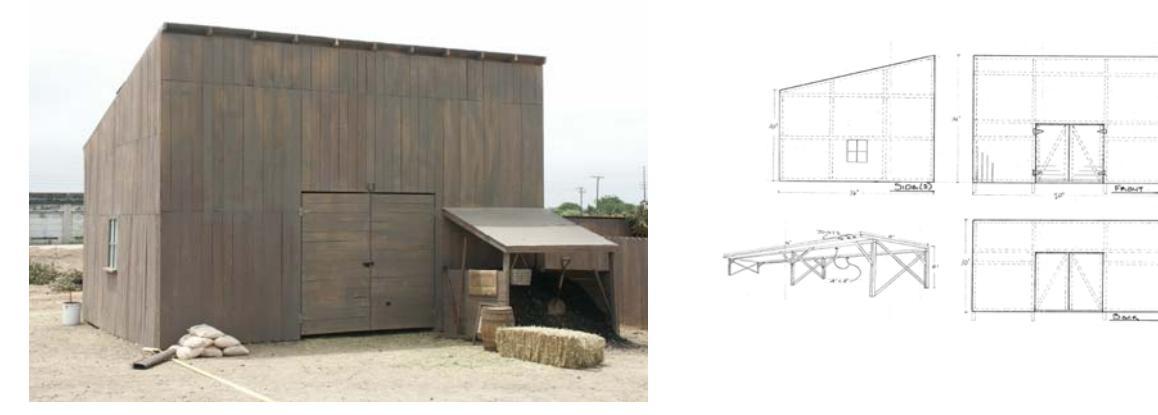
Figure 6 - Replica of Mrs. O'Leary's barn and drawings.

A replica of Mrs. O'Leary's barn, thought to have played a significant role in the Great Chicago Fire of 1871, was constructed by the Discovery Channel and burned as part of a reenactment of the events that led up to the fire. A picture of the barn along with construction drawings (as built dimensions were 20' wide, 14' maximum height, and 16' deep) is shown in Figure 6. At the invitation of the producer in charge of the documentary, the barn was instrumented with firesensors for the purpose of gathering structural response information on the barn and evaluating new fire-sensor designs and configurations. The burn was conducted at the Ventura County Fire Training Facility in Camarillo, California in July 2003. Four sensors were installed around the exterior of the barn including two original fire-sensors, Sunstrand newly Q-Flex Accelerometers (QA), and two developed MicroElectroMechanical (MEM) fire-sensors. A main objective was to evaluate the performance of the MEM sensor design against the QA sensors that have been in use since March 2001.

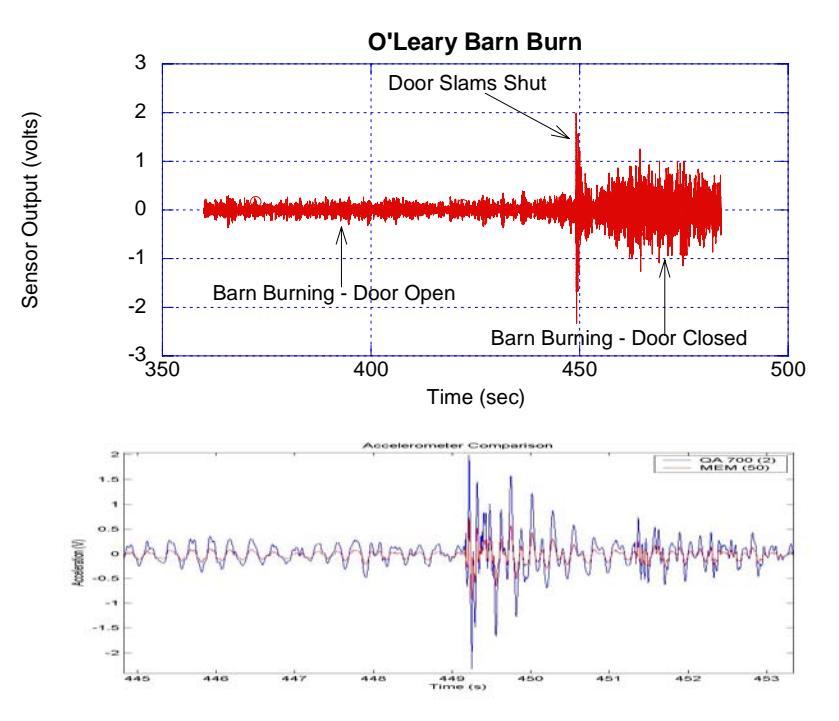
Figure 7 - Sample fire-induced vibration responses acquired during the O'Leary barn tests.

A segment of the measured fire-induced vibration response acquired during the test is shown in Figure 7 (top). The portion of the response prior to the time at which the barn door slams shut reflects a "steady burn" condition inside the barn. Once the barn door slams shut, however, response levels clearly increase reflecting the changes in fire dynamics within the barn. These changes, observable within the barn during the test, created a furious burn environment.

Figure 7 (bottom) provides a comparison of responses acquired using an original fire-induced vibration sensor (blue curve) and the new MEM based sensor (red curve). The top signal in Figure 7 demonstrates the MEM sensor's ability to track changing conditions in the barn as they occurred during the burn.

The initial portion of the response (refer to the top signal in Figure 7) corresponds to the early portions of the burn and what can be characterized as a "steady but random response." Close inspection of the time response beyond 400 seconds reveals the presence of multiple short duration transients leading to a large spike (or, transient) near 450 seconds that corresponds to the barn door slamming shut. A comparison of the QA and MEM sensor at the time of the large spike is shown in Figure 7 (bottom). Immediately after the barn door is shut, fire-induced vibration levels in the barn increase The responses shown in Figure 7 (along with other significantly. been measurements not shown here) have correlated and synchronized with video of the burn. The video provides clear evidence of the changing fire dynamics inside the barn that led to the door slamming shut against an upper doorstop, which produced the large transient response near 450 seconds.

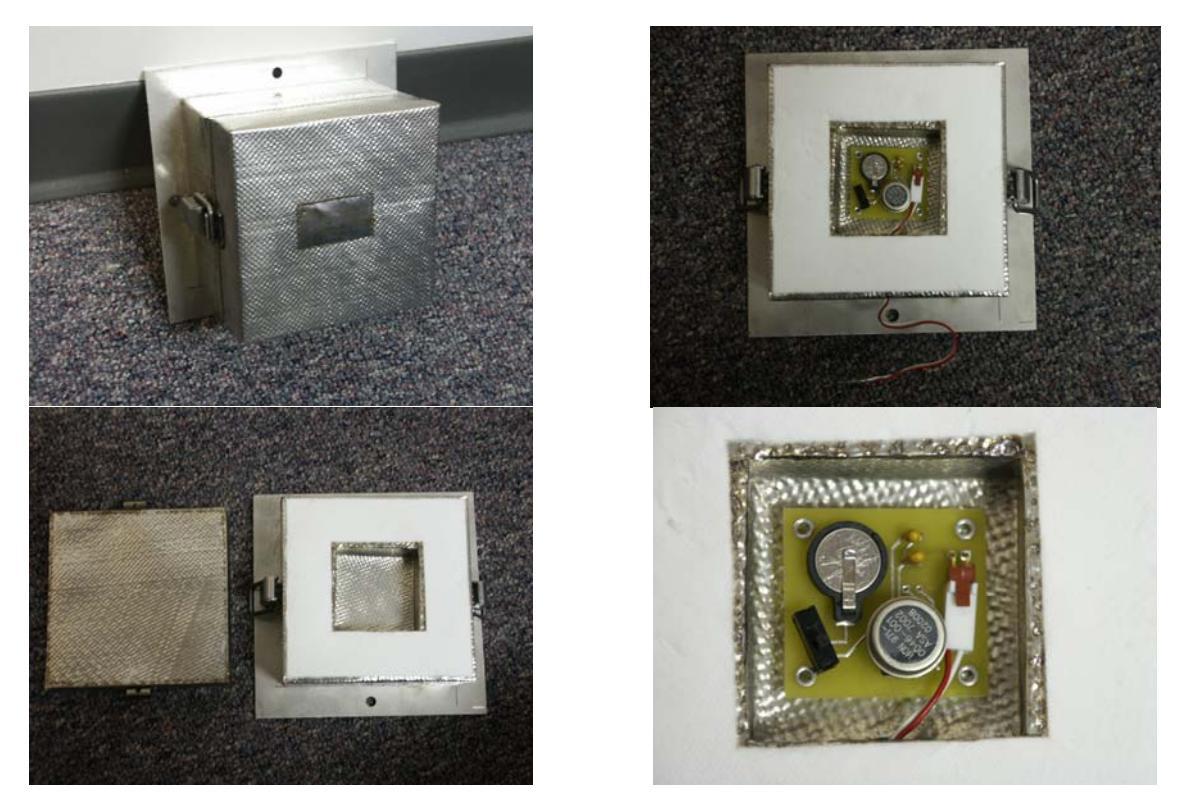
Figure 8 - New fire-sensor housing and MEM based design.

Pictures of the fire-sensor housing, the MEM based sensor, and cabling are shown in Figure 8. The housing was manufactured by Thermal Ceramics Inc. and designed to provide protection up to 1200 degrees Fahrenheit. The fire protection material is encased in a metal housing and welded to an attachment plate to facilitate installation. The MEM based sensor is shown in Figure 8 inside the housing. The sensor cable exits the box through an opening that requires fire protection during use. The main components of the MEM sensor include the button battery (top left corner), the MEM accelerometer (bottom center), a power switch (bottom left corner), and the signal cable (right side, red and white wires). When assembled, a layer of fire protection blanket is placed over the sensor board to provide additional thermal protection as well as shock resistance in the event of direct impact (during installation or burn).

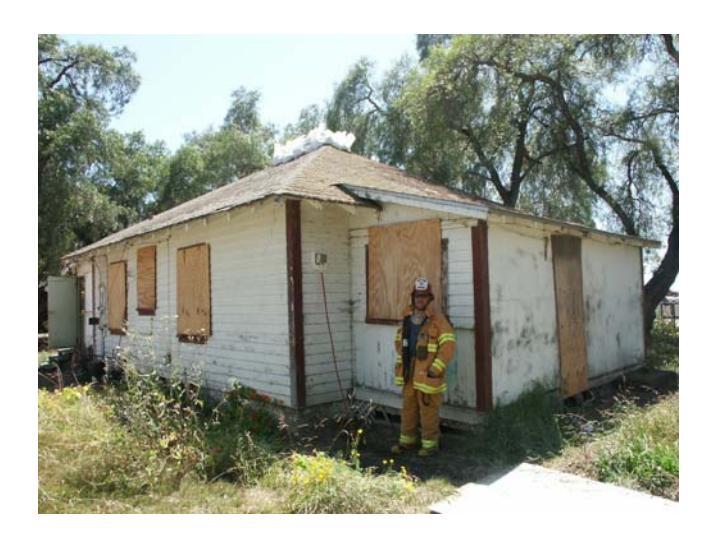
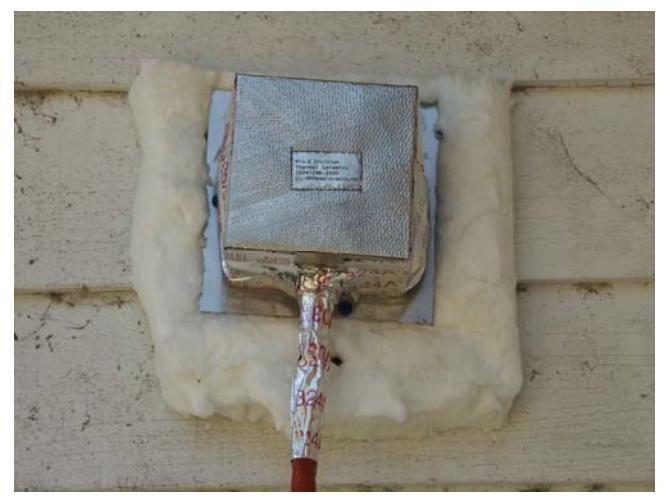
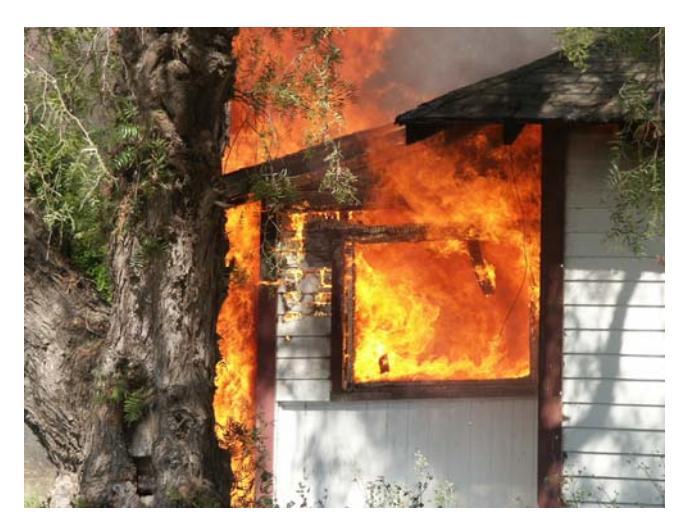
Figure 9 - Fire sensor evaluation tests.

These tests were primarily designed to evaluate the thermal protection of the sensor housing and of the cable sleeves (shown in red with aluminum tape Figure 9). Based on the performance of the sensor during these tests, improvements to both the housing and cable protection systems were made.

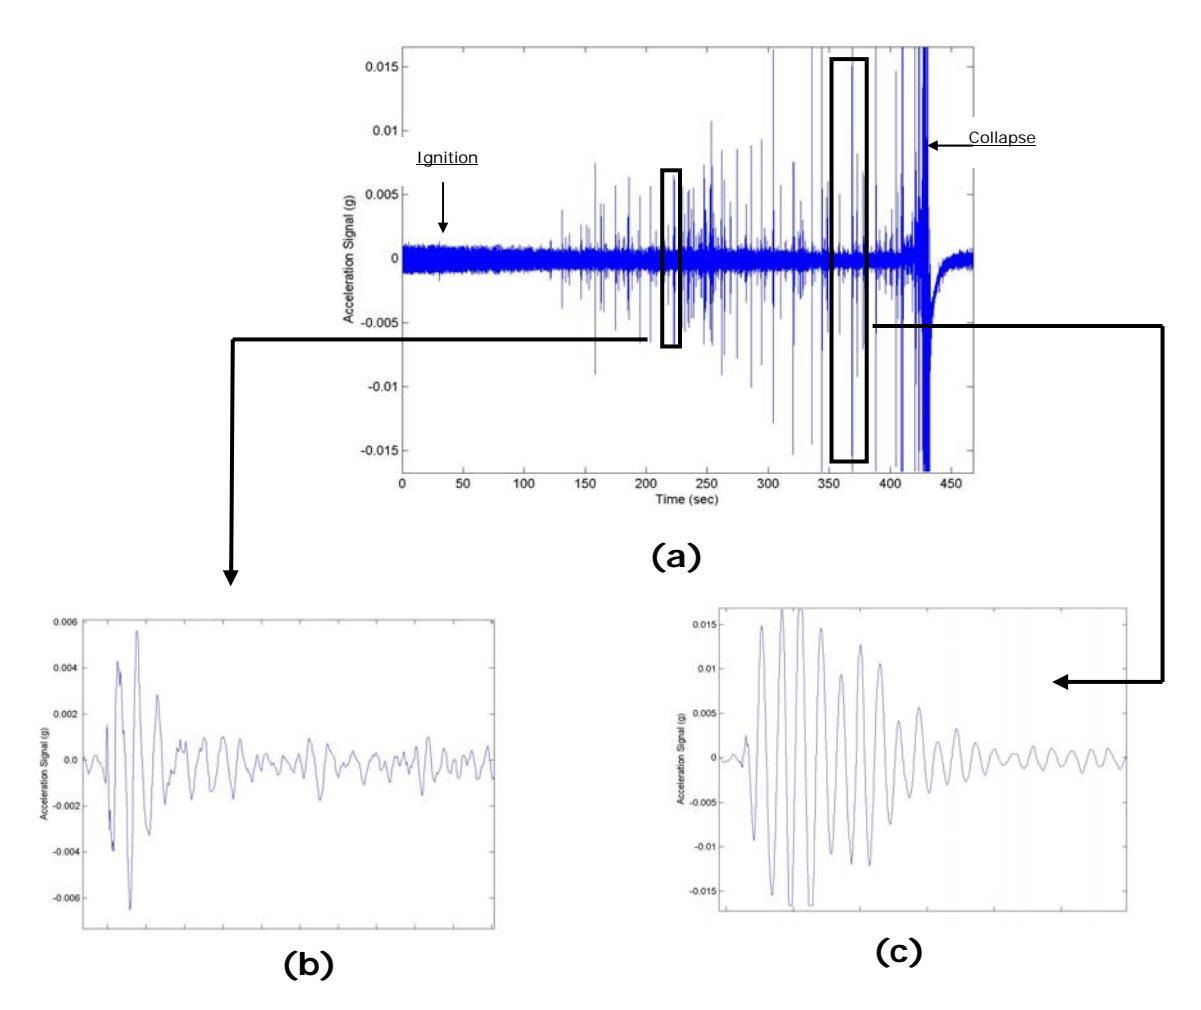
Figure 10 - (a) Acceleration response at the front of the strip mall store with extracted transients at (b) 205 and (c) 370 seconds. Changes in the transient character indicate the structure's weakened state approaching collapse.

In order to illustrate that transient behavior can be captured during burn; a sample measurement acquired during a control burn of a strip mall store in Woodbridge, Virginia that took place in May 2001 is shown in Figure 10. During that test, fire sensors were placed at the front and at the back of the store (rectangular floor plan), and the roof was loaded with 5800 lbs to encourage roof collapse. Monitoring began at 120 seconds before ignition and continued through the collapse of the roof at 426 seconds.

Figure 10 shows the data retrieved from the accelerometer nearest the collapse. The extracted segments at 205 and 370 seconds illustrate transients due to fire-induced events. Indeed, each spike observed in the measured vibrations (Figure 10a) correlates with a response transient of this nature.

As collapse nears, observed changes in transient characteristics include: increased magnitude of response (from 0.006g to 0.0015g), shallower exponential slope, and a decrease in high frequency components. In order to quantify these changes, statistical and frequency distribution analyses were performed. Yet, the results provided little more than indication of the growing magnitude of the system response leading to collapse.

For the measured fire-induced vibration response shown in Figure 10, the assumption of linear time-invariance (3 above) does not strictly apply due to the changing nature of the system's behavior as it burns. However, if RD signatures were computed over sufficiently short time blocks in the measured response, an approximation of time-invariance might be made. Still, some error would persist, particularly nearing collapse.

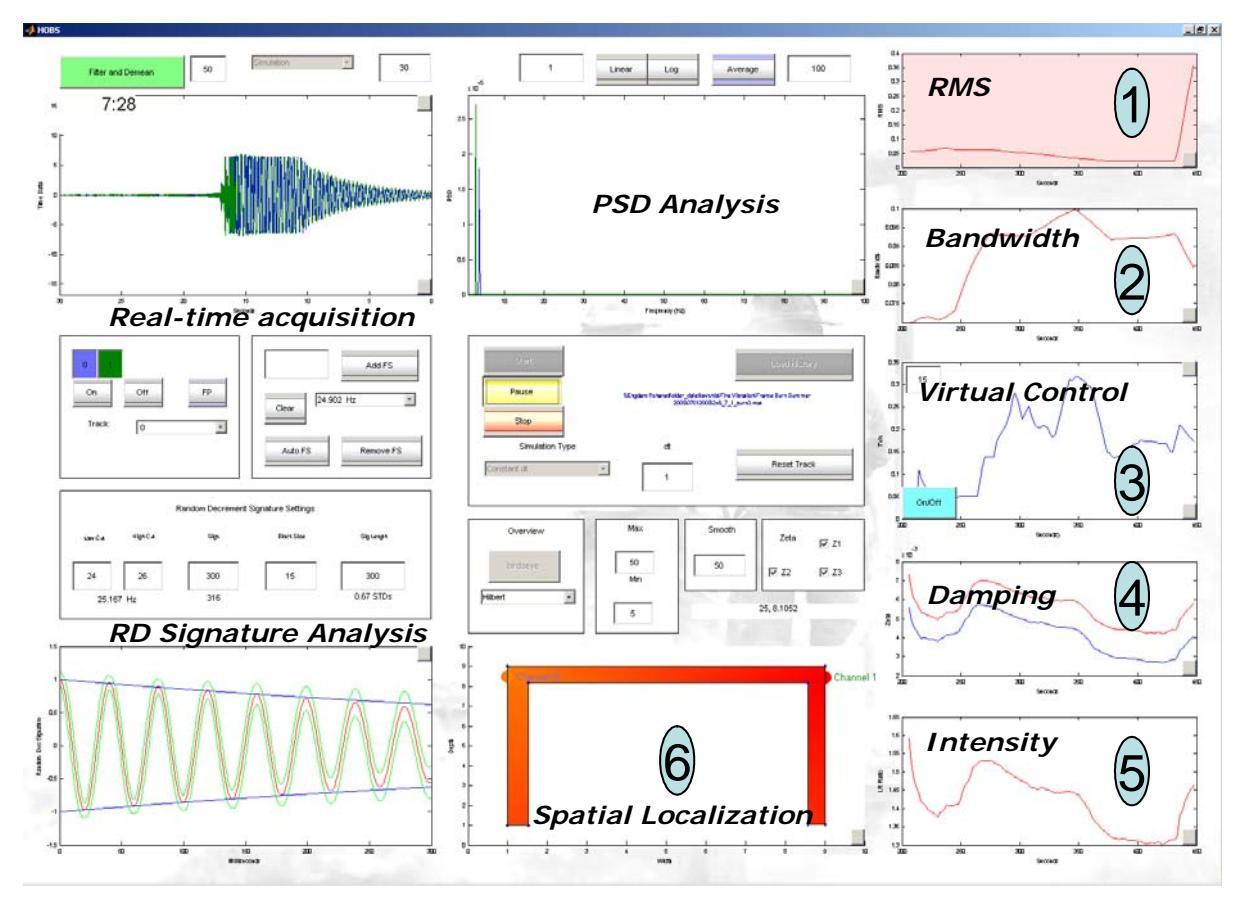
Figure 11 – Image of HOBS panel during simple frame burn.

HOBS is a real-time monitoring tool that provides researchers with the ability to acquire and analyze fire-induced vibration measurements in the field. Analysts may use HOBS to track a series of indicators that can be interpreted in the context of structural stability. HOBS acquires data via a National Instruments PCMIA data acquisition card (installed in a laptop) and provides a series of visual and numeric indicators for tracking changing conditions during burn. A sample image of the HOBS front panel at the conclusion of a burn test on a simple frame is shown in Figure 11.

Transforming the measured fire-induced vibrations (as shown in the upper left window in HOBS) to corresponding Random Decrement signatures (as shown in the lower left window in HOBS) is a key step in producing stability indicators that track changing conditions during burn. Other analyses, including frequency distribution, power spectral density, RMS and tuned vibration absorption can be performed on both filtered and non-filtered responses. A description of the indicators shown in the HOBS panel in Figure 11 (identified as 1-6) follows.

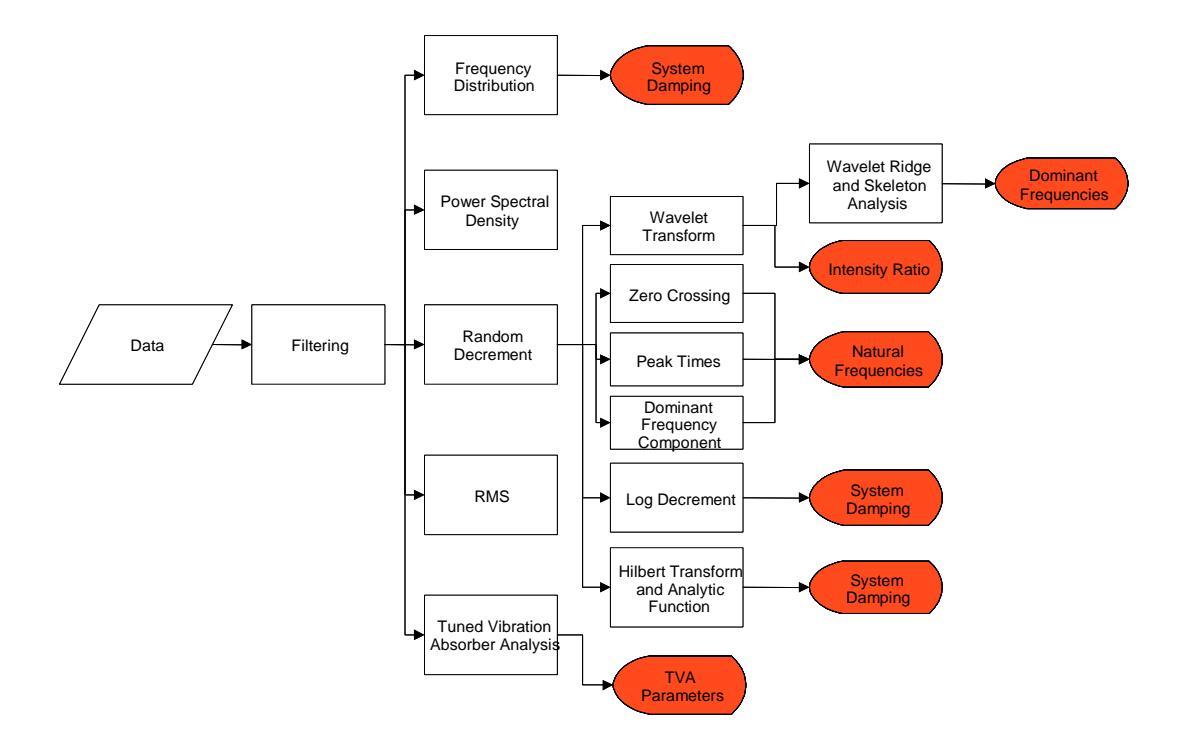
Figure 12 – HOBS analysis flowchart.

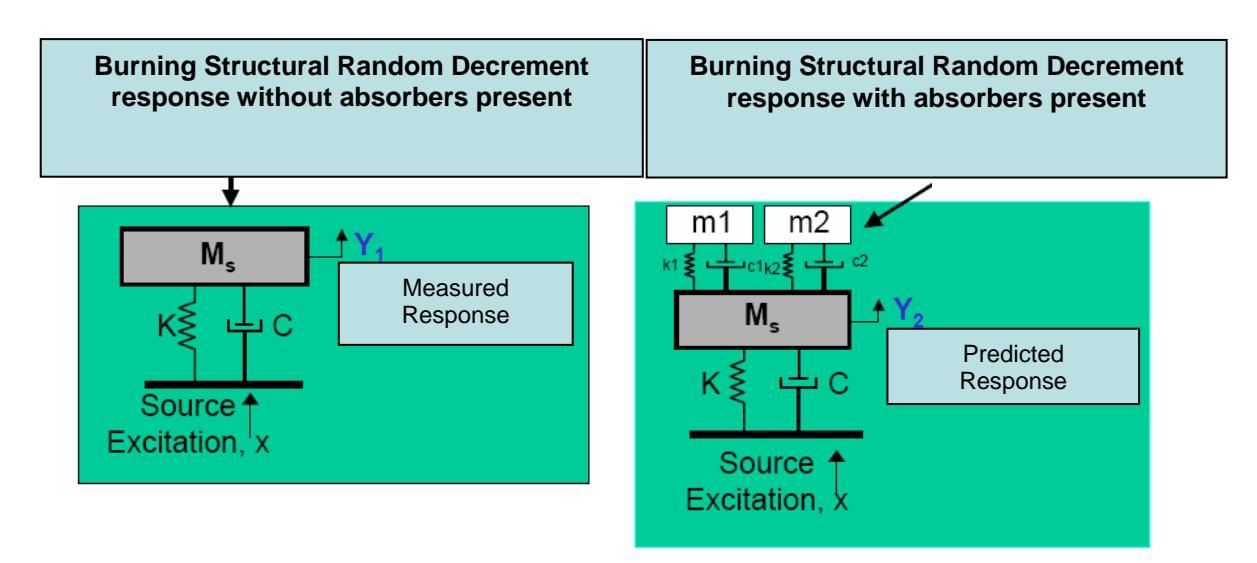
Figure 13 - Vibration absorption model.

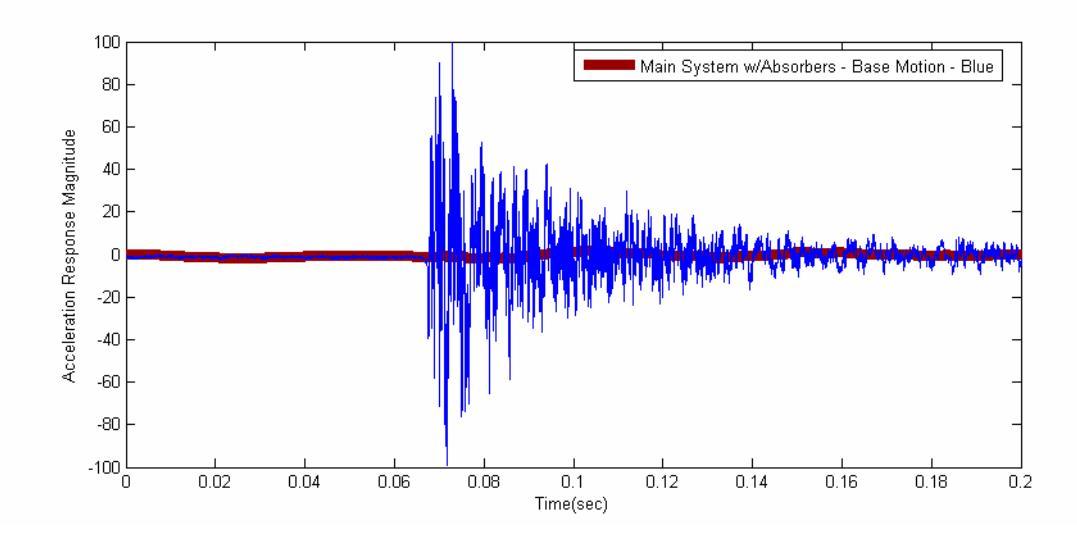
Figure 14 - Influence of absorbers on response magnitude.

in quality) Random Decrement response (blue) and the response of the main mass in the presence of just one tuned absorber (red) are depicted. The response with the single absorber is significantly reduced in magnitude and indicates that effective tuning has been achieved.

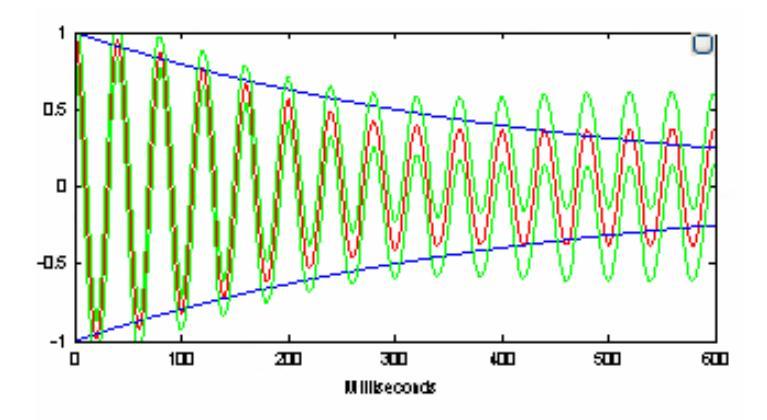
Figure 15 - Random decrement signature with enveloping function and standard deviation, normalized.

signature (green signal in Figure 15) to provide an estimate of the confidence in this result.

Problems arise, however, when the Random Decrement signature does not appear as in Figure 15, and instead appears more like the signature in Figure 16.

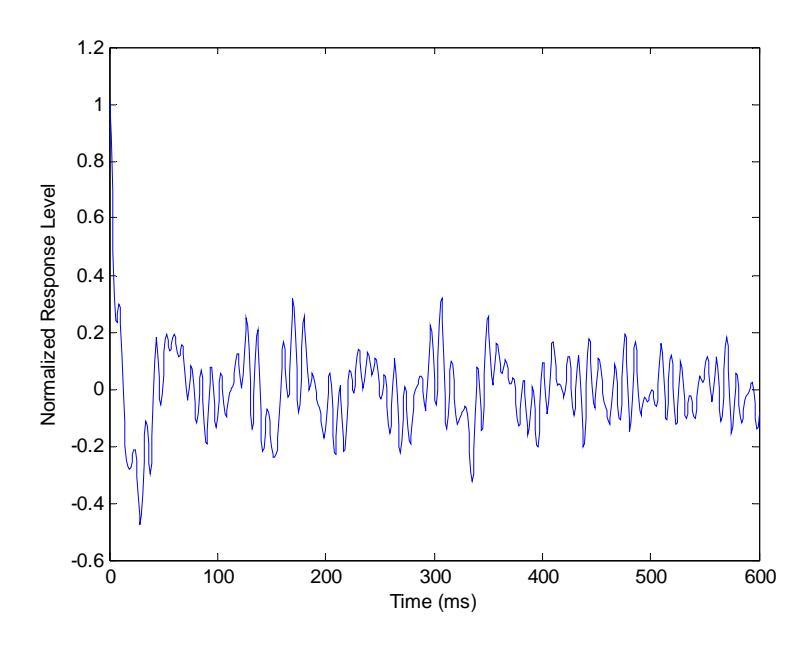
Figure 16 – Signature acquired from Fillmore High School burn utilizing Random Decrement analysis with no applied bandpass filtering and the removal of 60 Hz noise

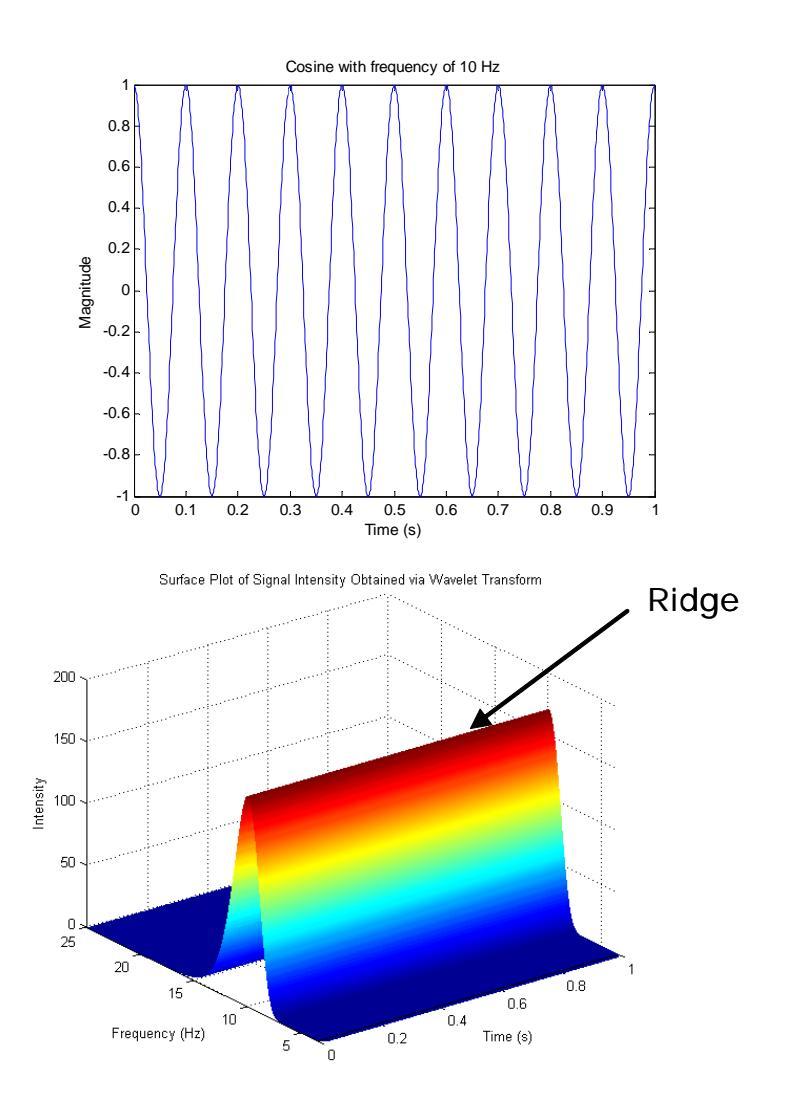
Figure 17 – Theoretical Random Decrement signature (top) and surface plot of wavelet intensity (bottom).

Figure 17 shows a sample cosine function with a frequency of 10 Hz (top) and a surface plot of $|W(a,t)|^2$ for the signal (bottom). $|W(a,t)|^2$ represents the intensity contained in the signal as a function of frequency and time. A Ridge is defined along a frequency where the maximum intensity values occur, as indicated in Figure 17 (bottom). The wavelet coefficients corresponding to the Ridge can be extracted to yield a (complex) wavelet skeleton. The real and imaginary parts of the skeleton approximate the signal at the instantaneous frequency that the Ridge follows, and also approximates the complex representation of the signal (described above). In this example, a single skeleton would be extracted from the analysis since only one dominant frequency exists in the signal.

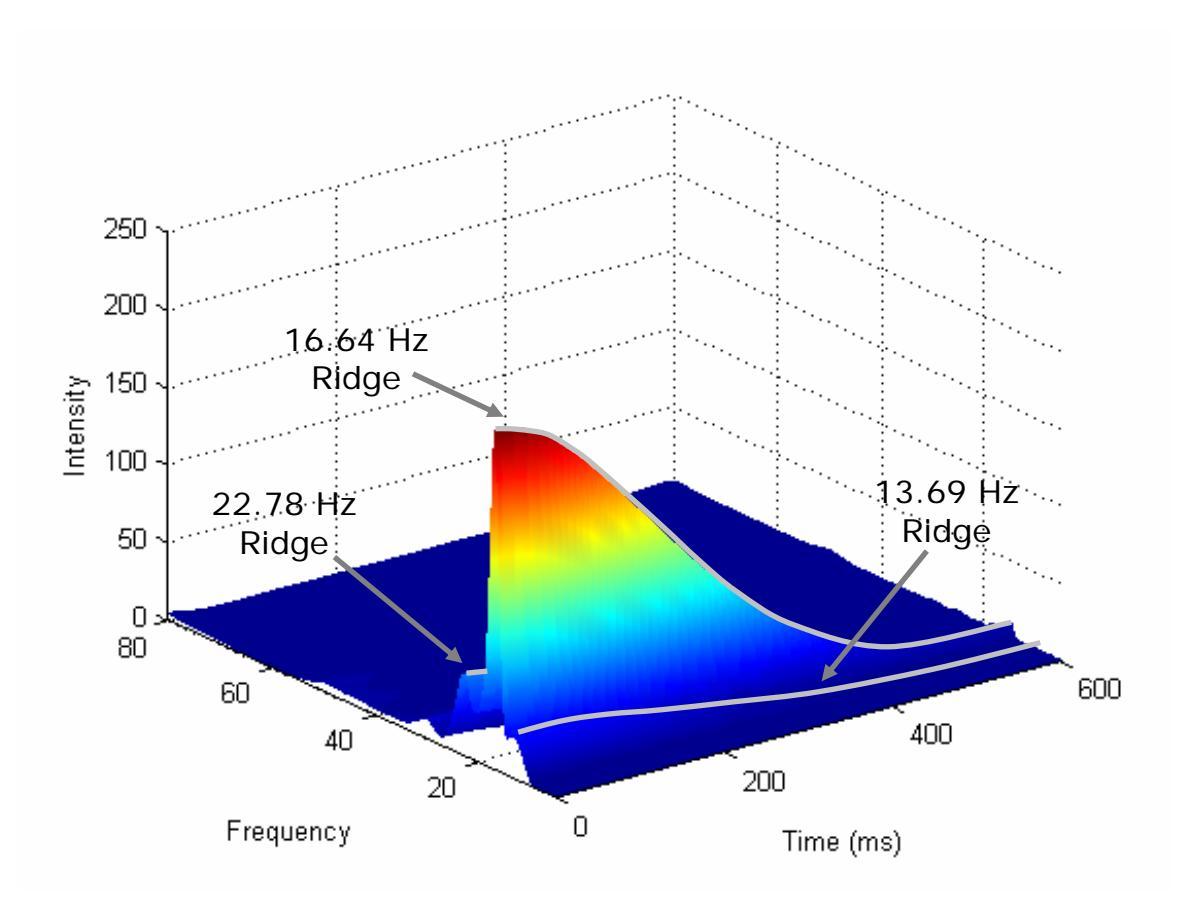
Figure 18 – Surface plot of the wavelet intensity of the signature shown in Figure 16. Ridges indicated in light gray

After the dominant frequencies are determined, the Ridges at these frequencies are extracted. An example of successful ridge identification may be seen in Figure 18 in which the three most dominant ridges, found using P(f), are indicated across time. The skeleton of each of these ridges can be extracted to provide the dominant components in the Random Decrement signature. For the signature shown in Figure 16, the skeletons associated with the three most dominant Ridges, are shown in Figure 20.

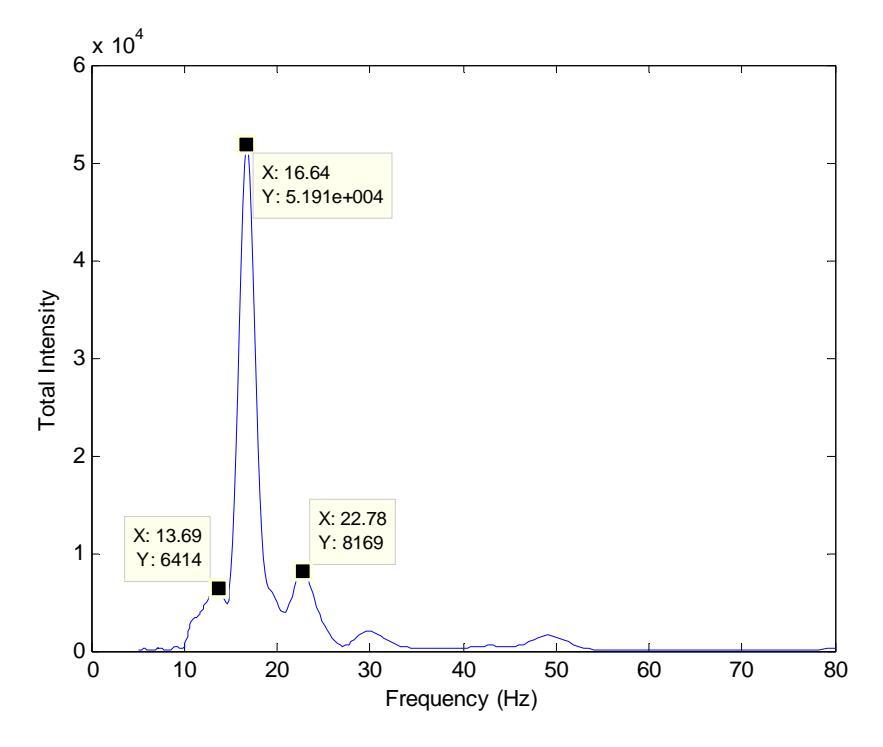
Figure 19 – The total intensity, P(f), of the signature shown in Figure 16.

The P(f) plot generated from the wavelet intensity of the signature shown in Figure 16 that highlights the three most dominant peaks is shown in Figure 19. The summation is performed even though the response of the structure is not time invariant due to the slowly varying frequency content in each random decrement signature.

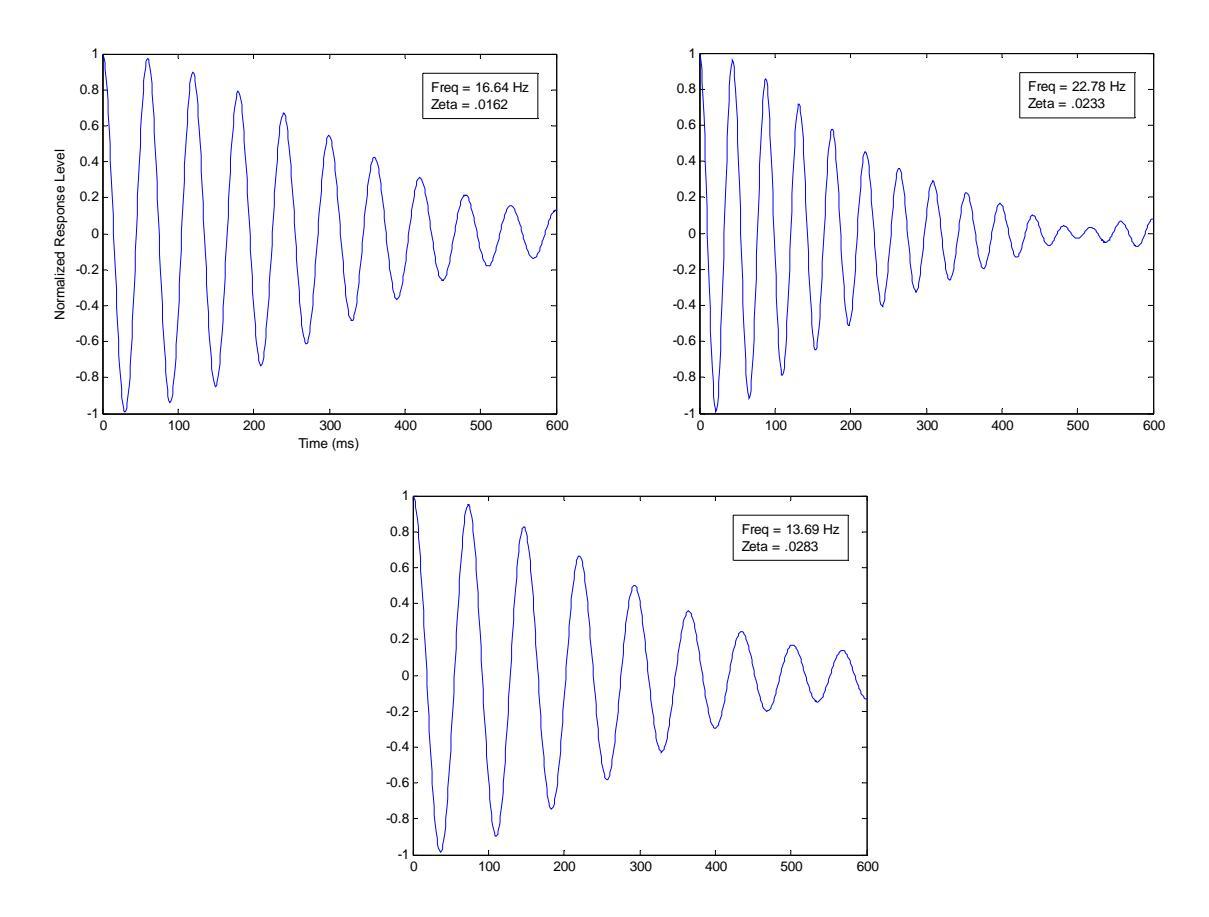
Figure 20 – The skeletons associated with the 1st, 2nd, and 3rd most dominant ridges generated from the signature in Figure 16.

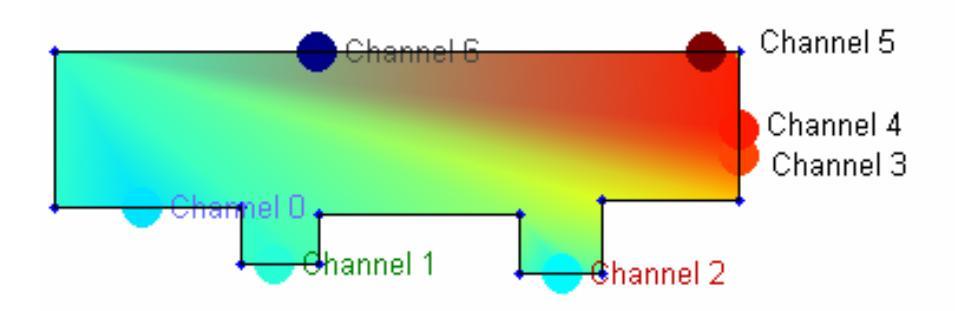
Figure 21 – Localization or RMS indicator during Fillmore Burn

At the time corresponding to Figure 21 the structure was near collapse and the region most afflicted was the upper right corner. In a relative sense, the structure appears least stable in the upper right corner, and in fact, collapse occurred in this area shortly after this time.

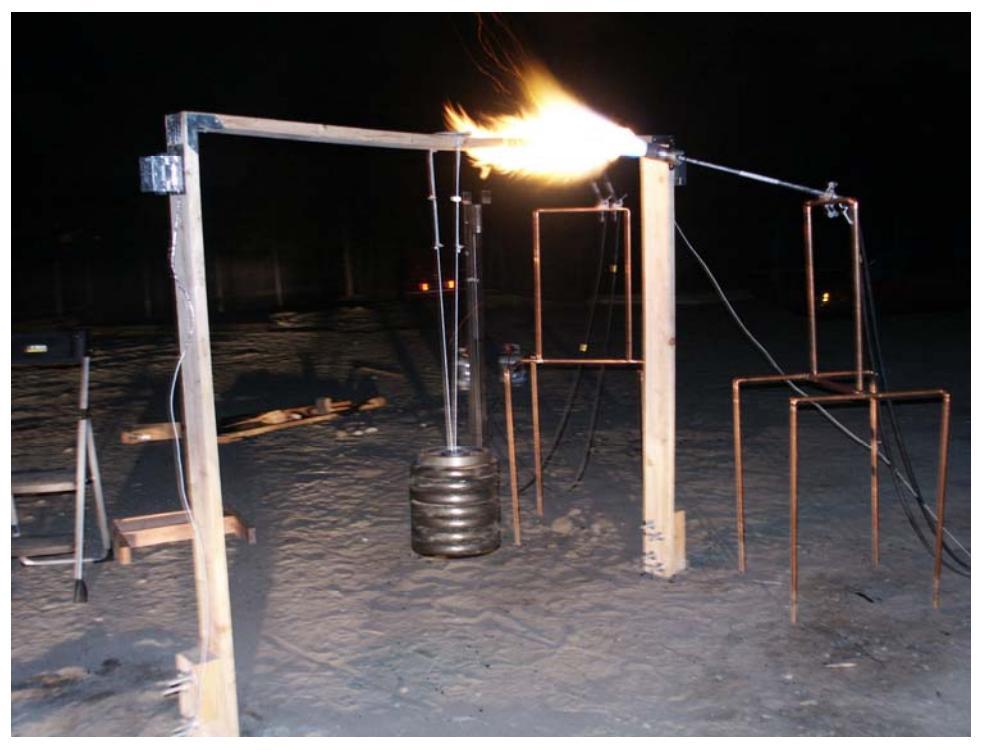
Figure 22 - Simple frame burn test.

Fire was applied through the use of a flame impingement device consisting of four torches, each fueled by a 5 gallon propane tank. Control valves were used to regulate the line pressure and the size of the flame. Stands made of copper tubing facilitated the positioning of the torches at the desired locations along the cross beam. A picture of one of the wood column/cross beam simple frames along with the torch system is shown in Figure 22. Two fire-sensors are shown attached at the upper end of each supporting column, and the metal hardware connecting the cross beam to the column supports is also shown. To obtain distinct indicators of impending collapse, the connections were designed to prevent a failure scenario in which nails are "pulled out" as the cross beam weakens.

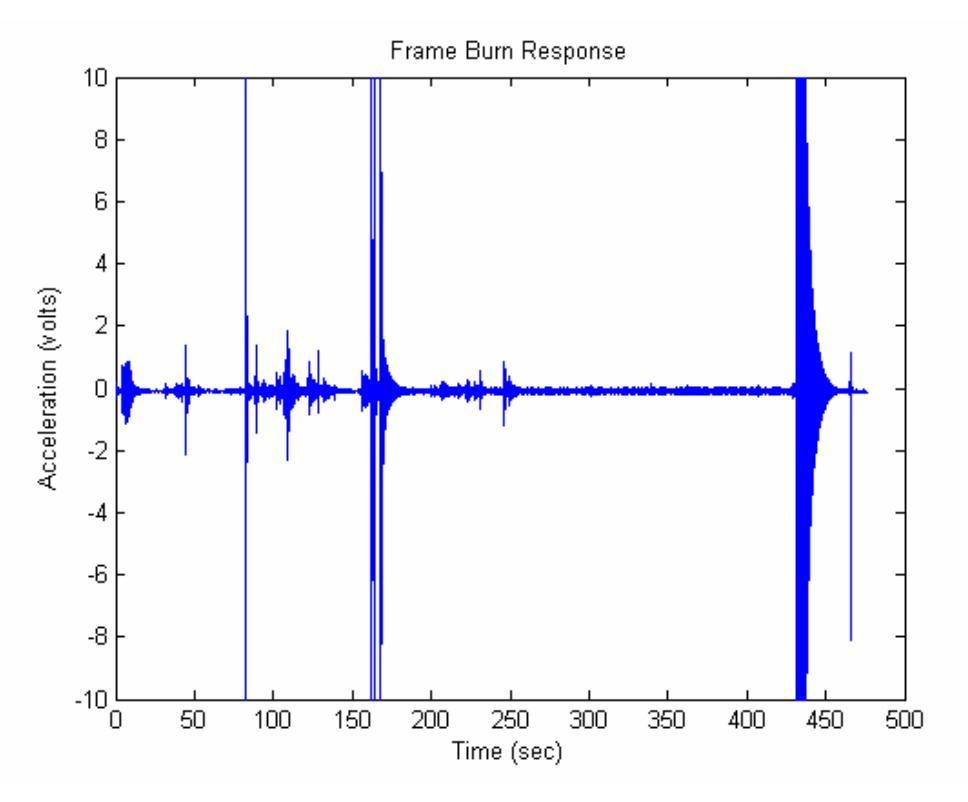
Figure 23 – Vibration response data for simple frame burn.

Evaluating the changing structural conditions in the frame from the response indicated in Figure 23 can be achieved by examining the magnitudes of the recovery response portions of the signal. While the trends in recovery response magnitude may be a possible indication of relative stability, a better picture of the changing conditions emerges if comparisons of the recovery response levels can be made throughout the response. For the frame burn response shown in Figure 24, there exists a measurable difference in the magnitude associated with the 1st Recovery as compared to the larger response magnitude of the 2nd Recovery. Further examination of the recovery response levels consistent in magnitude throughout the remaining duration of this test.

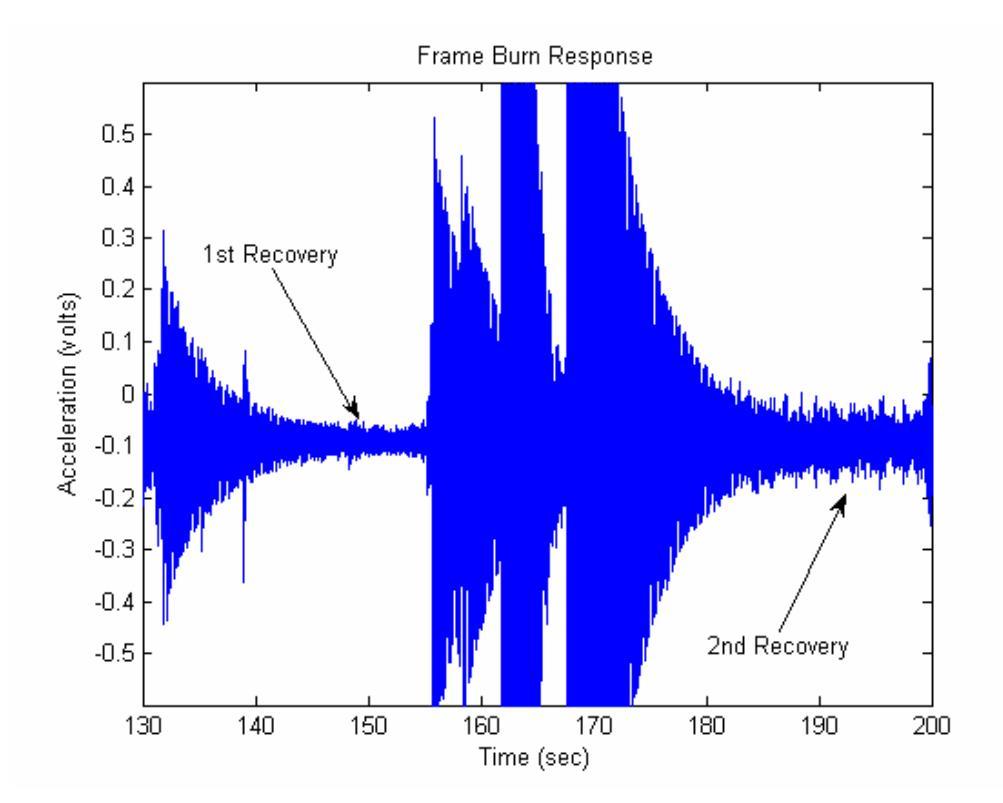
Figure 24 – Changing response levels between 130 and 200 seconds.
