NIST GCR 06-885

FIRE INDUCED VIBRATION MONITORING FOR BUILDING COLLAPSE. FINAL REPORT

Final Report

Award No. 60NANB2D0124 Contract Period – August 1, 2002 – July 31, 2005

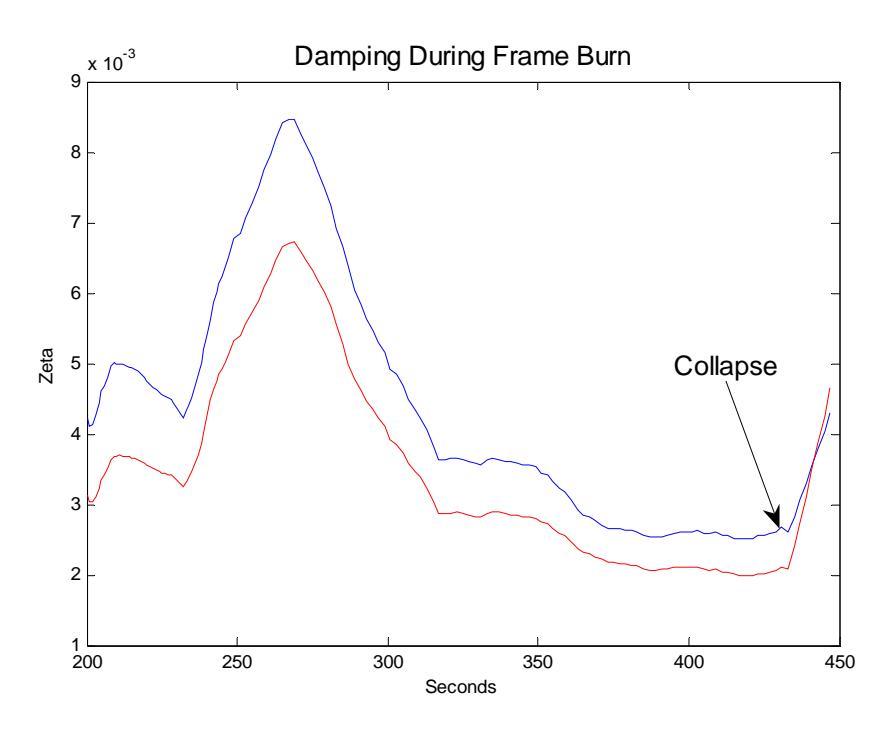
Figure 25 – Damping index during simple frame burn.

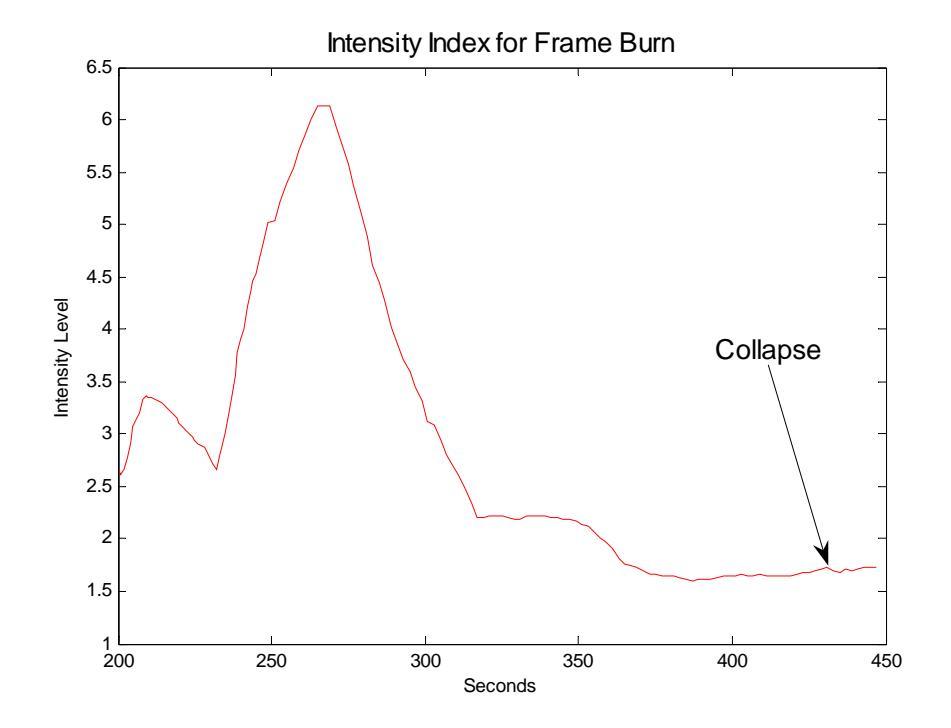
Figure 26 – Intensity index for simple frame burn.

Another HOBS index is shown in Figure 26 and is based on the intensity ratio derived from the wavelet analysis of the Random Decrement signatures. The intensity index shows a similar drop in value near 270 seconds as observed in the damping indices, leveling off near 1.5 as collapse occurs. The similarity in the character and trends in both damping and intensity indices provide added confidence in the performance of HOBS and in its ability to track changing conditions during the burn.

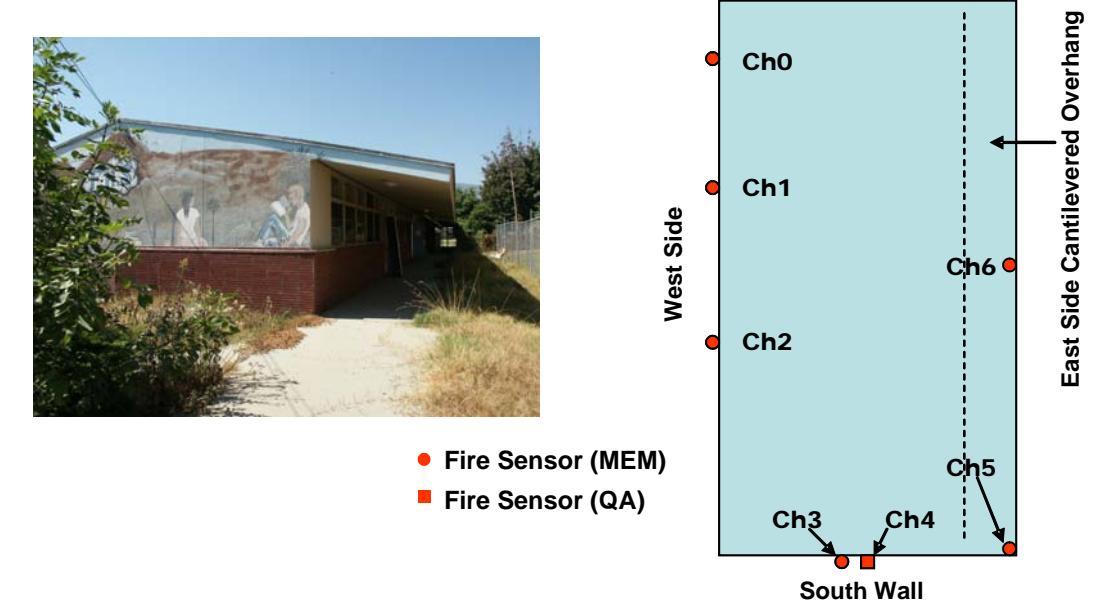
Figure 27 – South wall and measurement layout of Fillmore High School classroom building.

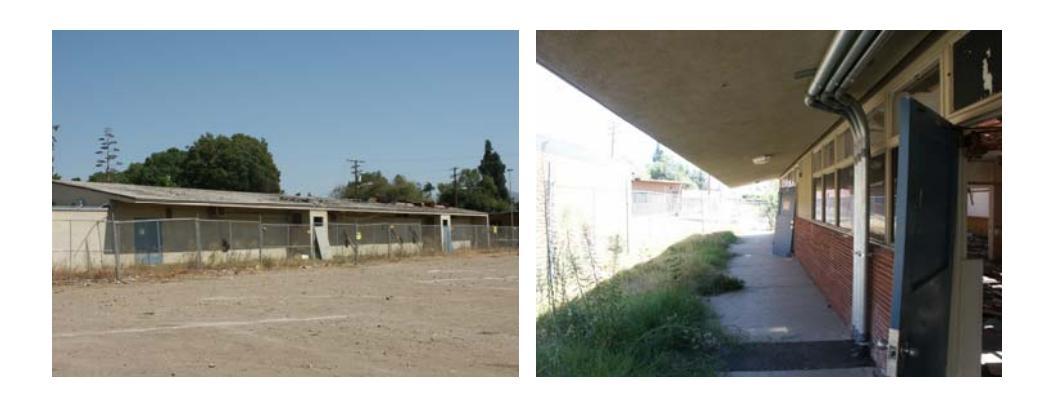
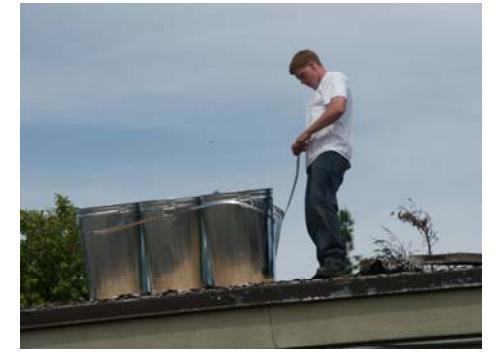
Figure 28 - West side of building (top left), view along east side corridor (top right), and installation of steel cans filled with sand simulating roof load of 1200 lbs (bottom).

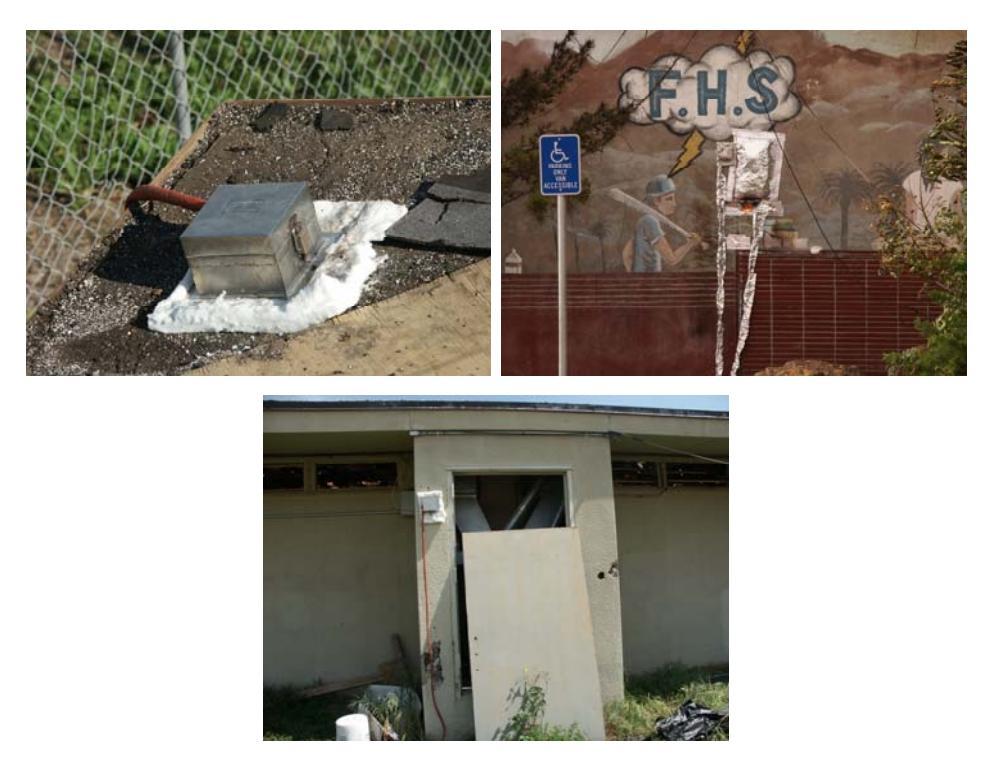
Figure 29 – Fire sensors installed on cantilevered overhang (top left), on south wall (top right), and west side (bottom).

Pictures of the sensors installed on the cantilevered overhang (Ch5) and at one location along the west side (Ch2) are shown in Figure 29. MEM based fire sensors were installed at all measurement locations, and one of the QA fire sensors (Ch4) was installed adjacent to a MEM sensor (Ch3) on the south wall of the classroom. The QA sensor provided a signal that was used to evaluate the quality and content of the MEM sensor's signal, and to assess the MEM sensor's suitability for this application. Figure 30 shows the south wall and roof loaded during burn and a picture of the collapsed cantilevered overhang is shown in Figure 31. Fire-induced responses were acquired for slightly more than 80 minutes.

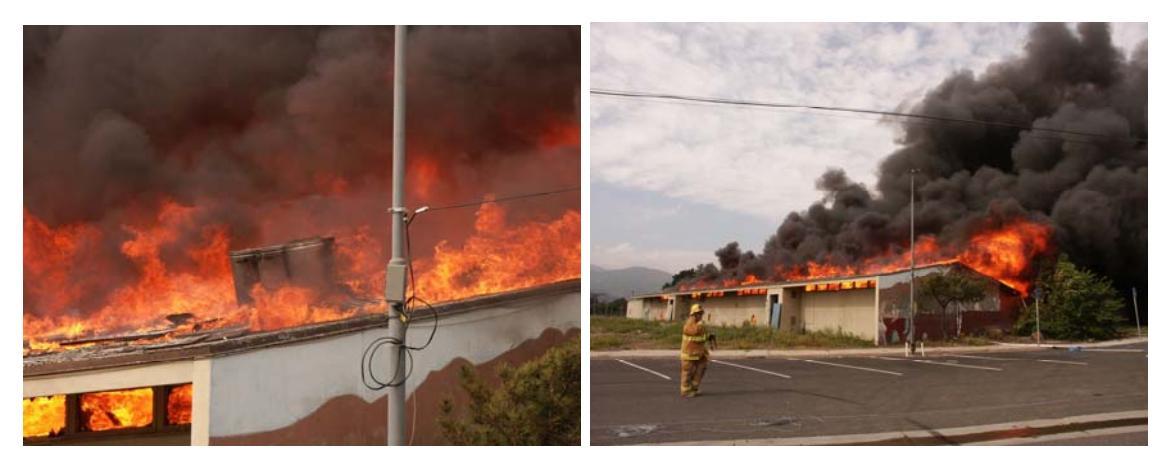
Figure 30 – Conditions over south wall during burn.

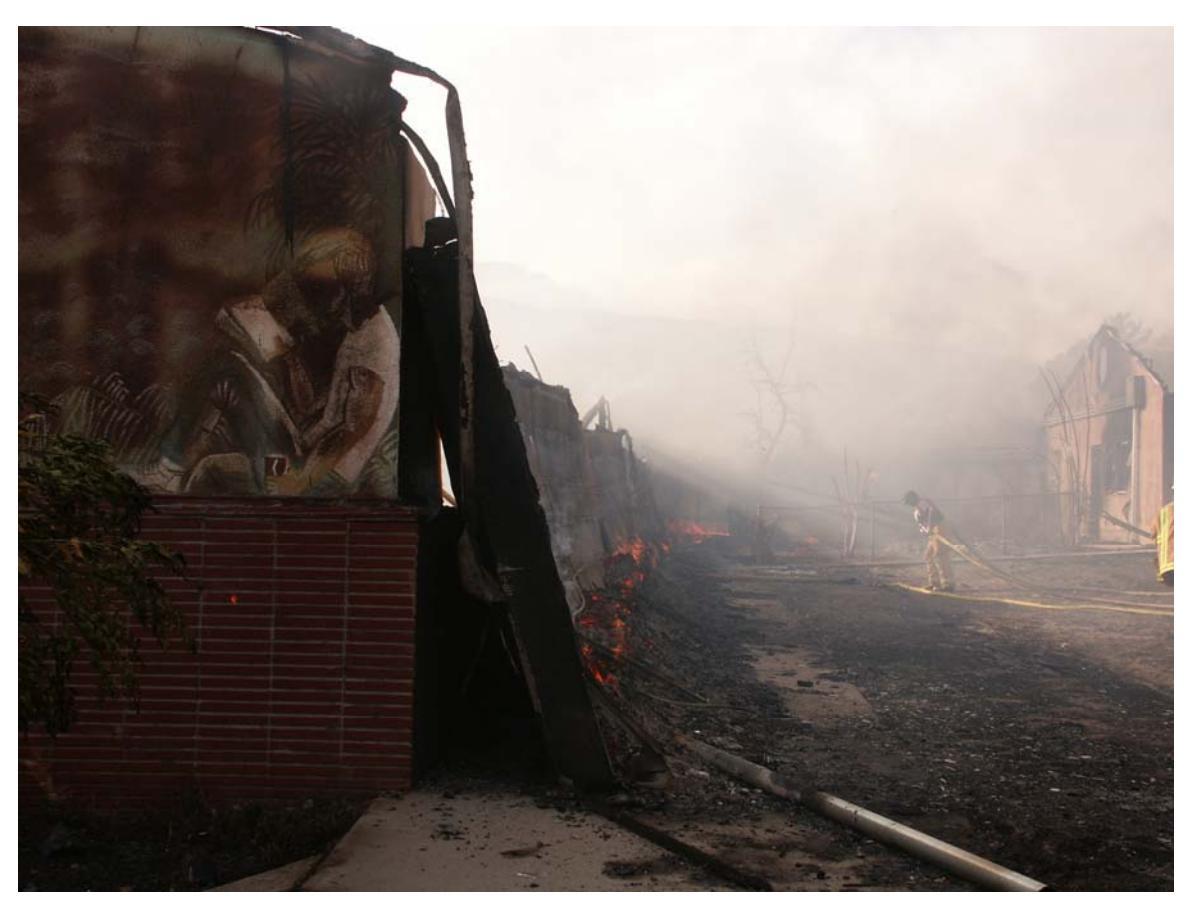
Figure 31 – Collapsed cantilevered overhang along east side of building.

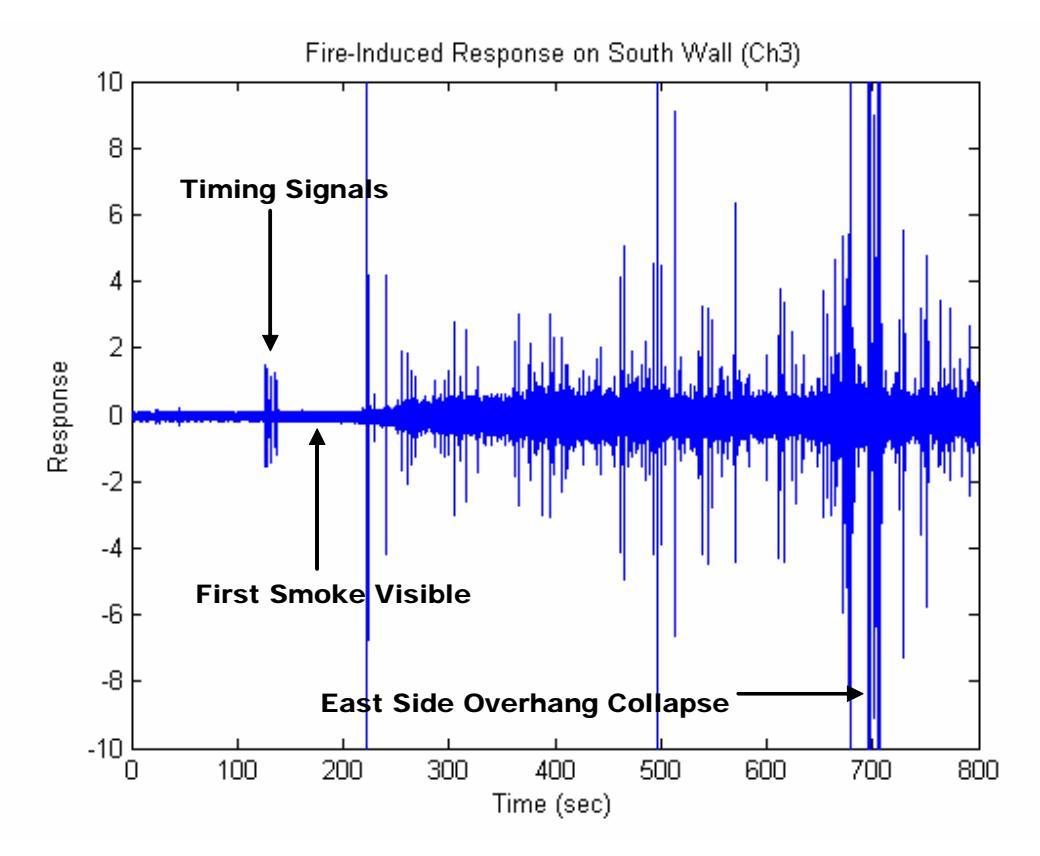
Figure 33 – Measured fire-induced response on the south wall of Fillmore High School.

Samples of measured fire-induced responses acquired during the burn tests at Fillmore High School are shown in Figure 33. The top response was acquired on the west side of the building and the bottom response was taken at the south wall. Both responses were acquired using the MEM fire-sensor and timing signals were used to synchronize the responses with video acquired during the burn. Actual time of ignition was not clearly identified (due to a delayed confirmation at ignition), however, the first visible smoke was observed 150 seconds after the start (at t=0 sec) of data acquisition. Both signals clearly indicate the collapse of the east side cantilevered overhang near 700 seconds. These high quality data sets are representative of the data acquired from all sensors.

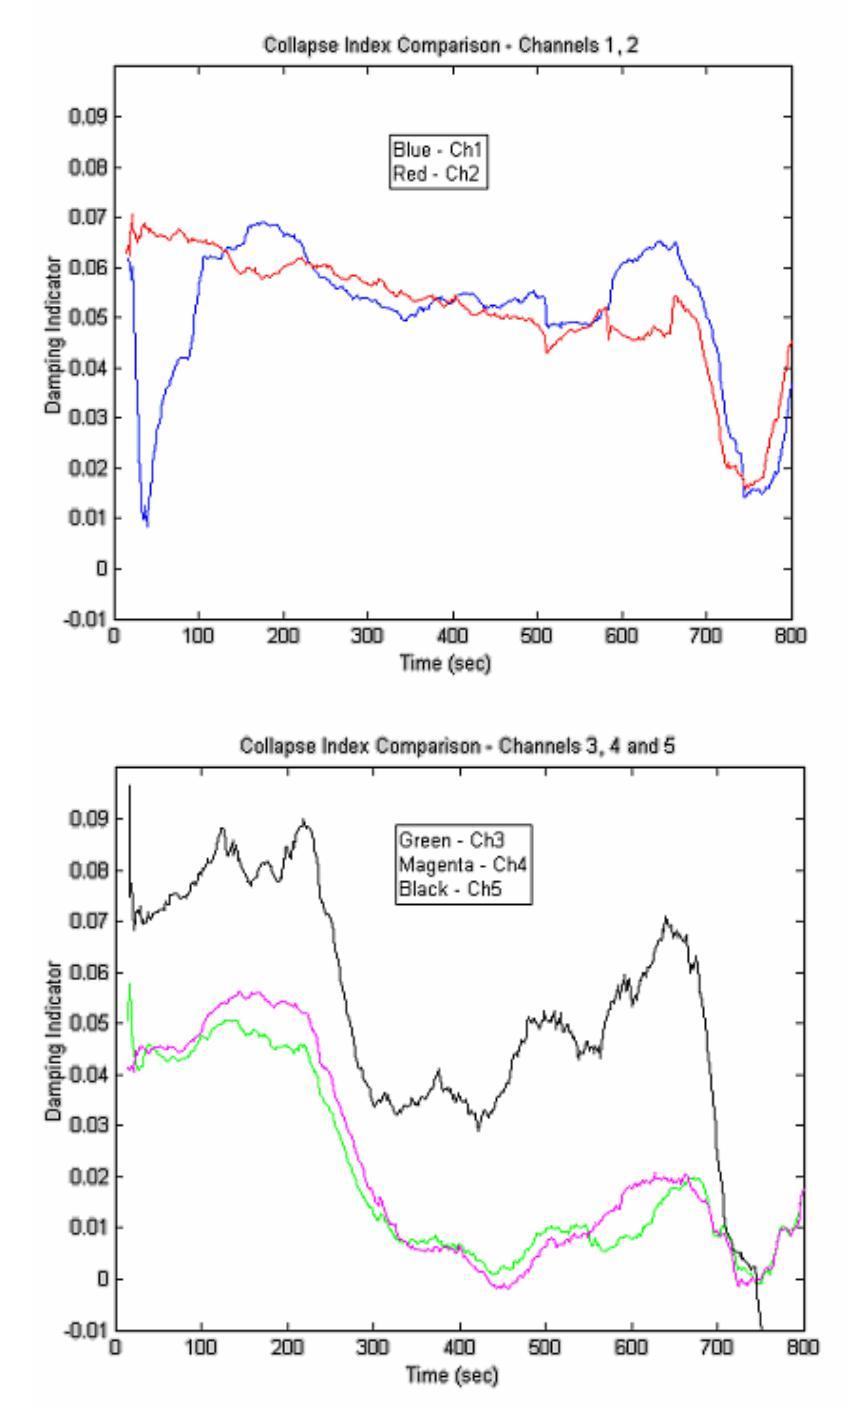
Figure 34 – Damping based collapse indicator response behavior.

- The magnitudes of the damping indicators prior to ignition are consistent with values reported in the literature from ambient surveys of large civil structures. As the structure weakens, damping values approach zero.
- Based on the timing of the observed collapse of the east side overhang, measurable changes in the collapse indicators are seen (approximately) 2 minutes prior to the collapse.

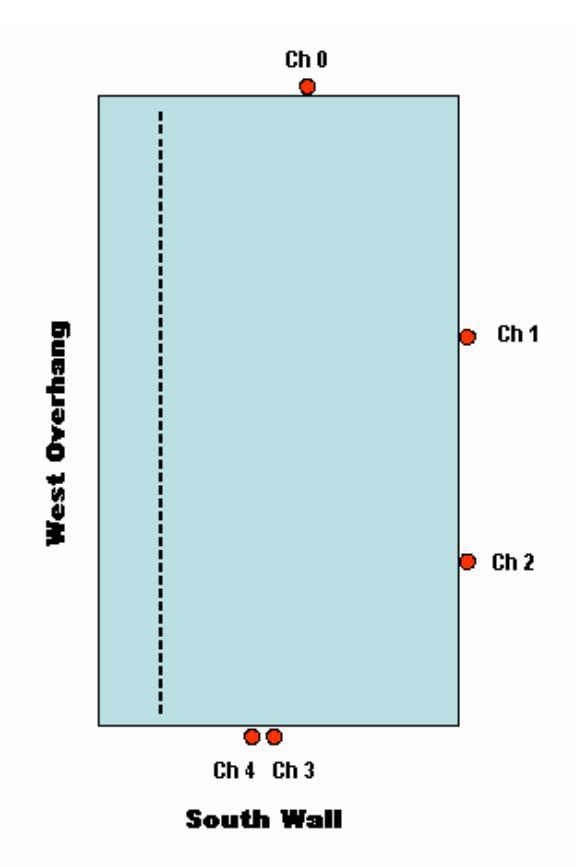
Figure 35 – Accelerometer layout for Santa Paula Burn.

HOBS was used during the burn test conducted at Isbell Junior High School (Santa Paula, CA) in July, 2005 on a structure similar to that tested at Fillmore High School. The structure was approximately 35 ft wide, 165 ft long, and constructed using wood frame members covered by a stucco exterior. The purpose of this test was to capture the collapse of the cantilevered overhang in the structure while monitoring fire-induced responses at locations around the perimeter of the building (see measurement layout in Figure 35). Unlike the tests at Fillmore High School, the roof was not pre-loaded to induce additional collapse events and only MEM sensors were used.

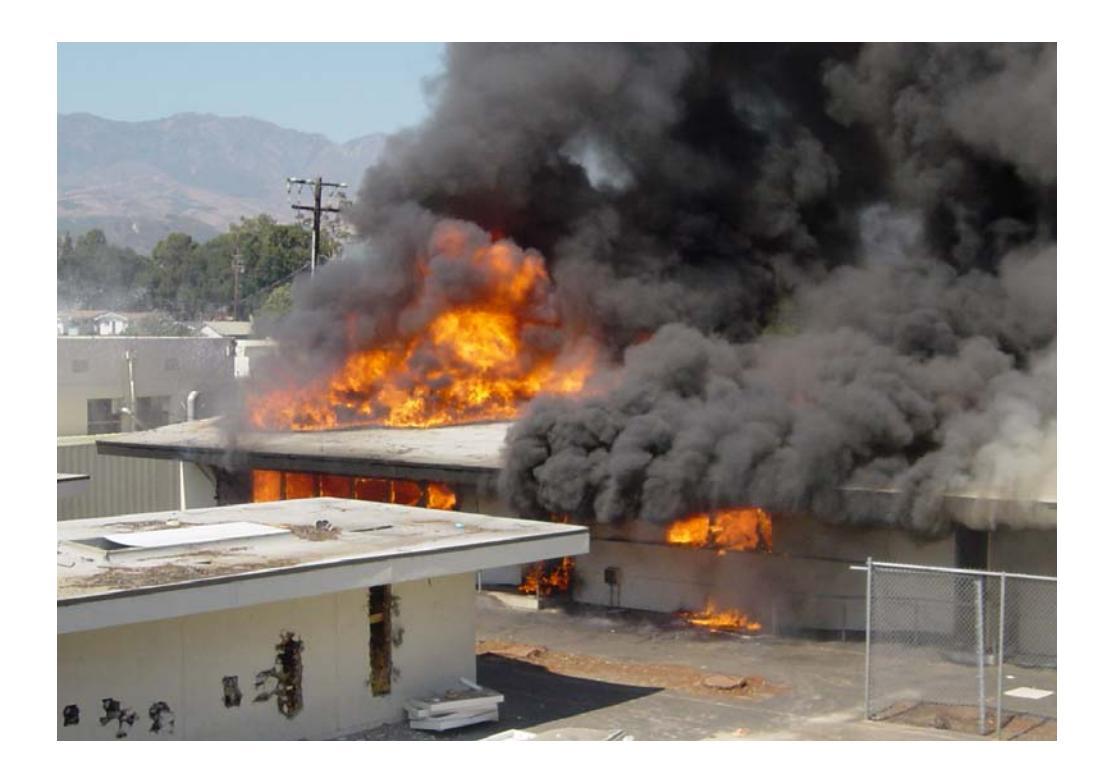
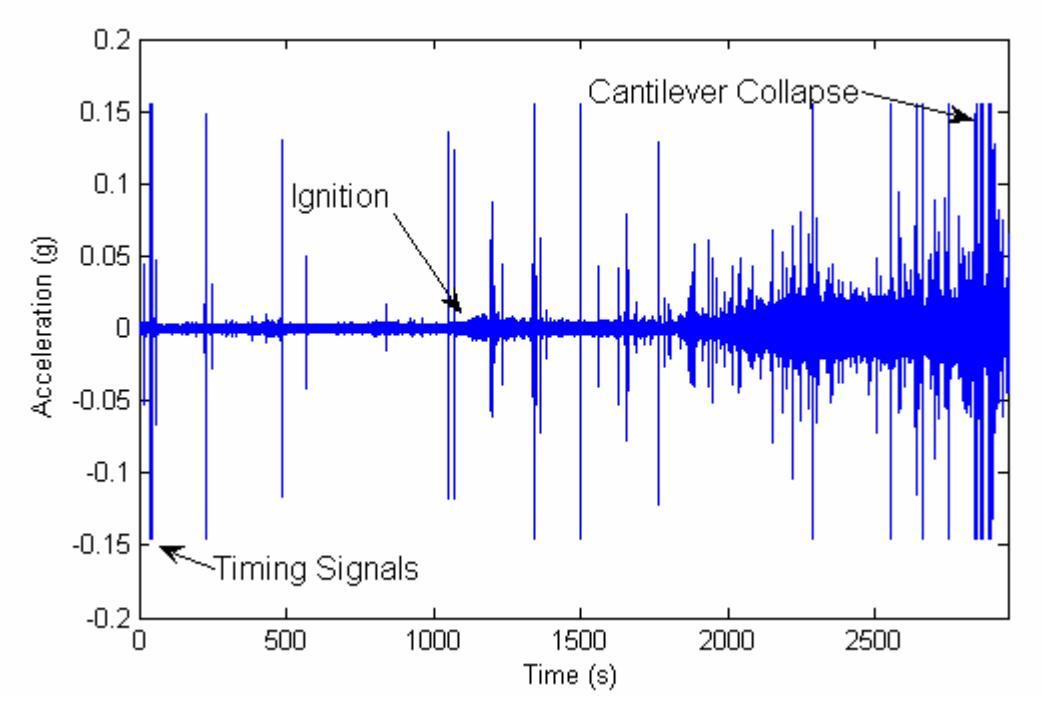
Figure 36 – Isbell Junior High School during burn and fire induced vibration response from accel 2.

A picture of the classroom structure during burn and a sample of the measured response behavior acquire during the test is shown in Figure 36.

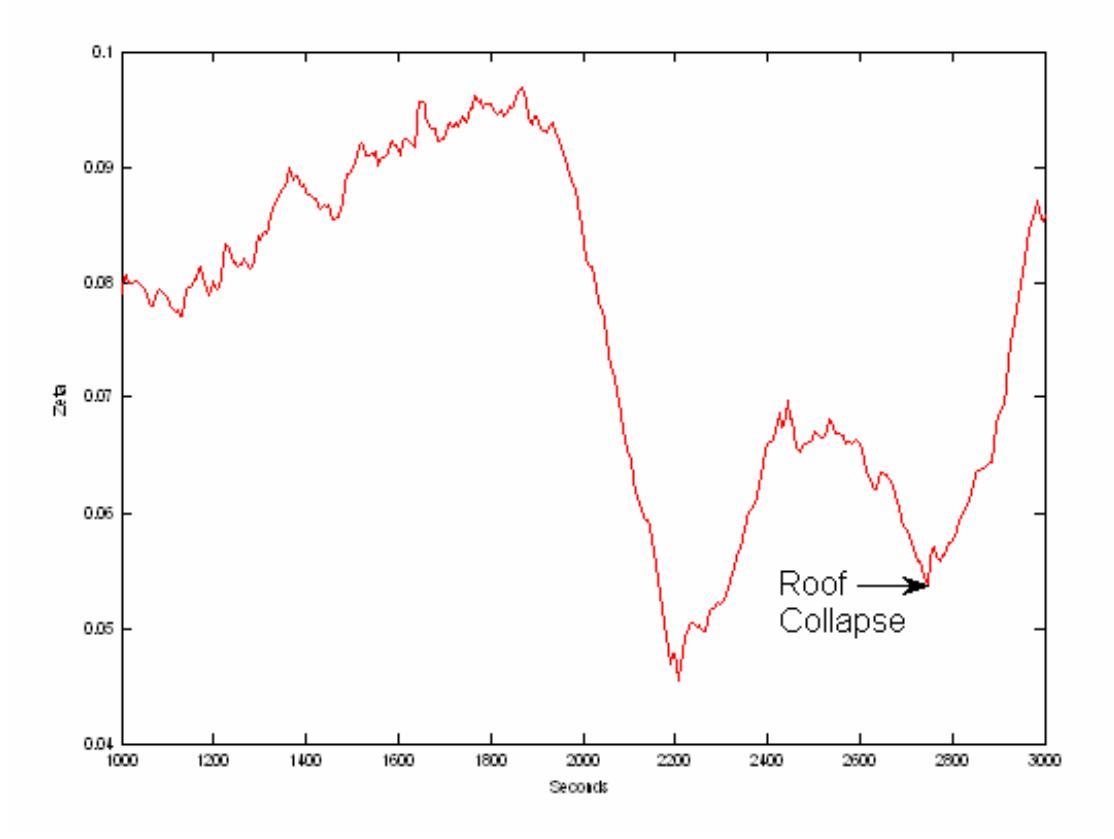
Figure 37 – Damping indicator for Santa Paula burn.

The damping indicator generated using HOBS on the concatenated data set is shown in Figure 37. The damping trend is similar to that observed during the Fillmore tests where a dramatic decrease in damping is followed by relatively steady behavior with a smaller drop in damping just prior to roof collapse 2765 seconds. As observed during the simple frame tests, damping can increase during actual collapse due to the added friction of the movement across connections.

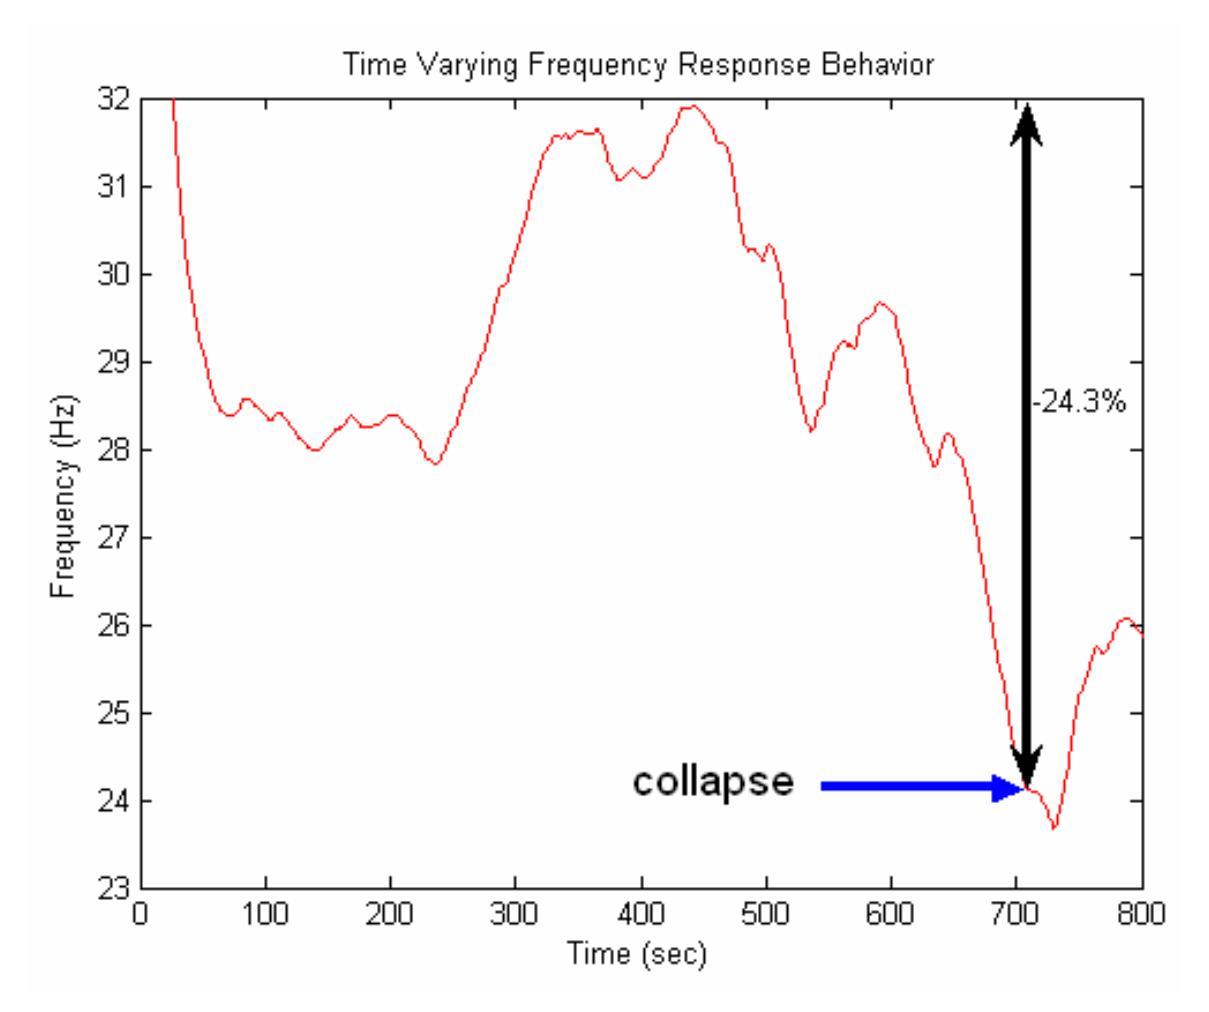
Figure 38 – Instantaneous frequency behavior for Fillmore High School burn

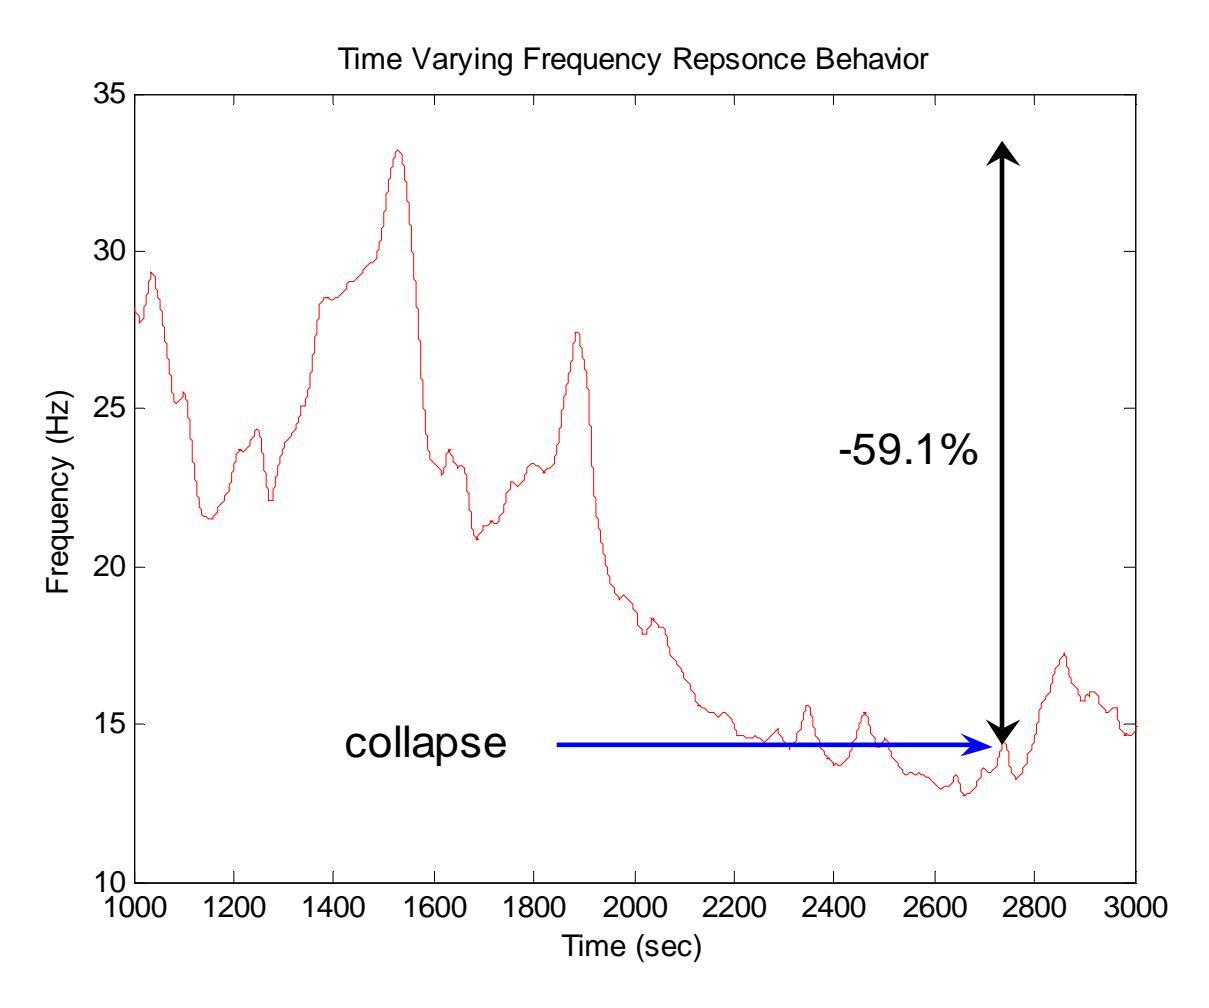
Figure 39 – Instantaneous frequency behavior for Isbell Junior High burn
