## Using Incandescent Lamp Failure Levels for Assessment of the Surge Environment

Hubert Bachl Cooperative Testing Institute Vienna, Austria François Martzloff National Institute of Standards and Technology Gaithersburg MD 20899 USA f.martzloff@ieee.org Doni Nastasi Power Electronics Applications Center Knoxville TN 37932 USA DNastasi@epri-peac.com

Reprinted, with permission, from Proceedings, 12<sup>th</sup> International Zürich Symposium on Electromagnetic Compatibility, 1997

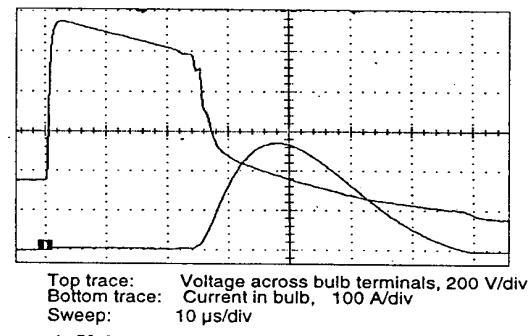
Figures 1, 2, 3, and 4 present oscillograms of the voltage across an energized 120-V bulb and of the current flowing in the bulb. Figure 1 shows a narrow window, commensurate with the duration of the surge delivered by a  $1.2/50 - 8/20 \ \mu s$  surge generator. We observe the chopping of the voltage wave, typical of a gap sparkover, and the rise of the surge current after the sparkover. The scale of the current trace selected to record the surge (hundreds of amperes) does not show the normal current (1 A) in the bulb.<sup>1</sup> Observations during this test include hearing a pinging noise and seeing a bright flash of light, followed by darkness. After the test, the filament can be seen broken at one or both its points of attachment to the supporting connecting stems.

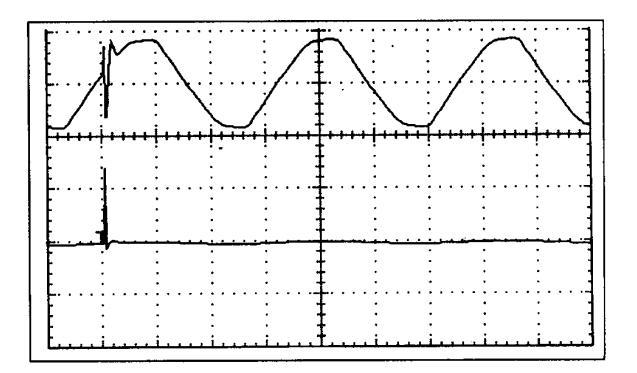
Figure 2: Voltage and current in bulb during application of a 1.2/50 - 8/20 µs surge at 30°, with surge sparkover but no power-frequency flashover

Top trace: Voltage across bulb terminals, 200 V/div Bottom trace: Current in bulb, 100 A/div Sweep: 5 ms/div

Figure 2 was recorded (with a new bulb) with a longer window than Figure 1, so as to display three full cycles of the power frequency. At that sweep rate, the surge is no longer resolved, and its apparent peak shown on the trace may be lower than the actual peak because not enough data samples are collected around the peak. However, the timing of the surge, not its amplitude is what is important in this figure. The surge event appears as a voltage spike and a current spike, followed by return to practically normal voltage and no visible large powerfrequency current.

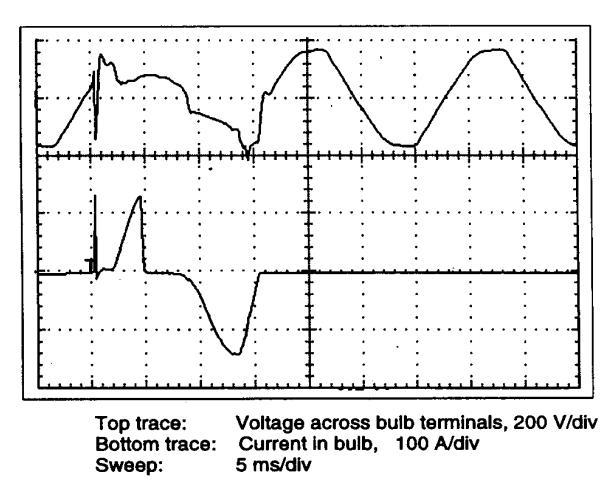
Figure 3 shows for the same bulb as that of Figure 2 the events during a subsequent shot under the same conditions. At first, after the surge, the pattern is identical to Figure 2. Then, suddenly, a pulse of power-frequency current appears, with a large amplitude -- the source of the observed flash. We believe that it is this current that causes the burn-out of the filament, not the "trigger" surge. The randomness of the process of igniting the power arc is such that in the case of Figure 2, the power arc was not ignited, while in the subsequent surge application on the same bulb (Figure 3) and in the same conditions, the power arc was ignited, resulting in burn-out of the filament -- a threshold situation.

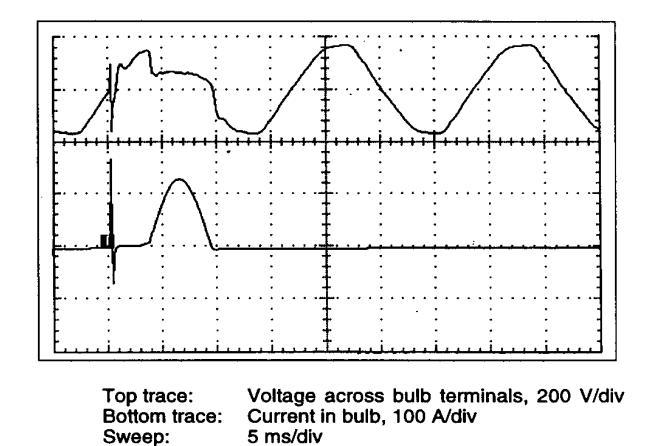
As further evidence, Figure 4 shows the process (in a new bulb) when the surge was applied at 0°, requiring more energy for ultimately igniting the power-frequency flashover. At zero degrees, there is the least power-frequency voltage to ignite a power arc. Figure 4 shows the last of a seven-shot sequence in which the first applied surge had an amplitude of 1200 V. The applied surge was then raised in 100-V steps to 1500 V, still with pinging heard but no fatal power-frequency arc. To explore the hypothesis that the filament might be burned out by the surge energy, we held the surge at 1500 V for the next three shots. Only the last of the three triggered the fatal flashover, recorded in Figure 4. At that level of energy deposited by the surge, enough plasma was generated in the path of the surge current to eventually ignite the power-frequency arc, but for that shot it had to wait until the power-frequency voltage had reached its peak, again indicating a threshold situation.

In Figure 5, a 230-V bulb shows the occurrence of a singlepulse of power-frequency flashover occurring immediately after the surge sparkover. Figures 6 and 7 show the occurrence of a delayed flashover with a single or double pulse, similar to the pattern for 120-V bulbs, respectively in Figures 4 and 3.

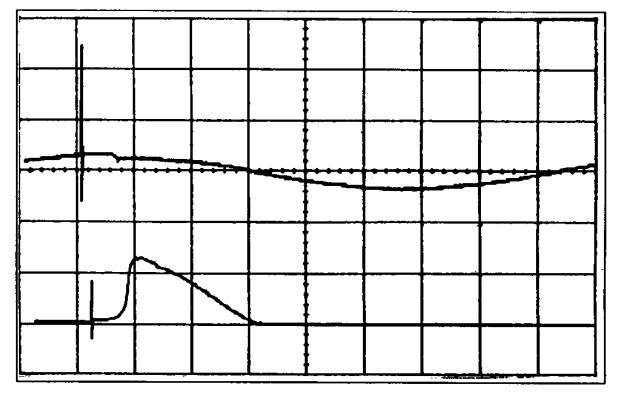
Figure 6: Voltage and current in 120-V bulb during application of a 1.2/50 µs - 8/20 µs surge at 90°. Surge sparkover and delayed one-pulse power-frequency flashover

Voltage across bulb terminals, 500 V/div e: Current in bulb, 50 A/div 2 ms/div

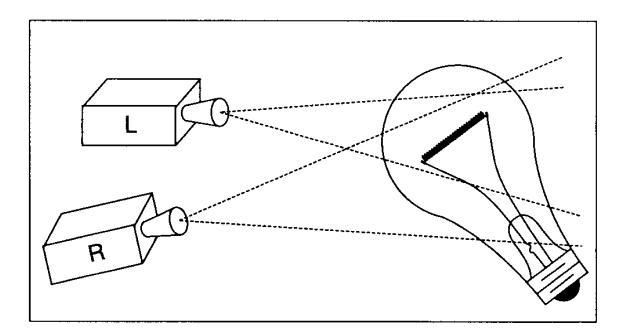
Figure 8: Arrangement of image converters to scan sparkover and flashover limited to the filament (L) and a full frame (R) including the base where the fuse is located

In an attempt to settle this uncertainty, we obtained a highspeed video system consisting of two image converters, a digital acquisition memory, display monitor, and video recorder. The image converters had a capability of 1000 full frames per second, with the possibility of multiple scans of a limited field during the 1 ms basic full-frame scan time. Figure 8 shows the arrangement of the two converters, with the left converter (L) controlled to perform four scans limited to the filament area, and the right (R) converter controlled to perform a full-frame view of the filament and fuse contained in the base stem of the bulb. The recording system was triggered by a signal from the surge generator, providing the beginning of the recording a few milliseconds before the surge, and lasting about 100 ms after the surge.

We now will examine in Figure 10, opposite page, four frames of video recording corresponding to the electrical record of Figure 9. The left half of the screen shows four scans from converter L of Figure 8, proceeding from top to bottom and each scanned in 250  $\mu$ s. The right side of the screen shows the full frame, scanned over a period of 1 ms. The timing of the frame is shown in the lower right corner of the picture, such as "ET + 0000000010" which indicates the 1 ms window during which the surge was initiated. Other descriptive data in the margins are not significant to our story. Figure 10 shows the four frames respectively in the sequence from top to bottom for 0-1 ms; 1-2 ms; 2-3 ms; and 4-5 ms.

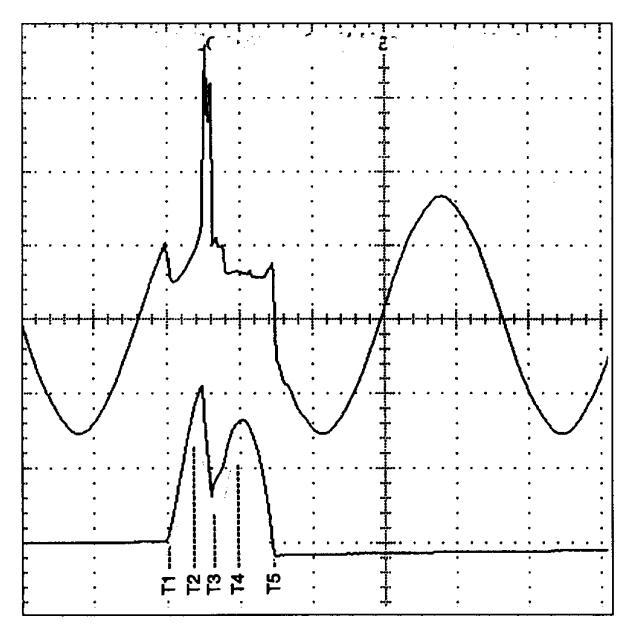
# Figure 9: Failure of a 230-V, 100-W bulb triggered by a 100 kHz Ring Wave applied at 30°, showing fuse operation

With this arrangement, recordings such as those shown in Figure 9 and Figure 10 were obtained. As an example of many oscilloscope recordings, Figure 9 shows the electrical record of the failure of a 230-V, 100-W bulb triggered by a 100 kHz Ring Wave applied 60 electrical degrees after the zero crossing. At time T1, sparkover of the filament occurs, accompanied in this case by immediate flashover of the power frequency arc, which rises to a first peak at T2, about 2.3 ms after its beginning. At that time, the current is throttled while the voltage increases sharply, indicating operation of the fuse. The fuse does not force a current zero at time T3, but allows a second peak of current at time T4, before decaying to a natural current zero at time T5.

This type of oscilloscope recording was the only one that was available until the video system was obtained. From such oscillograms we could only draw speculative inferences on the mechanism and behaviour, hence the motivation to enhance our tests by video recording. Figure 9 shows the voltage across the lamp terminals (top trace) and the current through the lamp (bottom trace). With the sweep set to cover 2 cycles of the power frequency, neither the surge voltage nor the surge current are resolved in this oscillogram. In this test series performed after the preliminary series, a separate oscilloscope with faster sweep was used to record the surge voltage and the surge current, as was done in the case of Figure 1. To conserve space, these surge recordings are not shown here, but the peak values of the resulting sparkover voltages recorded by the second oscilloscope are listed in Table 2 in the column "Typical threshold".

Top trace: Voltage across bulb terminal, 200 V/div Bottom trace: Current in bulb, 20 A/div Sweep: 5 ms/div

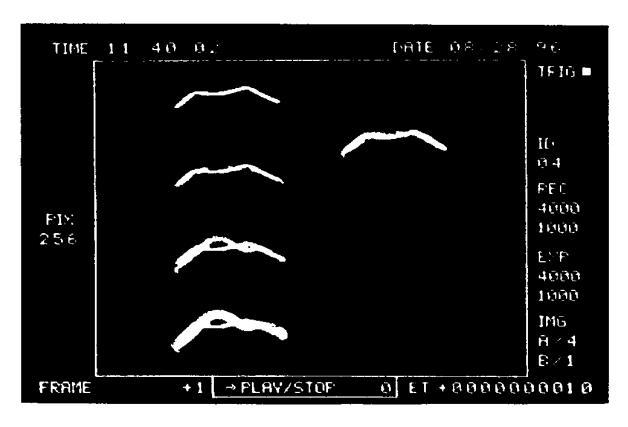
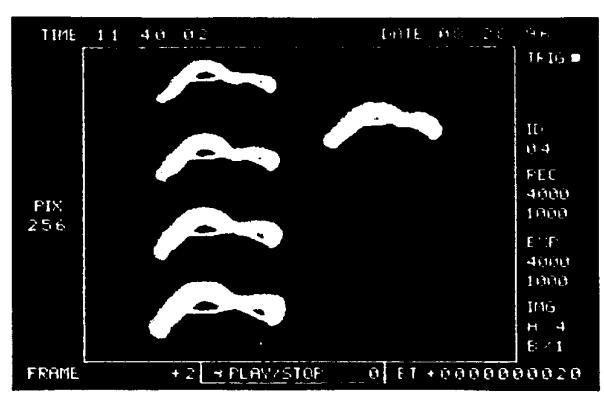
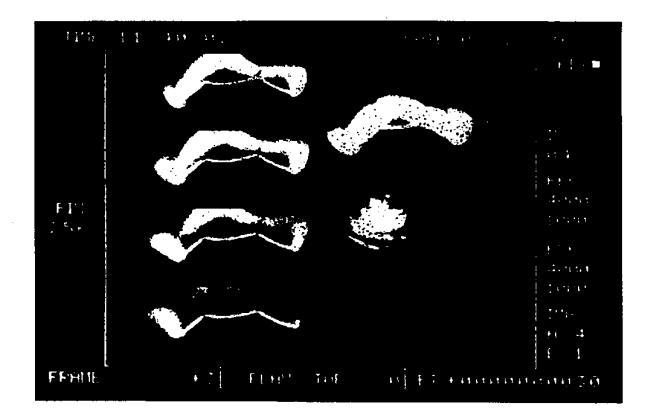
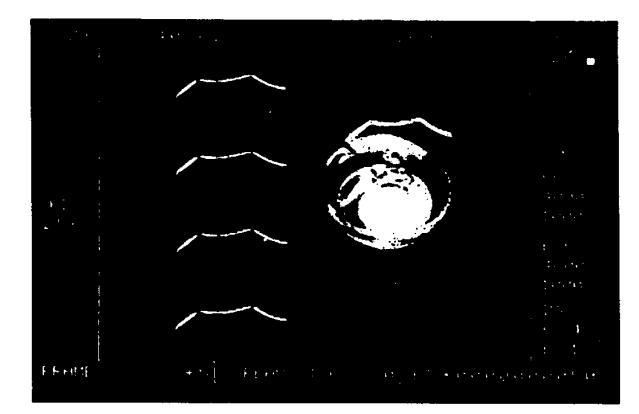
Figure 10: Sequence of flashover and fuse operation corresponding to the oscillogram of Figure 9

In the first frame, 0-1 ms, the Ring Wave sparkover is not visible because of its relatively low intensity/duration. The first 250- $\mu$ s scan (top) of the left side shows only the filament glow. Starting with the second scan, the beginning of the flashover (time T1 in Figure 9) is visible, while the right side scan, adjusted for less sensitivity, only shows the filament glow without the flashover beginning.

In the second frame, the flashover growth is visible on the four left scans (T1-T2 in Figure 9), while the right scan now has enough light integrated over the full 1 ms time to show the flashover.

In the third frame, the first two (top) left scans still show the flashover around the filament, but the last two (bottom) scans show the flashover current being starved as the fuse in the lamp base begins to operate and transfers the current to the space around the fuse. This corresponds to the time T2-T3 in Figure 9. The right side scan shows the beginning of the glow in the base of the lamp as the current around the fuse grows.

In the fourth frame, the four left scans show the filament still glowing, *but unchanged (not yet broken)*, while the right scan shows the integrated glow of the fuse operation, corresponding to the time interval T4-T5 of Figure 9.

These four frames, typical of many others recorded during our experiments, clearly show the mechanism of a flashover at the power-frequency current, and in this particular test sequence, the operation of the fuse in the base of the bulb. Other records taken with different light sensitivity show an intense glow near the connection of the filament, where the arc is concentrated at its point of attachment (the cathode hot spot) while the path around the filament is more diffuse. The concentrated heat near the point of attachment eventually causes a local melting of the filament. In other records, the filament is then seen separating from the stem and slowly falling in the time frame of about 20-50 ms after the flashover.
