NIST NCSTAR 1-5E

**Federal Building and Fire Safety Investigation of the
World Trade Center Disaster**

**Experiments and Modeling of
Multiple Workstations Burning in a
Compartment**

September 2005

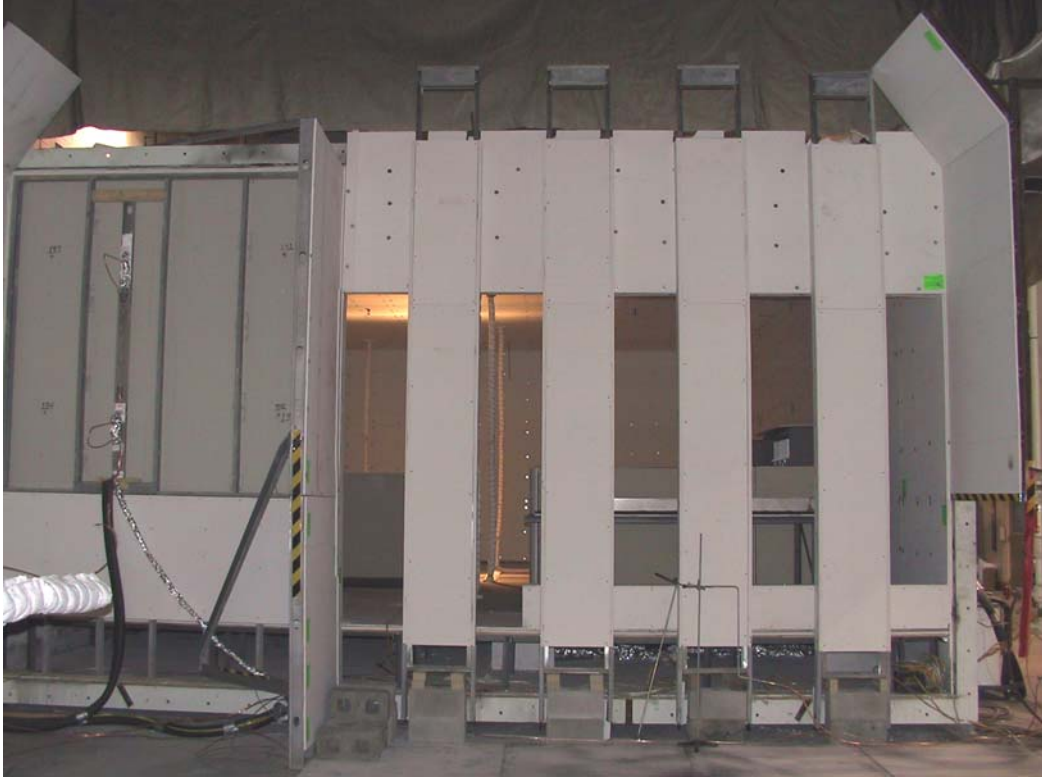
Figure 2–3. West side of experimental enclosure. Five ventilation openings are present. The knee wall was removed for access to instrumentation.

The enclosure had five openings and four columns on the front (west wall), mimicking window openings through which fresh air entered, and heat and combustion products were emitted. The openings were 2.12 m high, started 0.32 m above the floor, and were each 0.45 m wide. The narrow openings limited the amount of fresh air that entered the burning enclosure. In one test, (Test 6), the ventilation changed during the experiment as window glass, placed to the left of the ventilation openings, cracked and fell out approximately 3 min after ignition.

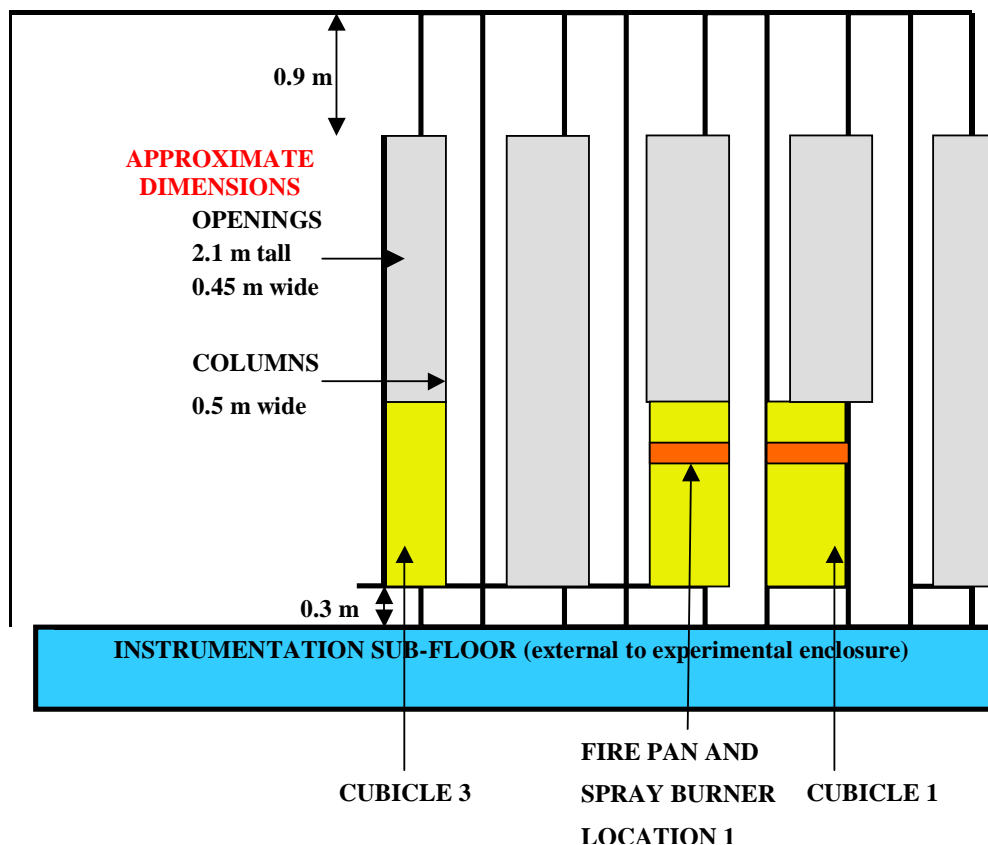
Figure 2–4. Elevation view of experimental configuration.

A schematic of the test configuration is shown in Figs. 2–2 and 2–4. The test series involved fires in compartments with the same height as that in WTC 1 or WTC 2. The steel-frame experimental enclosure was 10.81 m long by 7.02 m wide by 3.36 m tall (35.5 ft by 23 ft by 11 ft). The walls and ceiling were covered with two or three layers of Marinite I (calcium silicate board) each with a thickness of 1.25 cm. A sub-floor 0.48 m in height was used to house instrumentation and was not included in the above dimensions. The floor was also covered with Marinite I.

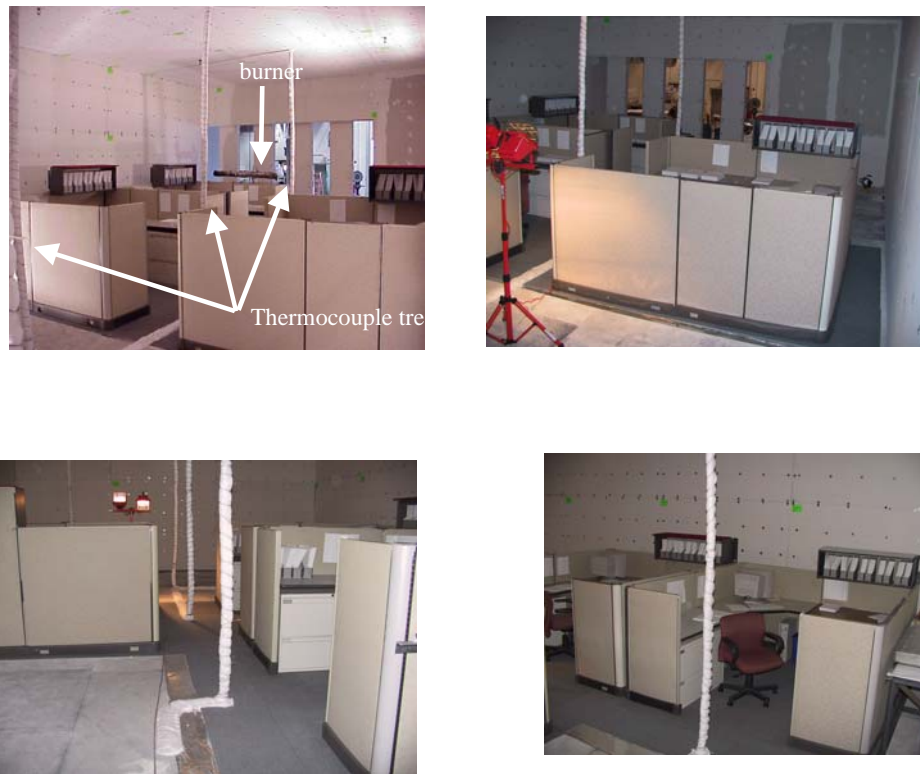
Figure 2–5. Views of interior of test compartment.

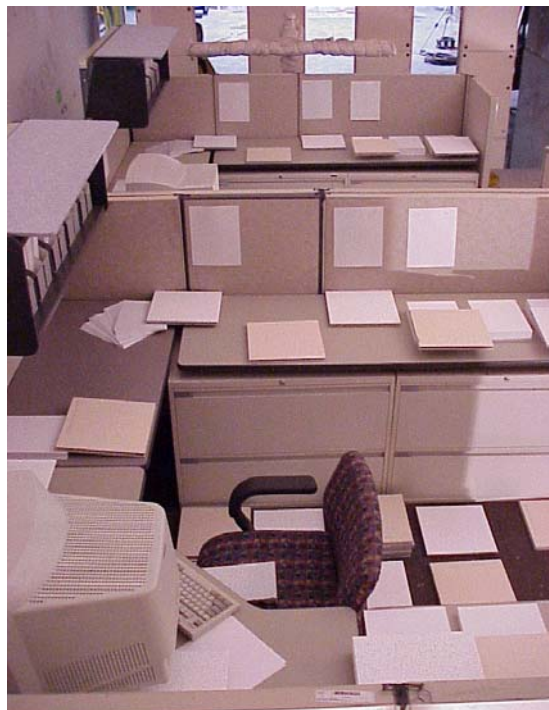
Figure 2–6. Image highlighting the arrangement of ceiling tiles used in Tests 3 and 4. The spray burner and compartment openings are visible towards the rear.

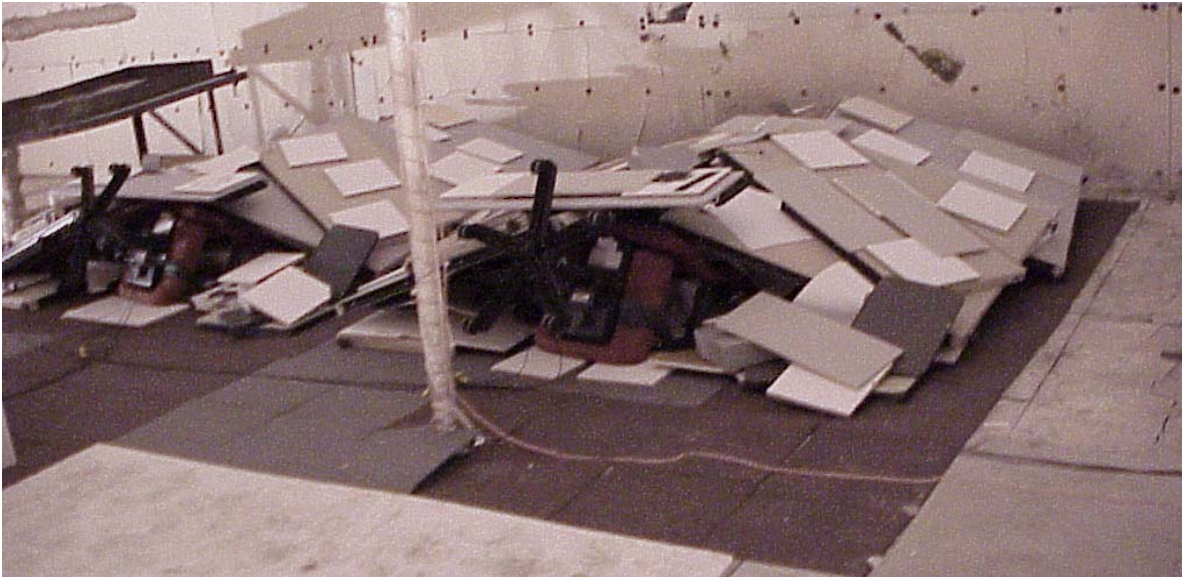
Figure 2-7. The arrangement of “rubblized” Workstations 1 (left) and 2 (right) with ceiling tiles before Test 5. Part of the spray burner is visible on the left.

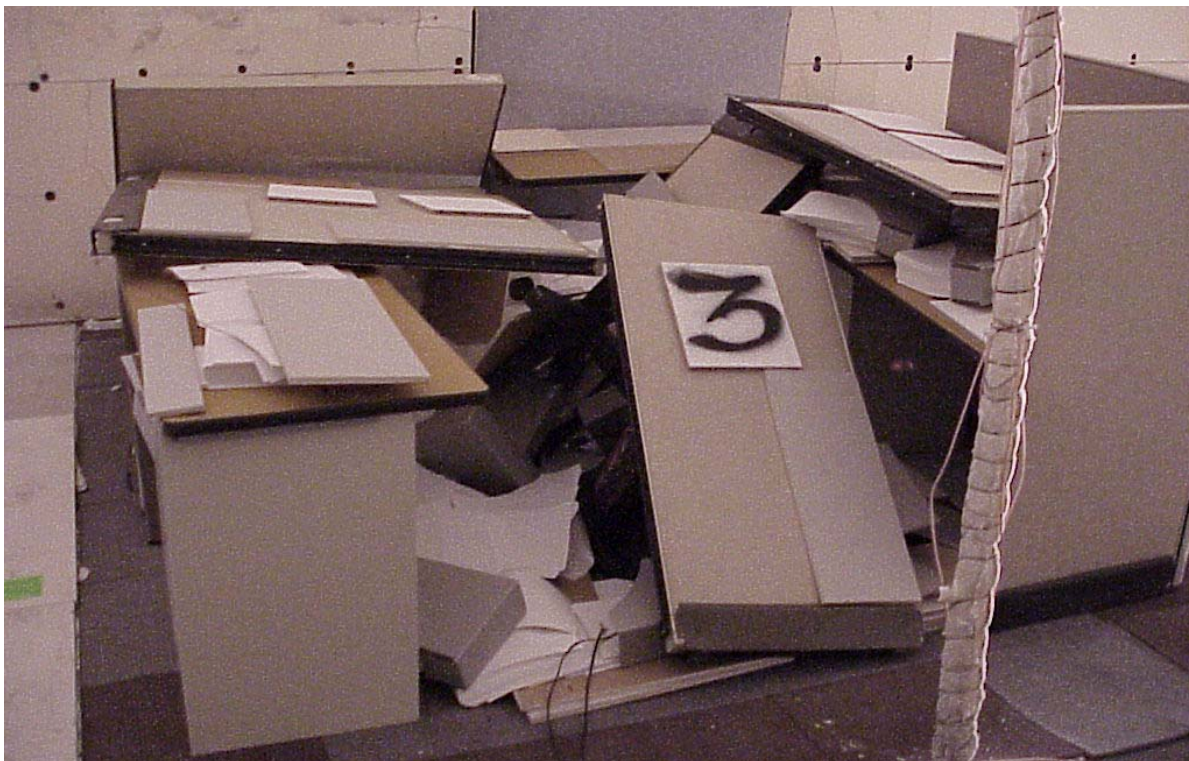
Figure 2-8. The arrangement of Workstation 3 before Test 5.

The distribution of ceiling tiles mimicked that used by for the single workstation (NIST NCSTAR 1-5C), which was based on a series of ambient temperature full-scale and reduced-scale experiments. In the fire tests, the tiles were laid out with their edges parallel to the privacy panels to facilitate reproducible placement in successive tests. Forty-nine tiles were used, and the percentage of the area covered by tiles in the fire experiments was as follows: central floor area, 67 percent; floor area under desk surfaces, 10 percent; desk surface remote from bookcase, 50 percent; two desk surfaces near bookcase, 32 percent; chair seat, 25 percent. All of the tiles were laid flat on horizontal surfaces, and some overlap of tiles was used. Figure 2-5 is a photograph taken before Test 3, which highlights the arrangement of the ceiling tiles used in Tests 3 and 4 for each of the workstations. The spray burner and compartment openings are visible toward the rear of the photograph shown in Fig. 2-6. In Test 5, the ceiling tiles were placed on top and within the “rubblized” workstations as shown in Figs. 2-7 and 2-8.

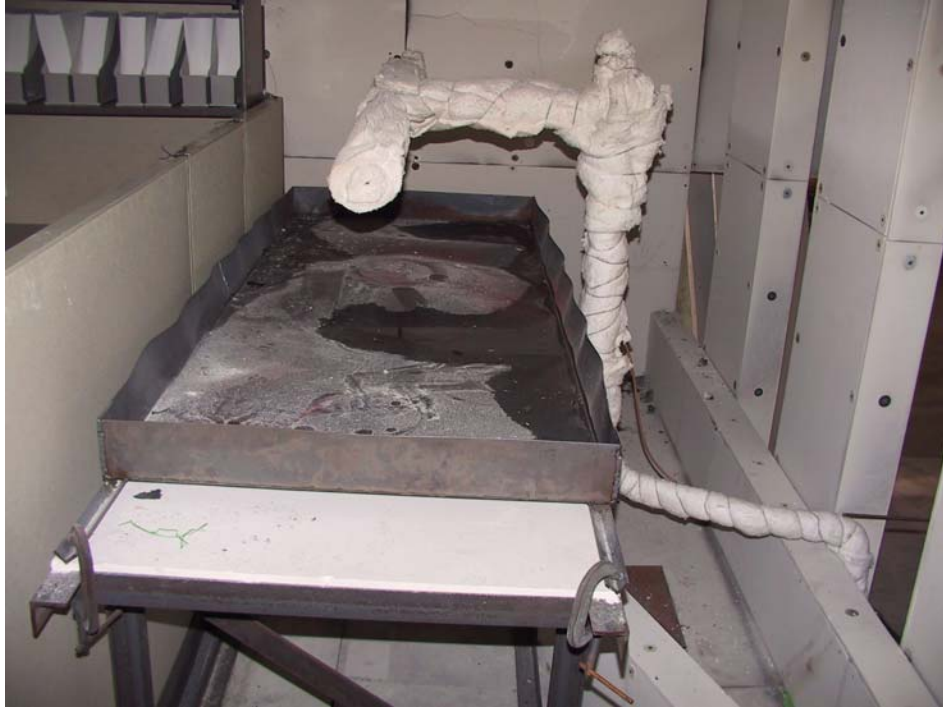
Figure 2–9. Spray burner and fire pan abutting Workstation 1 before Test 2 (location B1).

A blend of heptane isomers (designated here as “heptane”) was used as the spray burner fuel. The density, the heat of combustion, and the carbon to hydrogen ratio for the fuels were measured for the commercial heptane and n-heptane. The heat of combustion and the carbon to hydrogen ratio for the commercial heptane was measured to be within 1 percent of the value for n-heptane (Galbraith Labs 2003), which was within experimental uncertainty for the measurements. The fuel flow was 4.0 L/min, which was approximately equivalent to a 2 MW fire. The fuel flow to the hydrocarbon spray burner was calibrated before each of the experiments. The fuel was delivered through four 90 degree spray angle WL ½ type stainless steel nozzles spraying downward. The BETE nozzles were spaced 50 cm apart and located 47 cm above the fire pan. The 1 m by 2 m stainless steel pan was positioned 85 cm above the floor of the enclosure. Figure 2–9 is a photograph of the spray burner and fire pan abutting workstation 1 before Test 2. In the photograph, the burner is positioned at Location B1, which was near the ventilation openings on the west side of the compartment. The photograph shows that the pan was mounted on a table 80 cm above the floor.

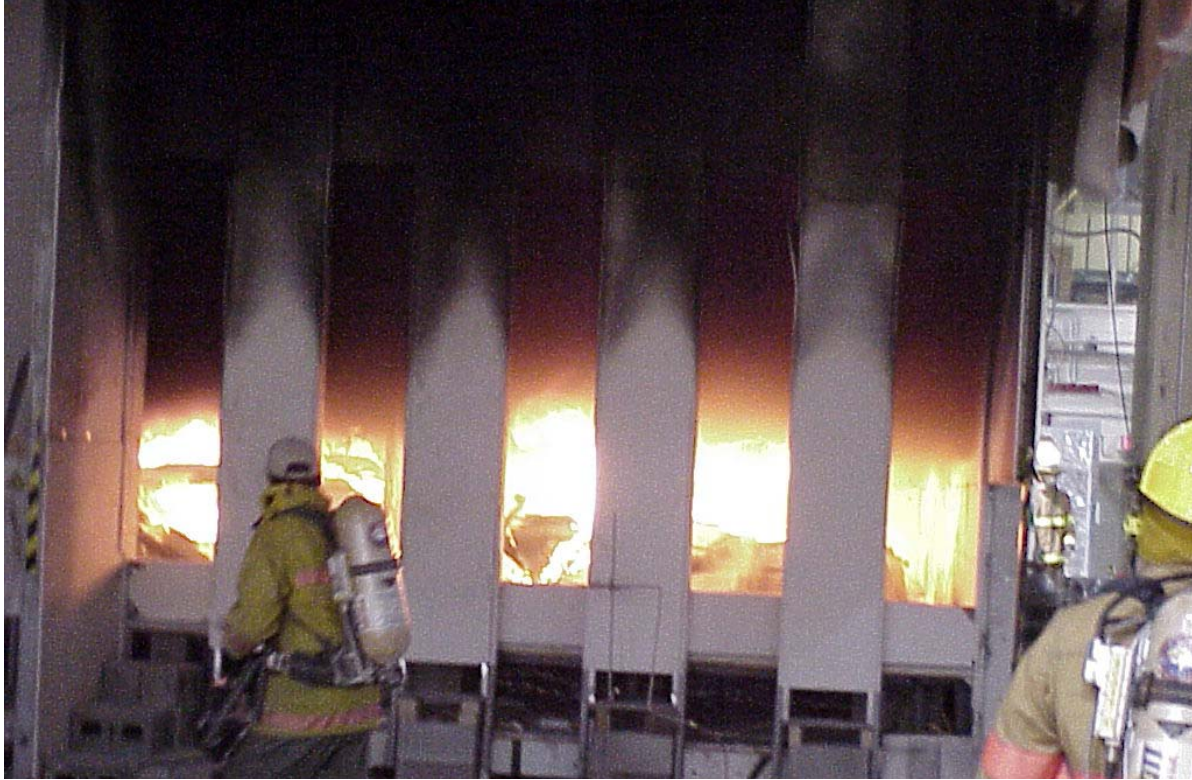
Figure 3–1. View of the fire compartment ½ min after the start of Test 5.

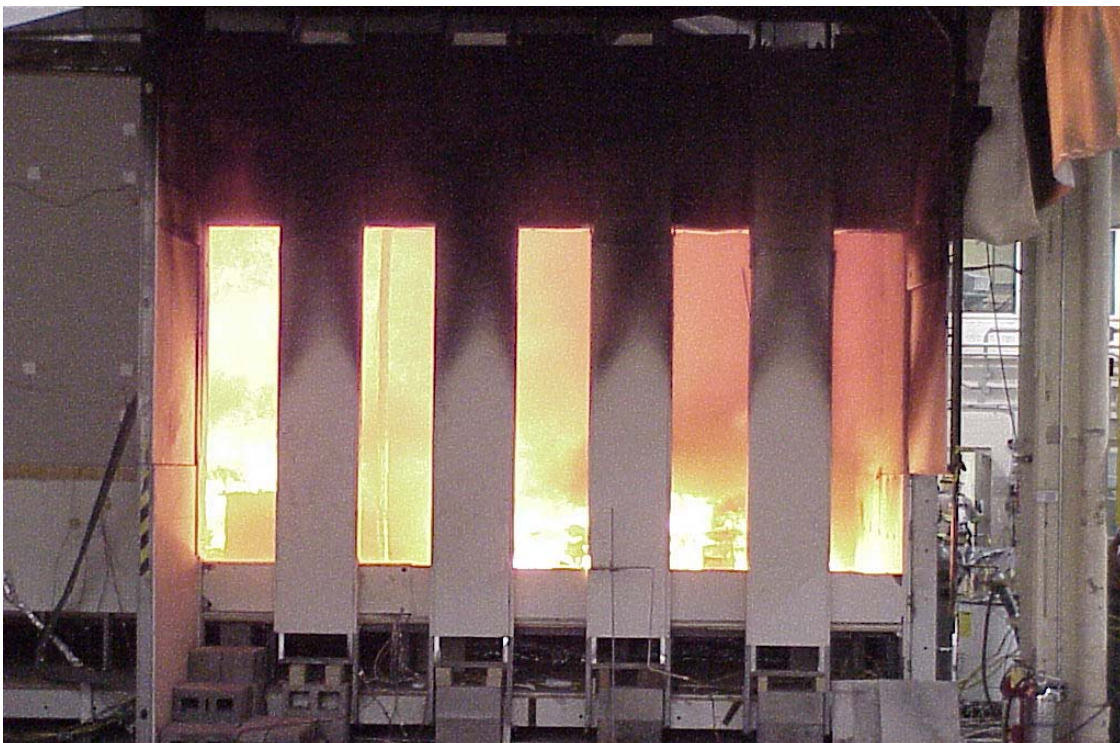
Figure 3–3. View of the fire compartment with test windows before the start of Test 6.

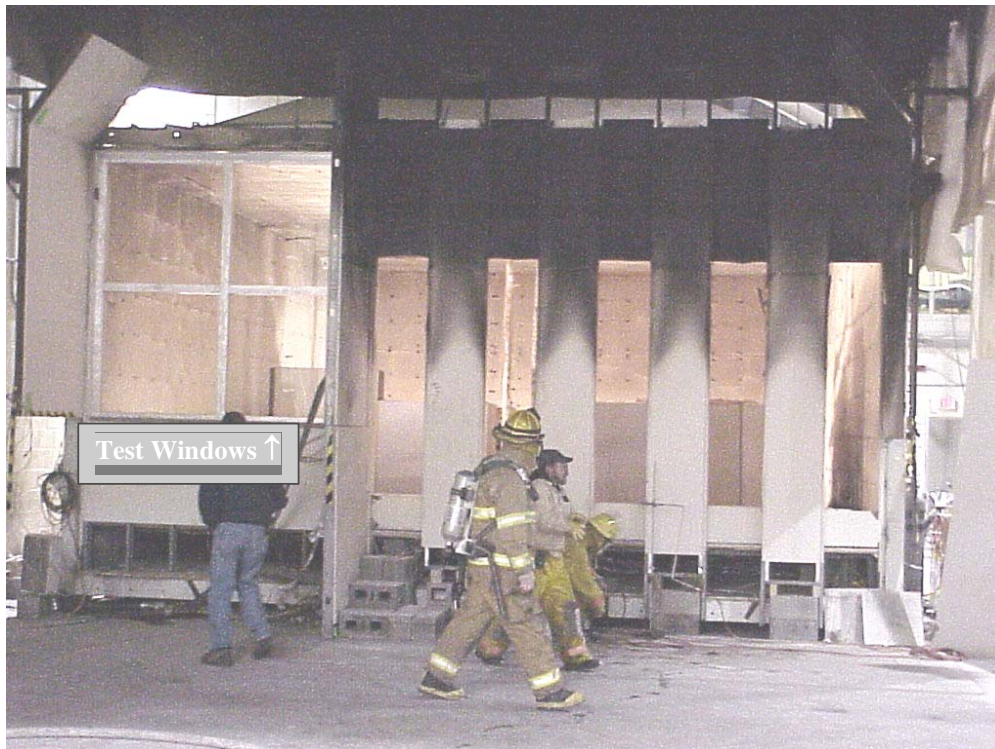
Figure 3–4. View of fire compartment 2 min after the start of Test 6.

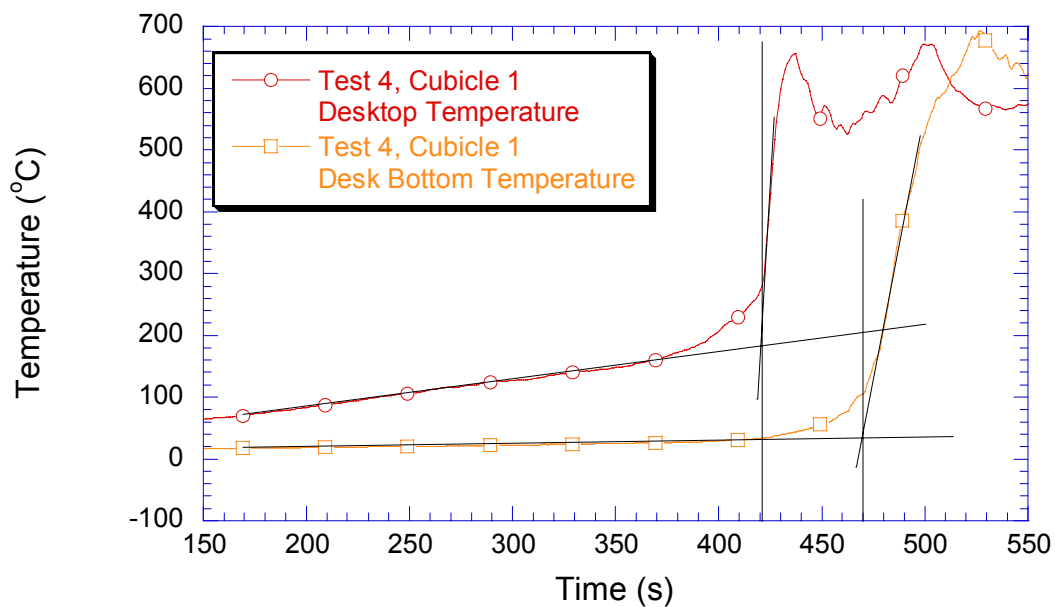
Figure 3–5. Determining ignition and full-involvement times from thermocouple data.

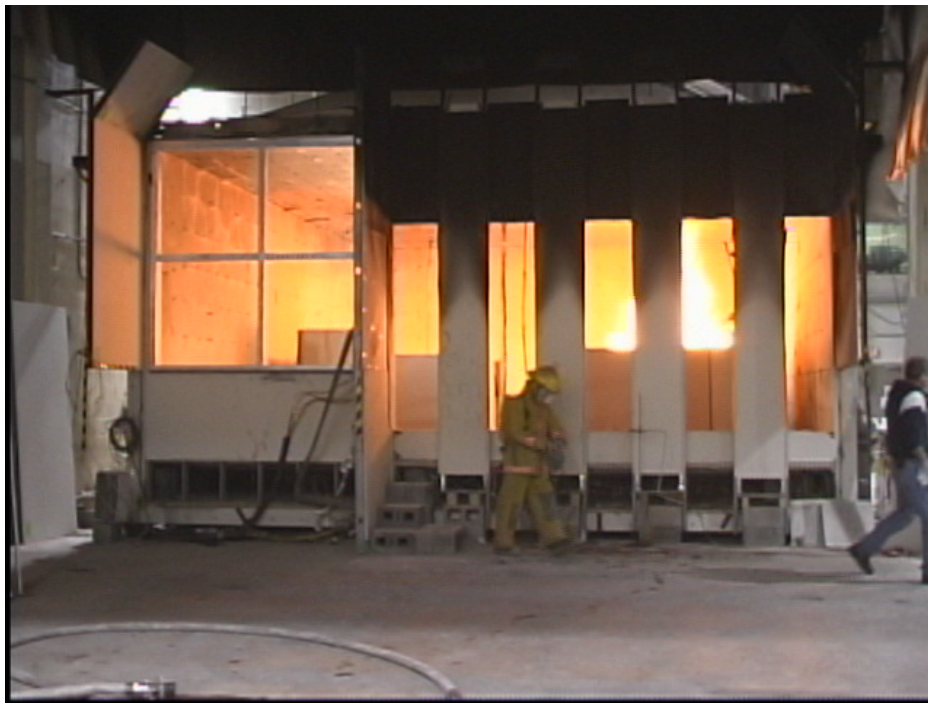
Figure 3–7. View external to the compartment 30 s before ignition of the spray burner in Test 6.

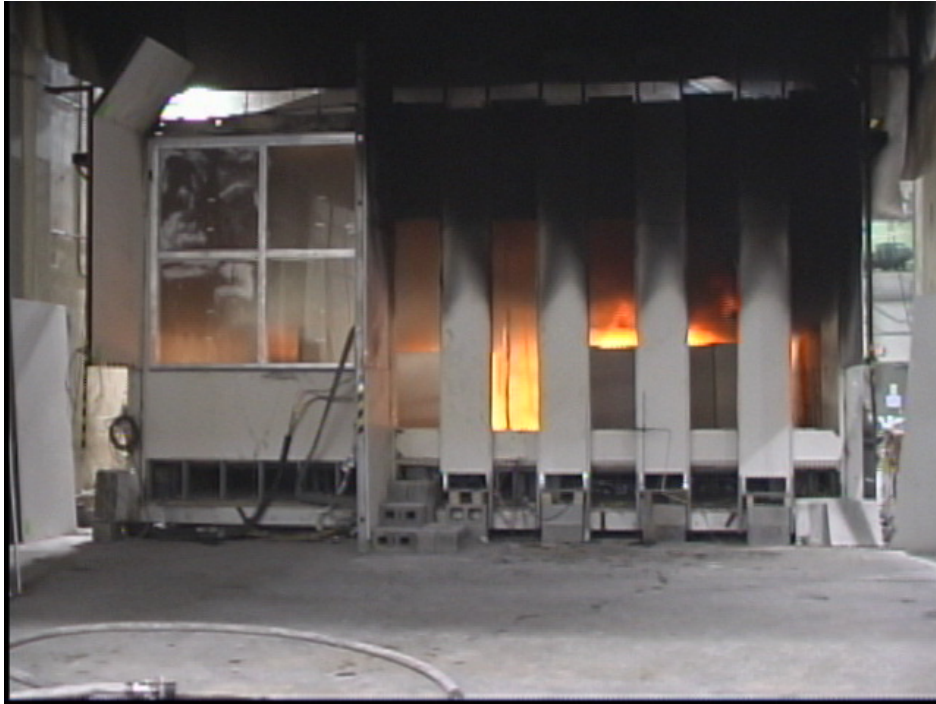
Figure 3–8. View external to the compartment 5 s before ignition of the spray burner in Test 6.

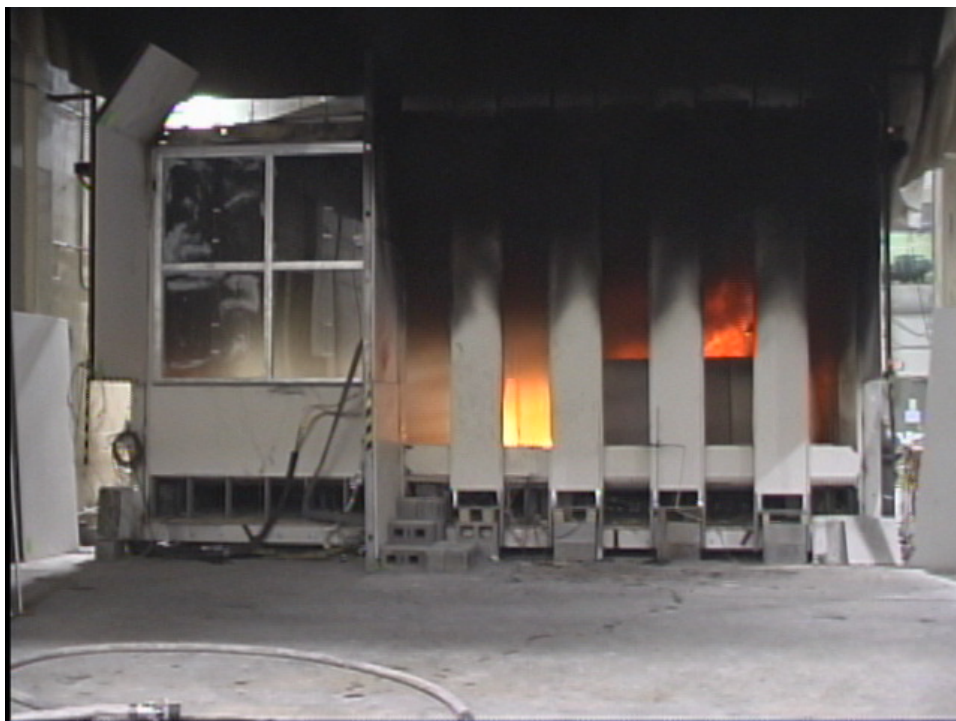
Figure 3–9. View external to the compartment 5 s after ignition of the spray burner in Test 6.

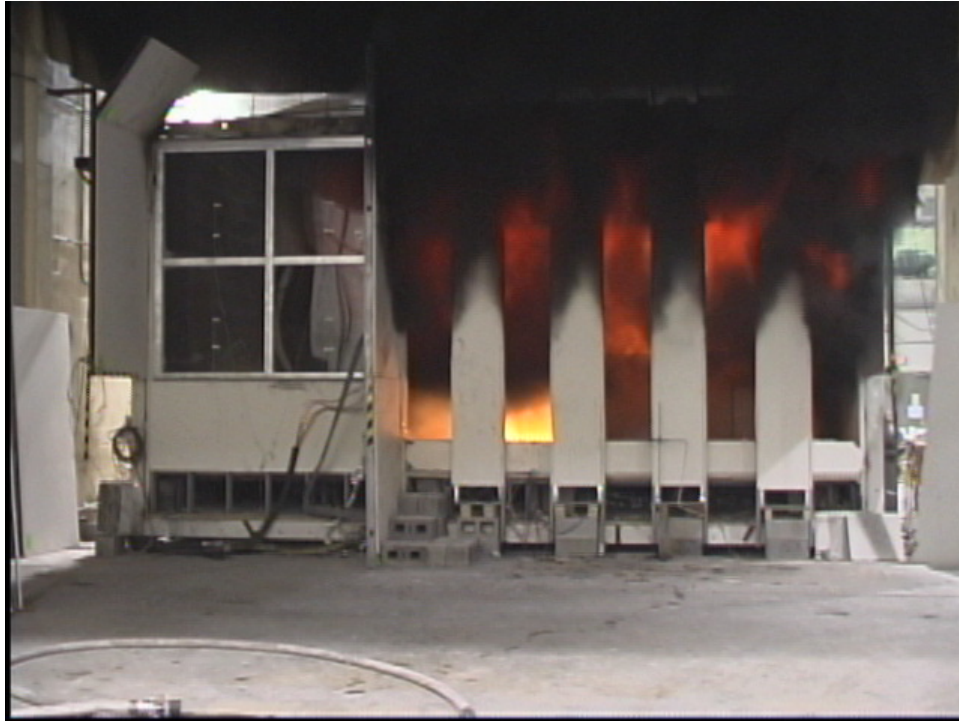
Figure 3–10. View external to the compartment 30 s after ignition of the spray burner in Test 6.

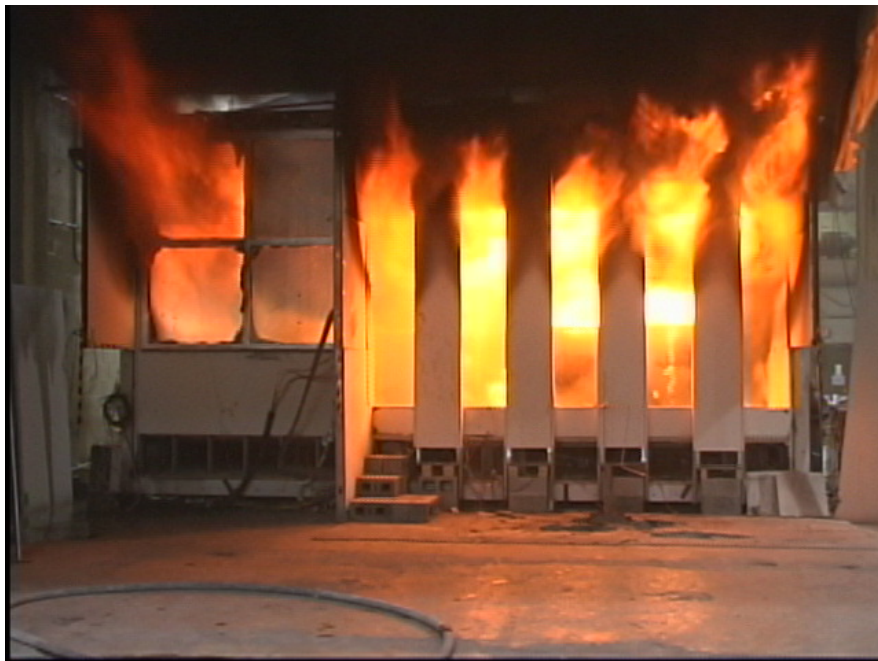
Figure 3–11. View external to the compartment 4 min 30 s after ignition of the spray burner in Test 6.

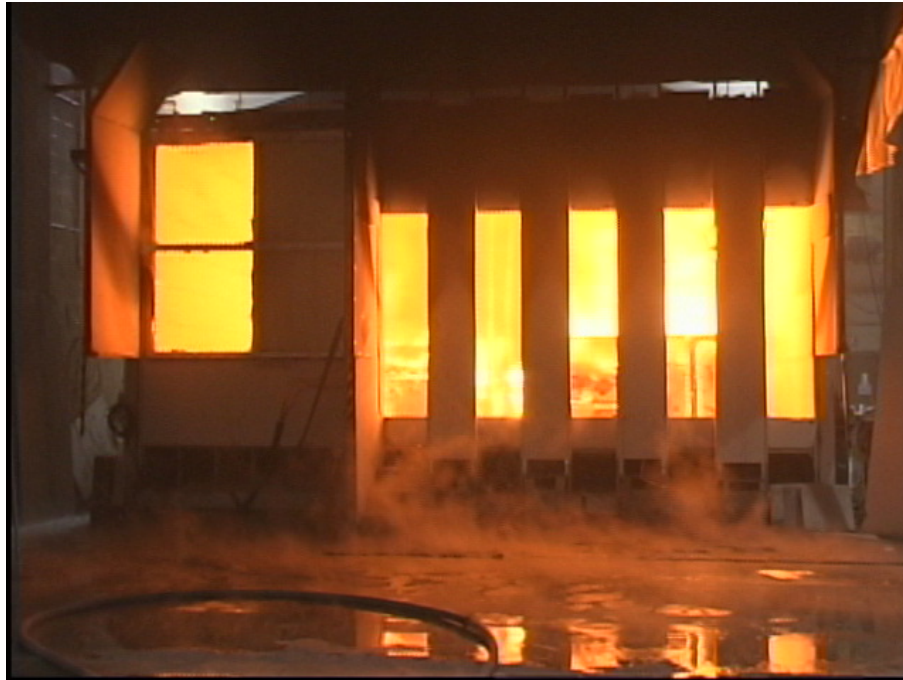
Figure 3–12. View external to the compartment 9 min 30 s after ignition of the spray burner in Test 6.

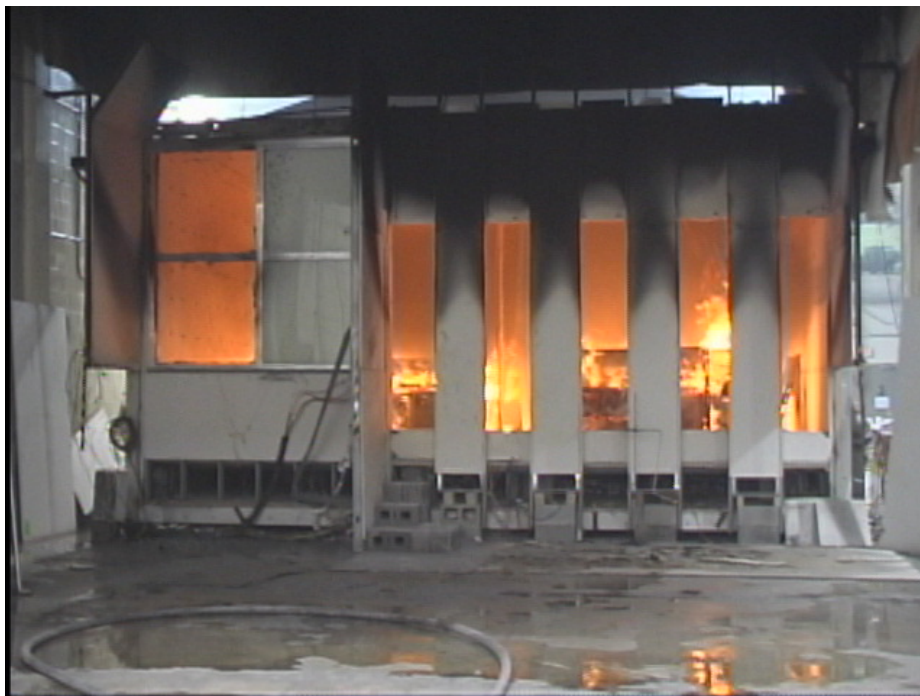
Figure 3–13. View external to the compartment 17 min after ignition of the spray burner in Test 6.

Figure 3–13 shows smoke markings due to deposits of soot-laden gases flowing from the compartment. The markings take the form of caret (“^” shaped black marks) on the outer columns that define the compartment “windows” or openings. Smoke deposits in the shape of straight lines on the wall adjacent to the glass windows was also observed (see Fig. 3–13). The same type of markings were observed in the WTC fires. Figure 3–15, for example, shows the caret-like markings near windows on the 95th and 96th floors of the south face of WTC 1.

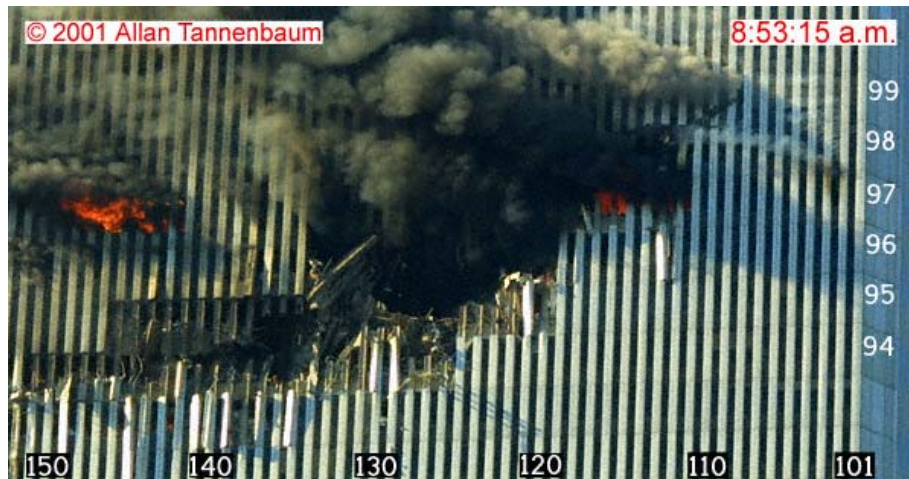
Figure 3–14. Photograph of the north face of WTC 1 recorded at 8:53:15 a.m. on September 11, 2001. Labels showing floor and column numbers were added to the original photograph.

Figure 3–14 reveals that at any one time, different locations on WTC 1 exhibited different smoke and flame yields as they were at different points in the burning process. Just a few minutes after the aircraft collision, the north face of WTC 1 (see Fig. 3–14) resembles early times during the experiments reported on here, when copious amounts of smoke (see Fig. 3–9) and flames (see Fig. 3–10) were emitted from the compartment. Almost an hour later, Fig. 3–15 shows that similar behavior was displayed on the south face of WTC 1. In this sense, the experiments conducted in this study recreated aspects of the WTC fires that can be thought of as typical of fires burning in compartments.

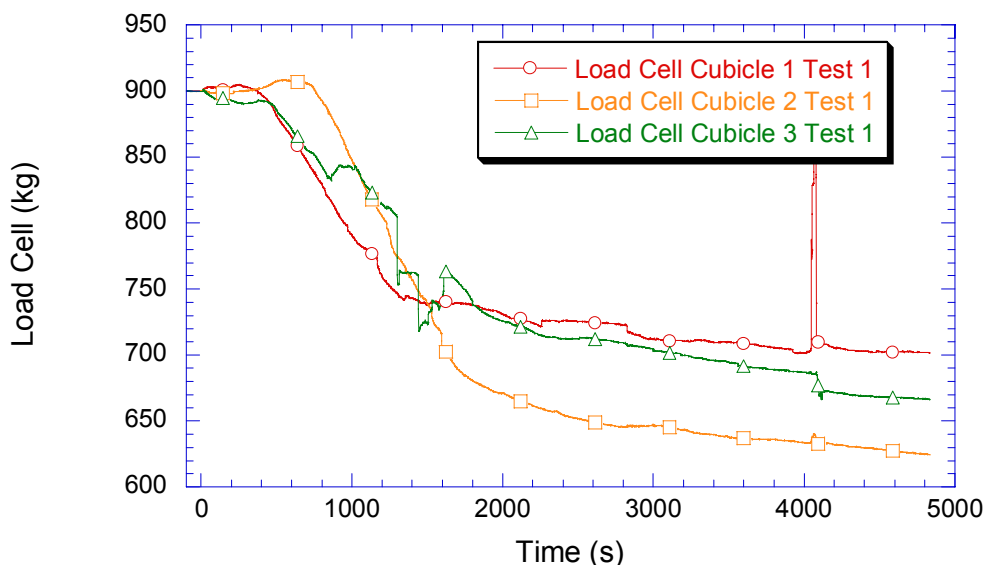
Figure 4–1. The mass of Workstations 1, 2, and 3 as a function of time during Test 1.

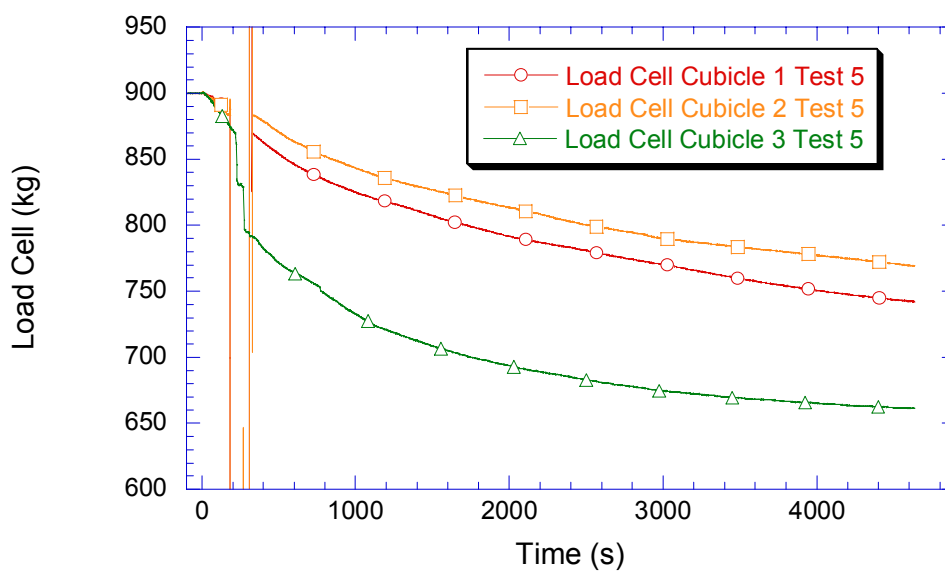
Figure 4–5. The mass of Workstations 1, 2, and 3 as a function of time during Test 5. The power to the load cells under Workstations 1 and 2 failed for 2.5 min at 180 s.

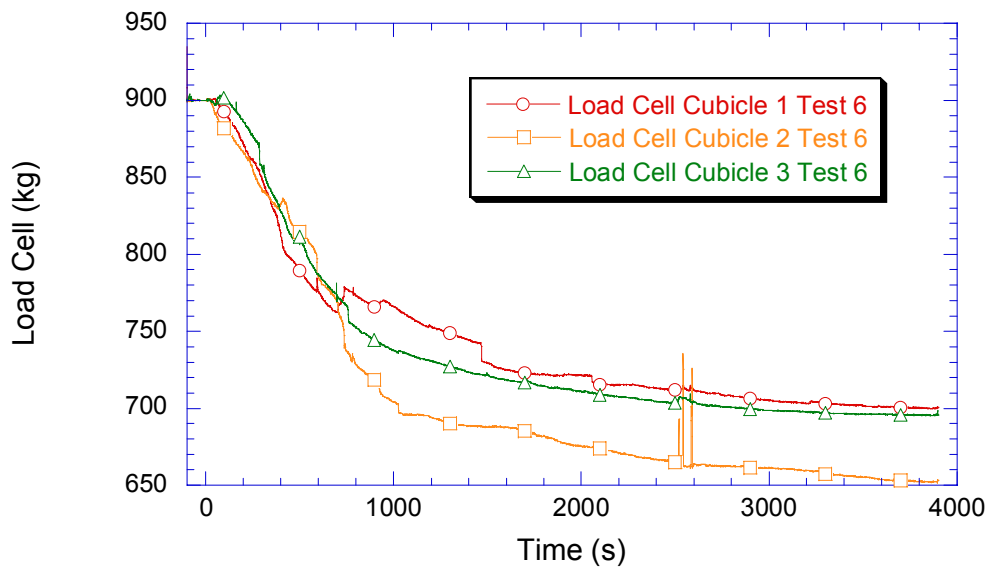
Figure 4–6. The mass of Workstations 1, 2, and 3 as a function of time during Test 6.

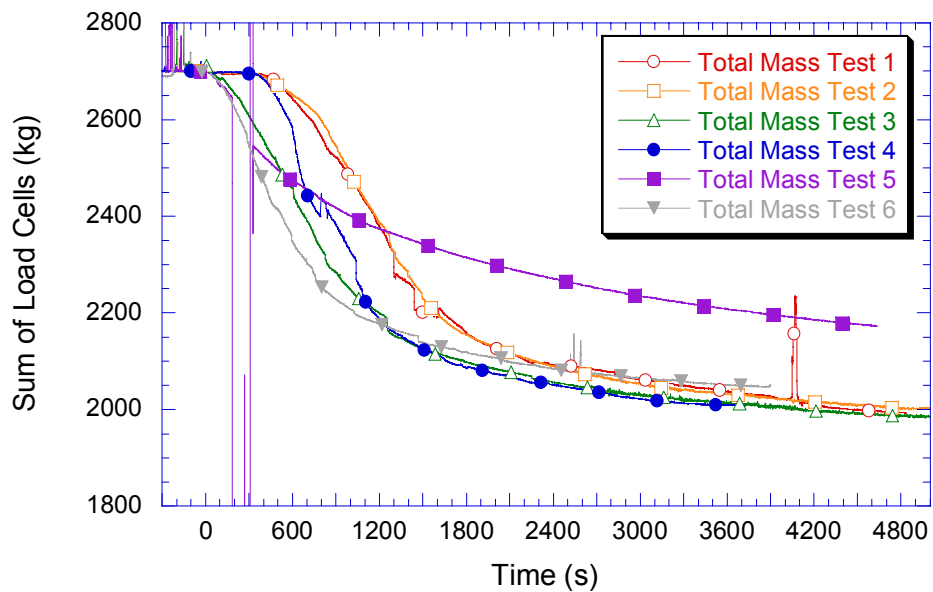
Figure 4–7. The sum of the mass of Workstations 1, 2, and 3 for Tests 1 through 6. The power to the load cells under Workstations 1 and 2 failed for 2 min at 180 s in Test 5.

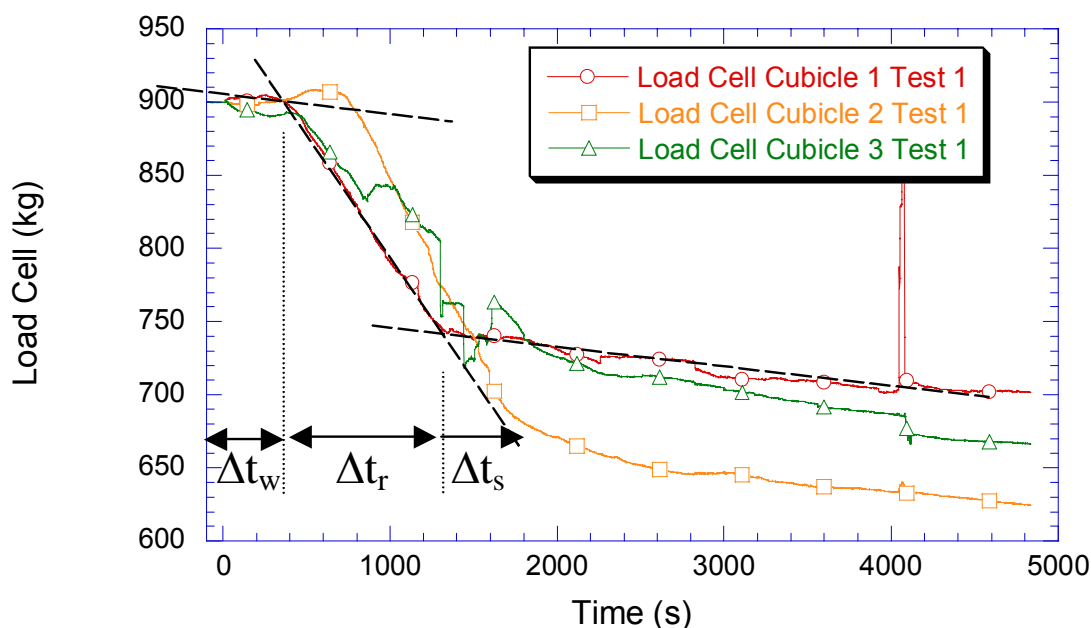
Figure 4–8. The mass of Workstations 1, 2, and 3 as a function of time during Test 1, showing straight line fits to each of the three burning periods for Workstation 1. The data is taken from Fig. 4–1.

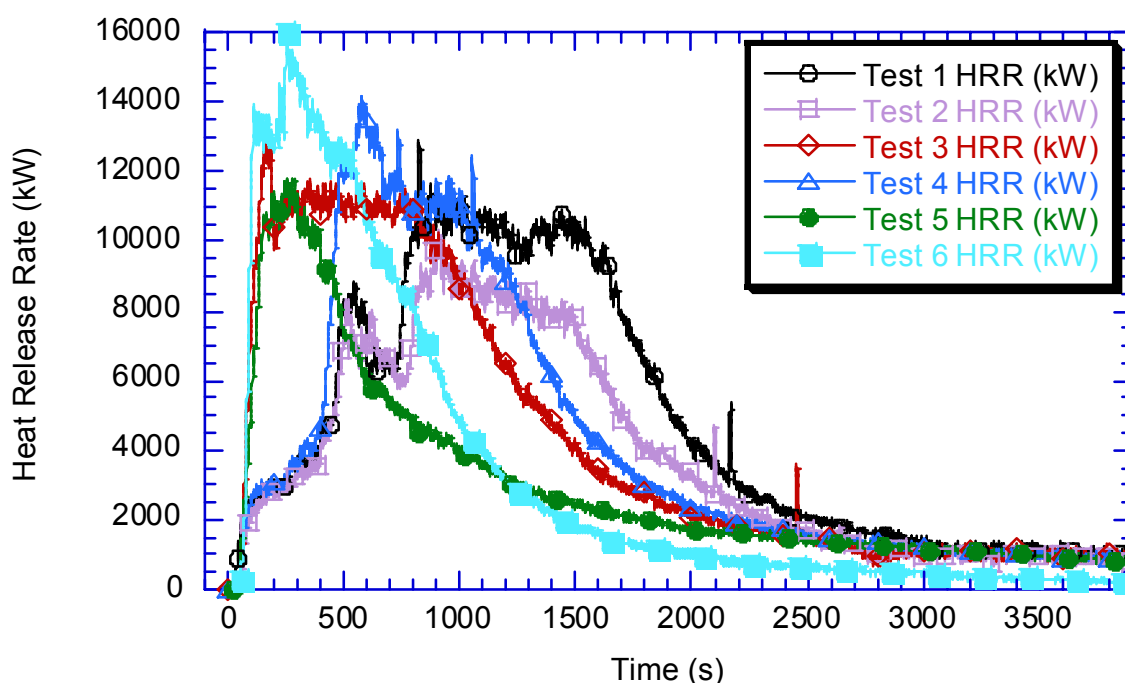
Figure 5–1. The heat release rate as a function of time for Tests 1 through 6.

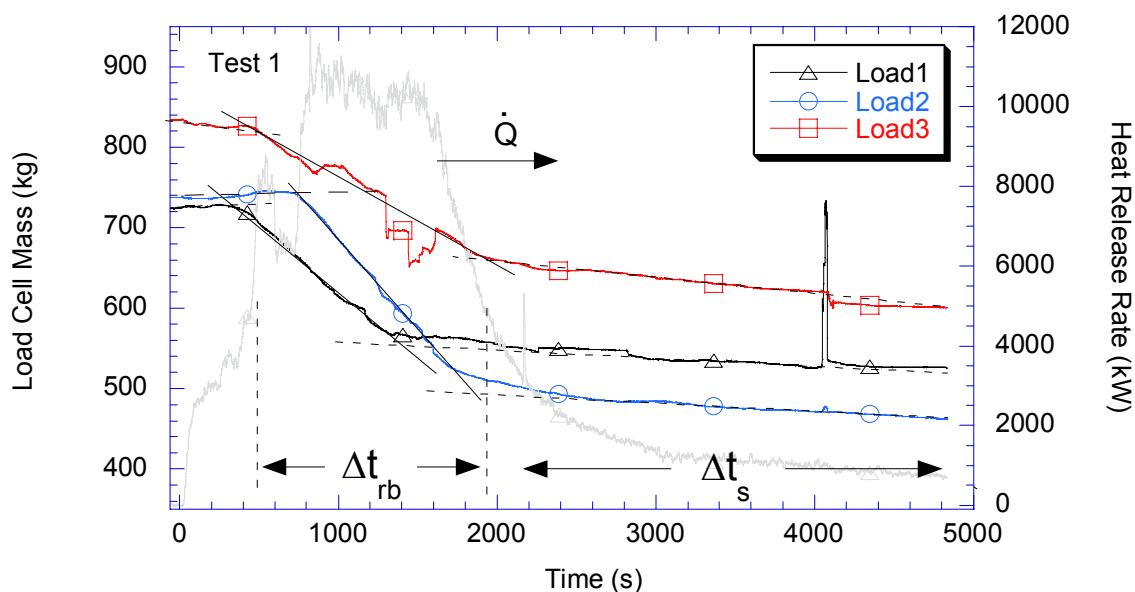
Figure 5–2. The load cell mass loss and the heat release rate (\dot{Q}) as a function of time during Test 1. The rapid burning (Δt_{rb}) and slow burning (Δt_s) periods are indicated.

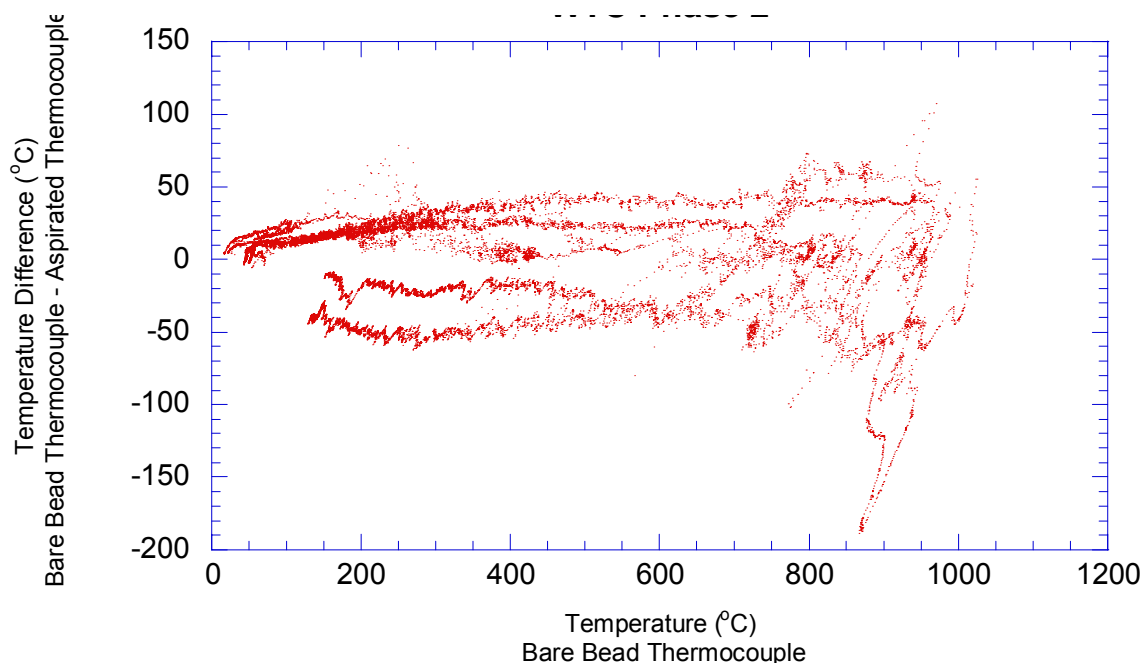
Figure 6–5. The difference between the bare bead and the aspirated thermocouple measurements as a function of the bare bead temperature for the data presented in Figs. 6–1 through 6–4.

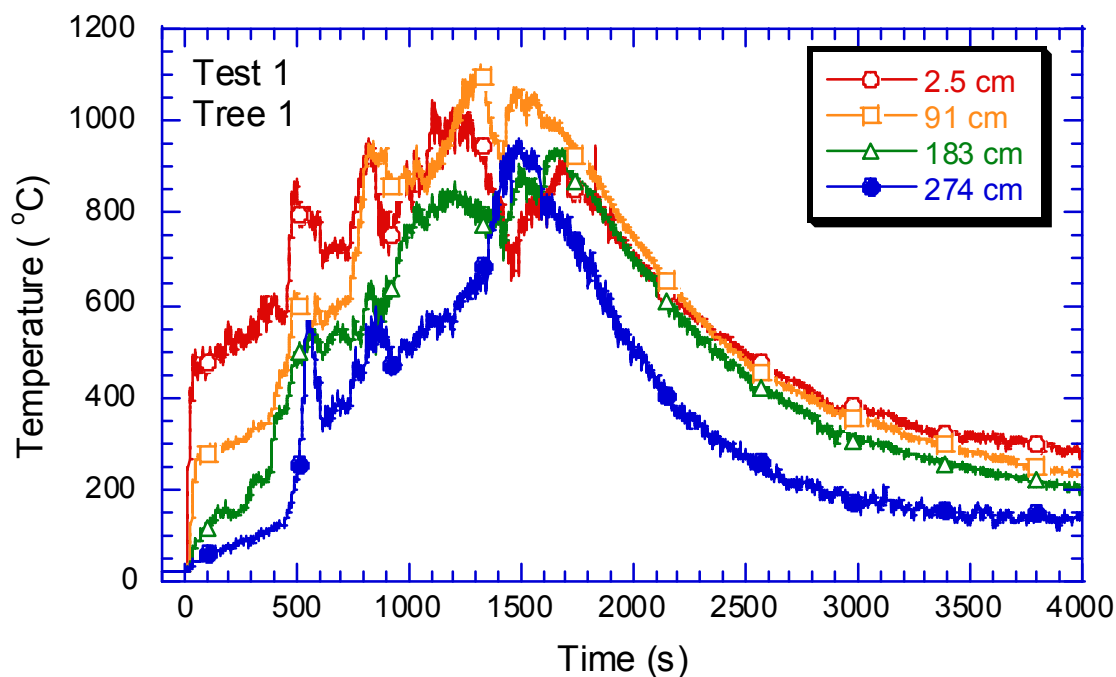
Figure 6–6. Bare bead thermocouple measurements as a function of time at four locations (below the ceiling) on Tree 1 during Test 1.

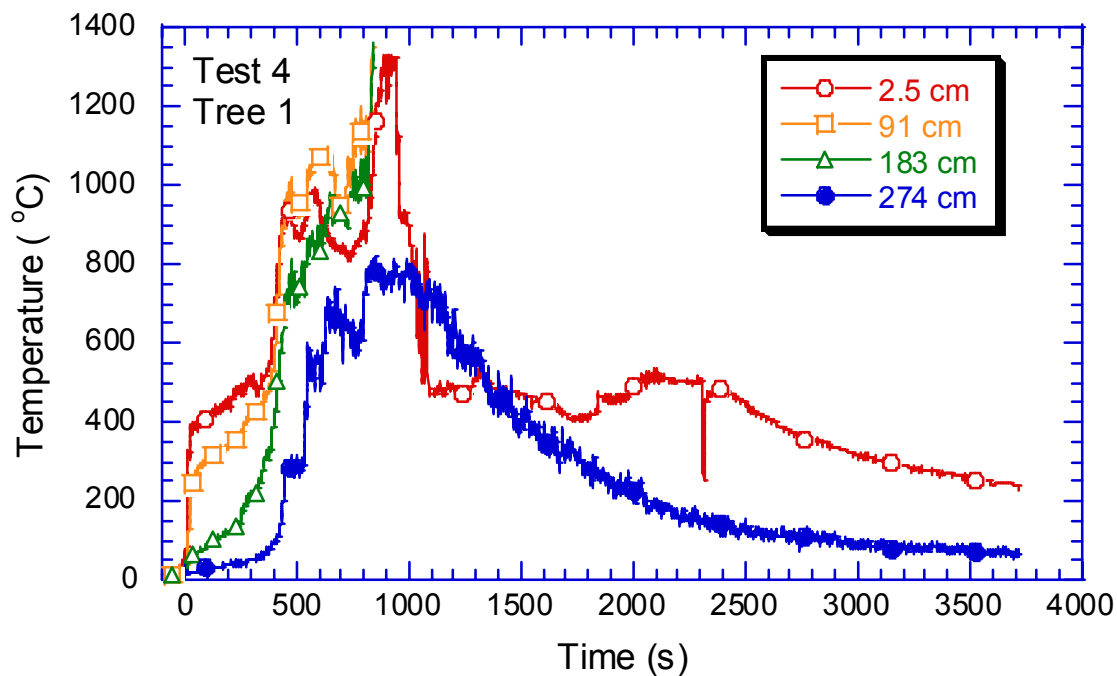
Figure 6-9. Bare bead thermocouple measurements as a function of time at four locations (below the ceiling) on Tree 1 during Test 4.

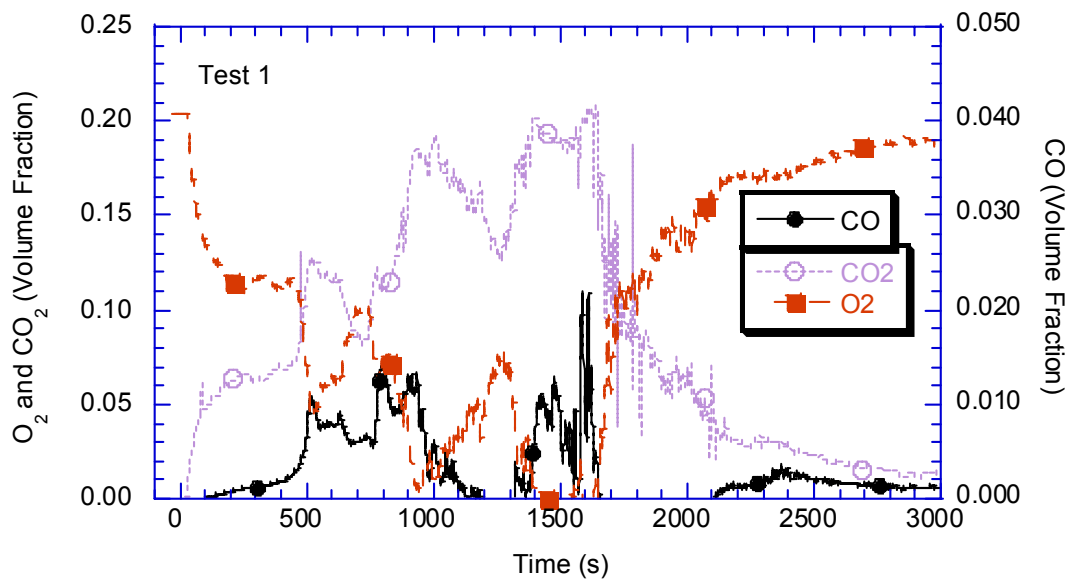
Figure 7–1. The volume fractions of O_2 , CO , and CO_2 on a dry basis as a function of time during Test 1.
