NIST NCSTAR 1-5E

**Federal Building and Fire Safety Investigation of the
World Trade Center Disaster**

**Experiments and Modeling of
Multiple Workstations Burning in a
Compartment**

September 2005

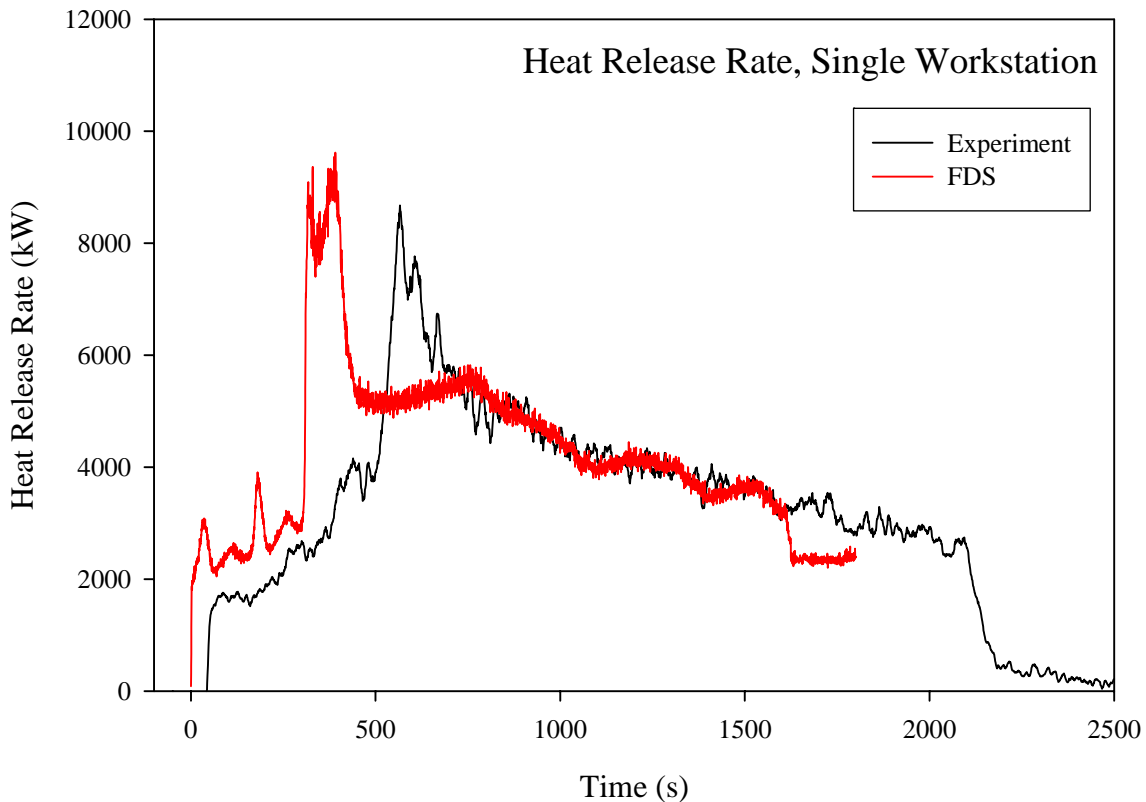
Figure 8–1. Comparison of the measured and simulated \dot{Q} for a single workstation.

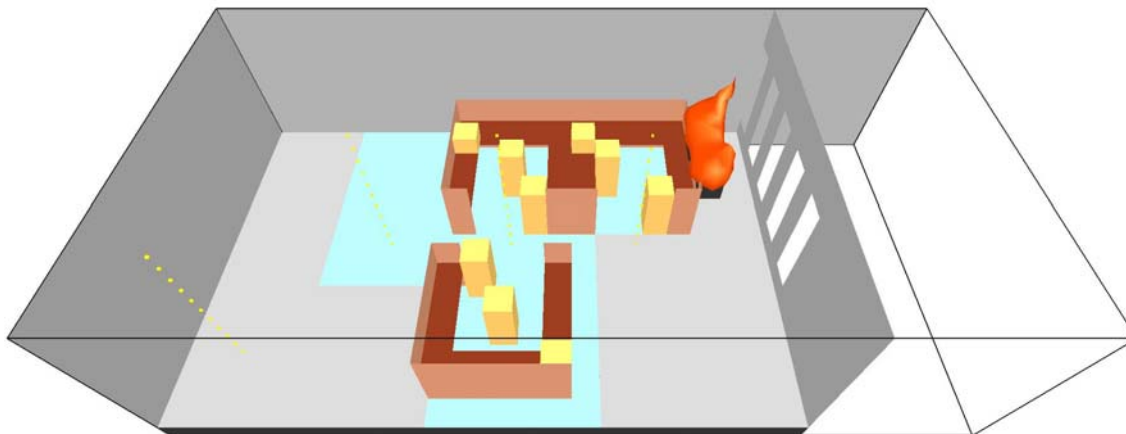
Figure 8–2. Geometry of the simulations.

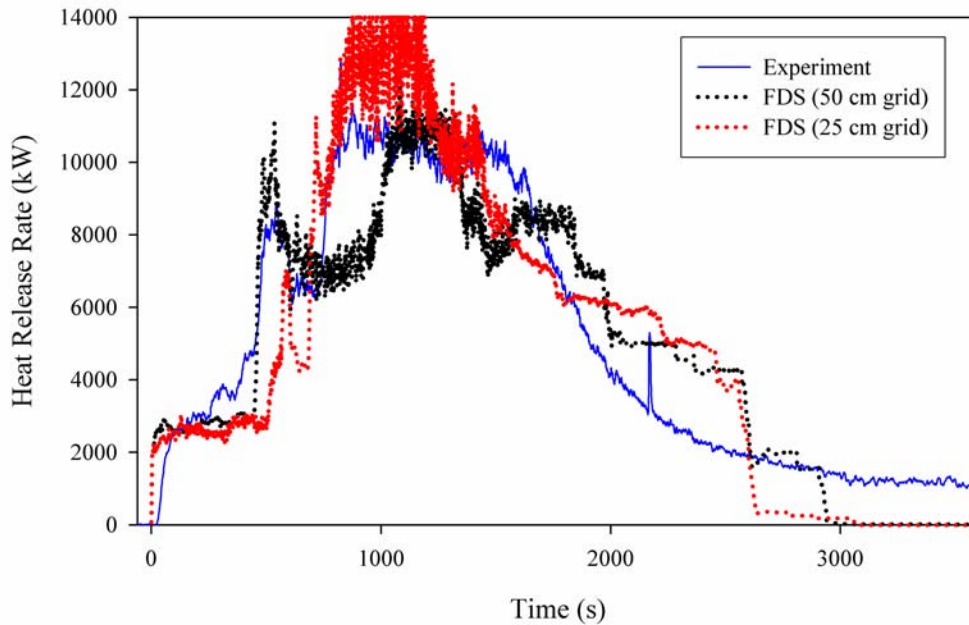
Figure 8–3. Comparison of the measured \dot{Q} with the simulated \dot{Q} using two grids sizes for Test 1.

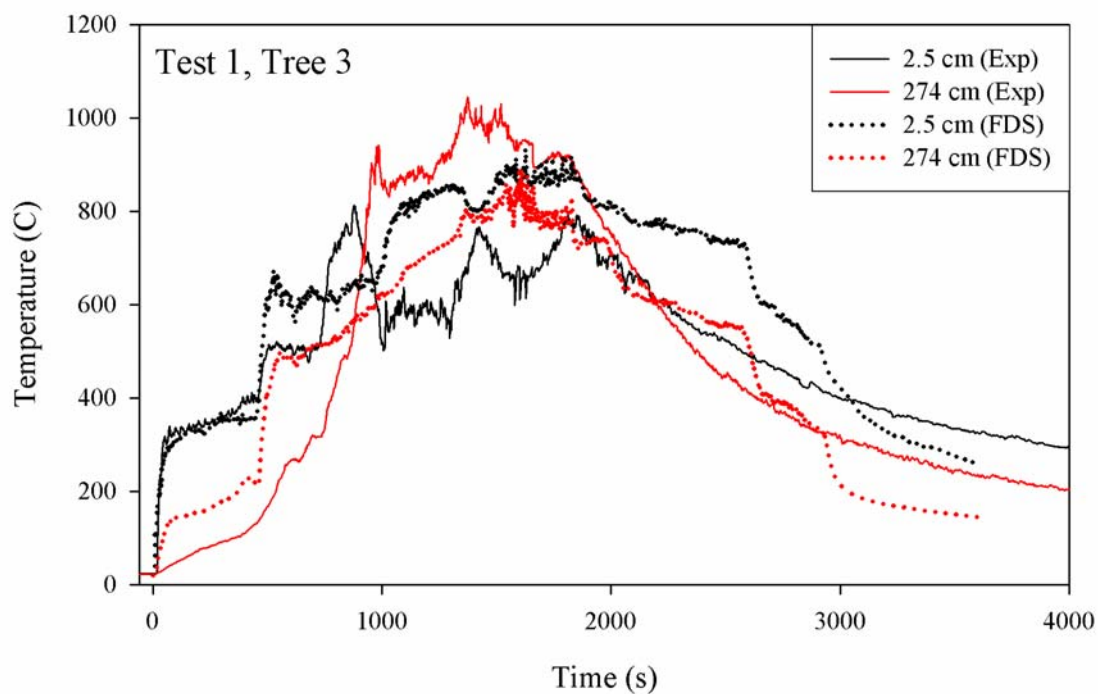
Figure 8–5. Comparison of the measured and simulated temperatures at 2.5 cm and 274 cm below the ceiling on Tree 3 (middle of the compartment) during Test 1.

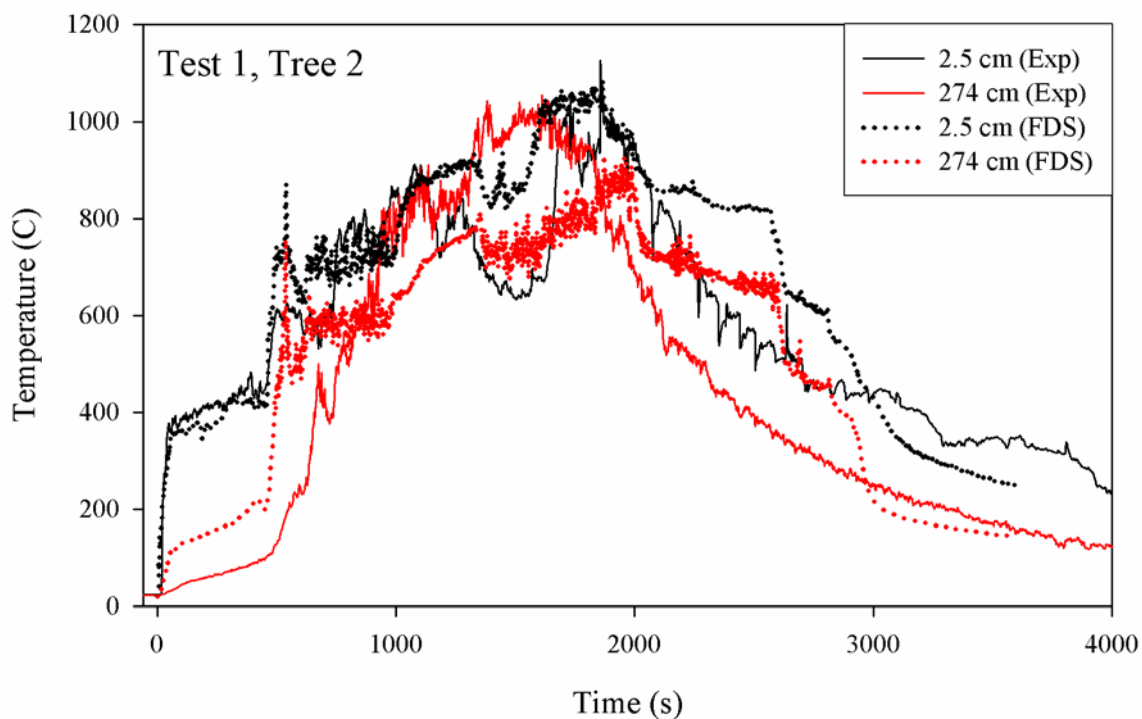
Figure 8–6. Comparison of the measured and simulated temperatures at 2.5 cm and 274 cm below the ceiling on Tree 2 (middle of the compartment) during Test 1.

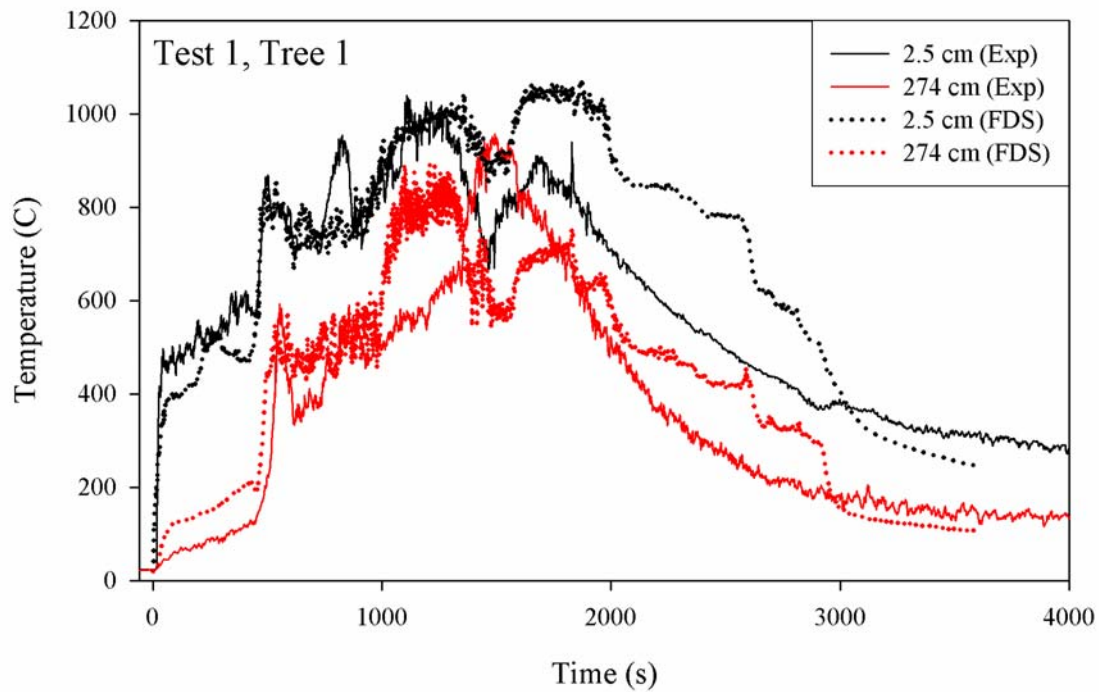
Figure 8-7. Comparison of the measured and simulated temperatures at 2.5 cm and 274 cm below the ceiling on Tree 1 (front of the compartment) during Test 1.

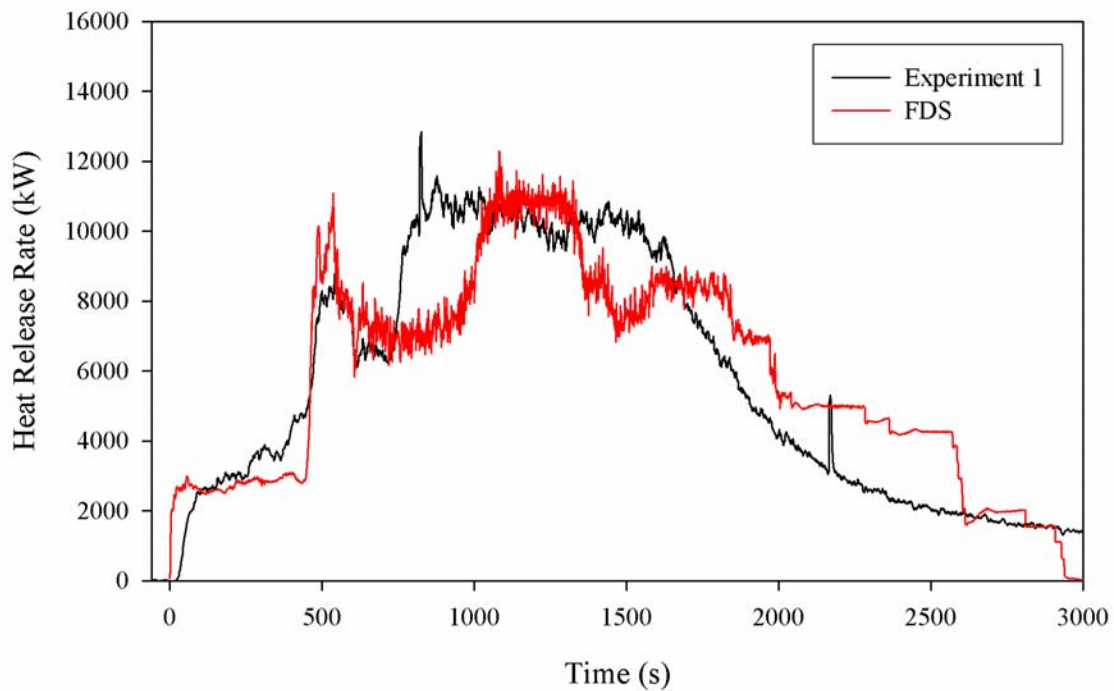
Figure 8-8. Comparison of the measured and simulated \dot{Q} for Test 1.

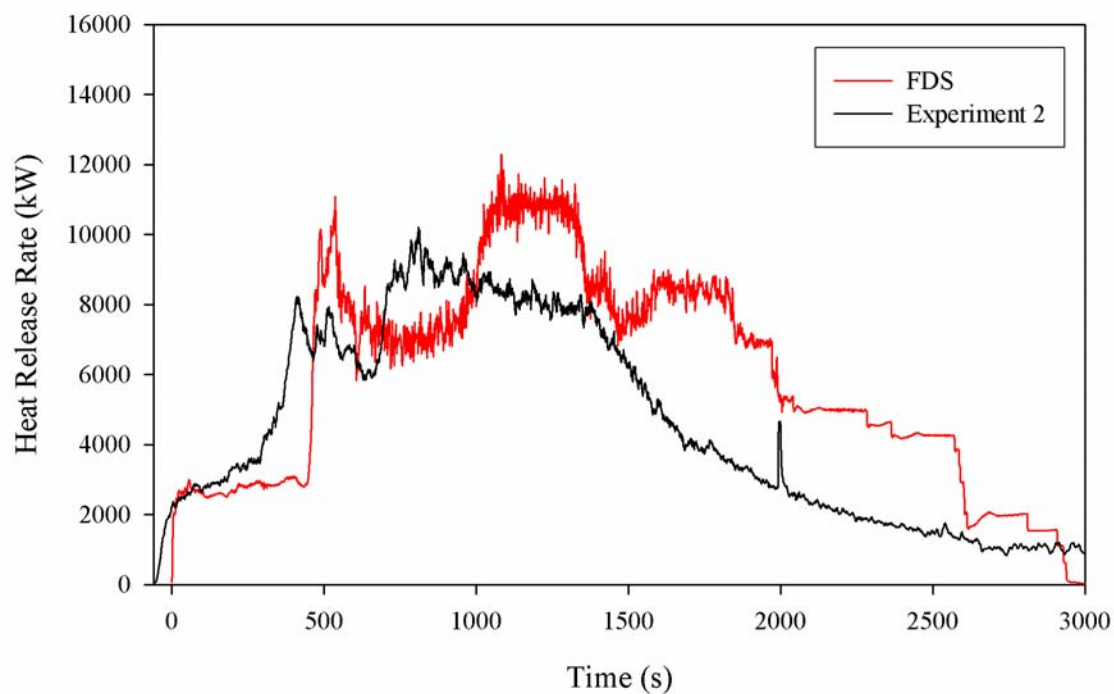
Figure 8–9. Comparison of the measured and simulated \dot{Q} for Test 2.

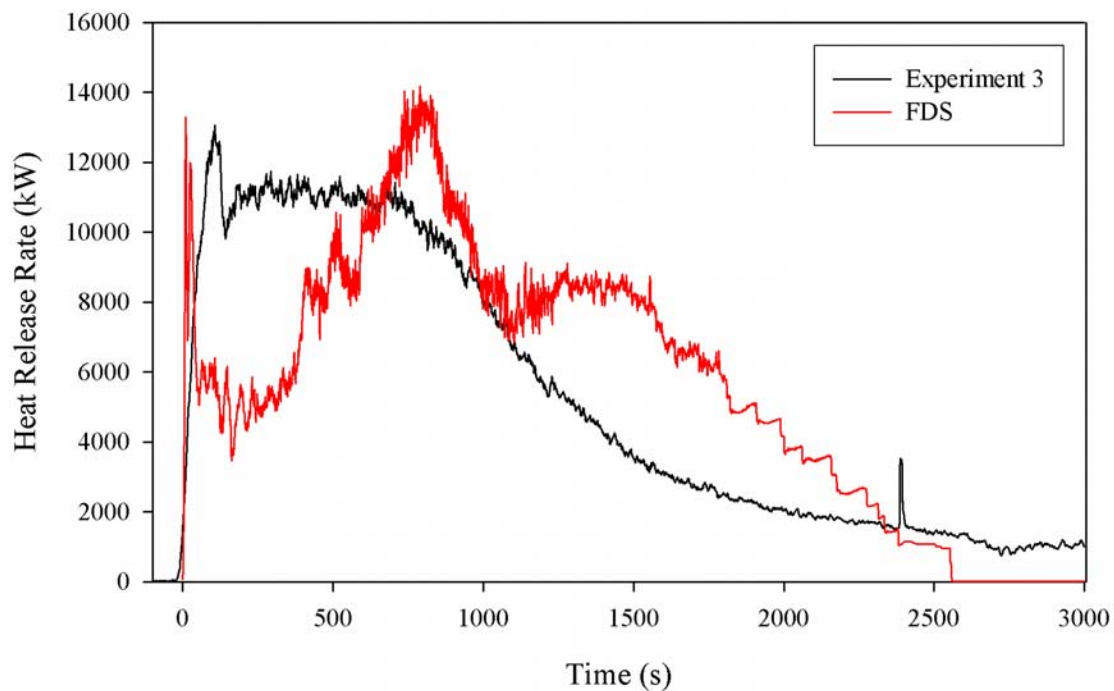
Figure 8–10. Comparison of the measured and simulated \dot{Q} for Test 3.

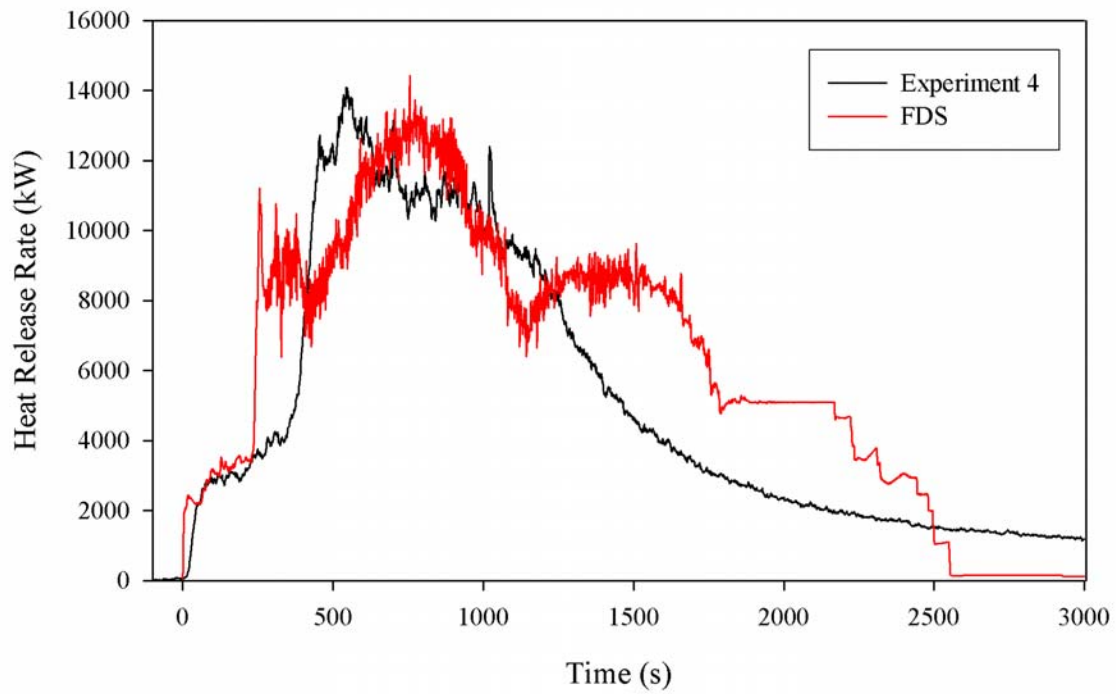
Figure 8–11. Comparison of the measured and simulated \dot{Q} for Test 4.

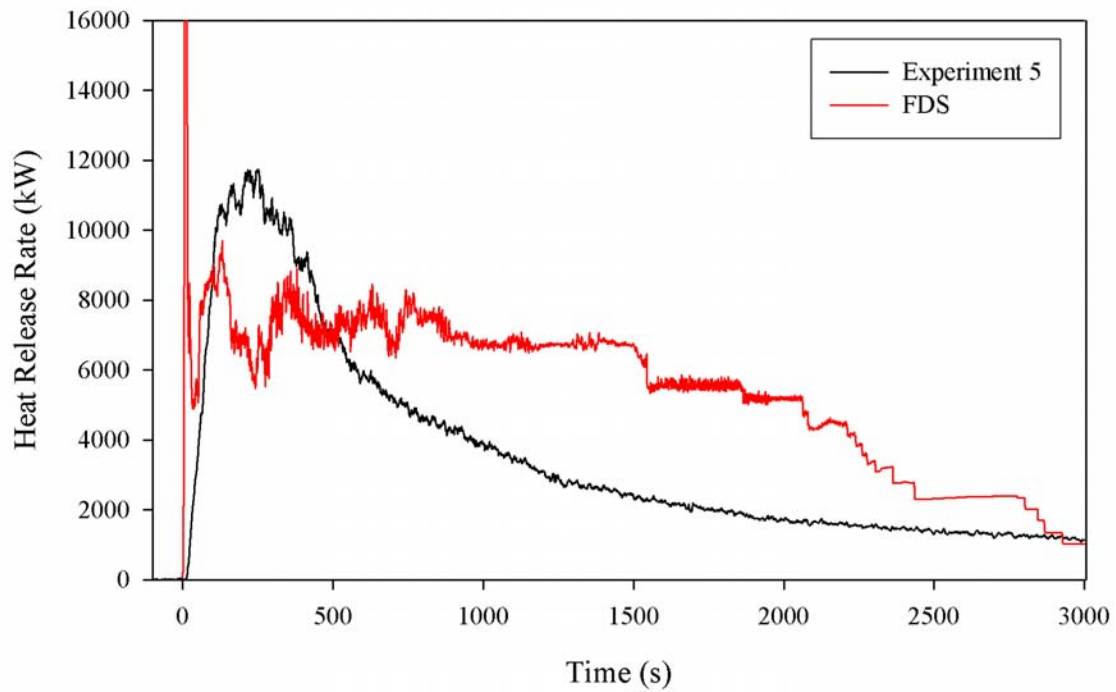
Figure 8–12. Comparison of the measured and simulated \dot{Q} for Test 5.

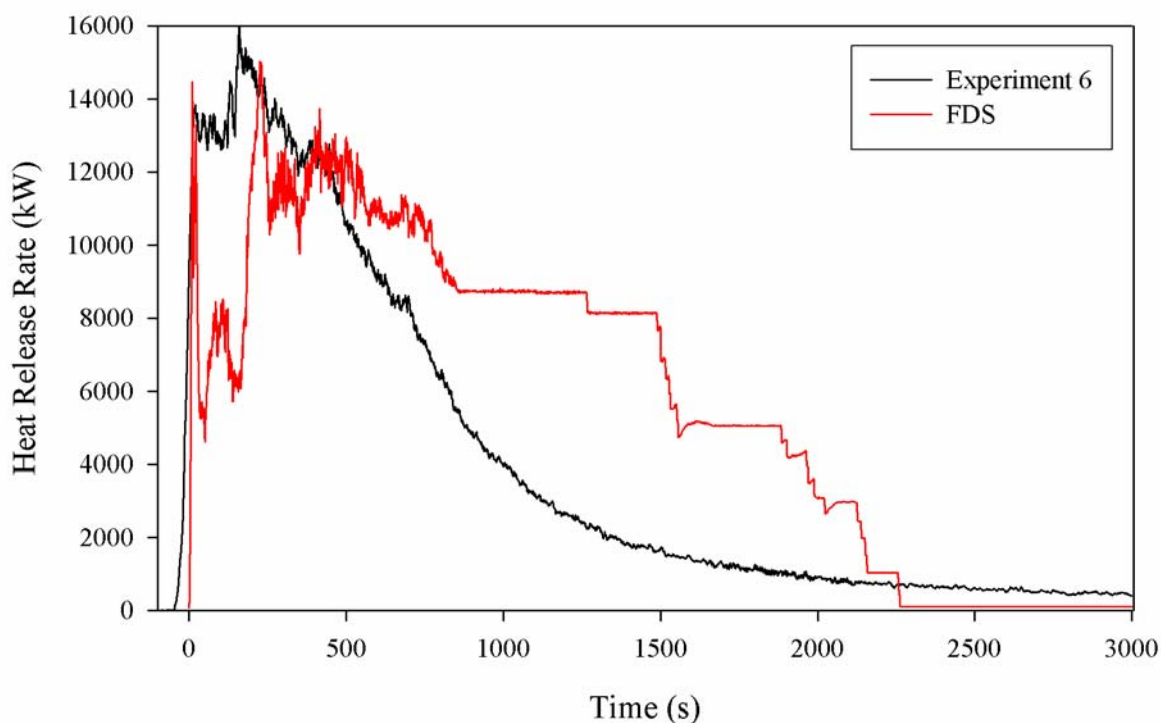
Figure 8–13. Comparison of the measured and simulated \dot{Q} for Test 6.

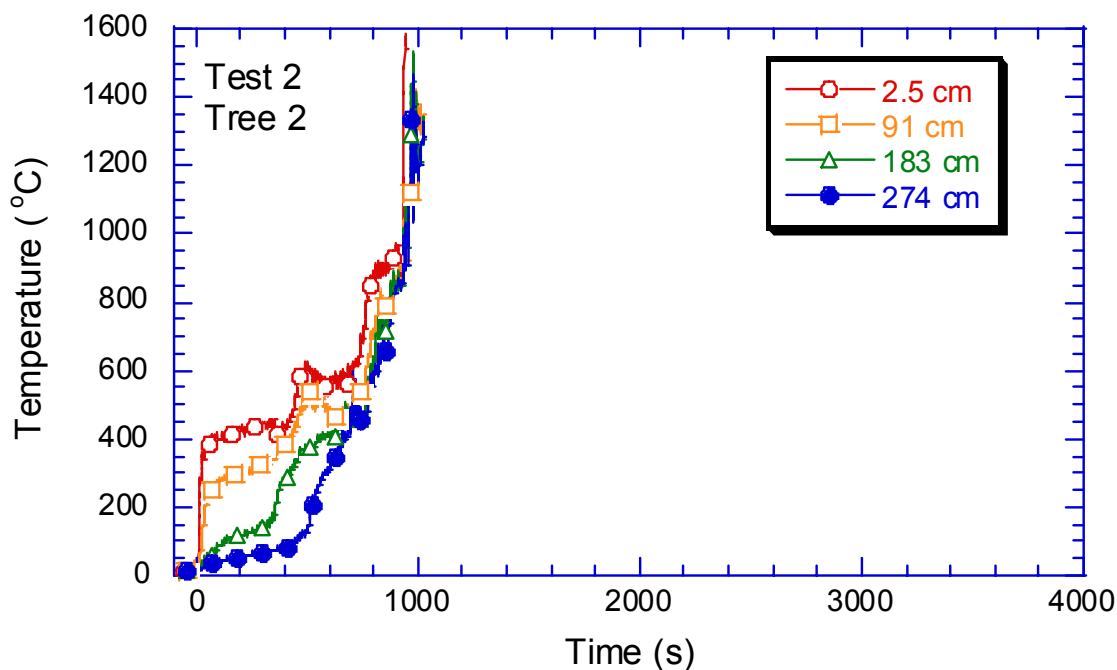
Figure C-2. Bare bead thermocouple measurements as a function of time at four locations (below the ceiling) on Tree 2 during Test 2. After approximately 1,000 s, the thermocouples failed in this test.

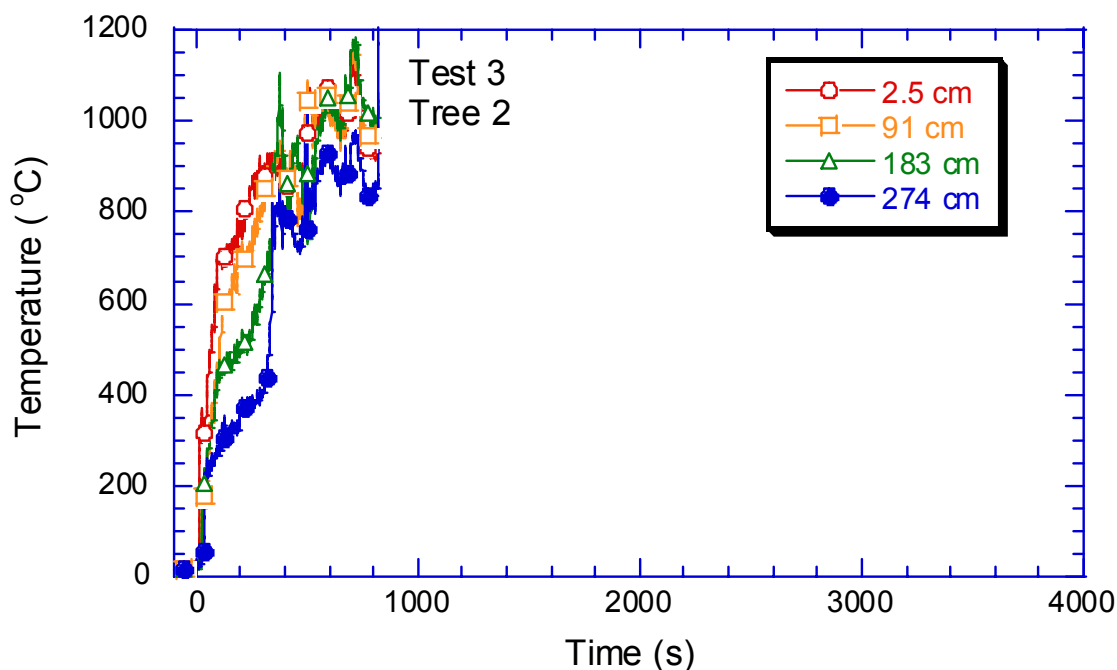
Figure C-3. Bare bead thermocouple measurements as a function of time at four locations (below the ceiling) on Tree 2 during Test 3. After approximately 800 s, the thermocouples failed in this test.

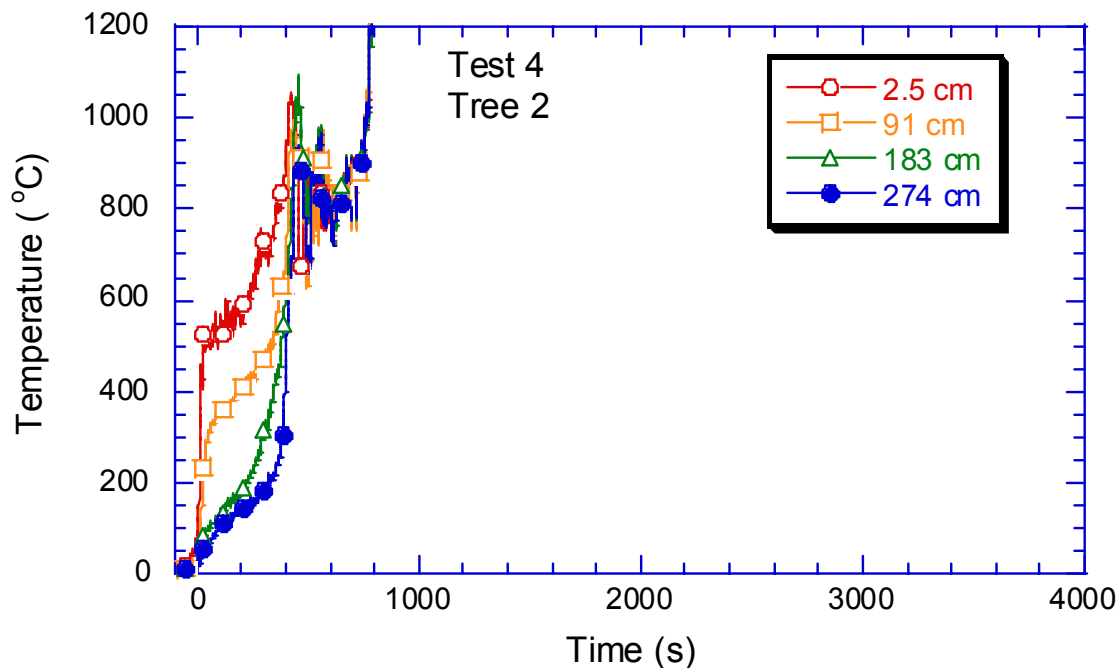
Figure C-4. Bare bead thermocouple measurements as a function of time at four locations (below the ceiling) on Tree 2 during Test 4. After approximately 750 s, the thermocouples failed in this test.

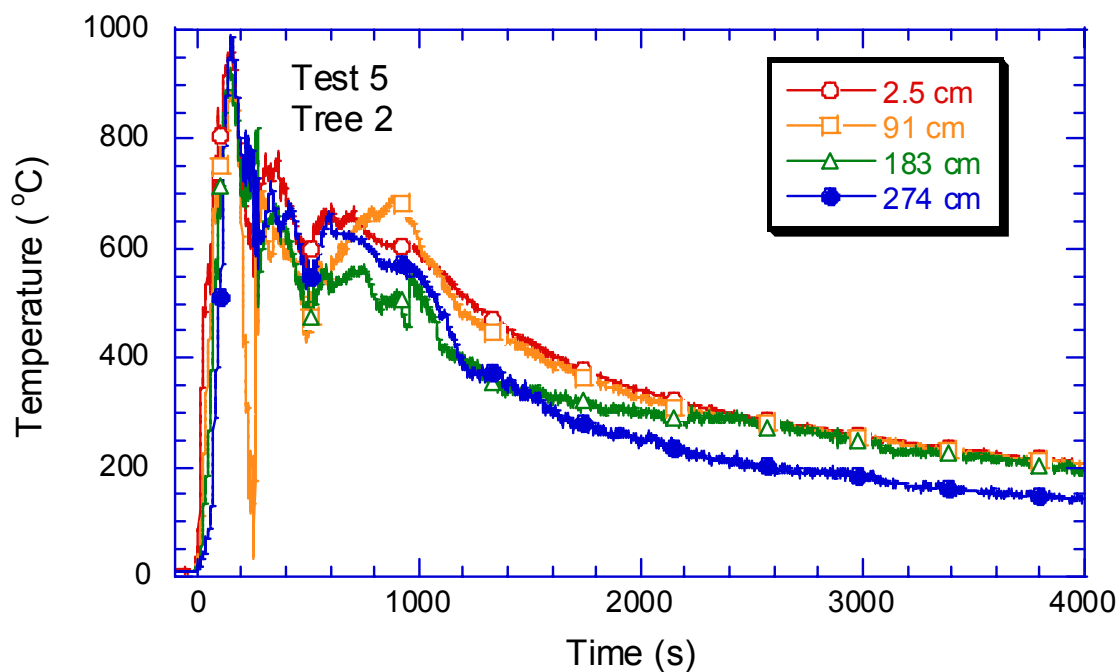
Figure C-5. Bare bead thermocouple measurements as a function of time at four locations (below the ceiling) on Tree 2 during Test 5.

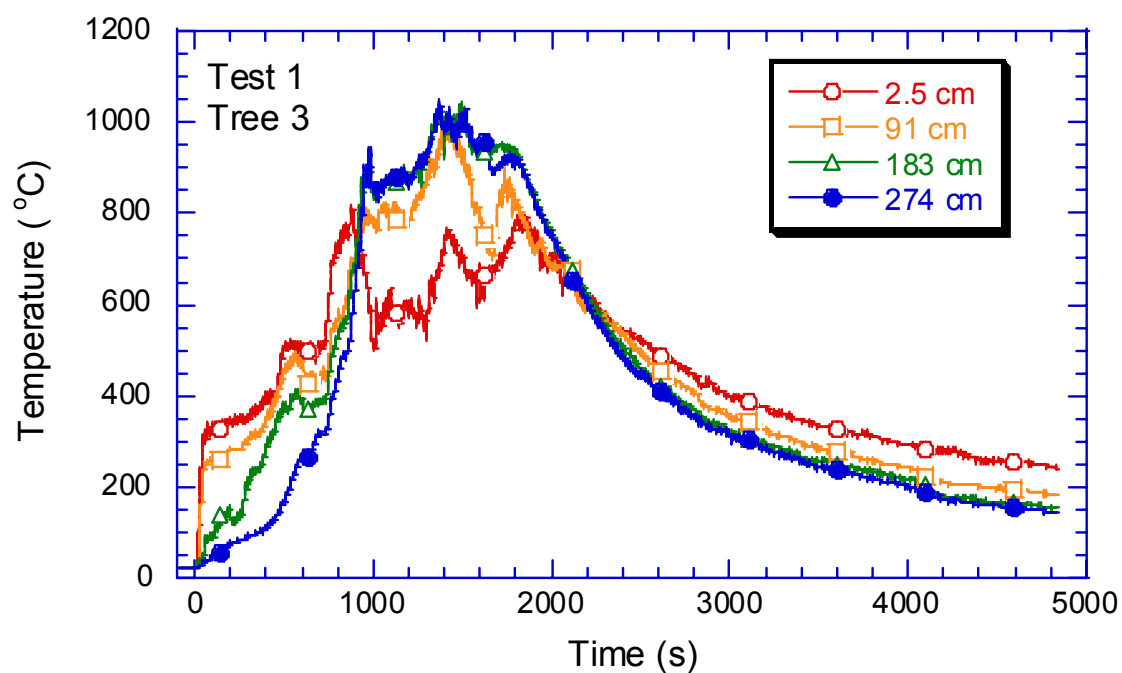
Figure C-7. Bare bead thermocouple measurements as a function of time at four locations (below the ceiling) on Tree 3 during Test 1.

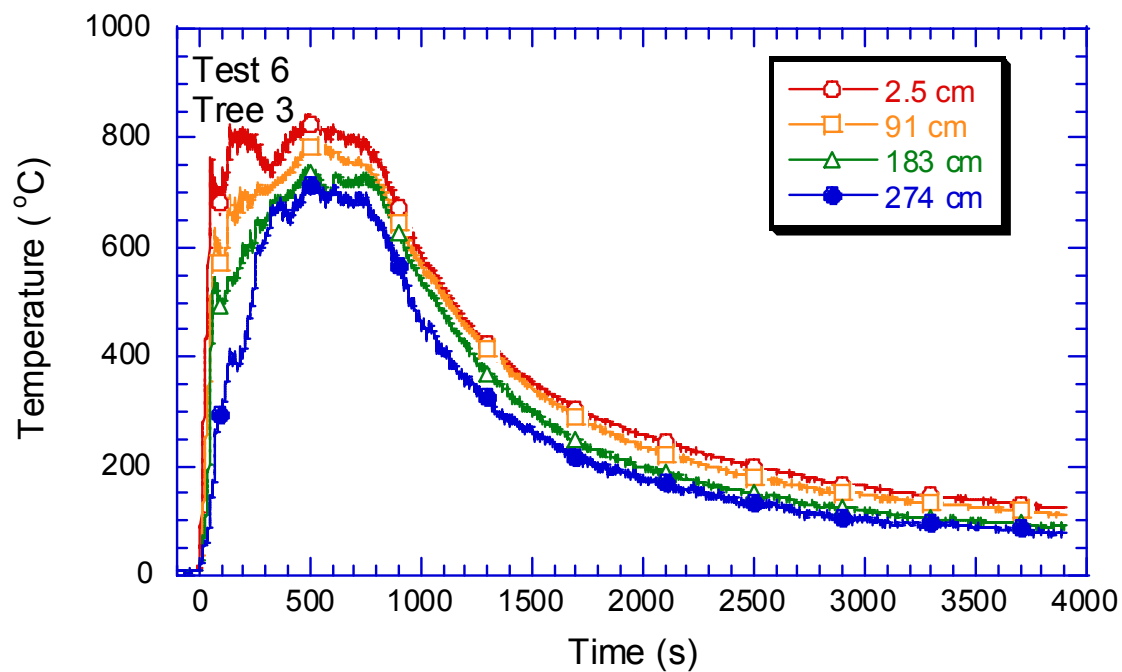
Figure C-12. Bare bead thermocouple measurements as a function of time at four locations (below the ceiling) on Tree 3 during Test 6.

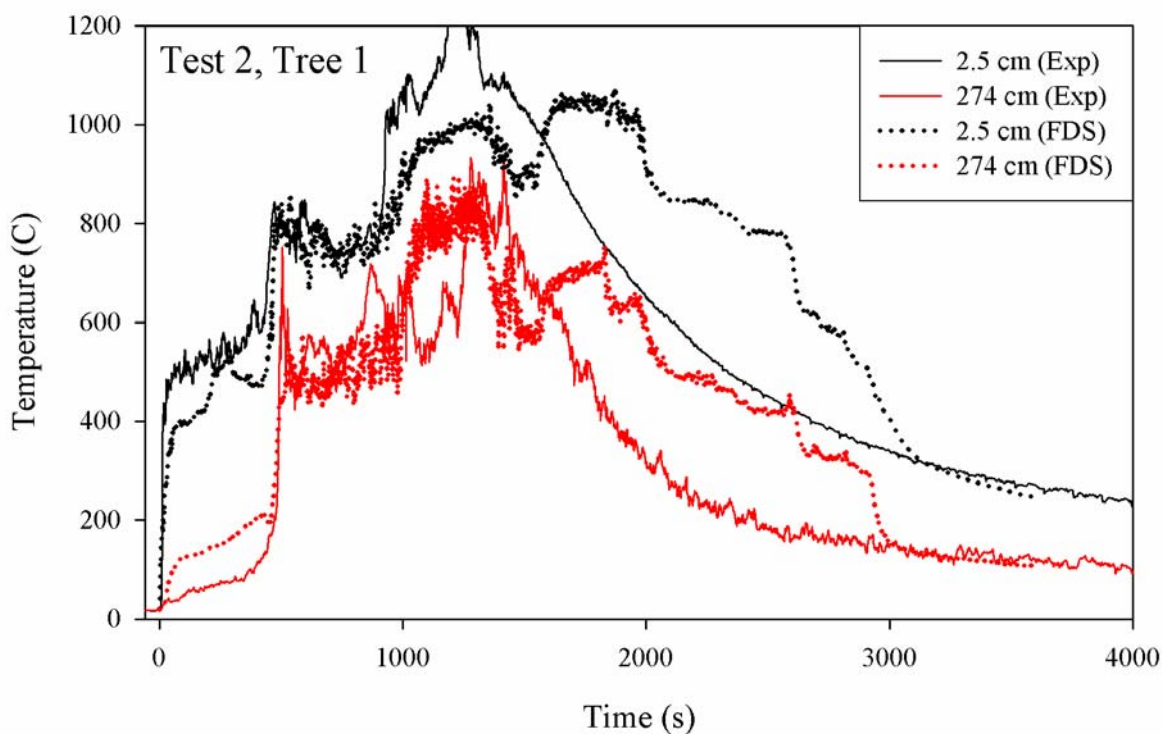
Figure D-1. Comparison of the measured and simulated temperatures at 2.5 cm and 274 cm below the ceiling on Tree 1 (rear of the compartment) during Test 2.

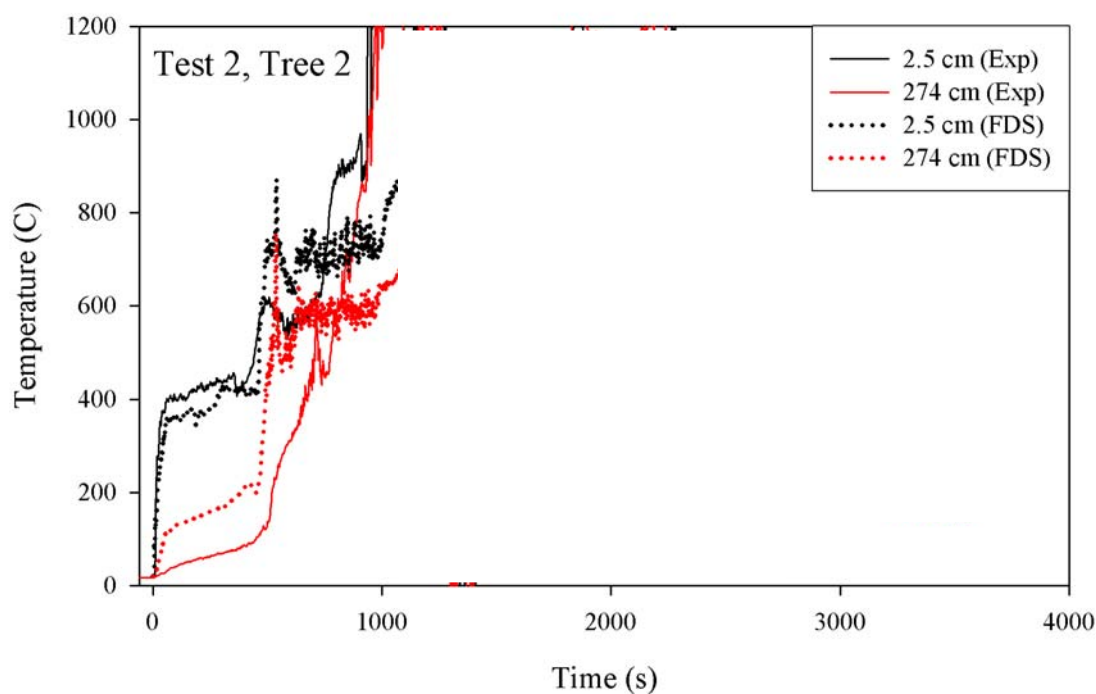
Figure D-2. Comparison of the measured and simulated temperatures at 2.5 cm and 274 cm below the ceiling on Tree 2 (middle of the compartment) during Test 2. After approximately 1,000 s, the thermocouples failed.

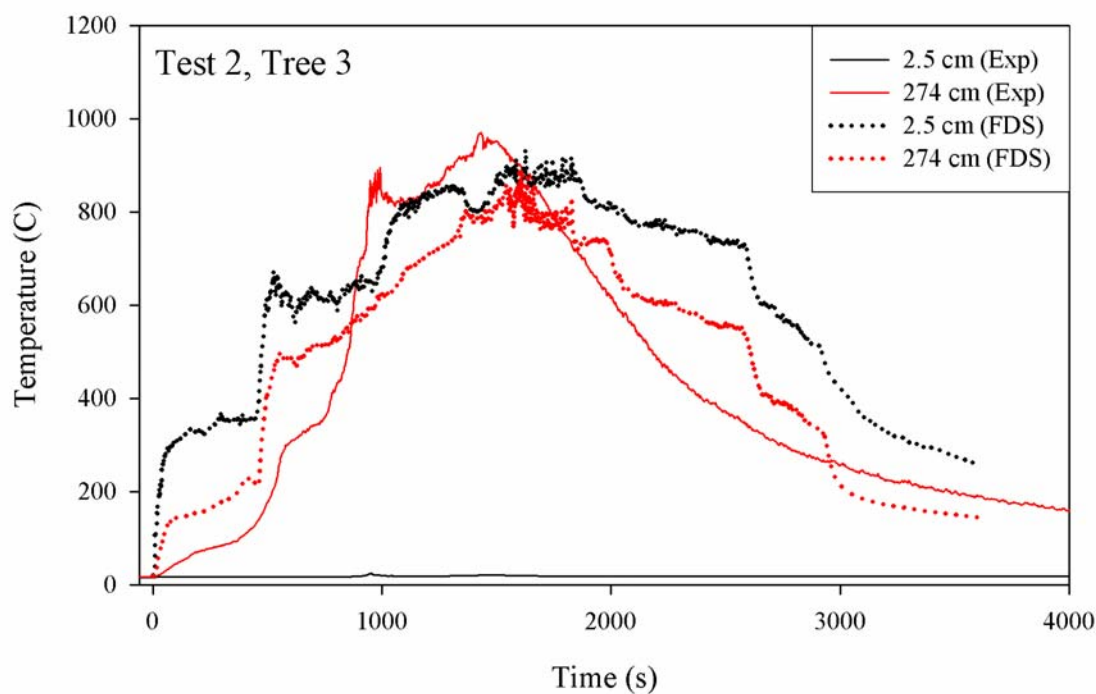
Figure D-3. Comparison of the measured and simulated temperatures at 2.5 cm and 274 cm below the ceiling on Tree 3 (middle of the compartment) during Test 2.

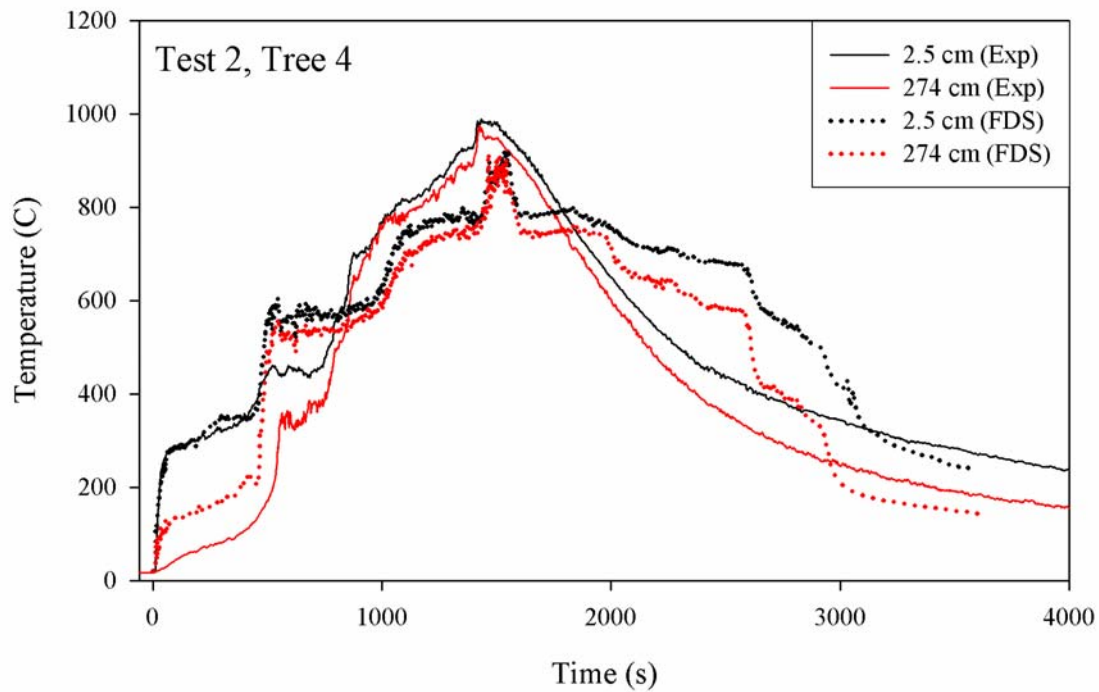
Figure D-4. Comparison of the measured and simulated temperatures at 2.5 cm and 274 cm below the ceiling on Tree 4 (rear of the compartment) during Test 2.

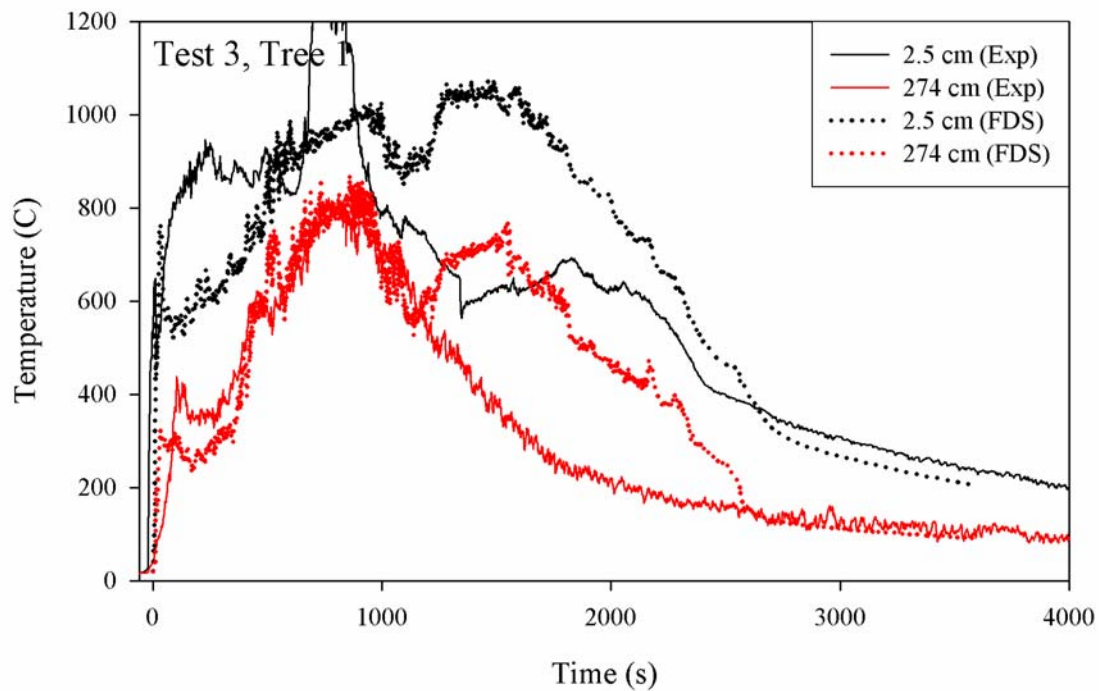
Figure D-5. Comparison of the measured and simulated temperatures at 2.5 cm and 274 cm below the ceiling on Tree 1 (front of the compartment) during Test 3.

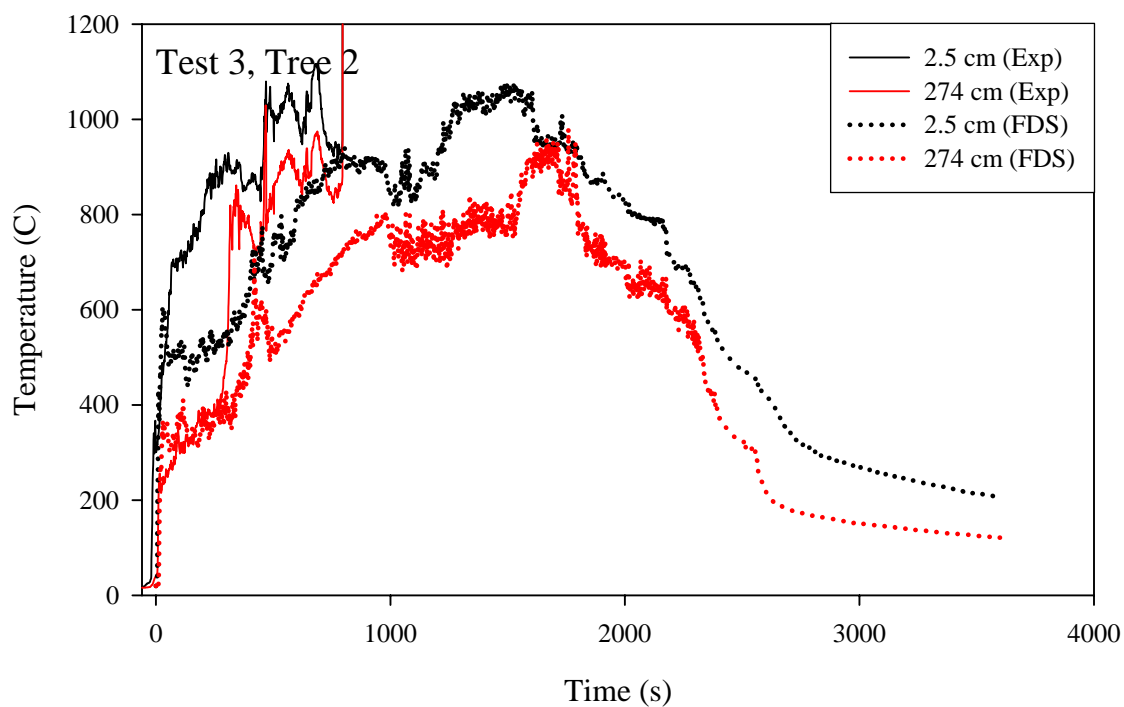
Figure D-6. Comparison of the measured and simulated temperatures at 2.5 cm and 274 cm below the ceiling on Tree 2 (middle of the compartment) during Test 3. After approximately 800 s, the thermocouples failed in this test.

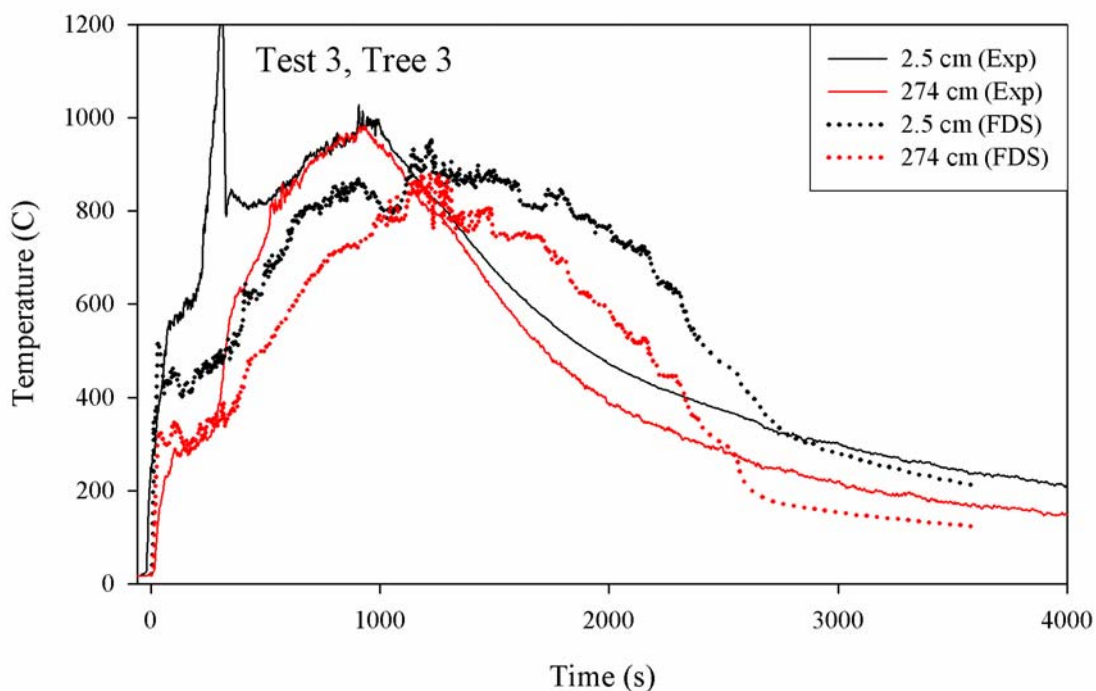
Figure D-7. Comparison of the measured and simulated temperatures at 2.5 cm and 274 cm below the ceiling on Tree 3 (middle of the compartment) during Test 3.

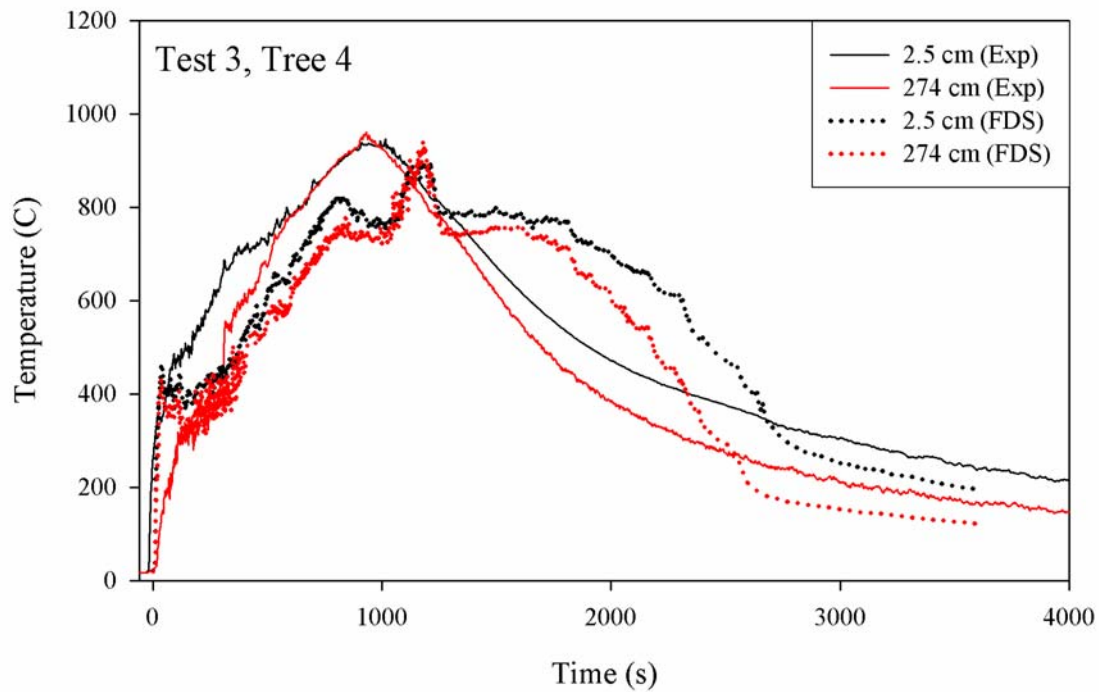
Figure D-8. Comparison of the measured and simulated temperatures at 2.5 cm and 274 cm below the ceiling on Tree 4 (rear of the compartment) during Test 3.

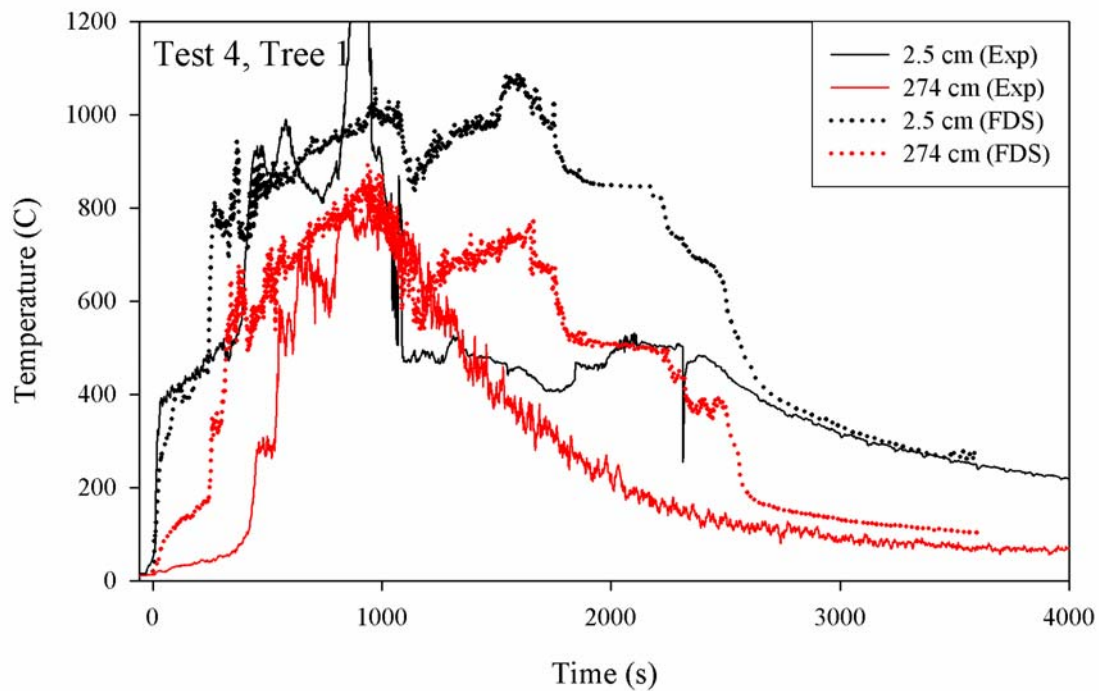
Figure D-9. Comparison of the measured and simulated temperatures at 2.5 cm and 274 cm below the ceiling on Tree 1 (front of the compartment) during Test 4.

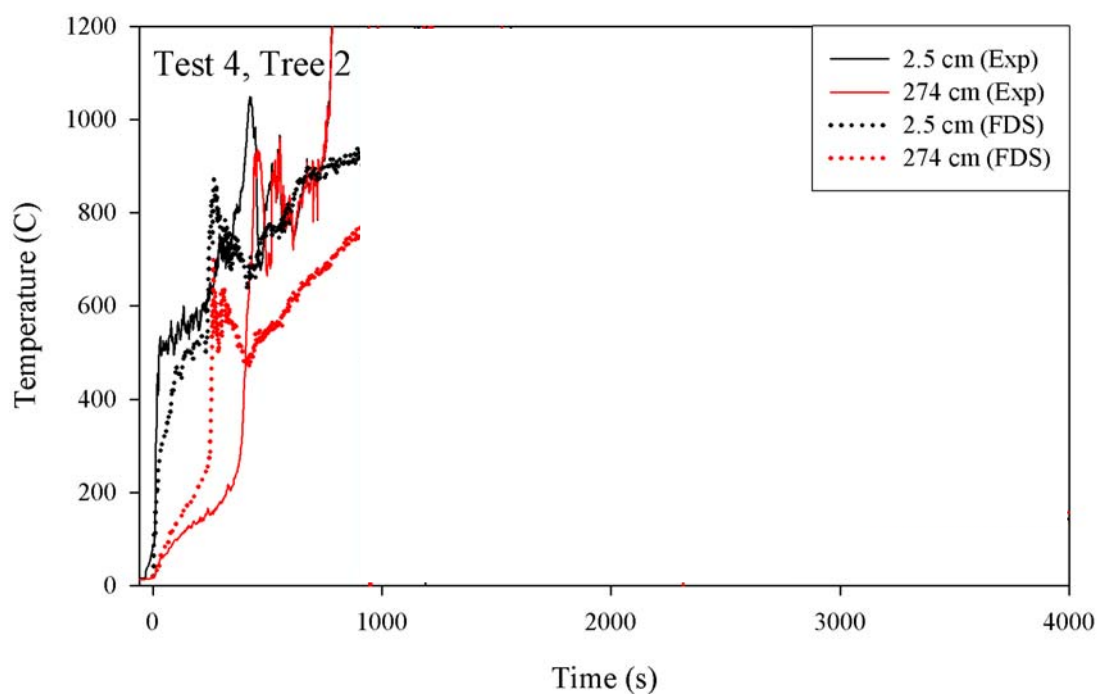
Figure D-10. Comparison of the measured and simulated temperatures at 2.5 cm and 274 cm below the ceiling on Tree 2 (middle of the compartment) during Test 4. After approximately 750 s, the thermocouples failed.

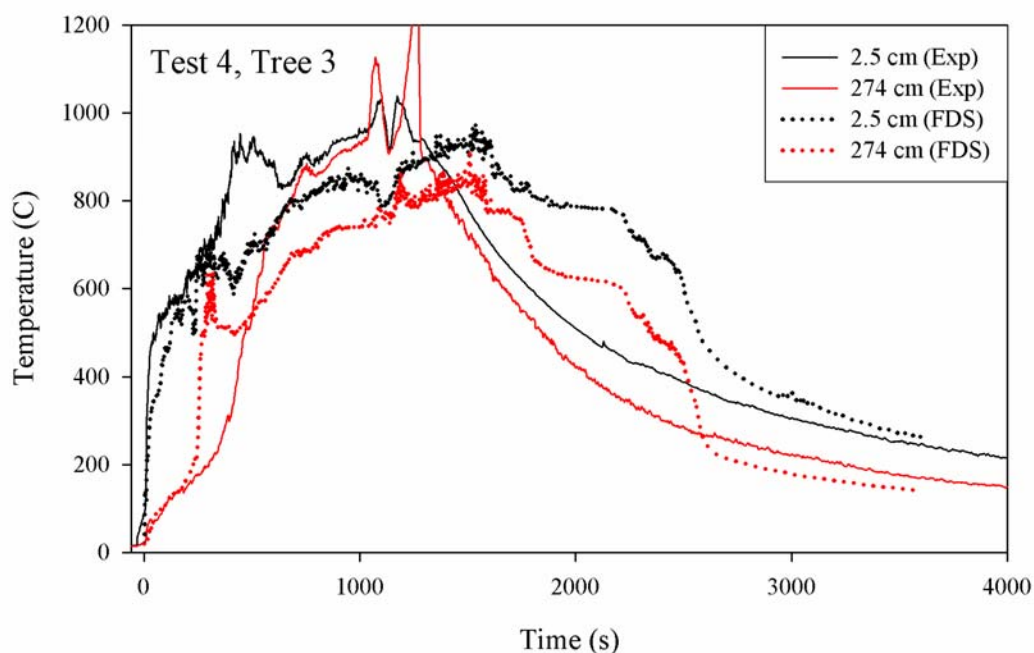
Figure D-11. Comparison of the measured and simulated temperatures at 2.5 cm and 274 cm below the ceiling on Tree 3 (middle of the compartment) during Test 4.
