NIST NCSTAR 1-5E

**Federal Building and Fire Safety Investigation of the
World Trade Center Disaster**

**Experiments and Modeling of
Multiple Workstations Burning in a
Compartment**

September 2005

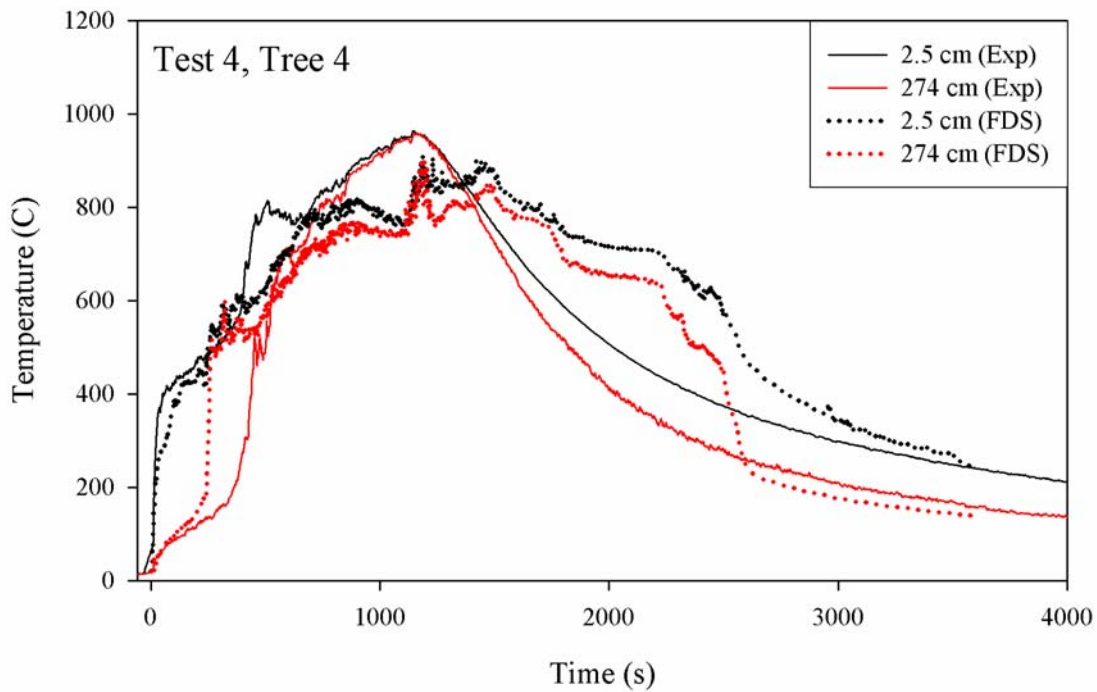
Figure D-12. Comparison of the measured and simulated temperatures at 2.5 cm and 274 cm below the ceiling on Tree 4 (rear of the compartment) during Test 4.

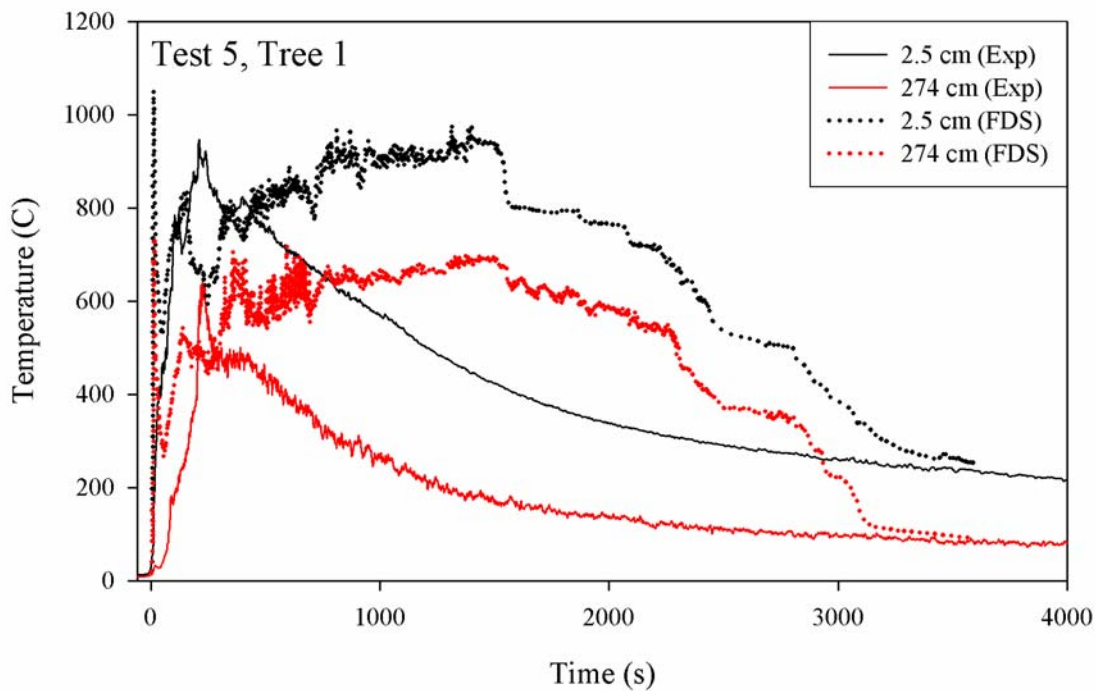
Figure D-13. Comparison of the measured and simulated temperatures at 2.5 cm and 274 cm below the ceiling on Tree 1 (front of the compartment) during Test 5.

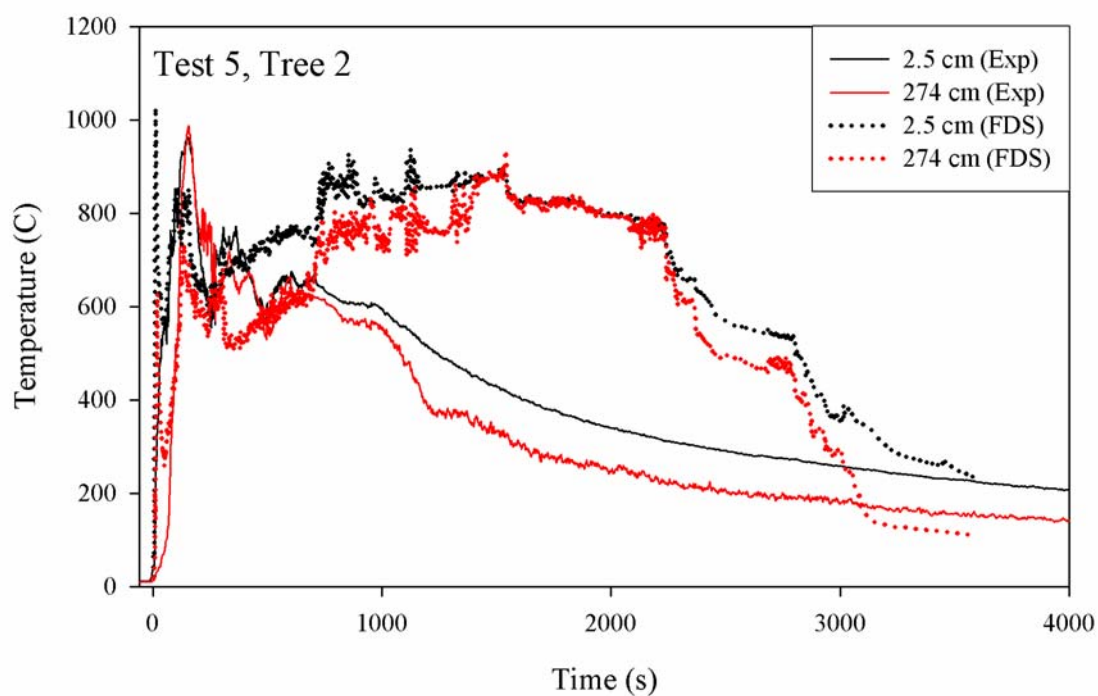
Figure D-14. Comparison of the measured and simulated temperatures at 2.5 cm and 274 cm below the ceiling on Tree 2 (middle of the compartment) during Test 5.

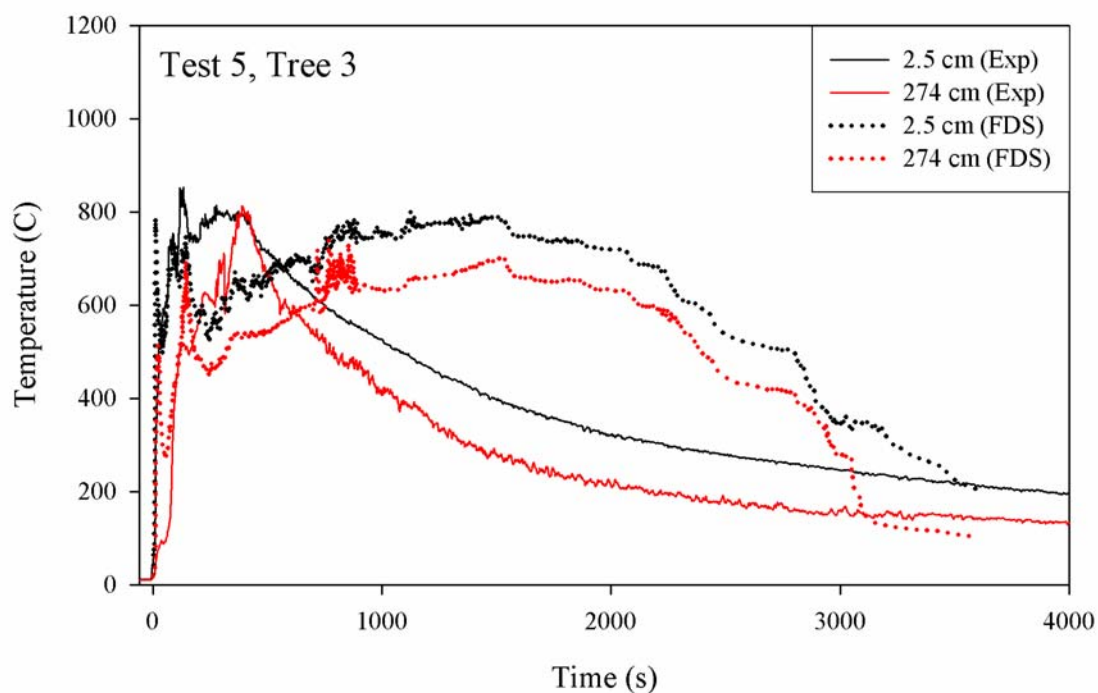
Figure D-15. Comparison of the measured and simulated temperatures at 2.5 cm and 274 cm below the ceiling on Tree 3 (middle of the compartment) during Test 5.

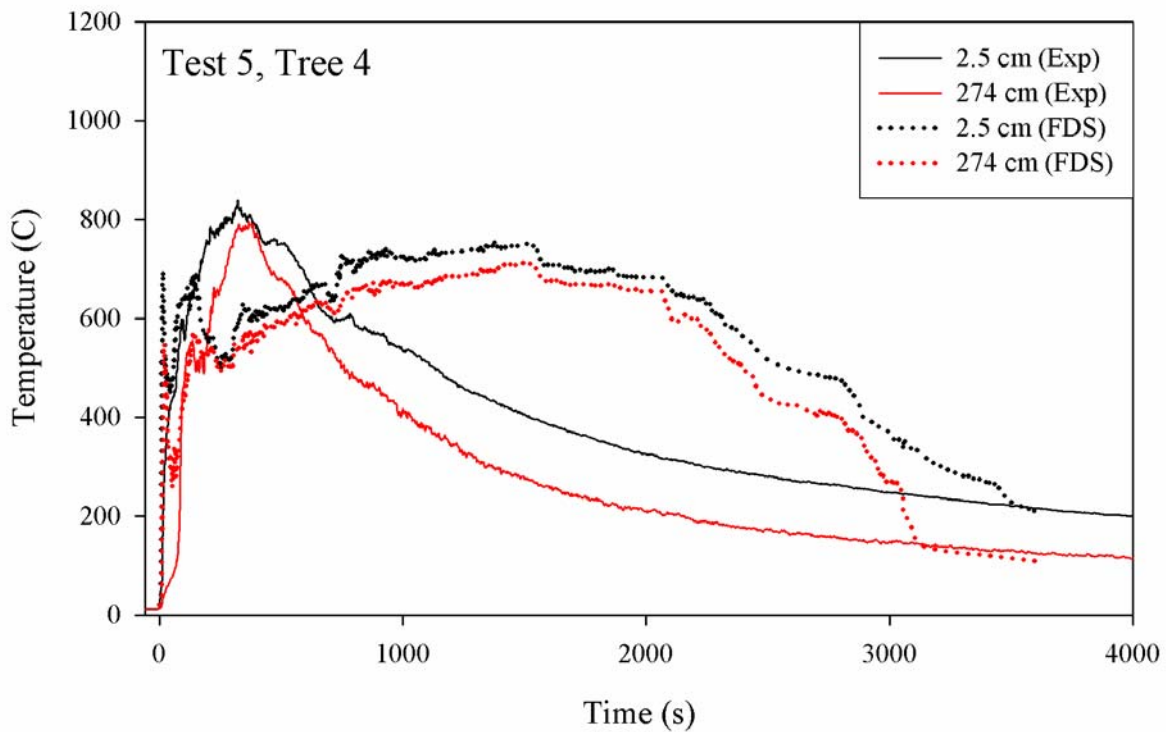
Figure D-16. Comparison of the measured and simulated temperatures at 2.5 cm and 274 cm below the ceiling on Tree 4 (rear of the compartment) during Test 5.

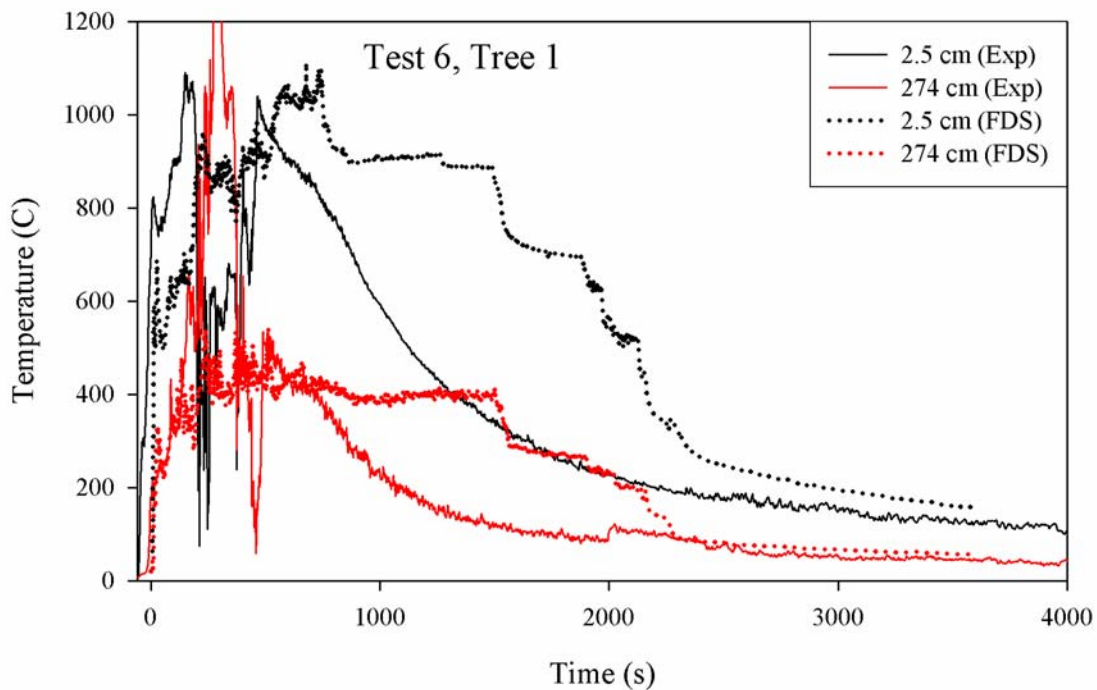
Figure D-17. Comparison of the measured and simulated temperatures at 2.5 cm and 274 cm below the ceiling on Tree 1 (front of the compartment) during Test 6.

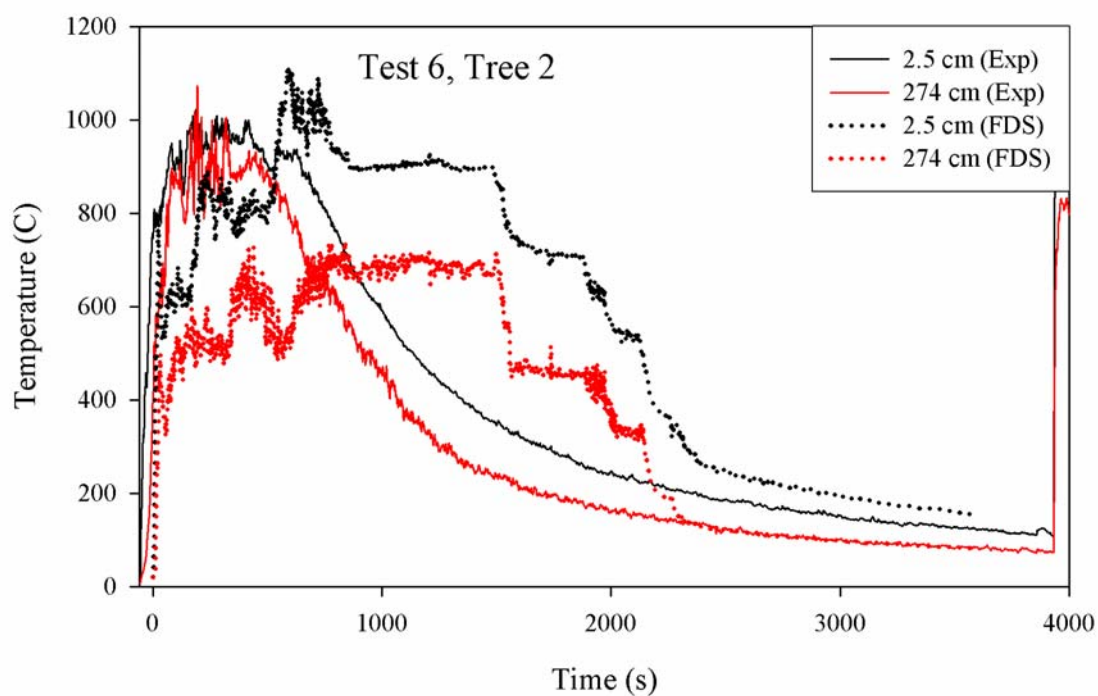
Figure D-18. Comparison of the measured and simulated temperatures at 2.5 cm and 274 cm below the ceiling on Tree 2 (middle of the compartment) during Test 6.

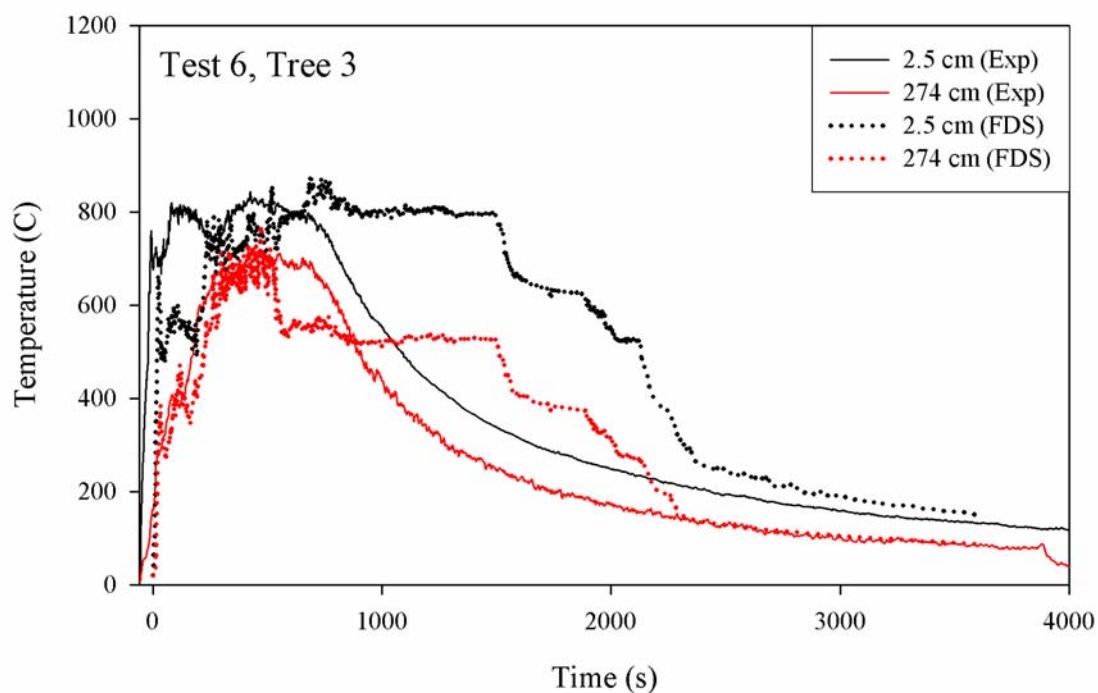
Figure D-19. Comparison of the measured and simulated temperatures at 2.5 cm and 274 cm below the ceiling on Tree 3 (middle of the compartment) during Test 6.

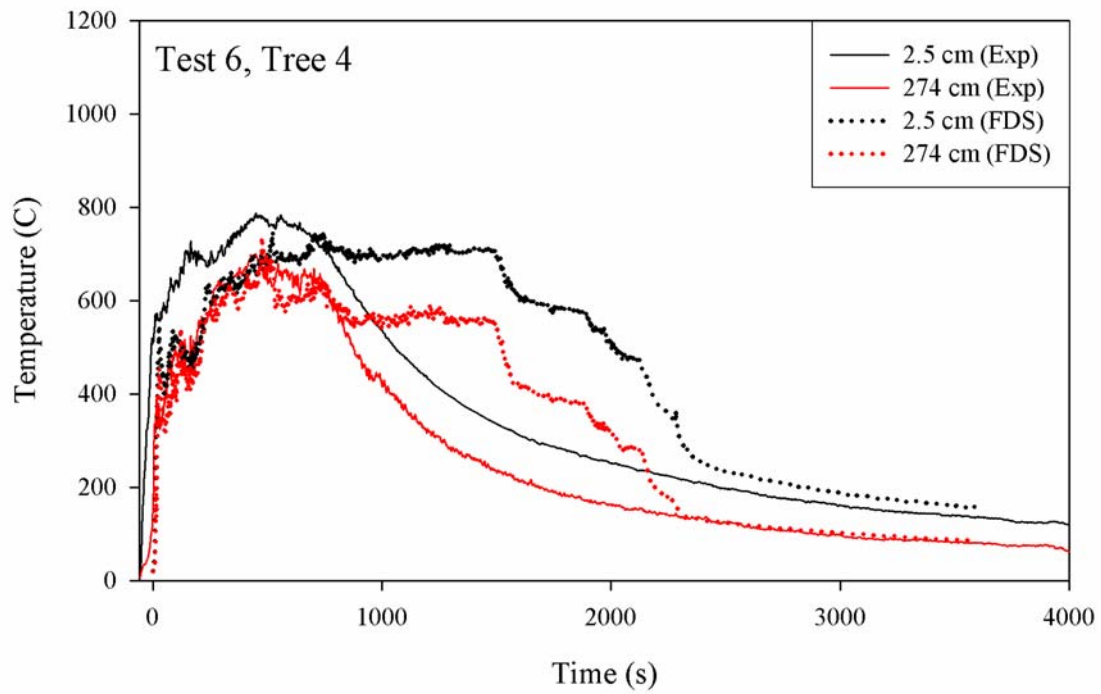
Figure D–20. Comparison of the measured and simulated temperatures at 2.5 cm and 274 cm below the ceiling on Tree 4 (rear of the compartment) during Test 6.
