NIST NCSTAR 1-2B (Draft)

**Federal Building and Fire Safety Investigation of the
World Trade Center Disaster**

Analysis of Aircraft Impacts into the World Trade Center Towers (Draft)

September 2005

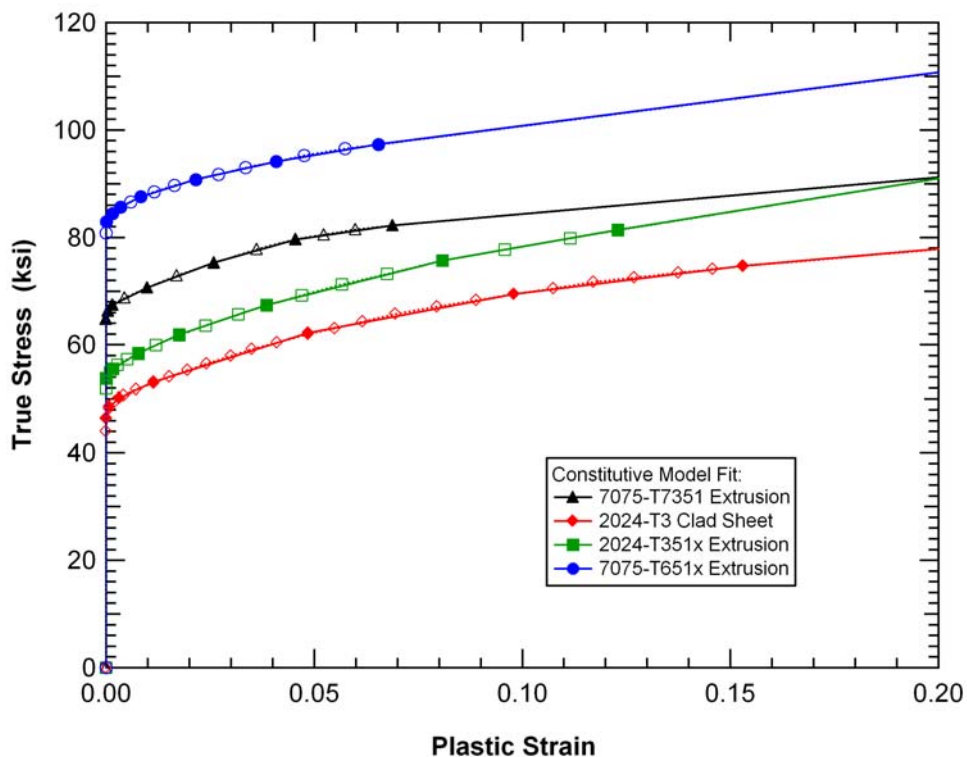
Figure E-6. True stress-strain curves developed for various aircraft aluminum alloys.

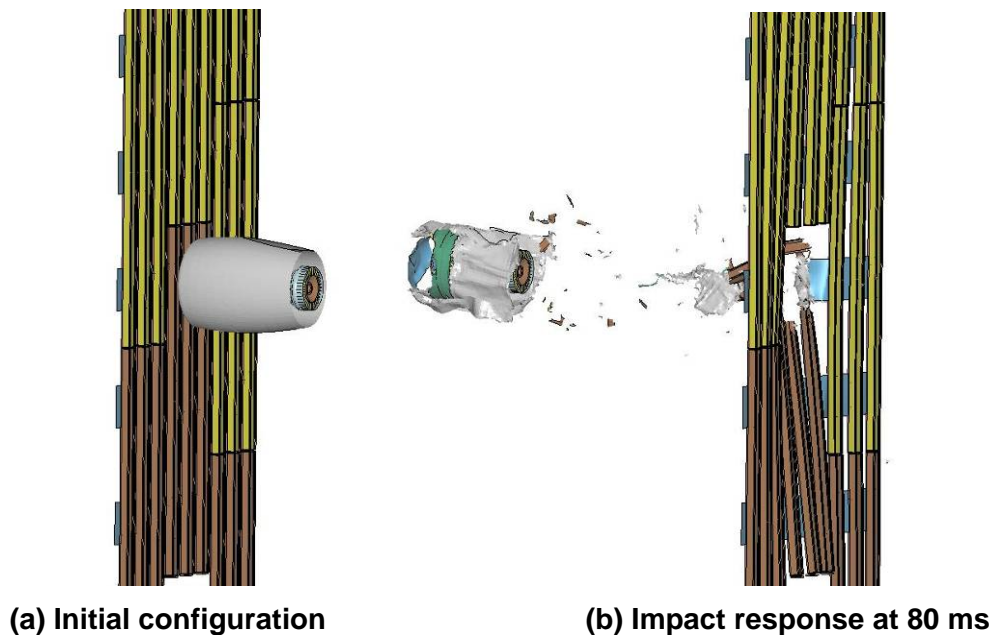
Figure E-15. Example engine impact analysis with exterior columns.

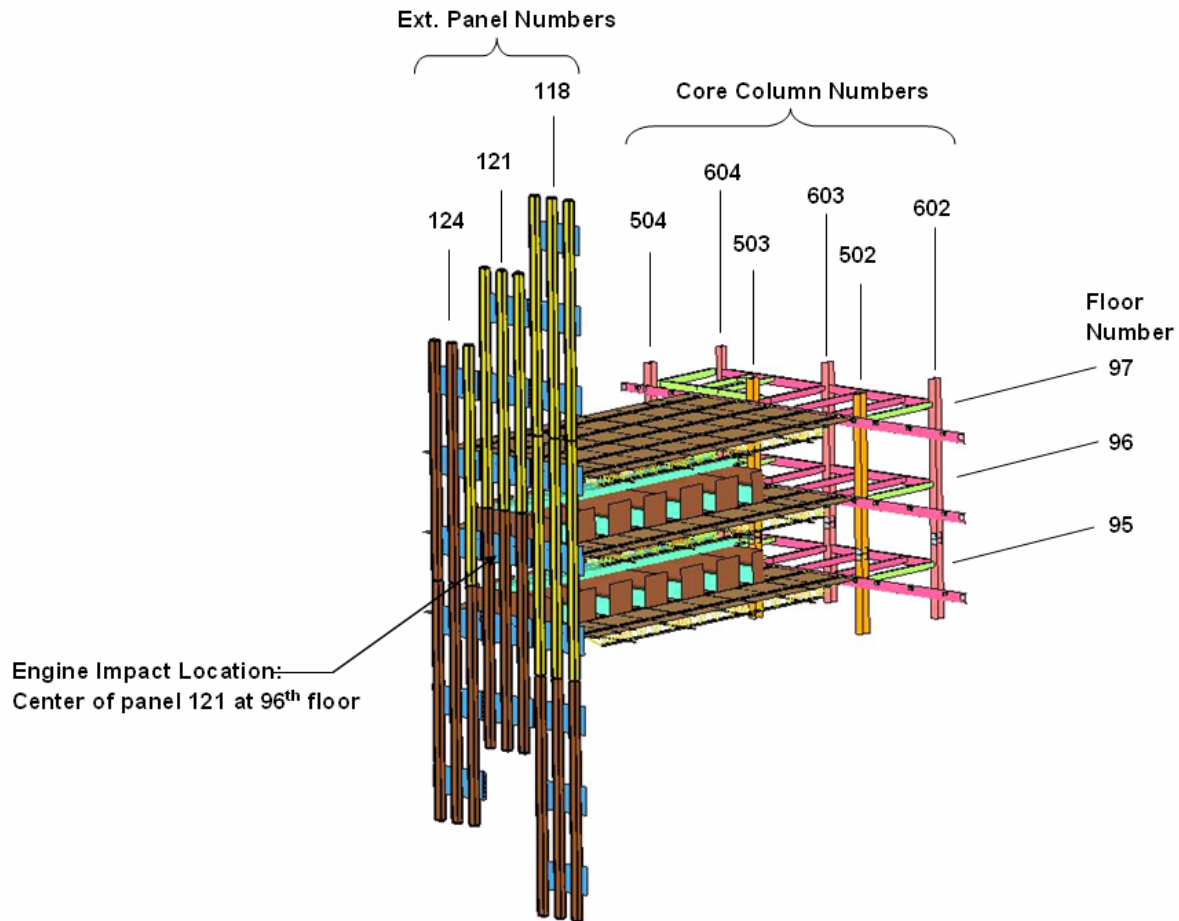
Figure E-18. Final WTC tower subassembly model.

The subassembly analyses were used as a transition between the component level analyses and the global impact analyses. With the subassembly analyses, more complex structural behavior not captured in the component analyses could be investigated with significantly shorter run times than required for the global analyses. The subassembly analyses were primarily used to investigate different modeling techniques and associated model size, run times, numerical stability, and impact response. The final subassembly model used structural components from the impact zone on the north face of WTC 1. The structural components in the final subassembly model included the exterior panels, core framing, truss floor structures, and interior contents (workstations), Figure E-18.

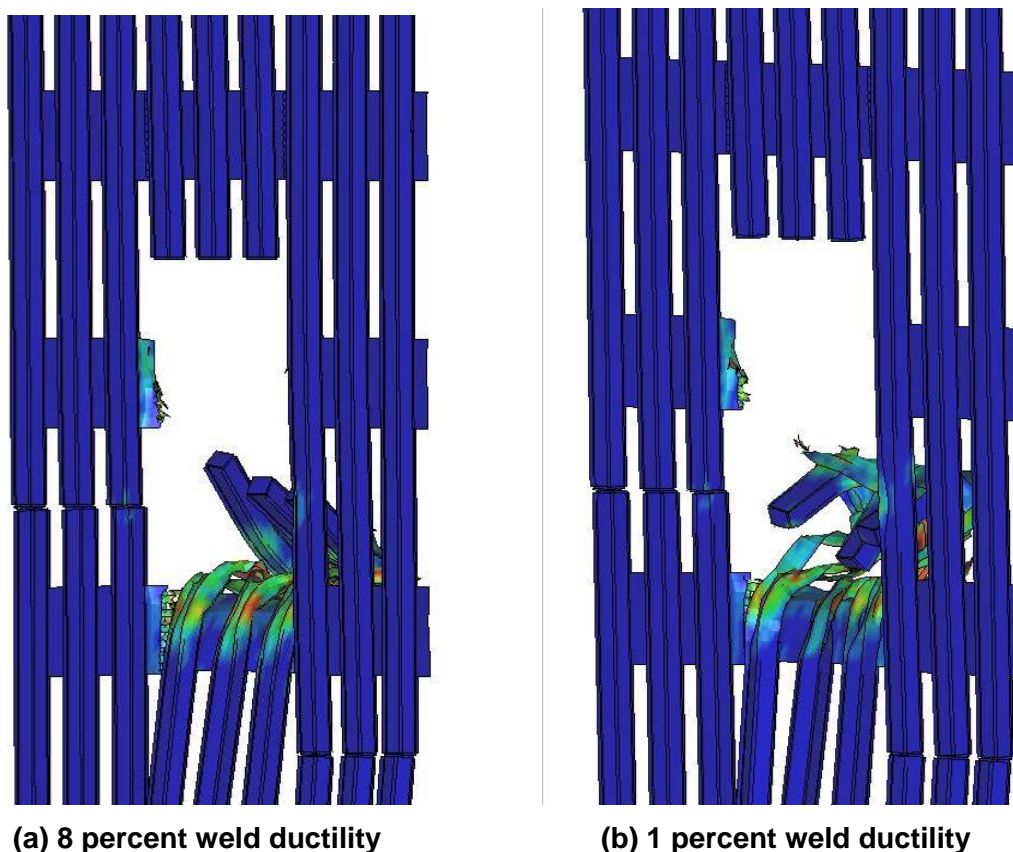
Figure E-21. Exterior wall damage for the wing section impact analyses.

Varying the ductility of the weld zone in the exterior columns from 8 percent to 1 percent did not result in any noticeable difference in the damage pattern (Figure E-21) or the energy absorbed by the exterior panels, indicating that the weld ductility had a negligible effect on the impact response.

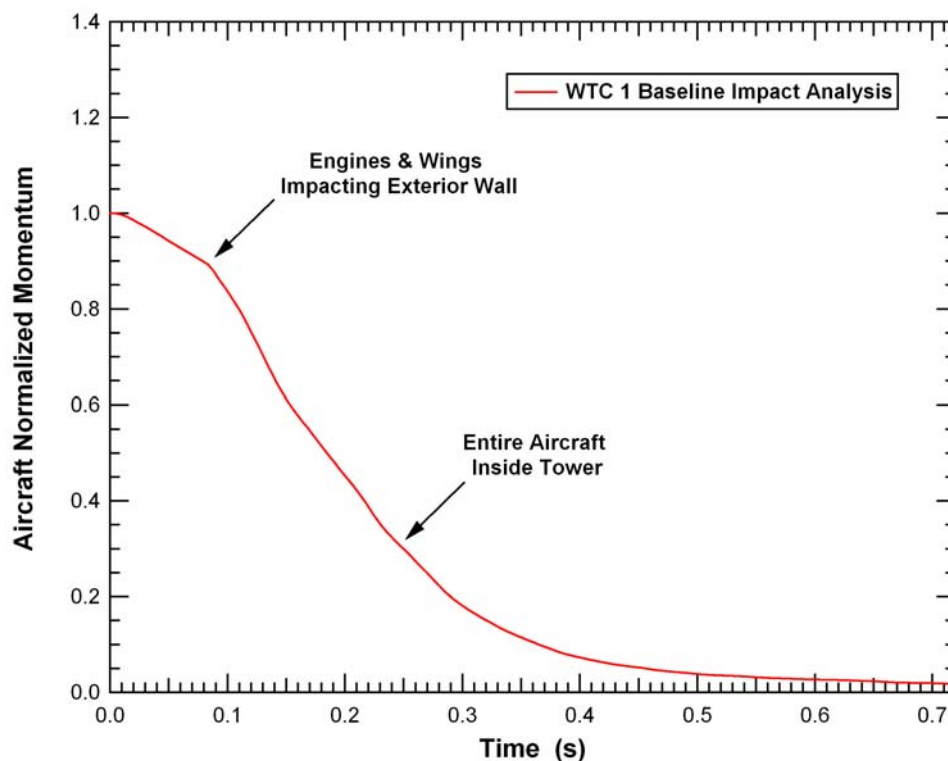
Figure E-27. Normalized aircraft momentum for the WTC 1 base case impact.

Load transfer of the aircraft momentum into the tower structure is shown in Figure E-27. The momentum plotted was for all of the aircraft structures and contents (including fuel) and was normalized by the initial momentum magnitude. During the first 0.1 s of impact, the forward fuselage penetrated the exterior wall and impacted the interior structures. Between 0.1 s and 0.25 s a more rapid load transfer rate was observed as the area of the impact was larger (extending outward in the wing impact regions) and a higher percentage of the aircraft mass was impacting the interior structures. At 0.25 s, as indicated in Figure E-27, the aircraft completely penetrated the building and retained approximately 30 percent of its initial momentum. Beyond this time, the rate of load transfer steadily decreased with very little load transfer after approximately 0.5 s.

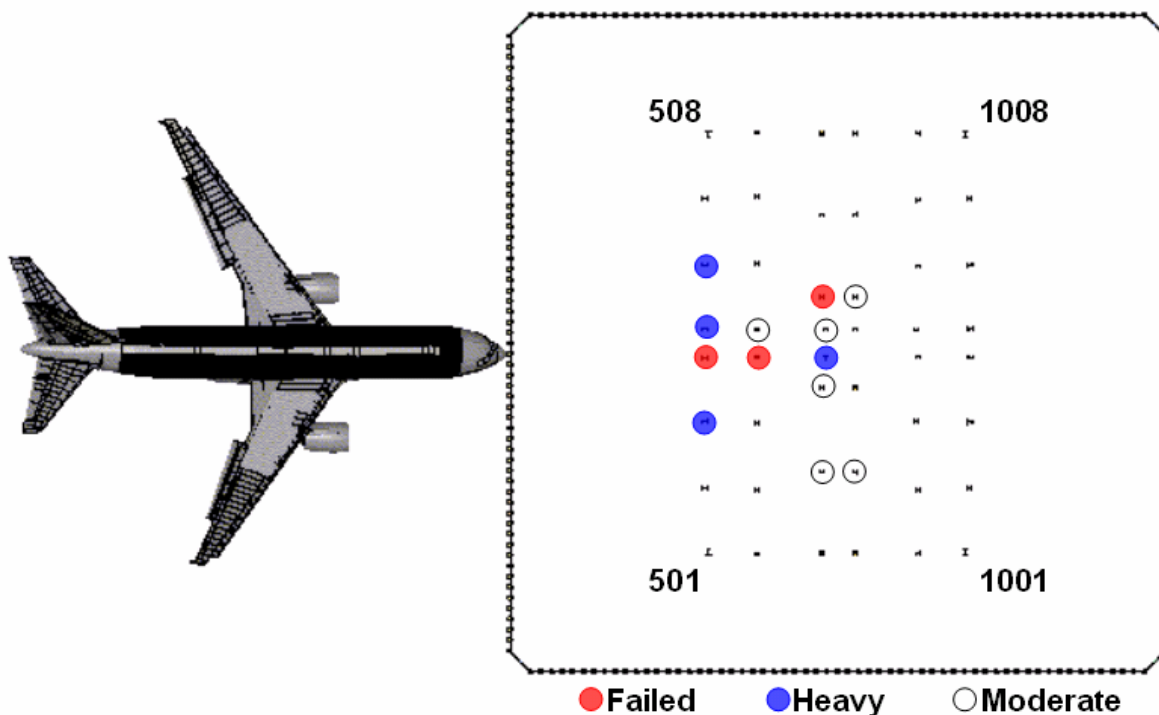
Figure E-31. Core column damage for the base case WTC 1 impact.

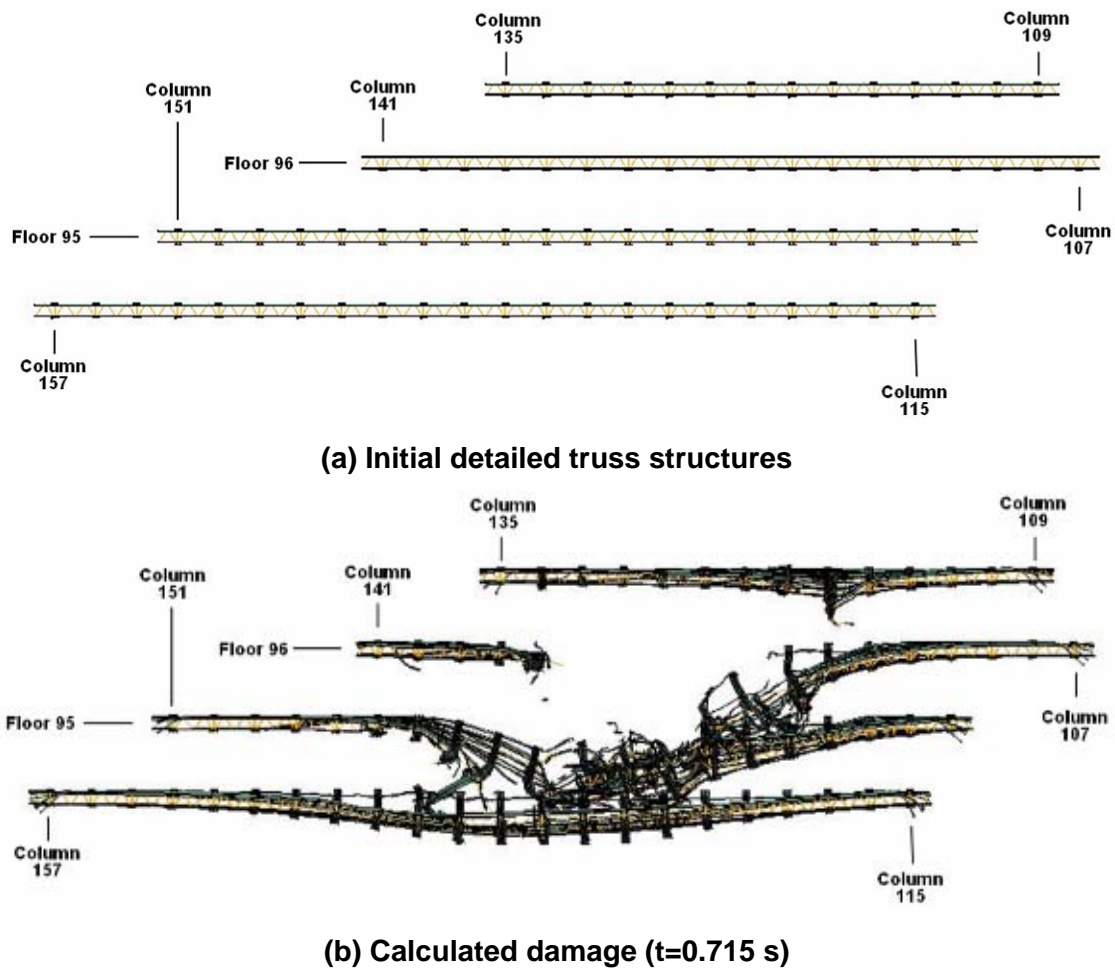
Figure E-32. Base case impact damage to the WTC 1 floor truss (front view).

An overall view of the floor truss structure in the impact zone, along with the calculated impact damage to the floor trusses, is shown in Figure E-32. The figure shows that the trusses experienced significant damage in the impact zone. The calculated impact response produced severe damage to the truss structures in the primary impact path of the fuselage. The truss structures were severely damaged from the exterior wall to the core. The truss floor system on floors 94 through 96 were damaged and sagging downward as a result of the impact loading.

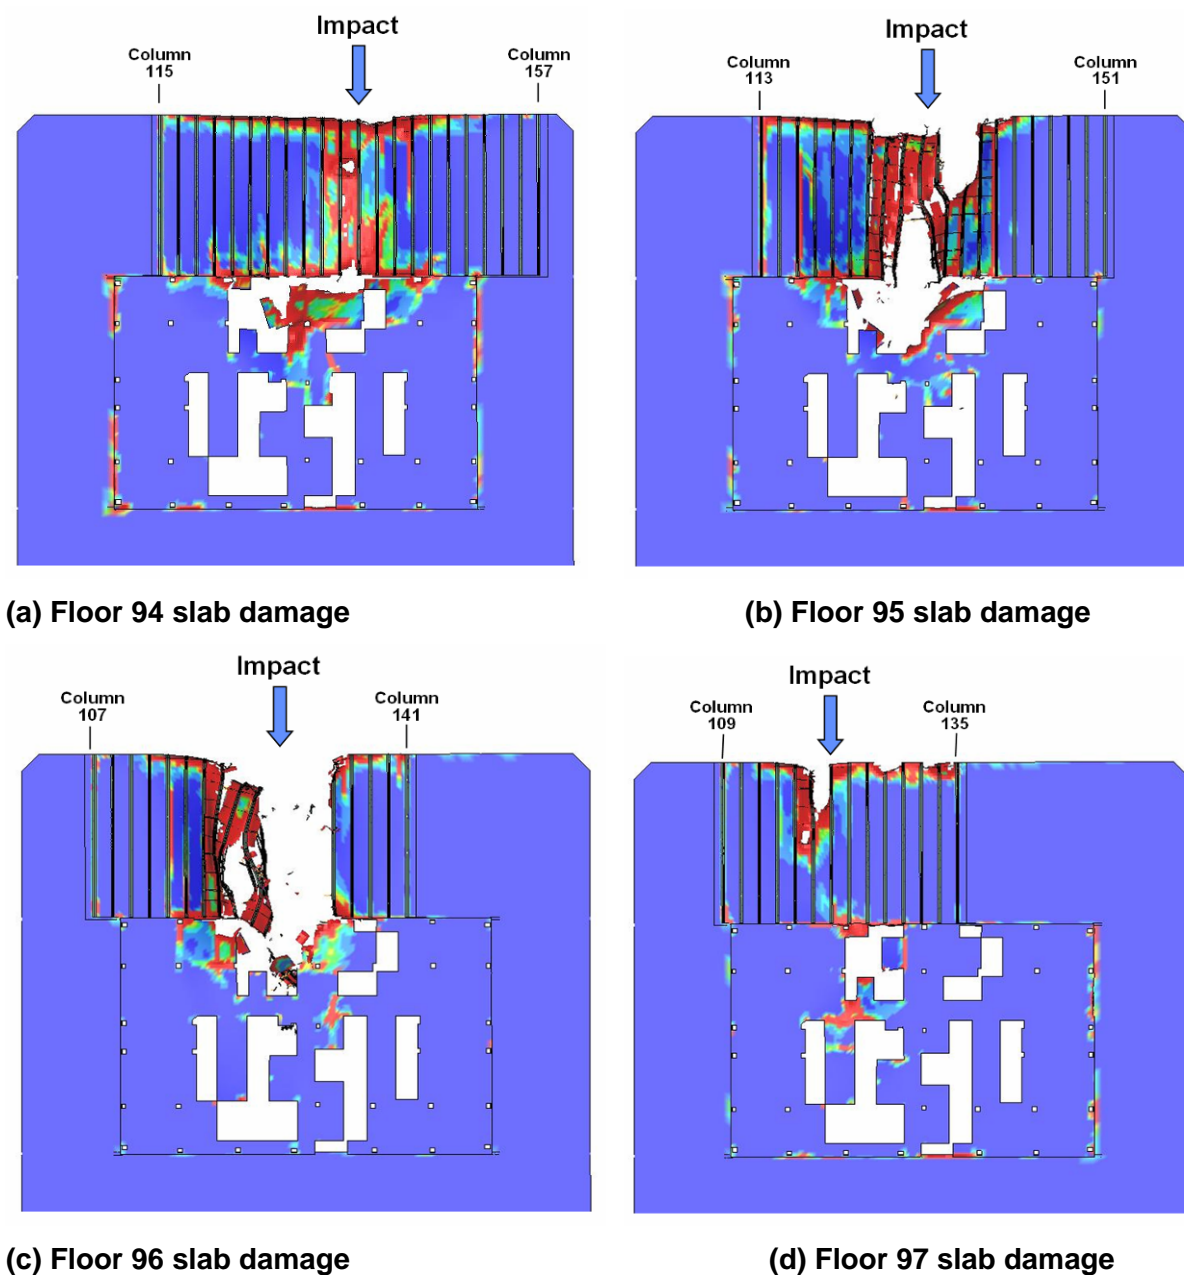
Figure E-33. Base case impact damage to the WTC 1 floor slab (plan view).

After concrete failure, break up, and removal, the strength of the floor slab was severely reduced in the analyses to model the residual strength of the metal deck. At a plastic strain of 30 percent, corresponding to failure levels for the metal decking material, the elements were eroded (seen as holes ruptured in the floor slabs shown). Figure E-33 shows that the truss floor and associated slab were heavily damaged or completely destroyed in the impact zone. The zone of heavy damage to the floor slab extended beyond the truss floor and was approximately one-third of the distance through the core on floors 94 through 96.

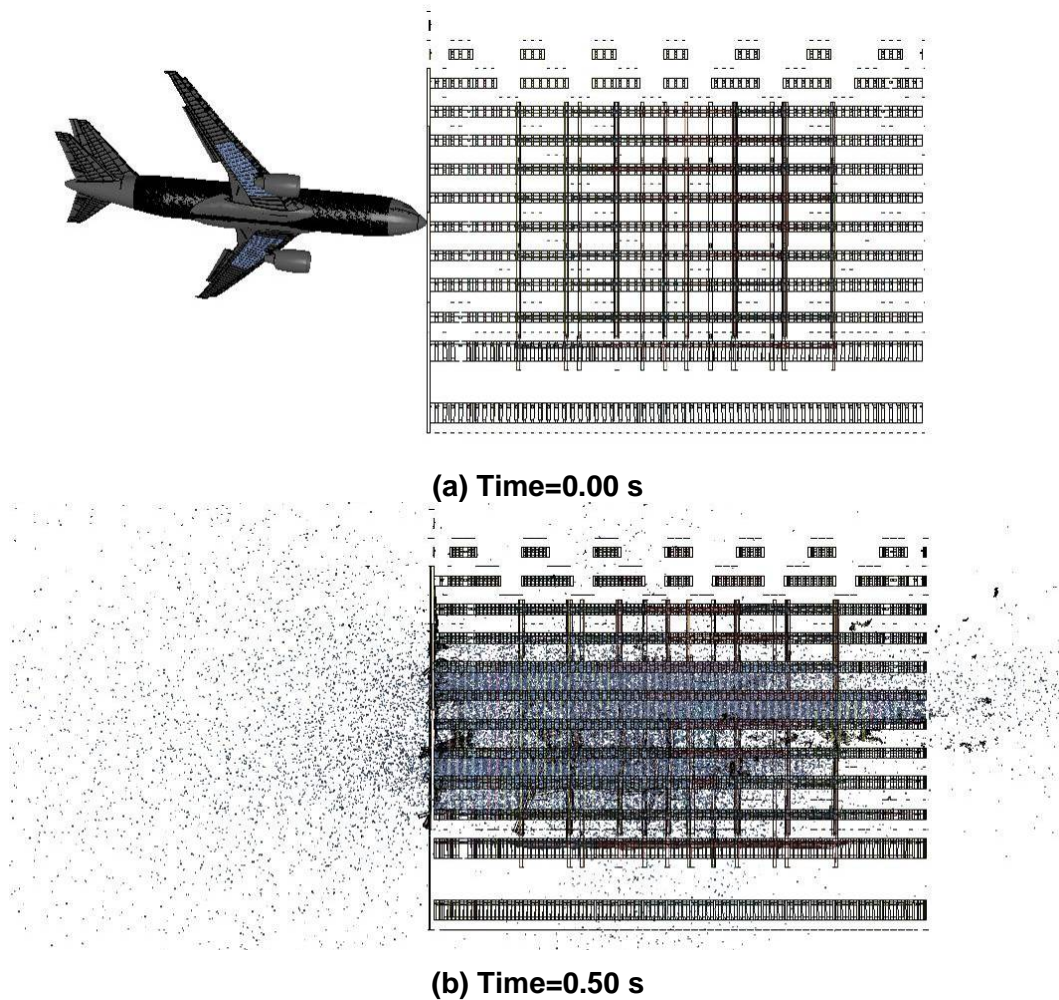
Figure E-34. WTC 2 base case global impact analysis – side view.

The WTC 2 base case impact analysis was performed for a 0.62 s duration following initial impact of the aircraft nose with the south exterior wall. The side view and top view of the base case WTC 2 global impact response is shown in Figure E–34 and Figure E–35, respectively. Full penetration of the aircraft into the tower was completed at 0.2 s after impact. The aircraft impact response was very similar to that of the WTC 1 impact and was dominated by the penetration and fragmentation of the airframe structures. The fuselage structures were severely damaged both from the penetration through the exterior columns and the penetration of the 81st floor slab that sliced the fuselage structures in half. The downward trajectory of the aircraft structures caused the airframe to collapse against the floor, and the subsequent debris motion was redirected inward along a more horizontal trajectory parallel to the floor. The downward trajectory of the aircraft structures had transferred sufficient vertical load that the truss floor structures on the 80th and 81st floors began to collapse in the impact zone by the end of the simulation.

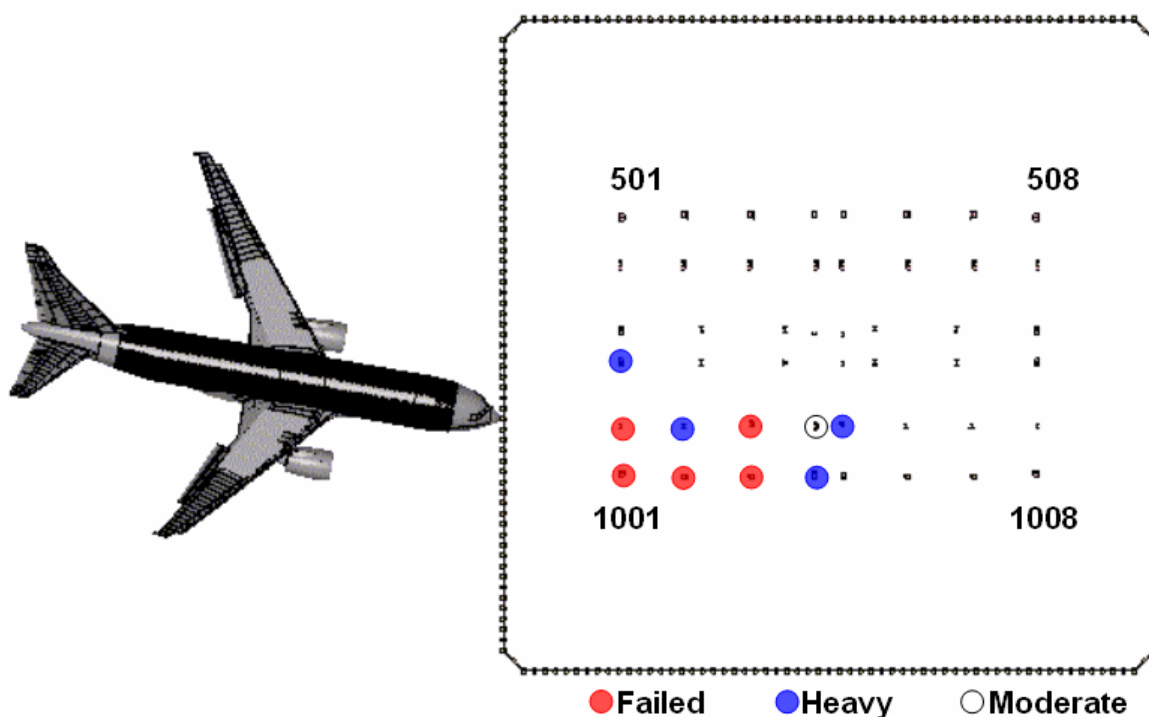
Figure E-39. Summary of core column damage for the base case WTC 2 impact.

In the base case WTC 2 impact damage analysis, significant damage to the core was calculated in the region close to the impact point (the south east corner of the core). The columns in line with the aircraft fuselage failed on the impact side of the tower and several of the core beams were also severely damaged or failed in the impact zone. In some cases, failure of the column splices located on floors 77, 80, and 83 contributed significantly to the failure of the core columns. This was particularly true for the heavy column number 1001 at the southeast corner of the core that failed at three splice locations. A summary of the column damage is shown graphically in Figure E-39. A total of five columns were failed (completely severed) and four columns were heavily damaged.

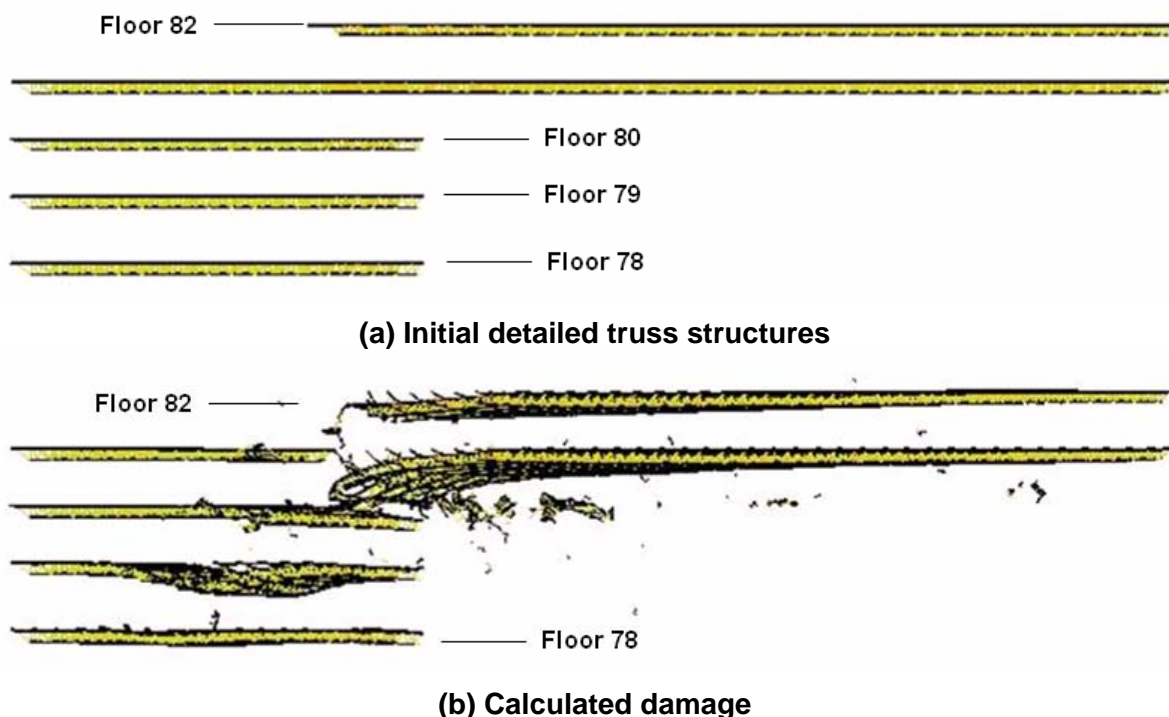
Figure E-40. Base case impact damage to the WTC 2 floor truss (front view).

angle directed more impact energy normal to the floor slab. The vertical component of the impact load in WTC 1 was approximately 40 percent higher than in WTC 2. The secondary factor was that the damage to the long span truss floor in the WTC 1 impact zone produced larger displacements than the corresponding damage to the short span truss region in WTC 2.

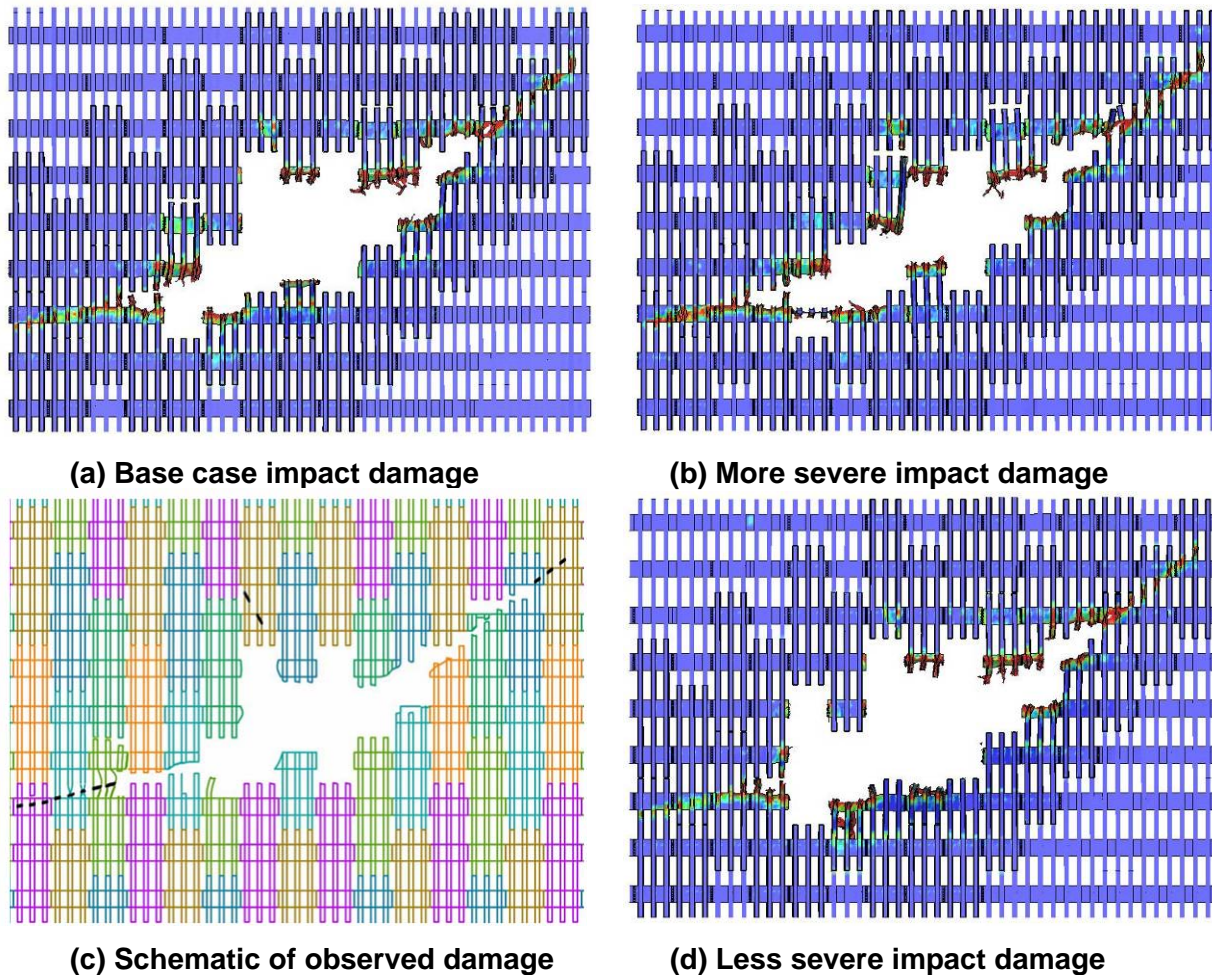
Figure E-41. Comparison of exterior wall damage for the WTC 1 impact analyses.

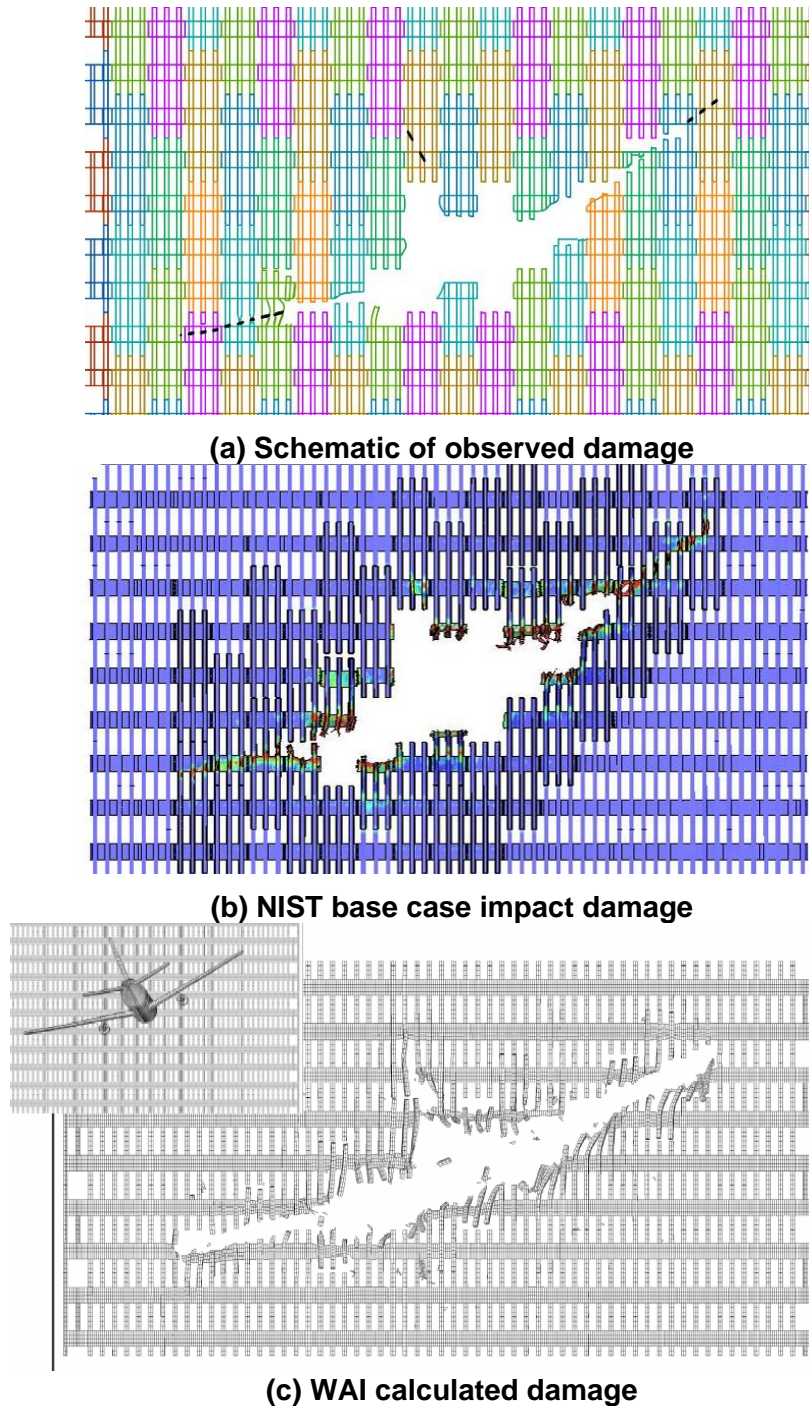
Figure E-44. Comparison of impact damage to the WTC 1 exterior wall.

The differences in the damage profiles in the two calculations most likely resulted from a variety of differences in the models. One major difference between the two studies was in the fidelity of the aircraft models. The WAI aircraft model was based on their model of a Lockheed C-141B military transport rather than the Boeing 767. The NIST aircraft model contained an order of magnitude more elements and modeled the fuel explicitly. Secondary differences between the WAI and NIST impact analyses included, but were not limited to, variations in impact conditions (impact velocity, angle, location, etc.), aircraft model differences (airframe geometry, component thicknesses, mass distribution, material properties, etc.) and tower model differences (material properties, geometry, joint modeling, number of elements, etc.).

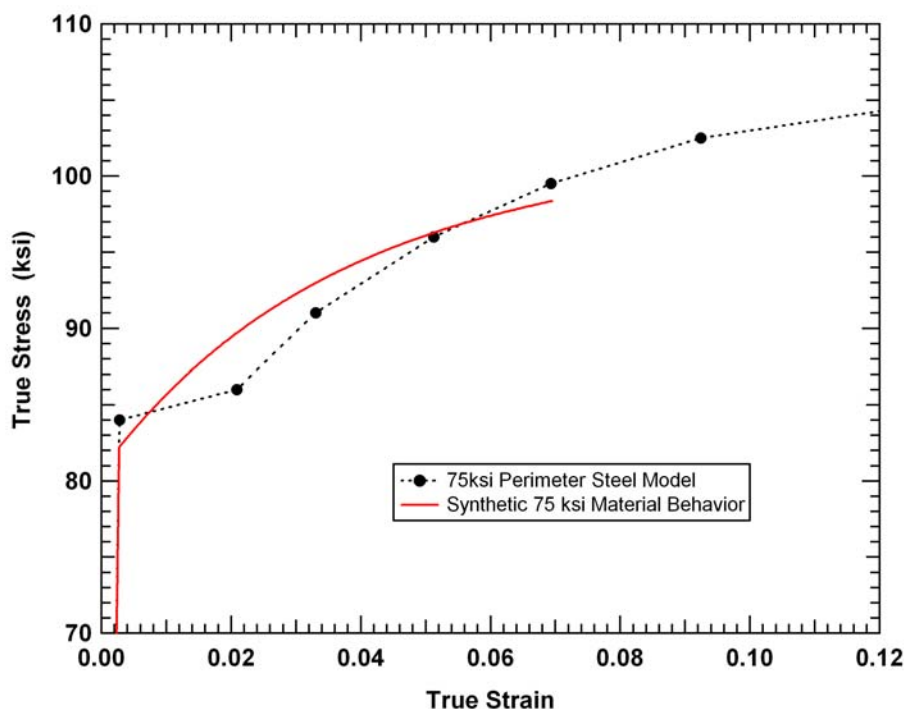
Figure 2–7. Comparison of the constitutive model and synthetic steel behaviors for the 75 ksi steel.

curve with the constitutive model behavior for the 75 ksi steel is shown in Figure 2–7. There were observable differences in the curves, such as the representation of a yield point behavior in the constitutive model. However, the differences were not sufficiently large to produce a large variation in the calculated structural impact behavior. In addition, the effect of material strength variation on impact damage was assessed in the uncertainty analyses.

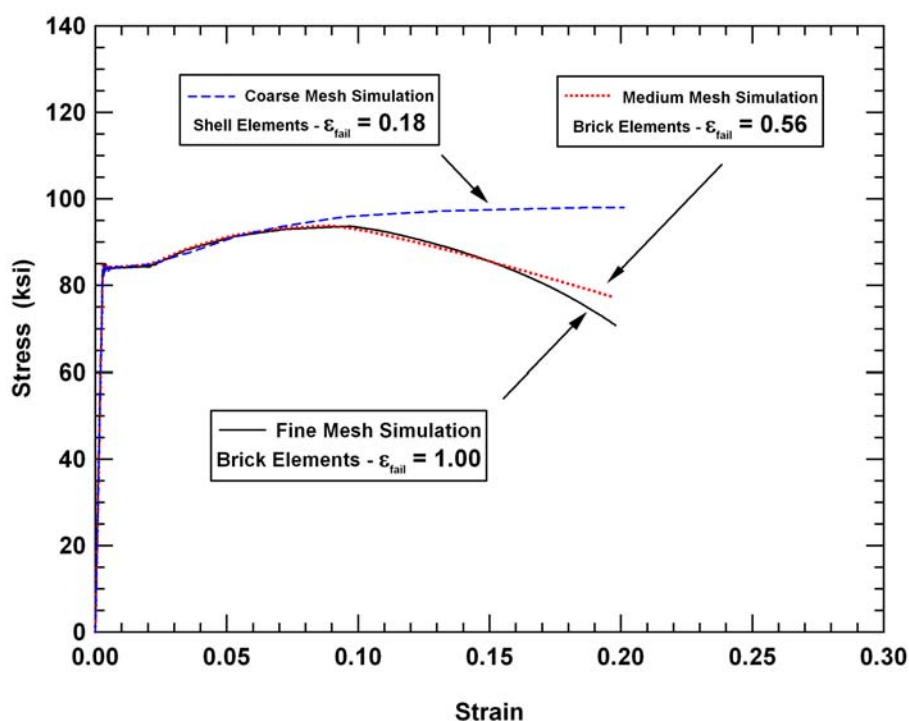
Figure 2-15. Mesh refinement effects in the calculated 75 ksi tensile test.

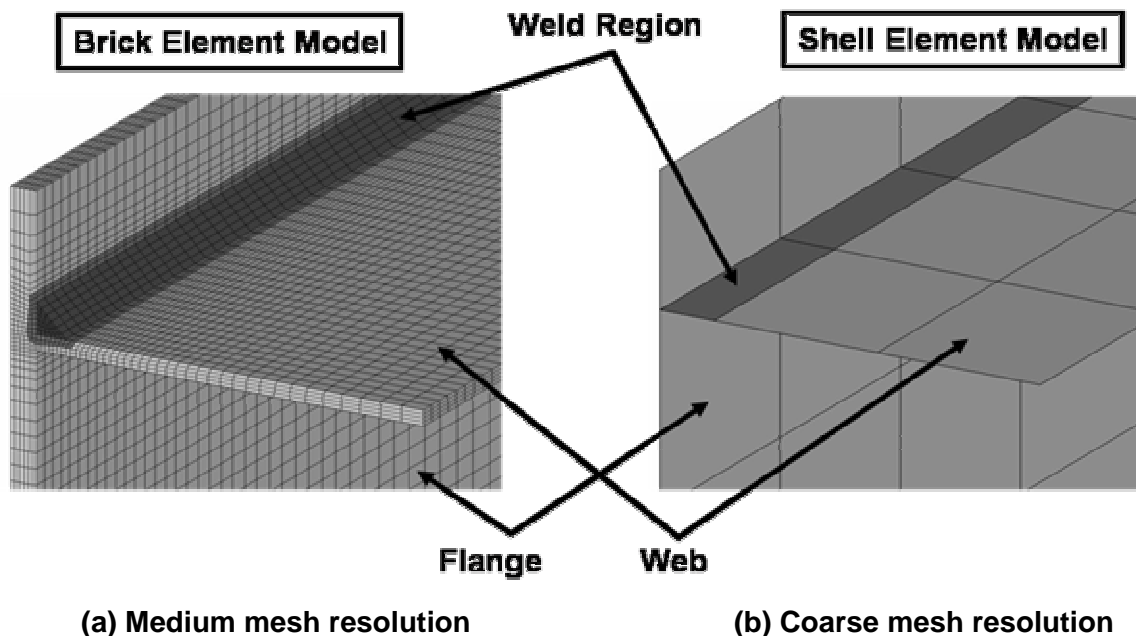
Figure 2–20. Models developed for column weld fracture analysis.

An average critical strain of approximately one-quarter of that in the corresponding base metal was selected for the 1 in. wide single shell element weld zone. This weld zone failure strain was 8 percent in the current example (55 ksi steel). The comparison of the resulting impact behavior for the brick and shell element models is shown in Figure 2–22. Both models had similar impact deformations, and the length of the weld failures were in good agreement. These analyses provided an upper bound value for the engineering fracture criteria in the weld region. Additional investigation of the weld failure and the effects of a more brittle fracture response were investigated in the subassembly analyses (Section 6.3.2). These subassembly impact analyses demonstrated that the weld zone fracture criterion had a negligible effect on the impact energy absorption and little significance on the impact damage.

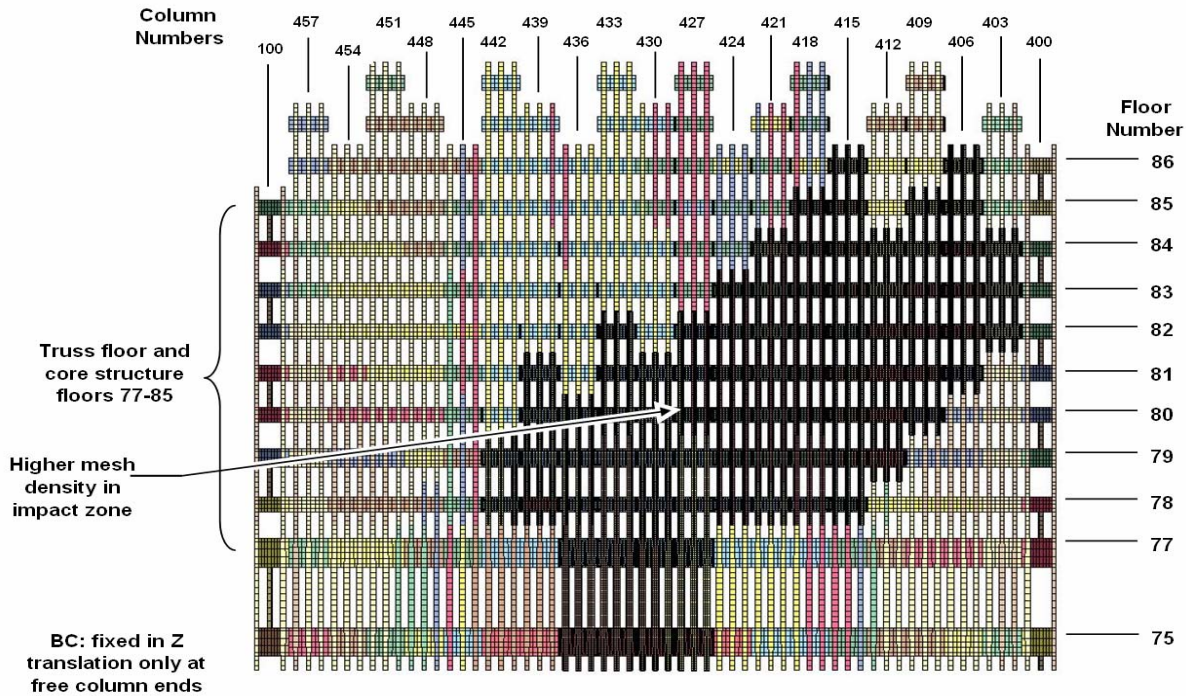
Figure 3-11. Impact face of the WTC 2 model - floors 75-86.

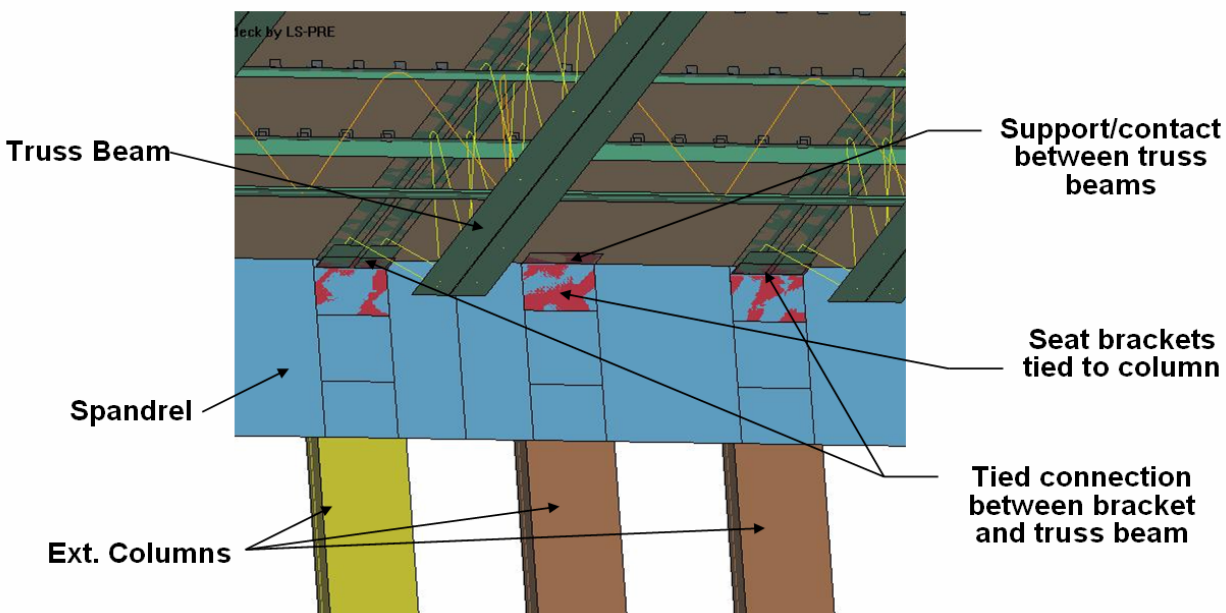
Figure 3-15. Truss floor connection detail at exterior wall.

Figure 3–15 and Figure 3–16 show truss floor connection details at the exterior wall and core, respectively. The models for the truss seat connections were developed using shell elements and attached using the tied interface algorithm. The failure of the seats only occurs as a result of exceeding the ductility of the seat or truss structures.

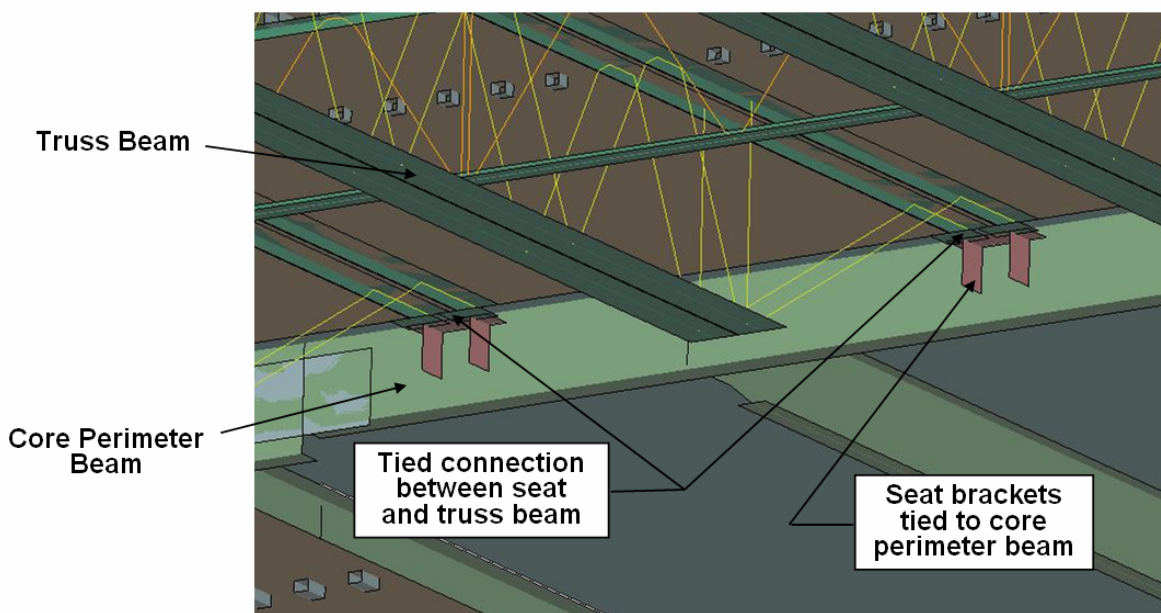
Figure 3-16. Truss floor connection detail at core perimeter.

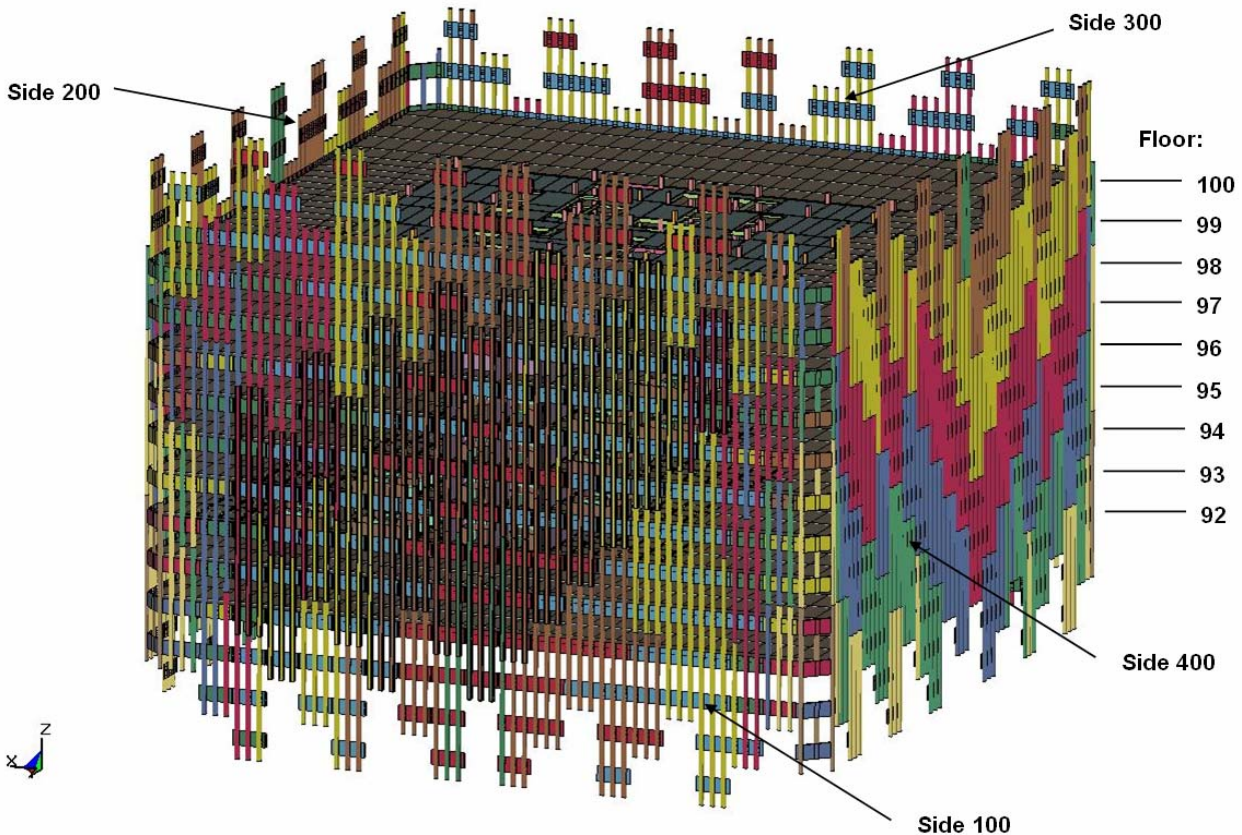
Figure 3–21. Multi-floor global impact model of the WTC 1 tower.

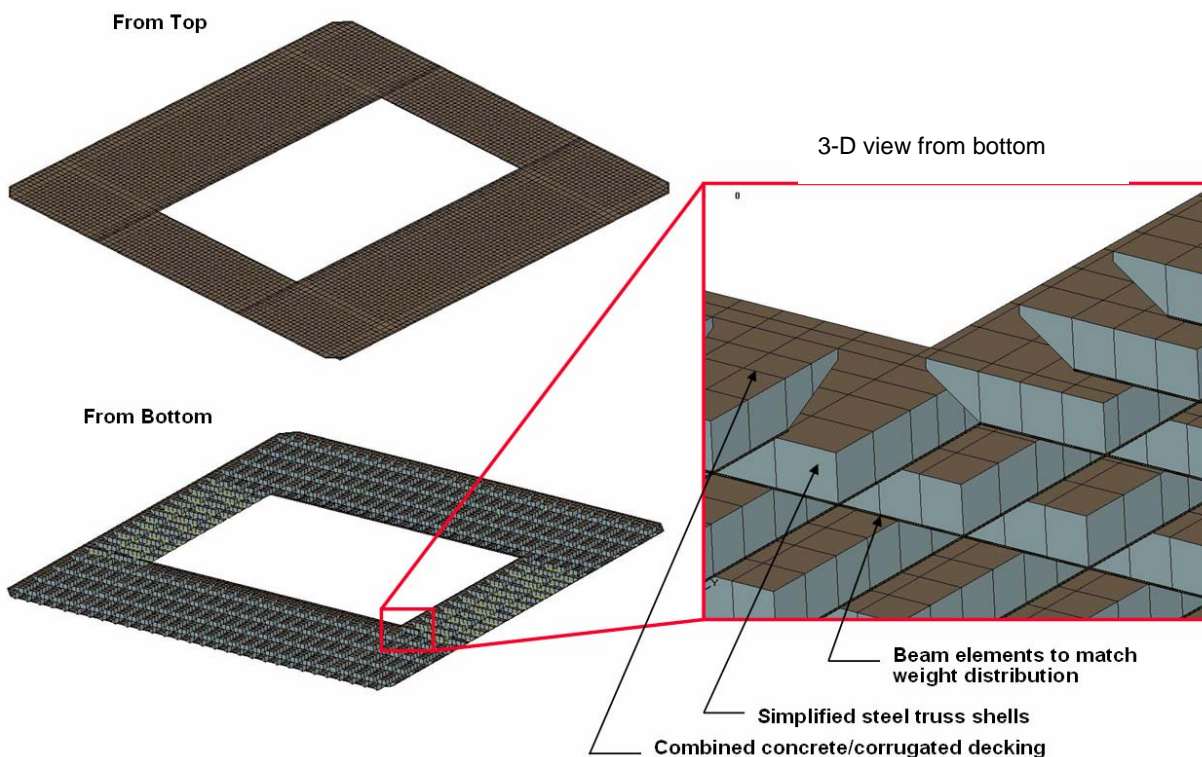
Figure 3–25. Far field truss floor model in the WTC towers.

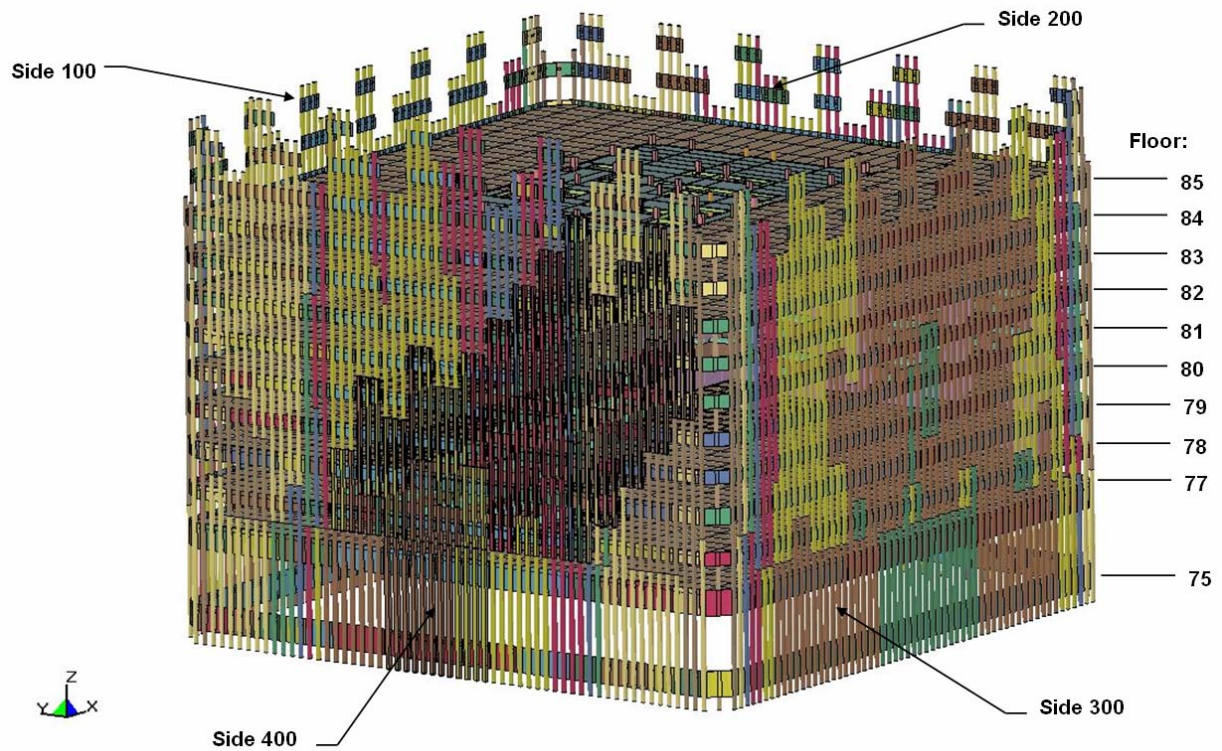
Figure 3-26. Multi-floor global impact model of the WTC 2 tower.

To summarize, the approach adapted for the development of the global impact models for towers WTC 1 and WTC 2 was similar. The structures were modeled primarily with shell elements with some beam elements in the detailed truss floor sections and bolted connections between the column ends in the impact zone of the exterior wall. Some brick elements were used at the exterior column butt plates in the detailed impact zone. A summary of the model size and element types for the global tower models is presented in Table 3–2.
