NIST NCSTAR 1-2B (Draft)

**Federal Building and Fire Safety Investigation of the
World Trade Center Disaster**

Analysis of Aircraft Impacts into the World Trade Center Towers (Draft)

September 2005

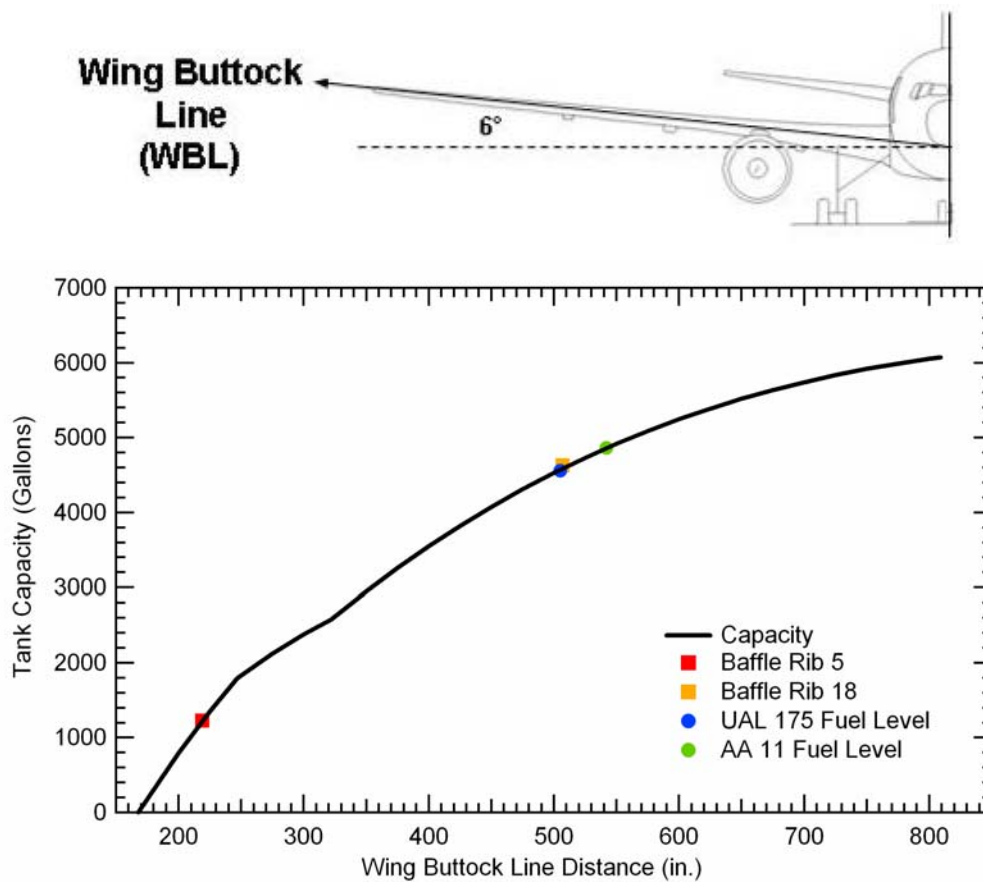
Figure 4-34. Fuel tank capacity.

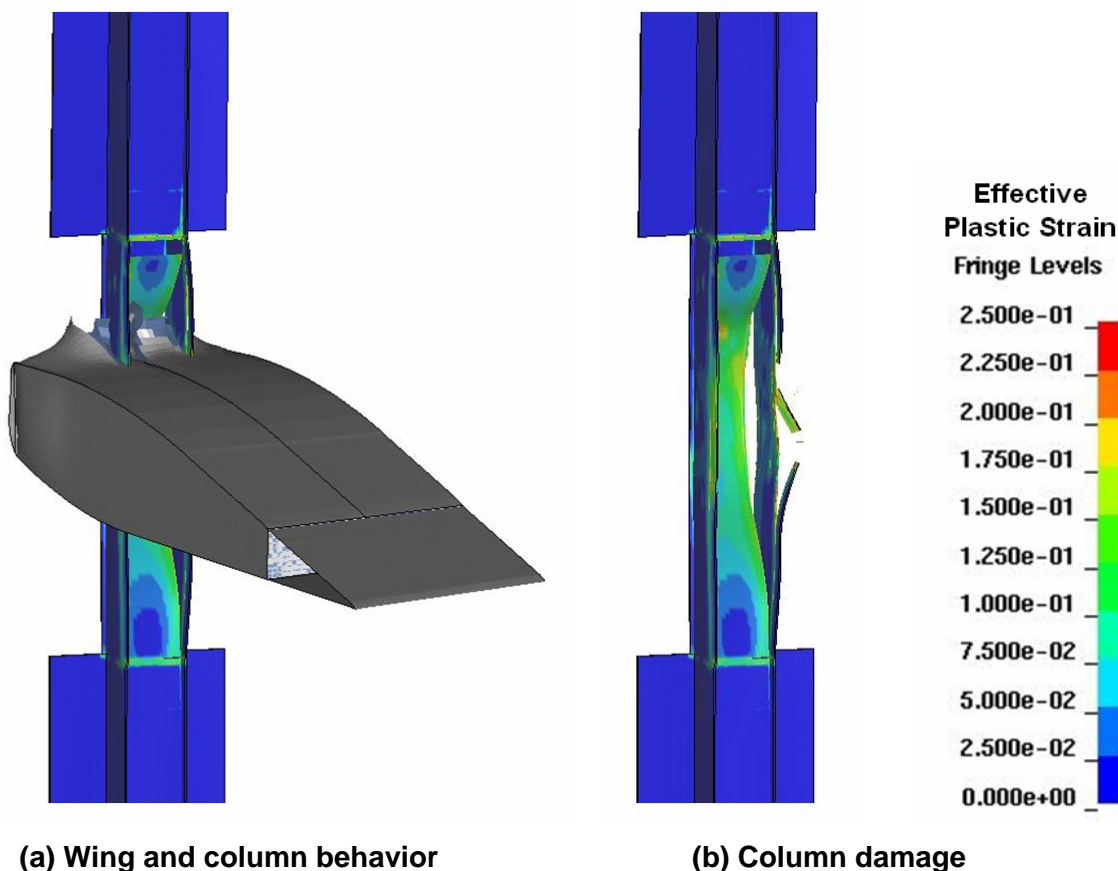
Figure 5–2. Calculated wing with fuel impact response on the exterior column.

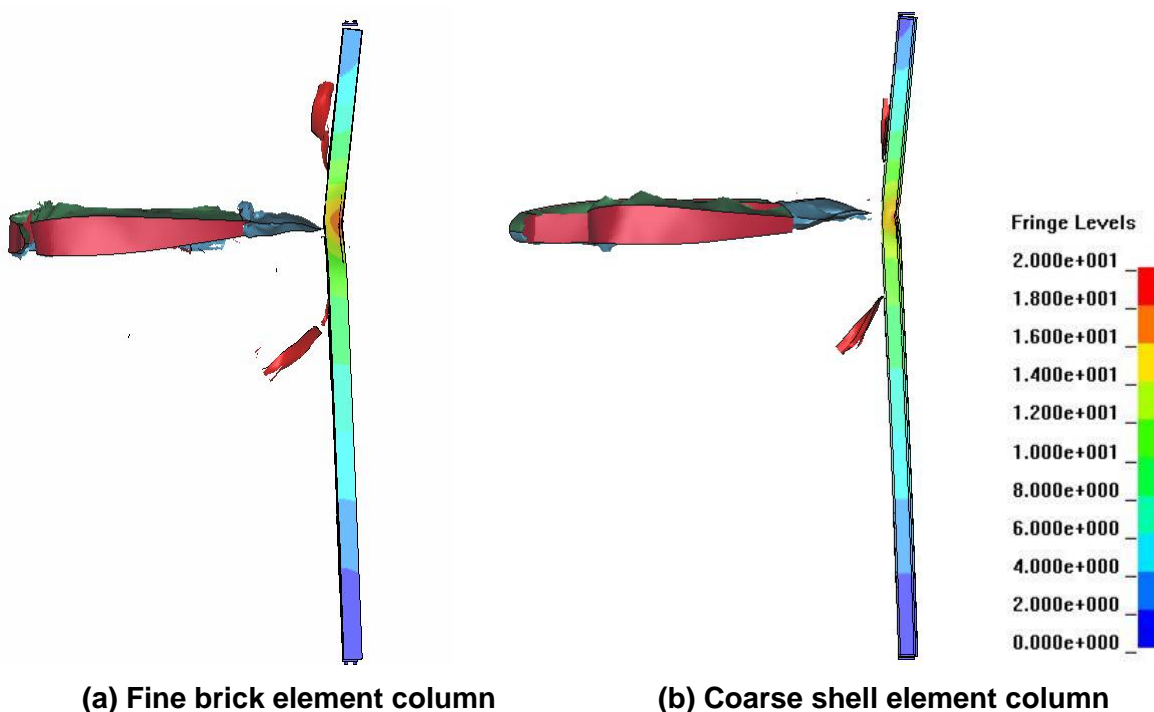
Figure 5–4. Exterior column response comparison, showing contours of the displacement magnitude (inches).

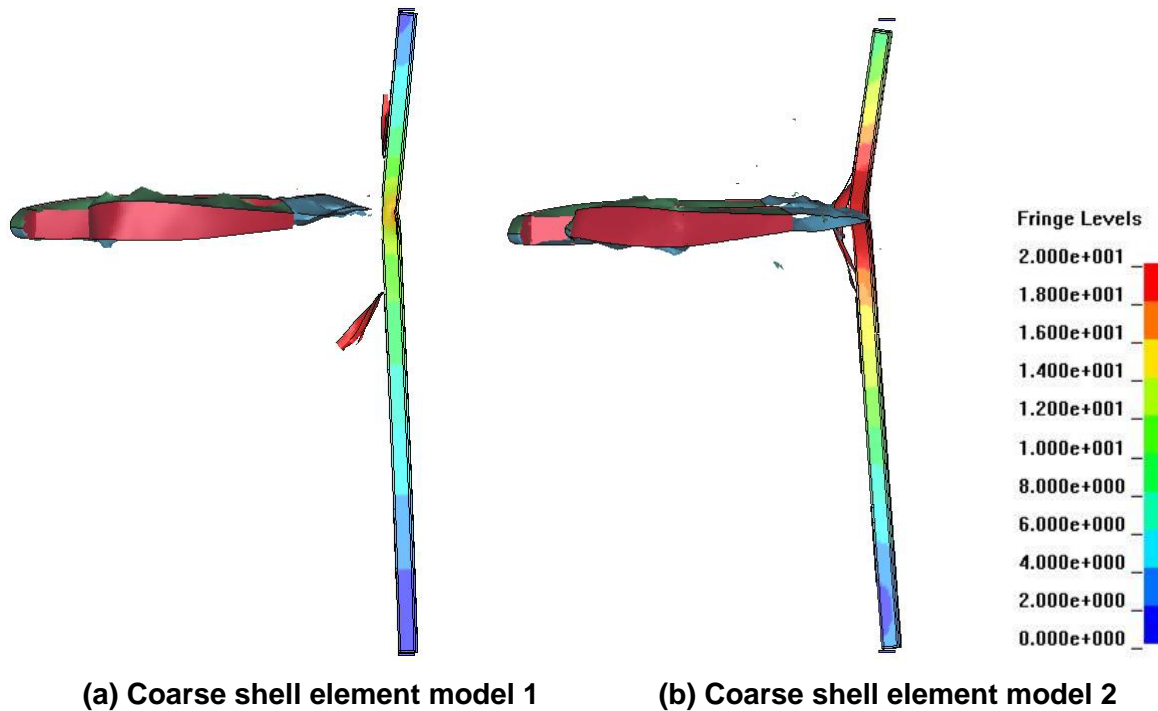
Figure 5–5. Exterior column response comparison, showing contours of the displacement magnitude (inches).

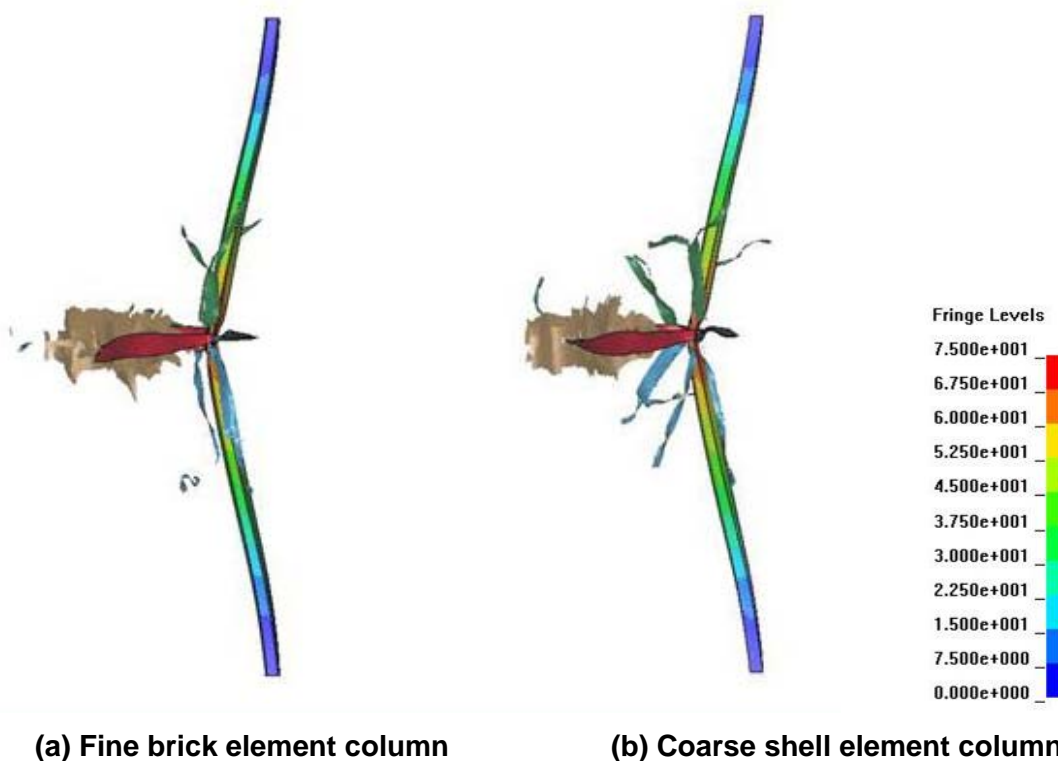
Figure 5–6. Wide flange core column response comparison, showing contours of the displacement magnitude (inches).

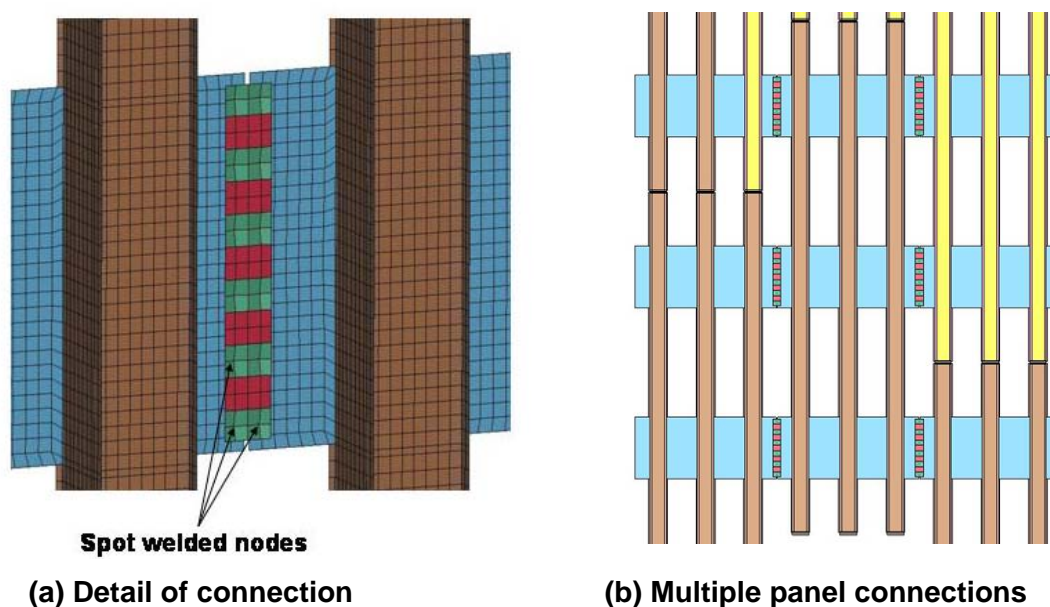
Figure 5–14. Bolted spandrel connection treatments.

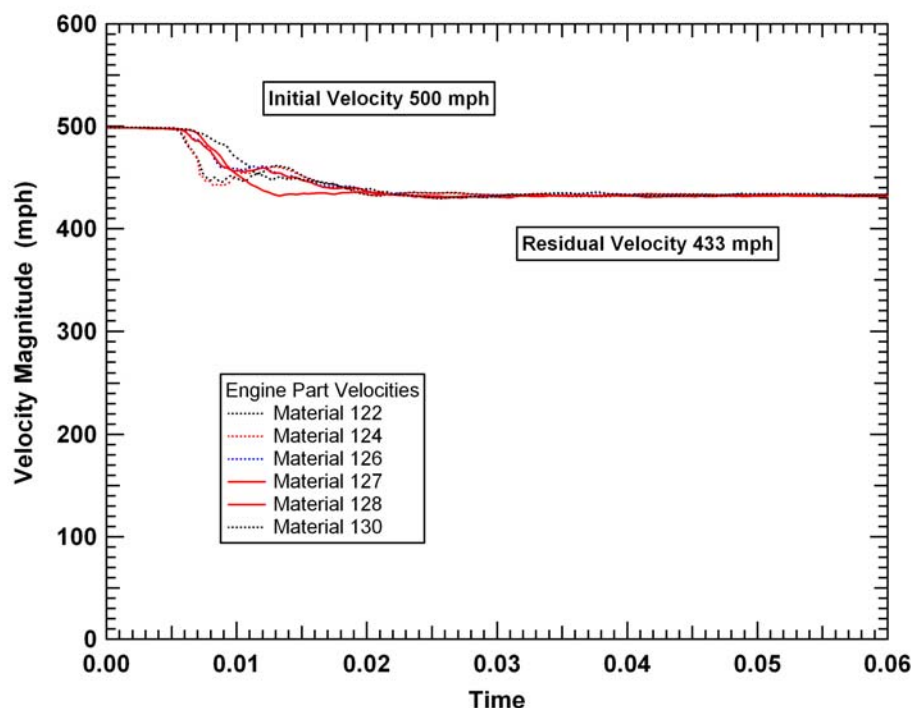
Figure 5–16. Engine velocity history for the exterior wall impact.

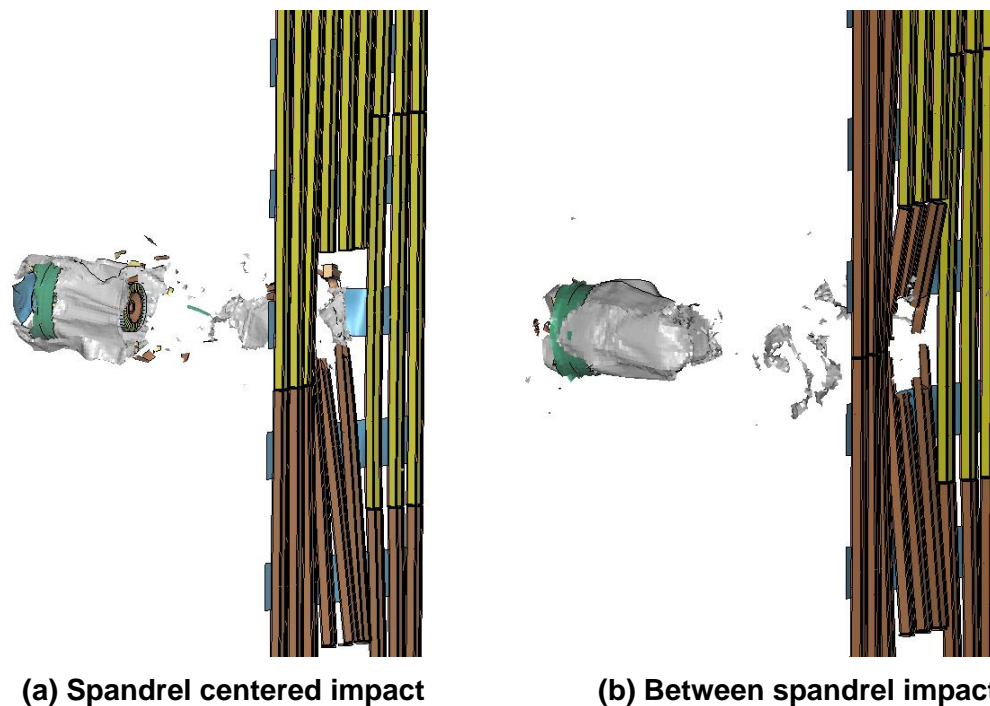
Figure 5-17. Example engine impact analysis with different impact locations.

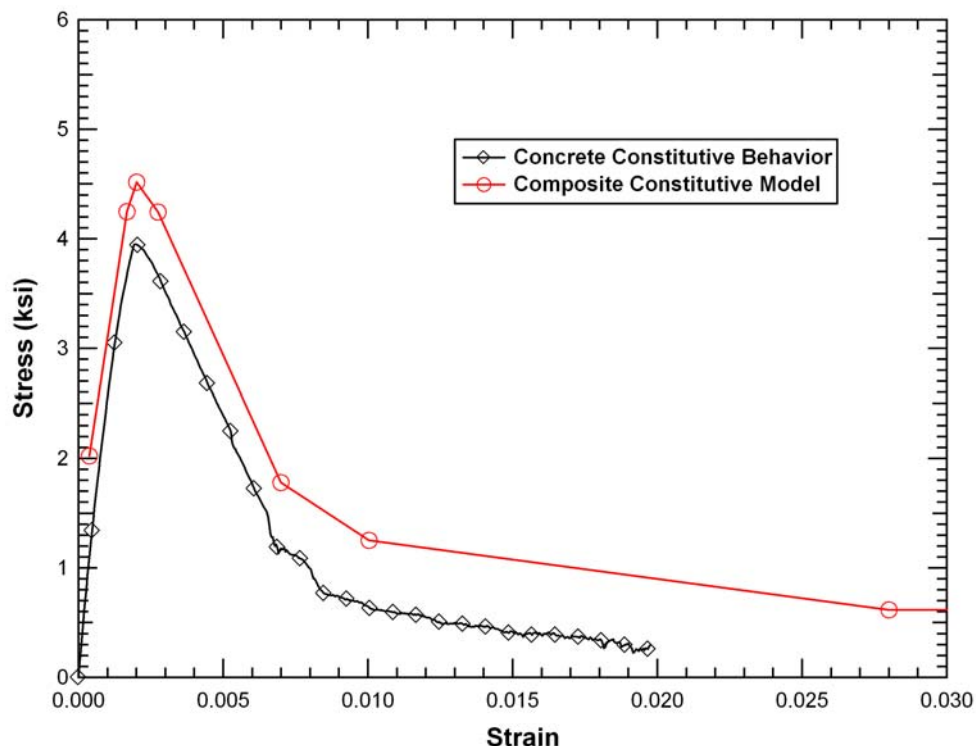
Figure 5–24. Constitutive behavior for the combined concrete and metal decking.

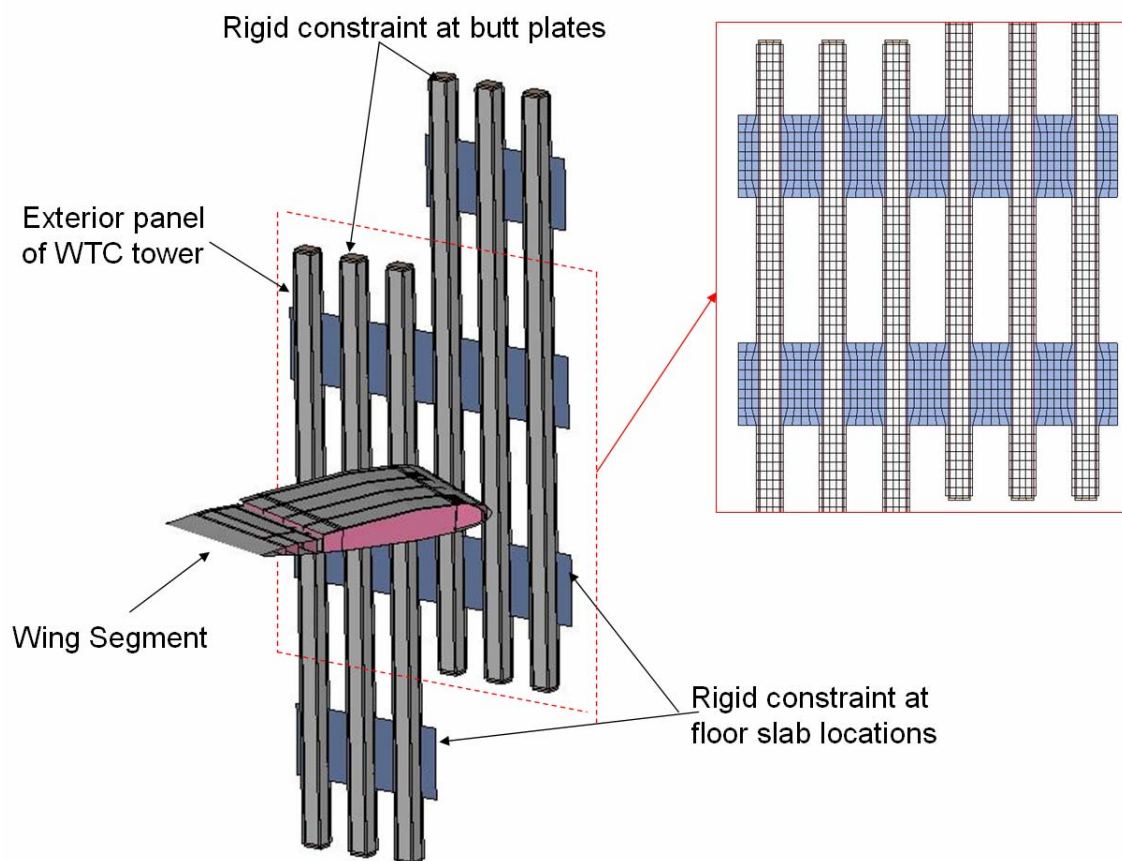
Figure 5–28. Empty wing section impact model with two exterior panels.

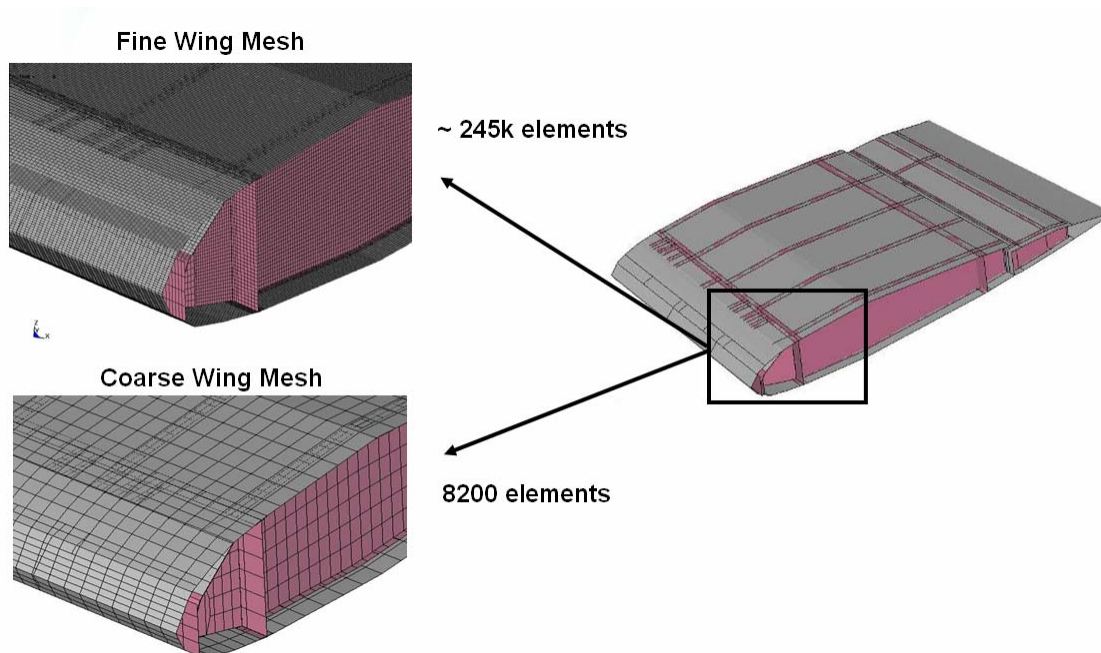
Figure 5–30. Coarse and fine mesh used in the small wing component model.

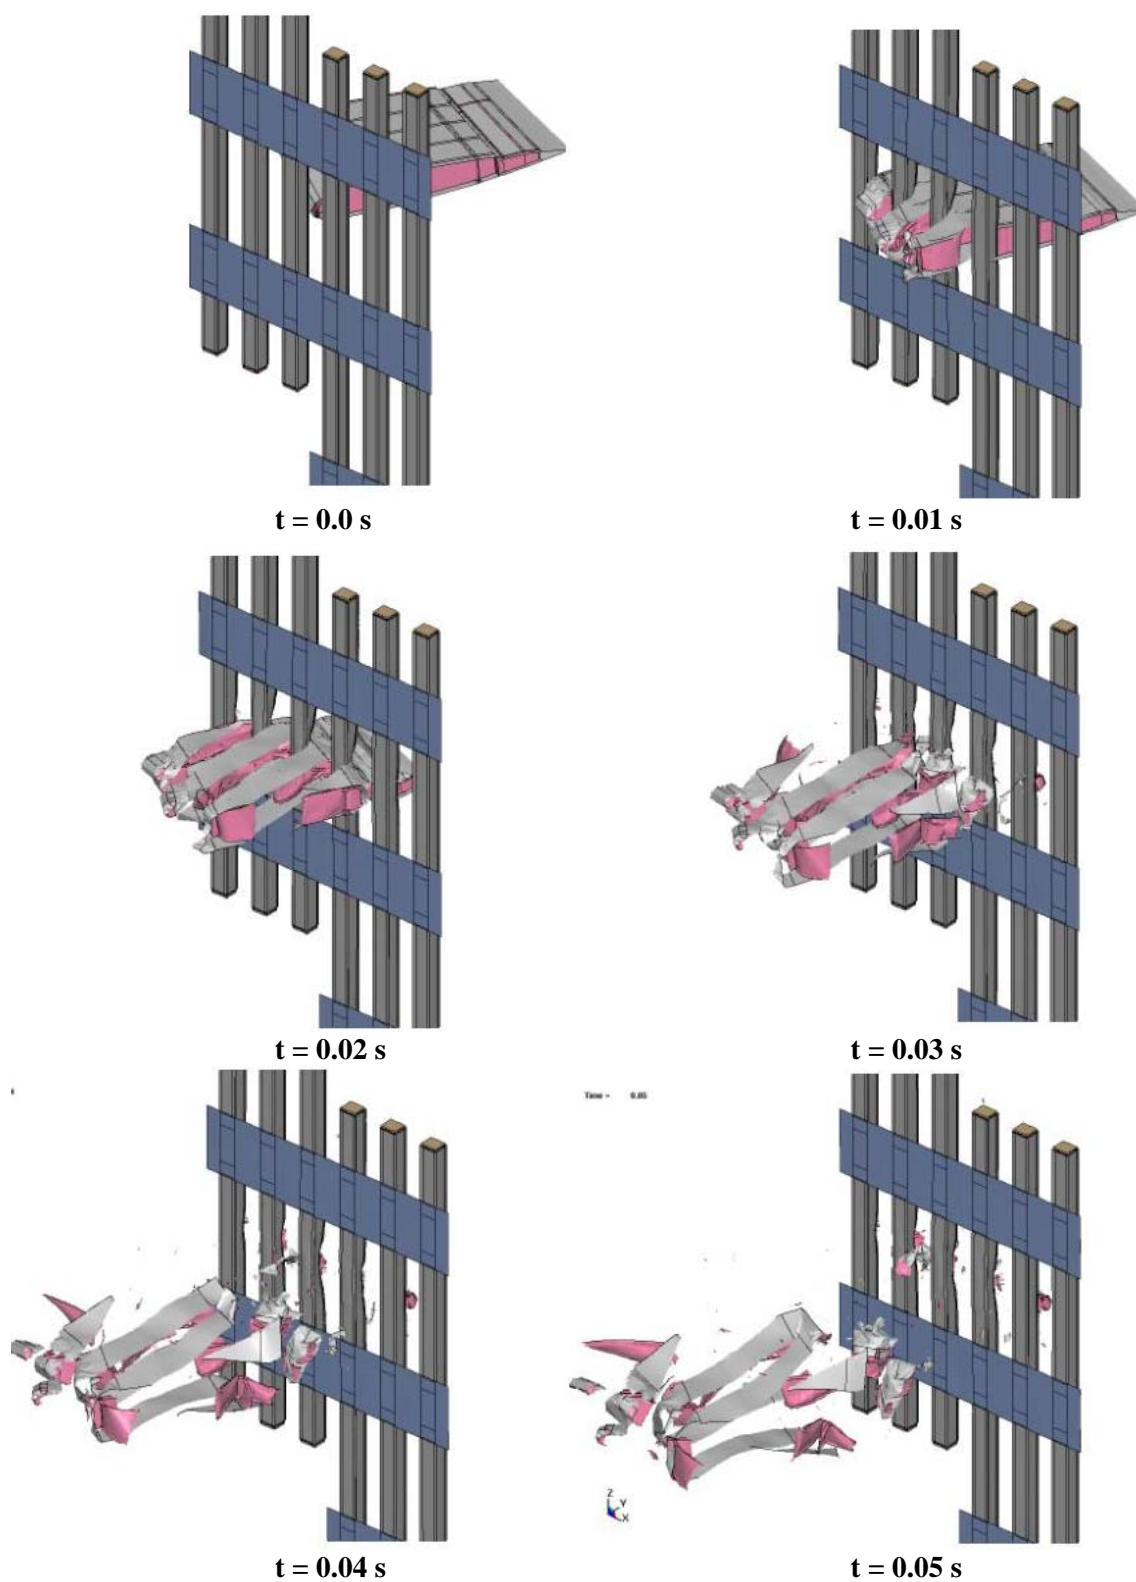
Figure 5–31. Calculated impact of a fine-mesh empty wing section with two exterior panels at 442 mph.

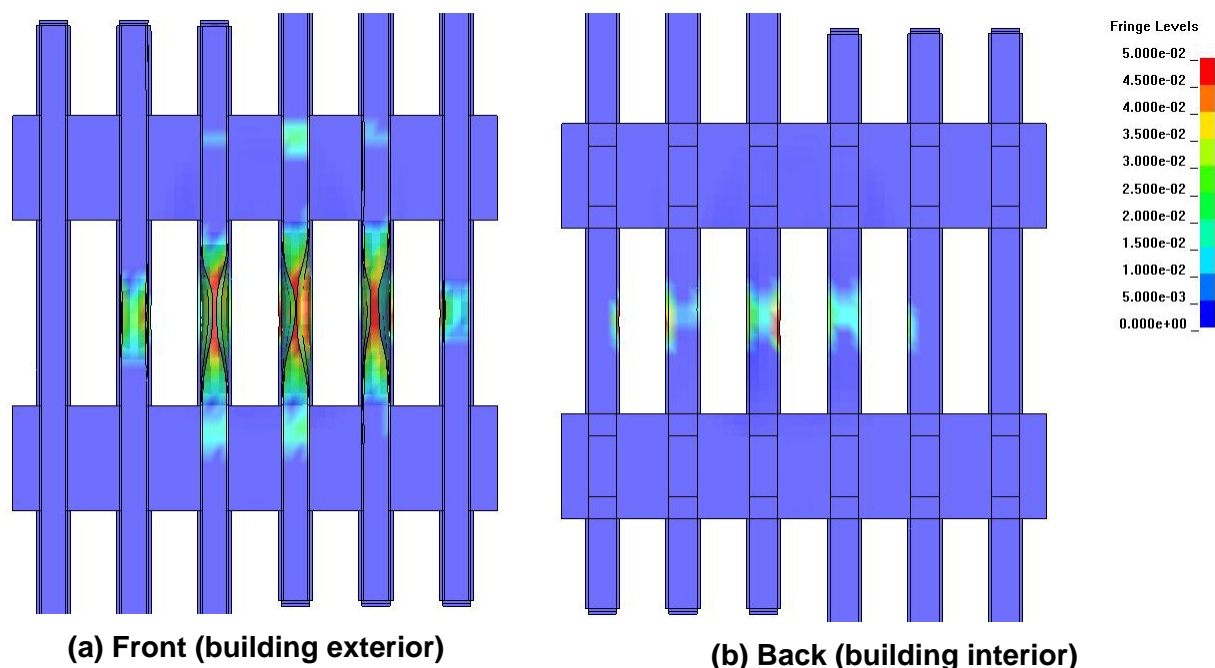
Figure 5–32. Fine-mesh empty wing section impact damage to the exterior panel.

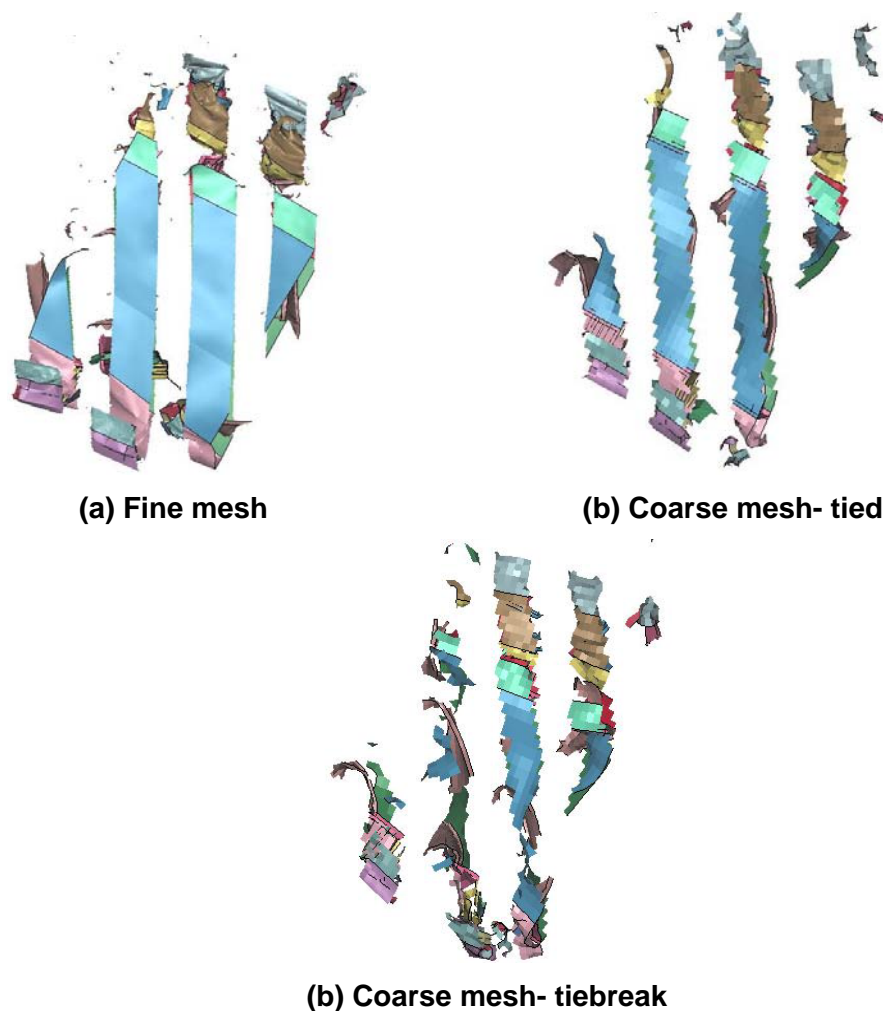
Figure 5–35. Fine and coarse mesh fragmentation.

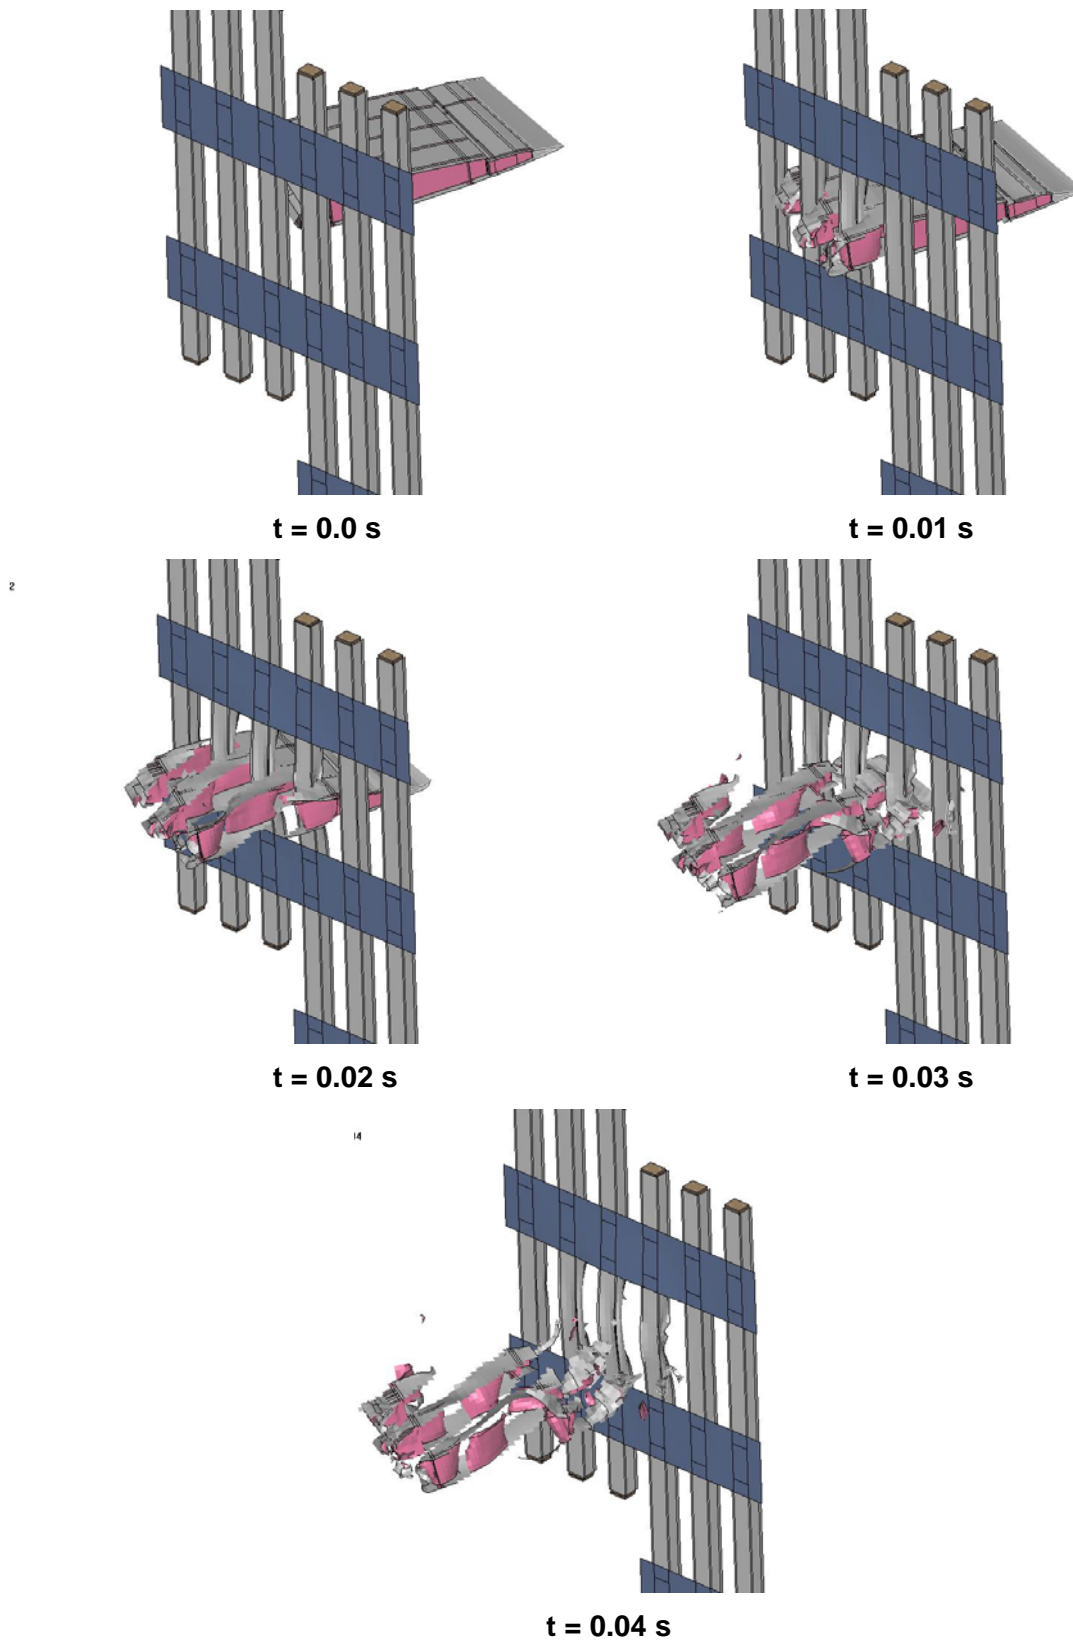
Figure 5–37. Calculated impact of a coarse-mesh empty wing section with two exterior panels at 442 mph.

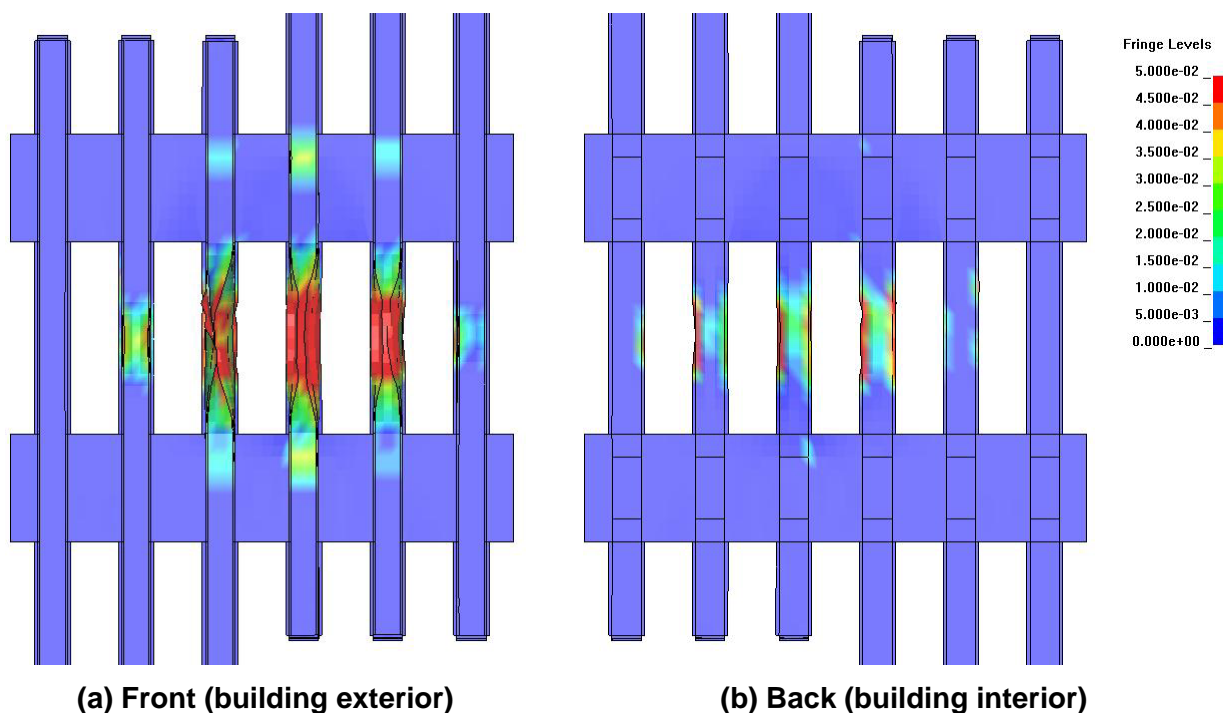
Figure 5–38. Impact damage to the exterior panel from a coarse-mesh empty wing section at 442 mph contours of effective plastic strain are shown.

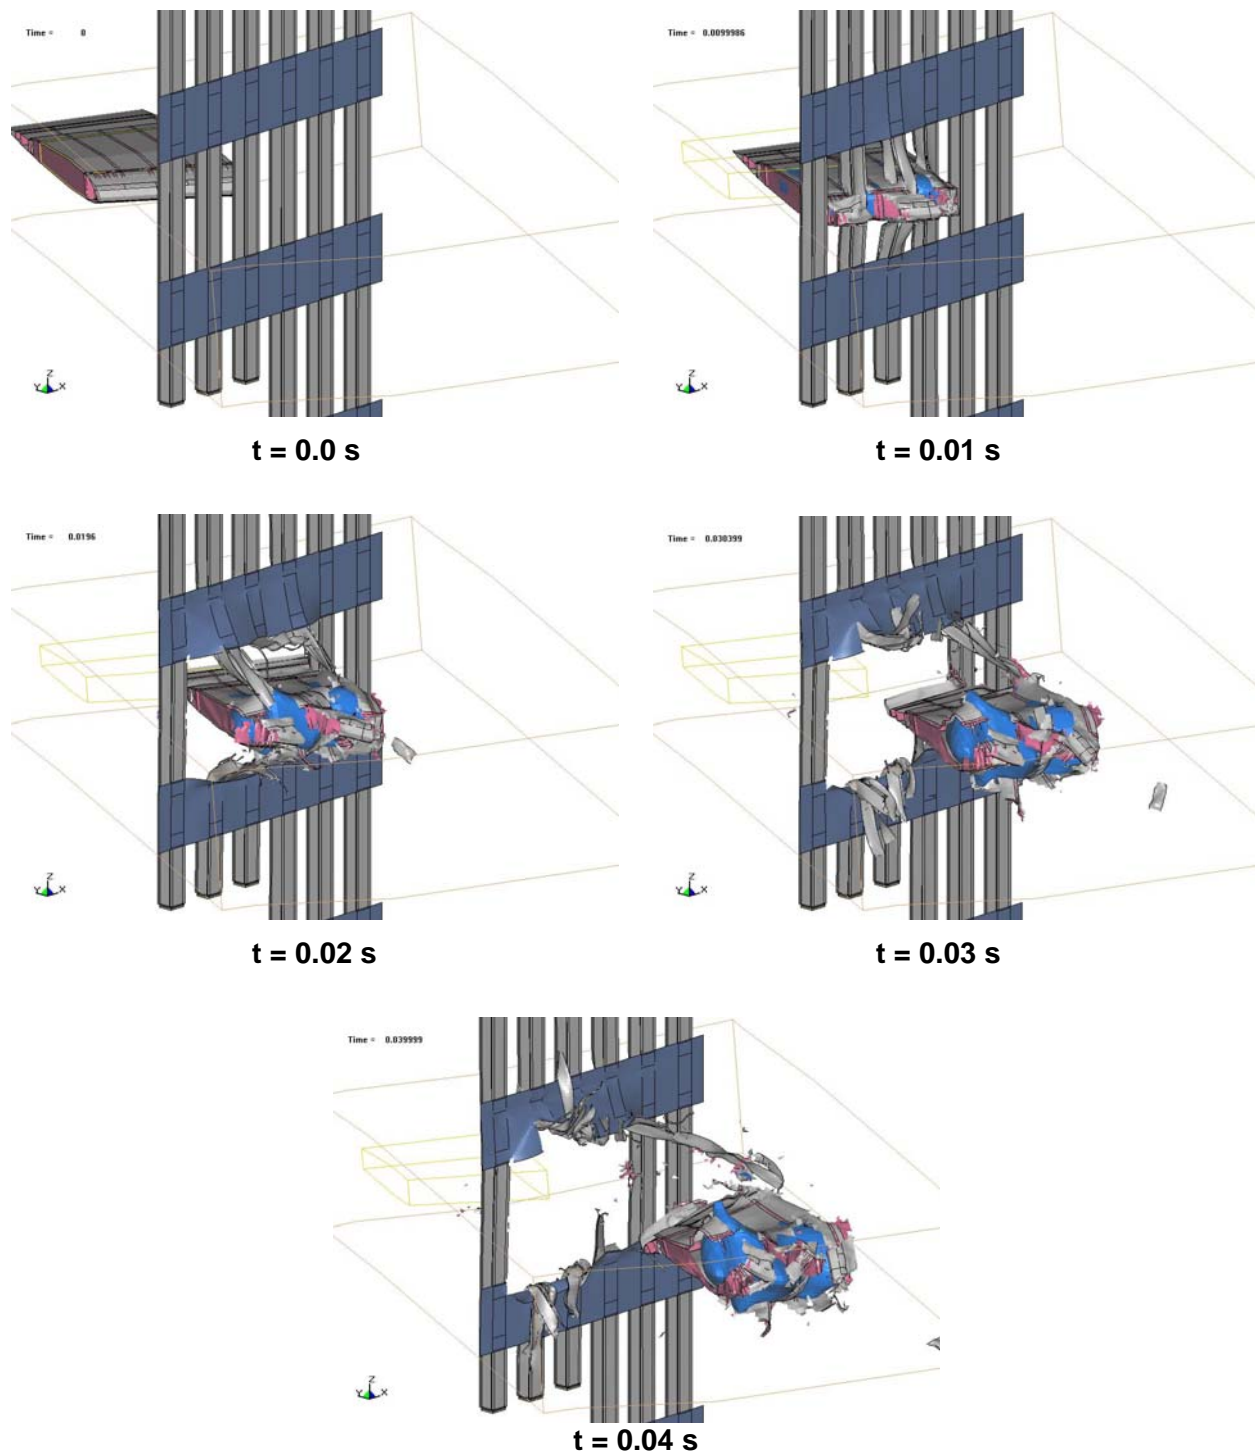
Figure 5–42. Calculated impact of a coarse mesh wing section laden with fuel modeled using ALE elements.

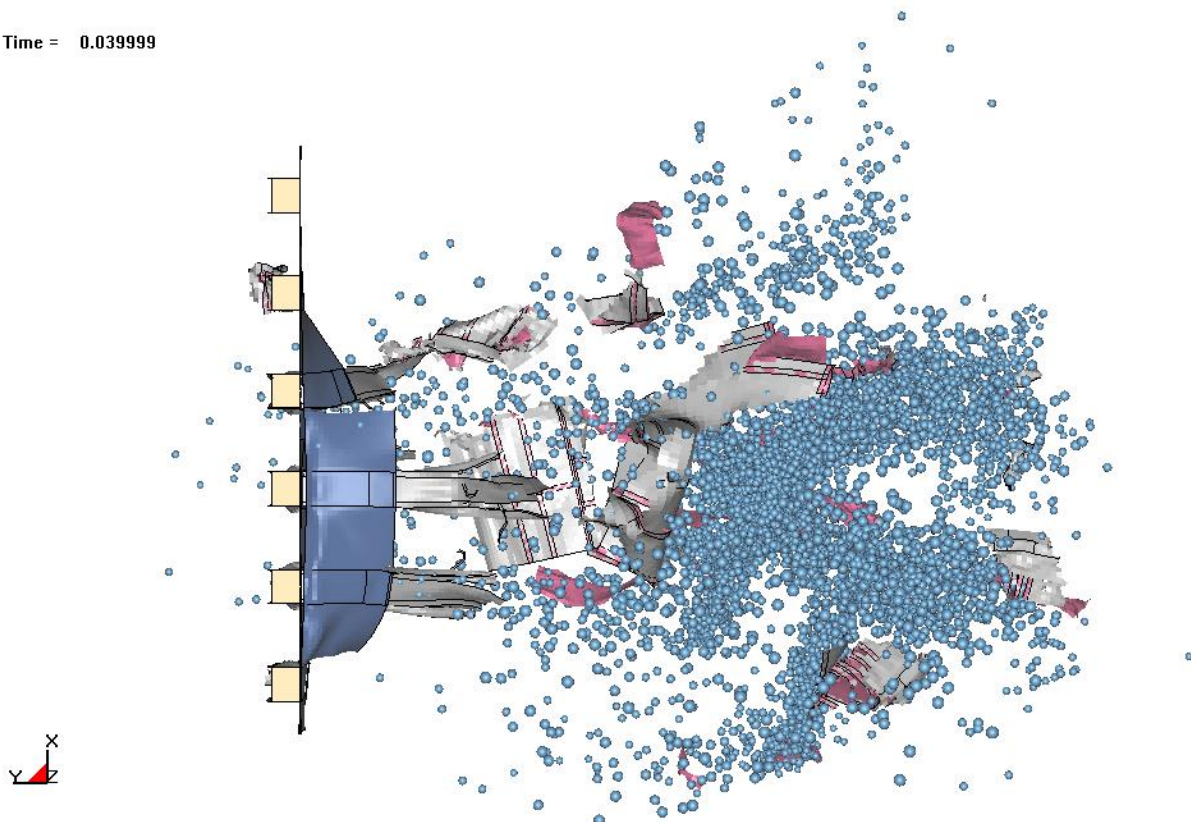
Figure 5-45. SPH analysis of structural damage and fuel dispersion at 0.04s (top view).

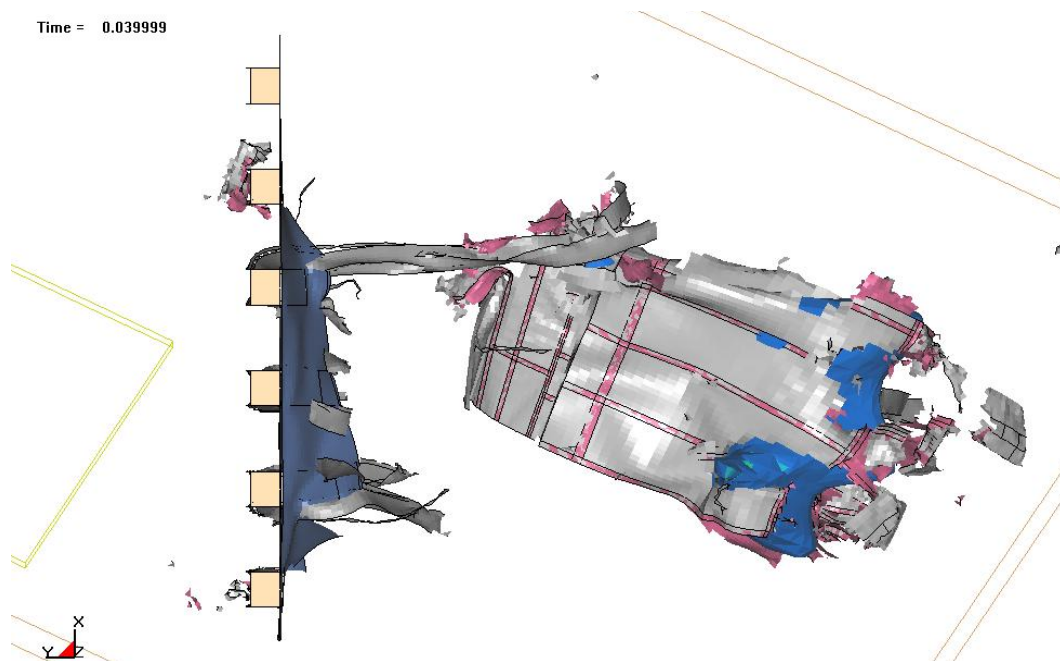
Figure 5–46. ALE analysis of structural damage and fuel dispersion at 0.04s (top view).

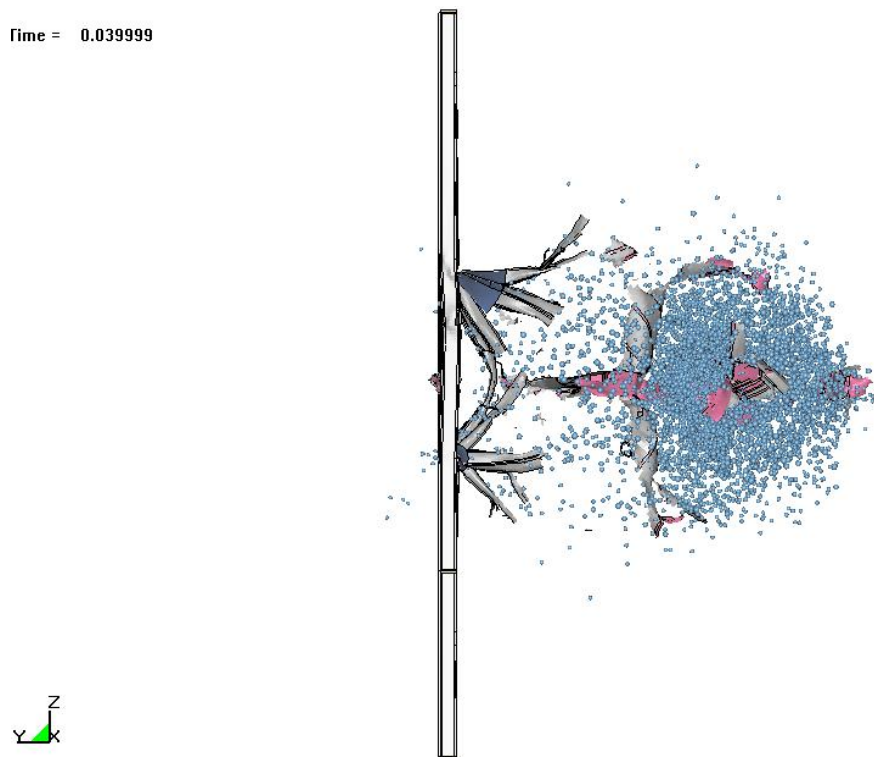
Figure 5–47. SPH analysis of structural damage and fuel dispersion (side view).

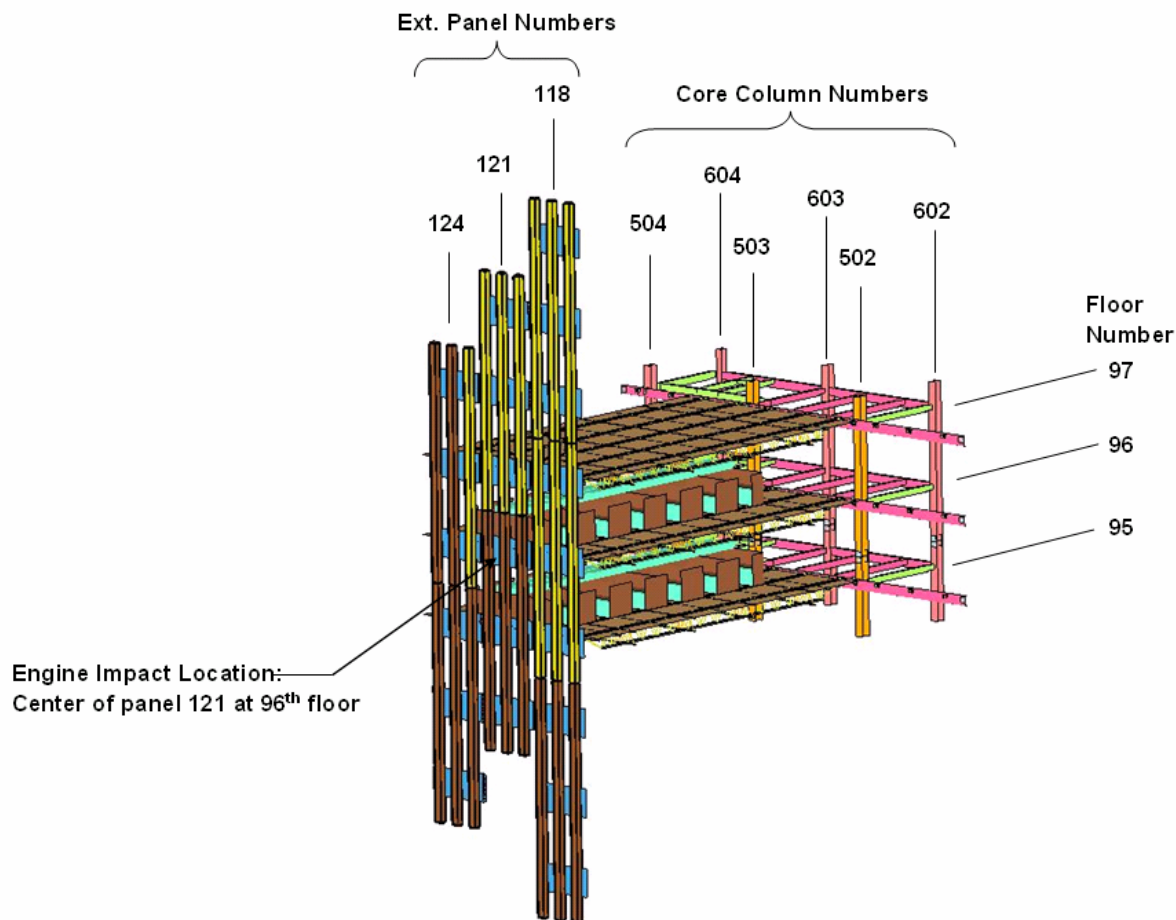
Figure 6–3. Final WTC tower subassembly model.

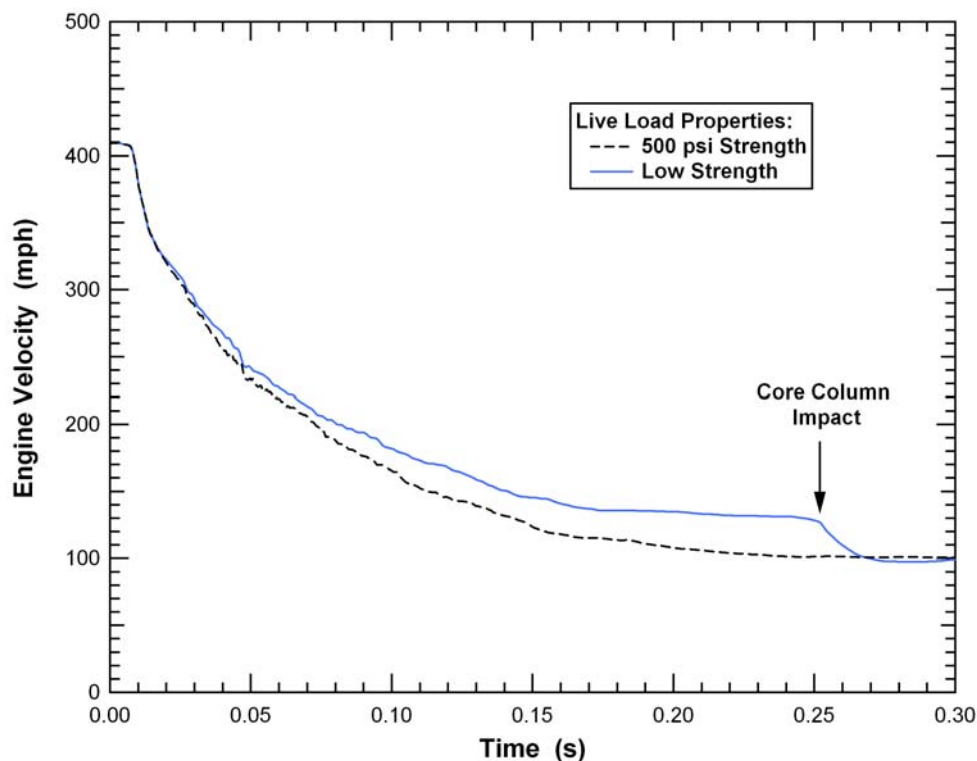
Figure 6–9. Effect of the building content strength on engine impact behavior.

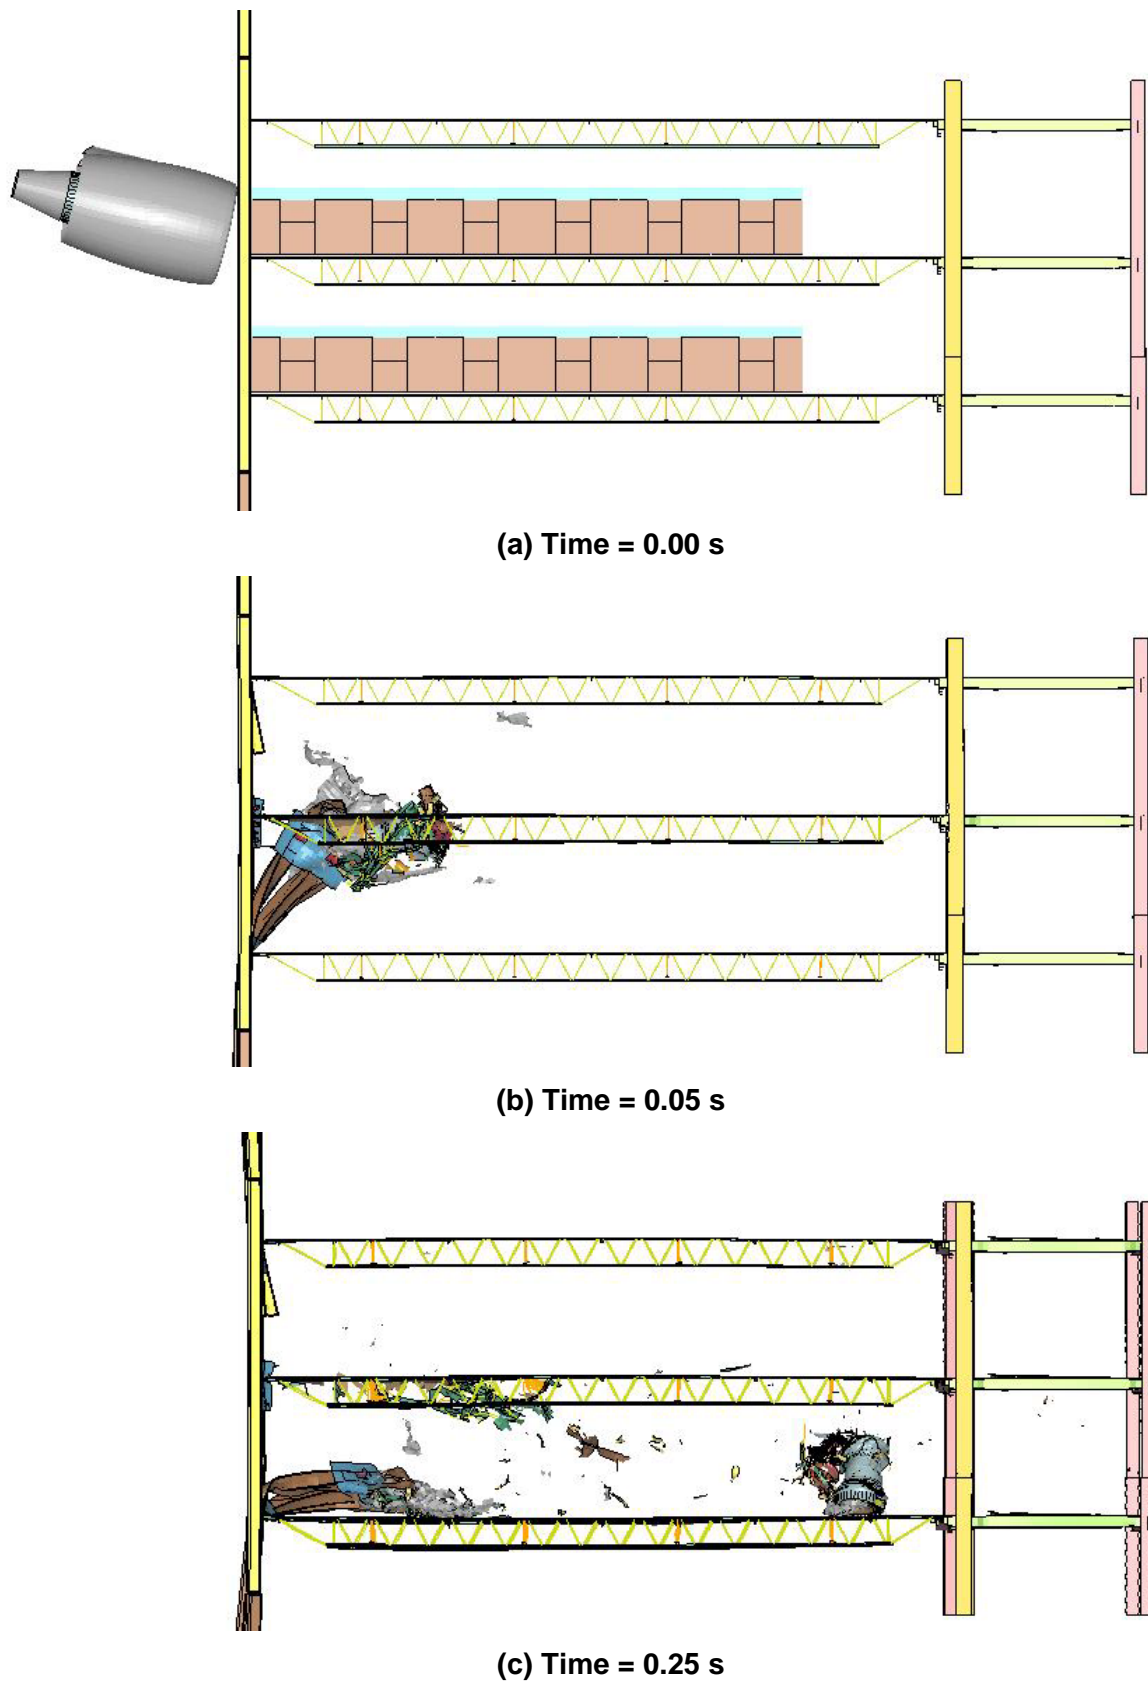
Figure 6–10. Engine impact for concrete strength evaluation (side view).
