NIST NCSTAR 1-2B (Draft)

**Federal Building and Fire Safety Investigation of the
World Trade Center Disaster**

Analysis of Aircraft Impacts into the World Trade Center Towers (Draft)

September 2005

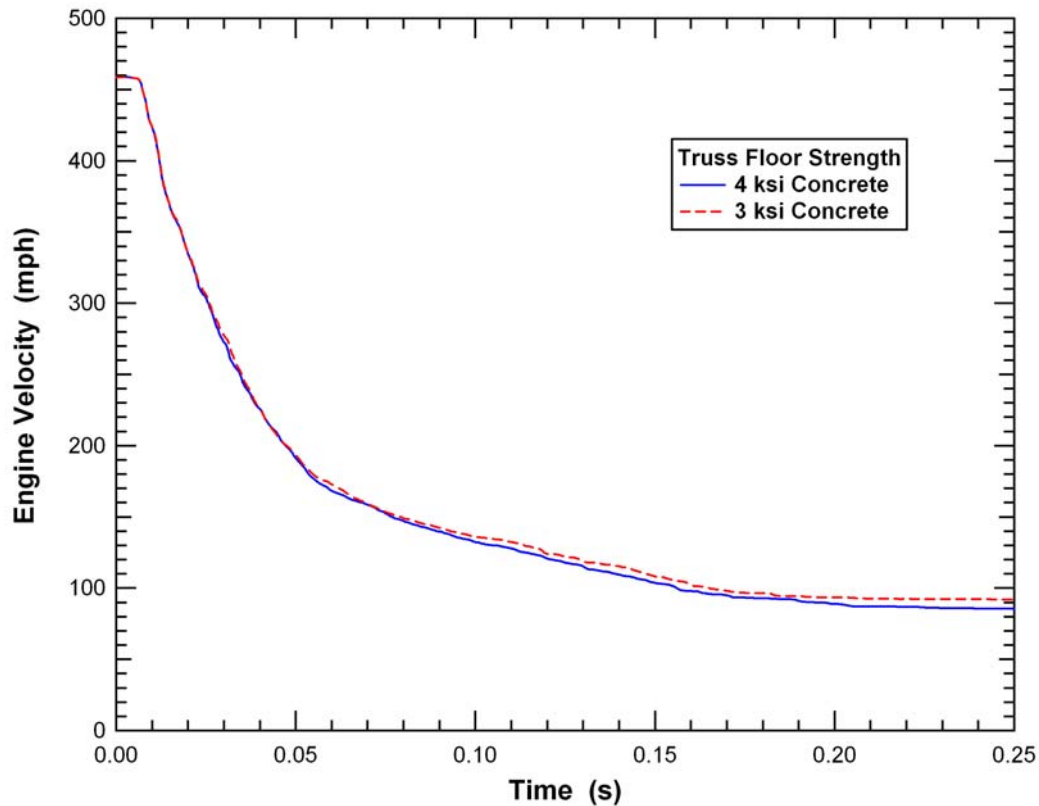
Figure 6–11. Effect of the concrete strength on engine impact behavior.

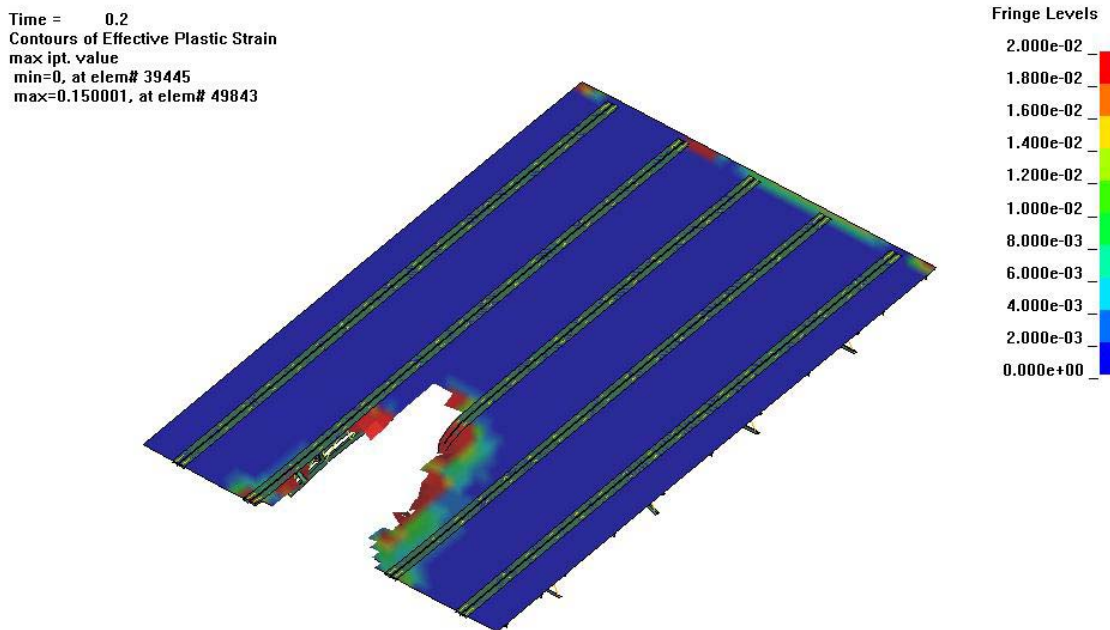
(a) 4 ksi concrete truss floor damage

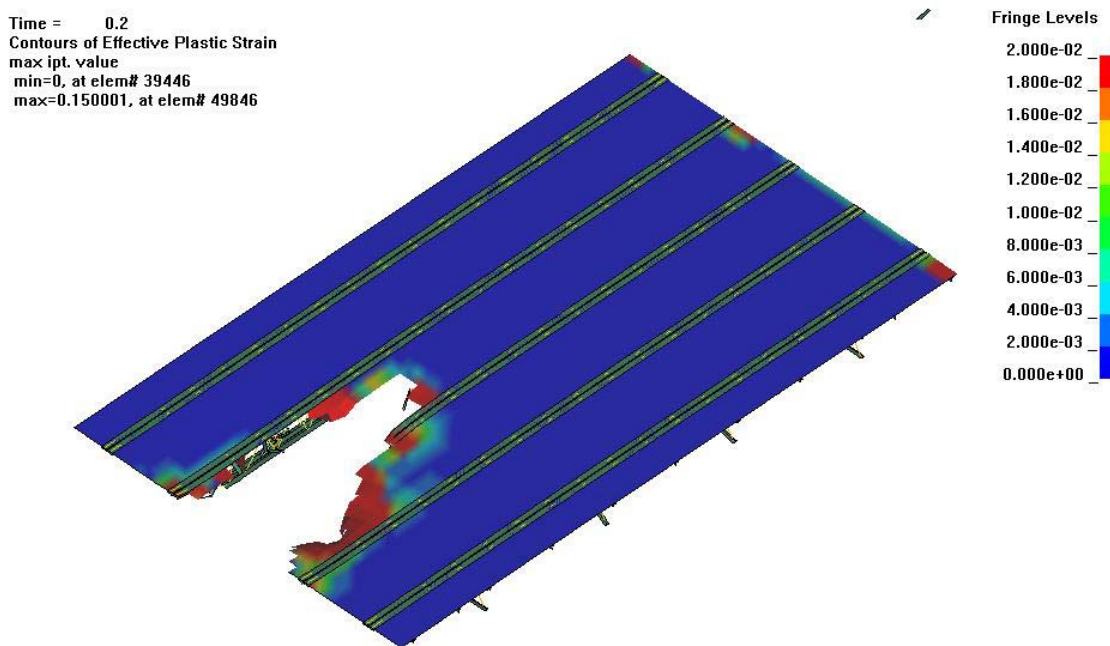
(b) 3 ksi concrete truss floor damage

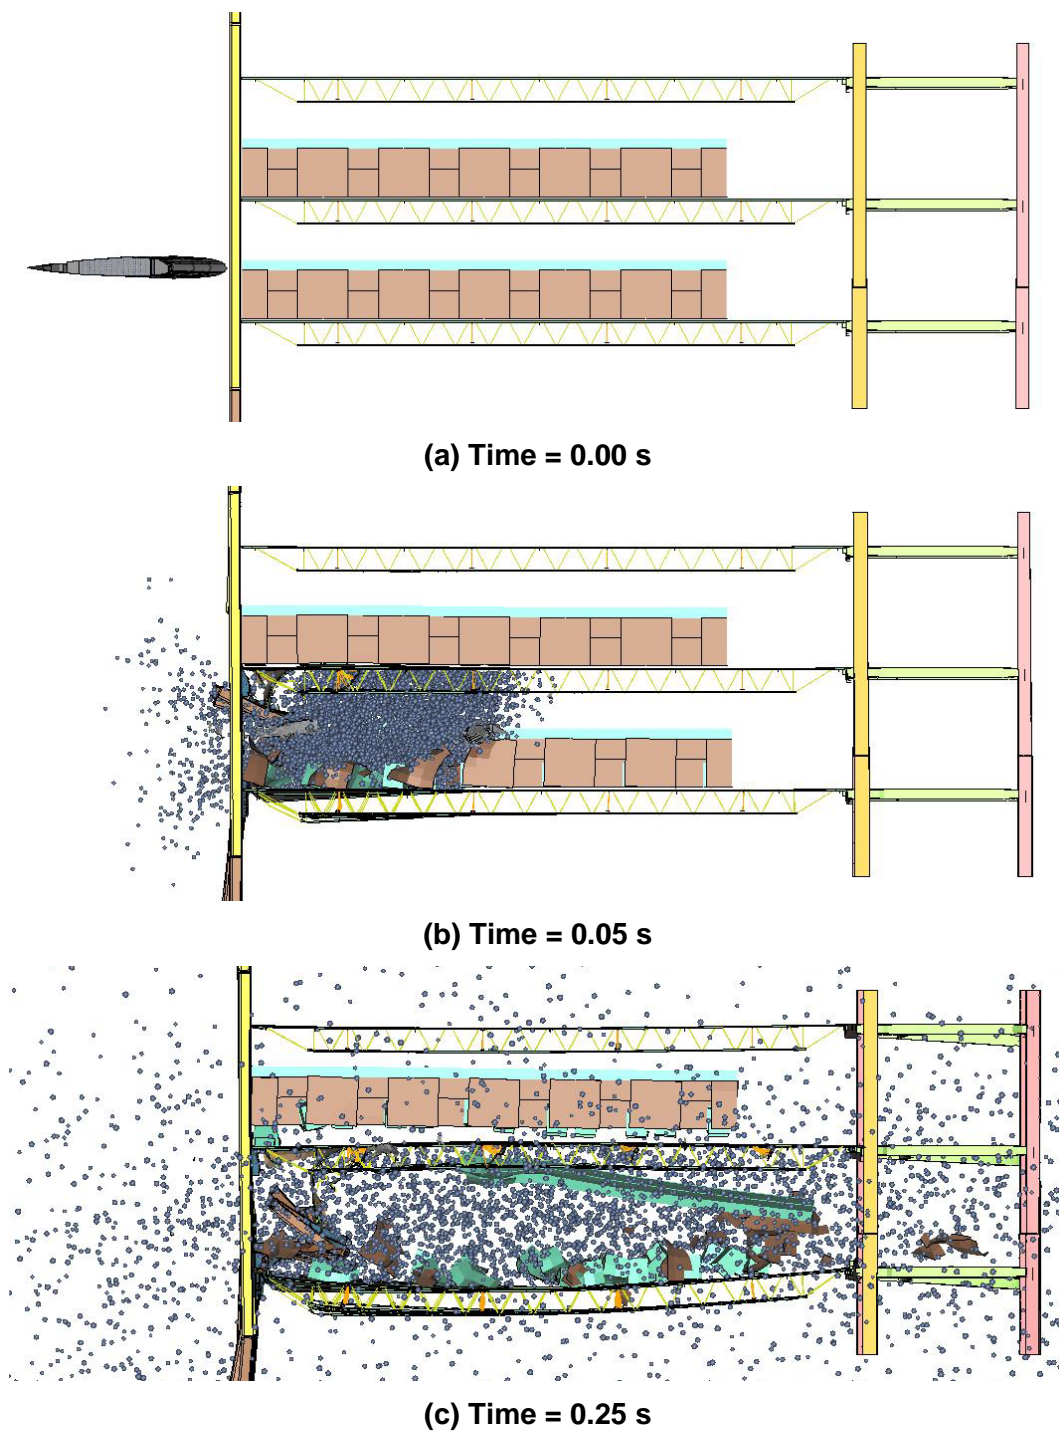
Figure 6–14. Baseline wing section impact and break up behavior (side view).

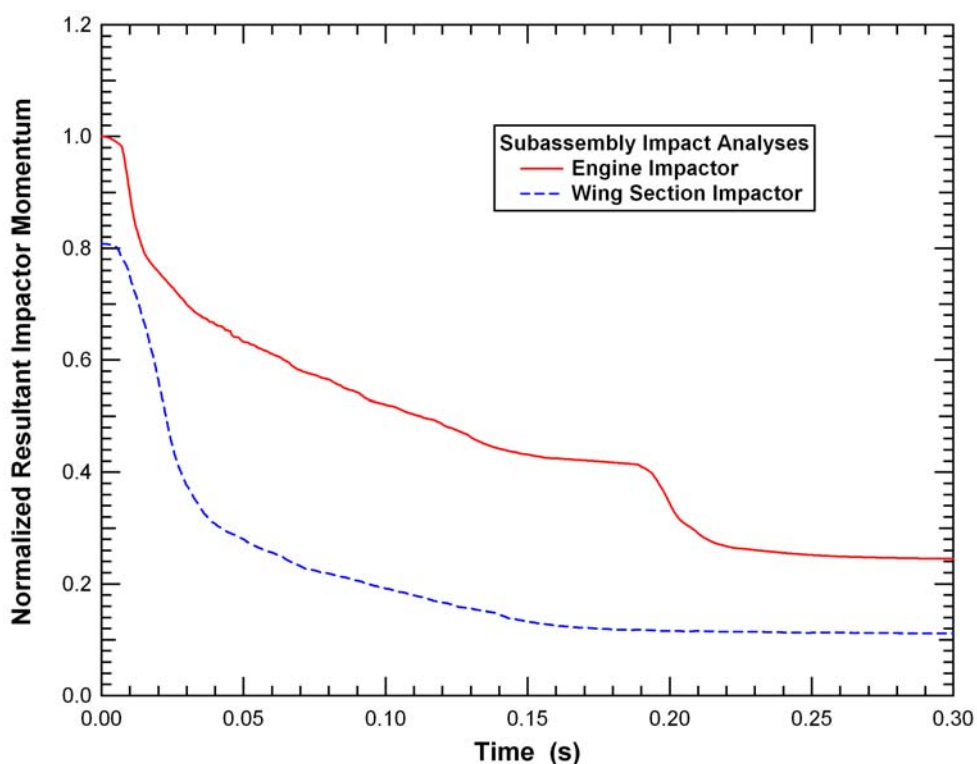
Figure 6–15. Impactor momentum histories for the engine and wing section analyses.

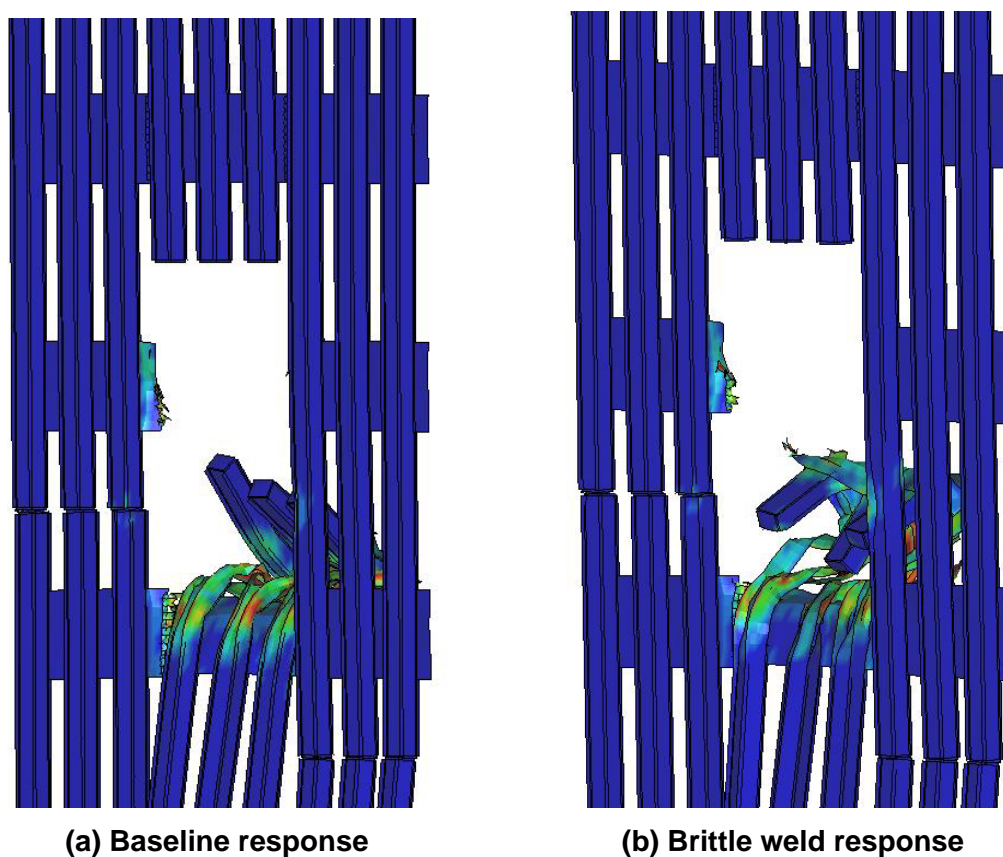
Figure 6–16. Exterior wall damage for the wing section impact analyses.

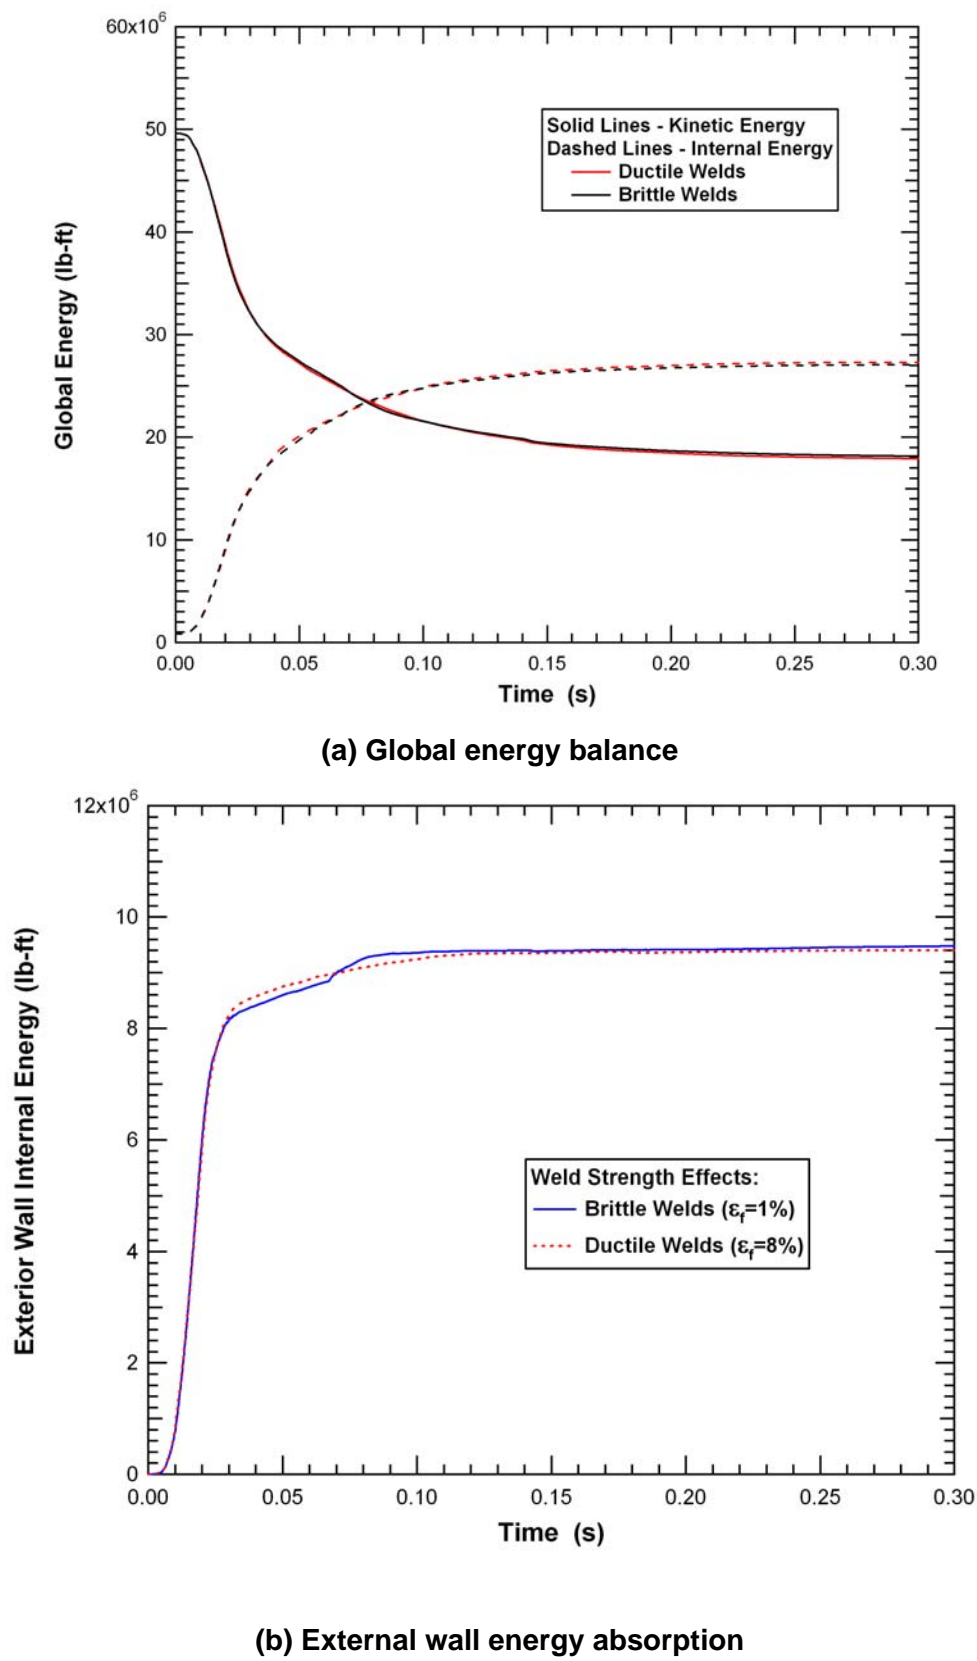
Figure 6-17. Effect of the weld strength on wing section impact response.

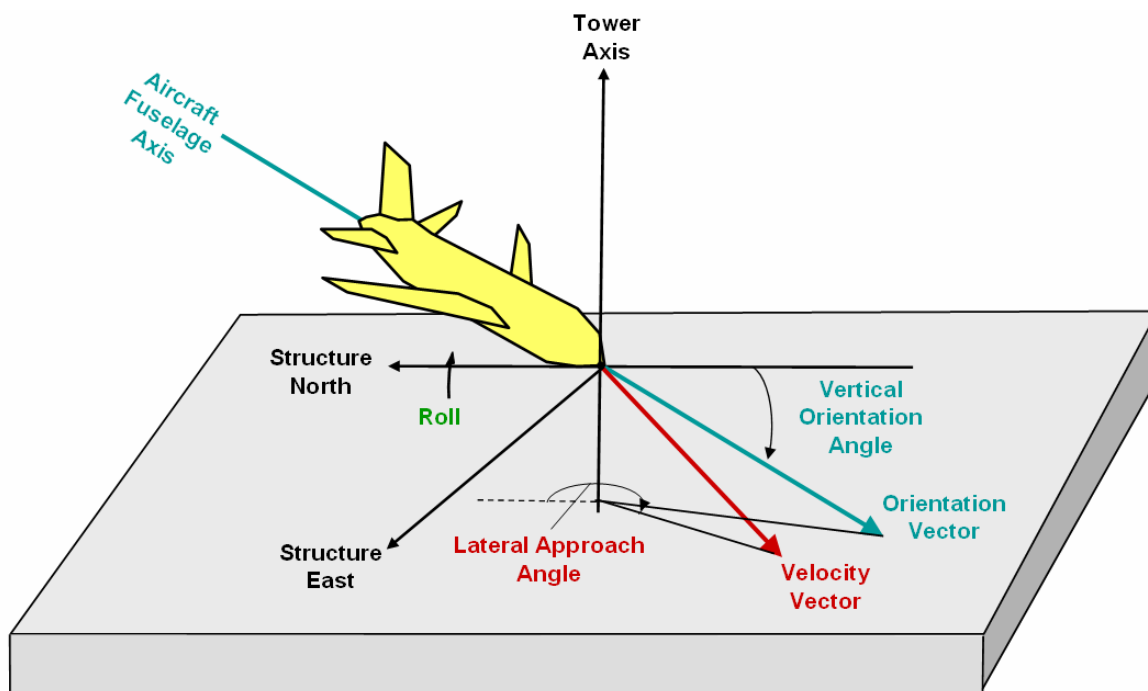
Figure 7–1. Definitions of the aircraft impact parameters.

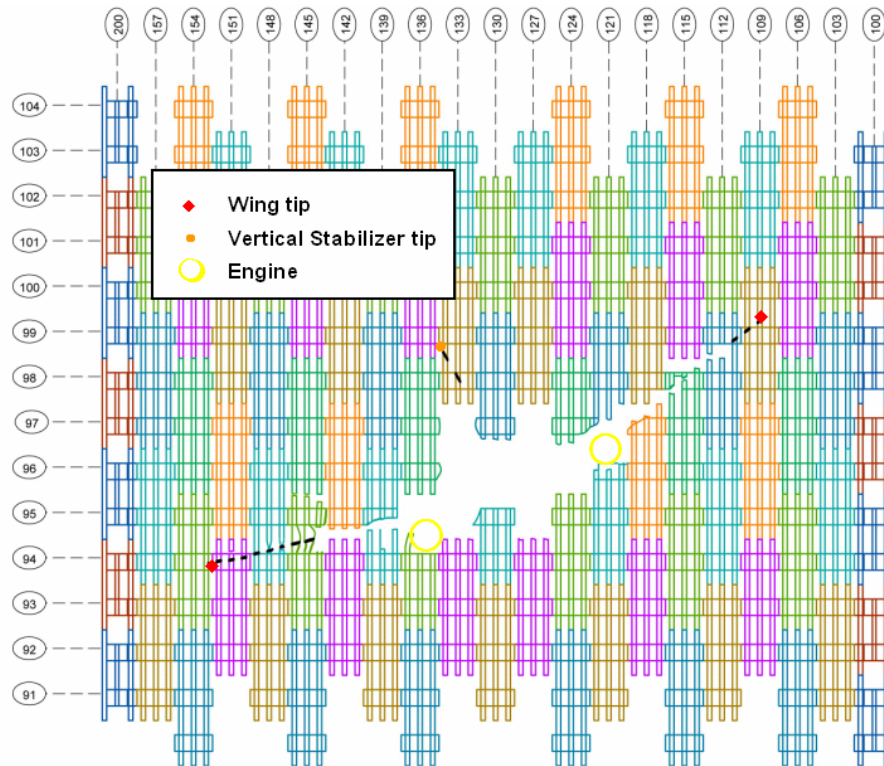
Figure 7–7. Estimated impact locations of aircraft components superimposed on the damaged face of WTC 1.

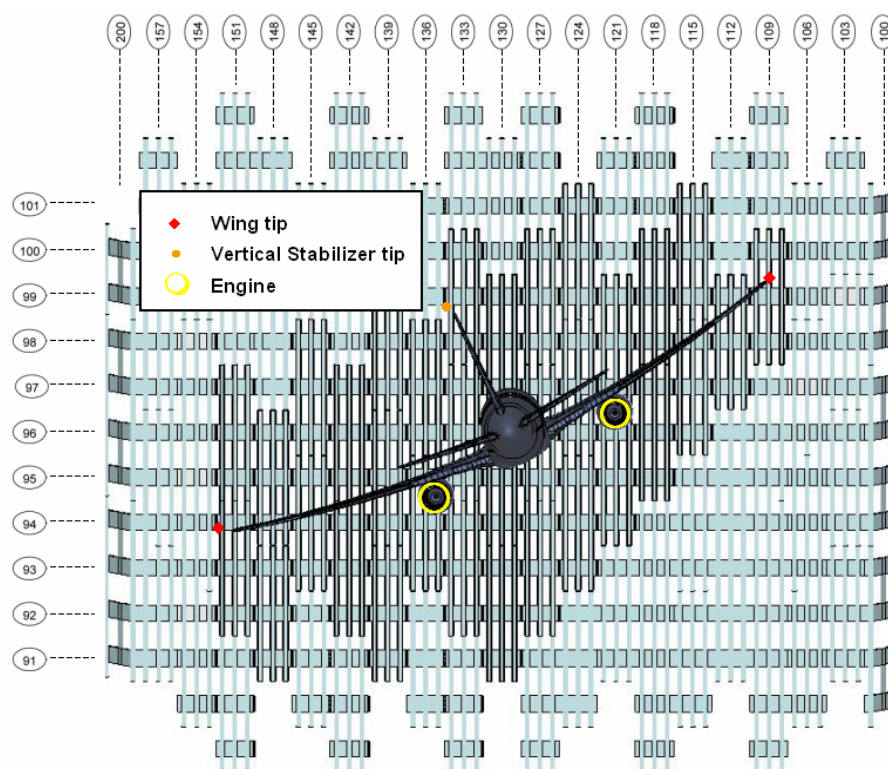
Figure 7–8. An orientation and trajectory of AA 11 that matches the impact pattern (vertical approach angle = 10.6°, lateral approach angle = 0°).

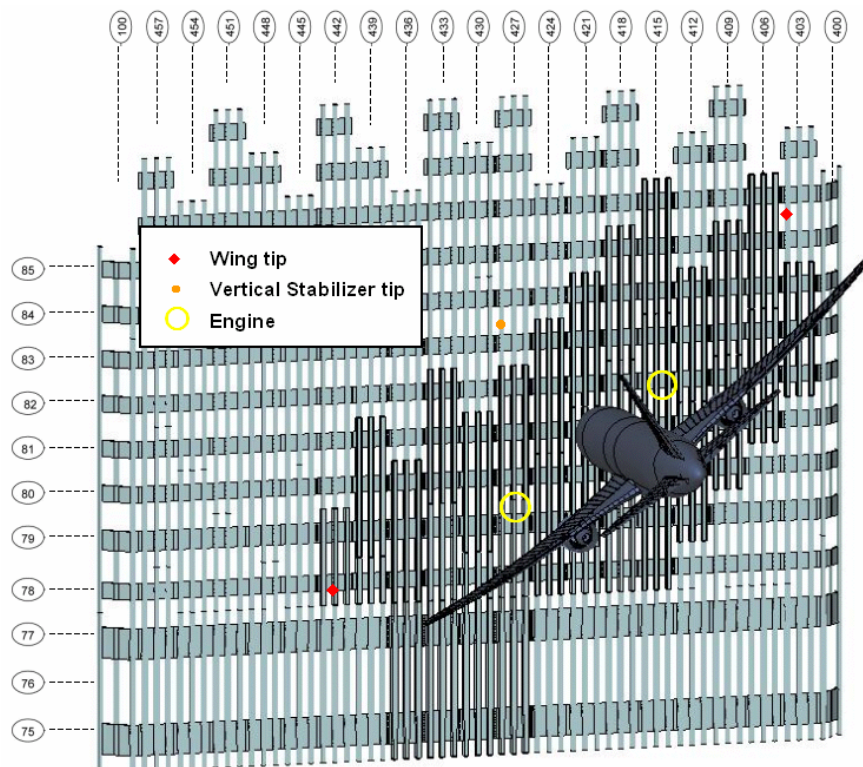
Figure 7-10. Baseline orientation and trajectory of UAL 175 from video analysis.

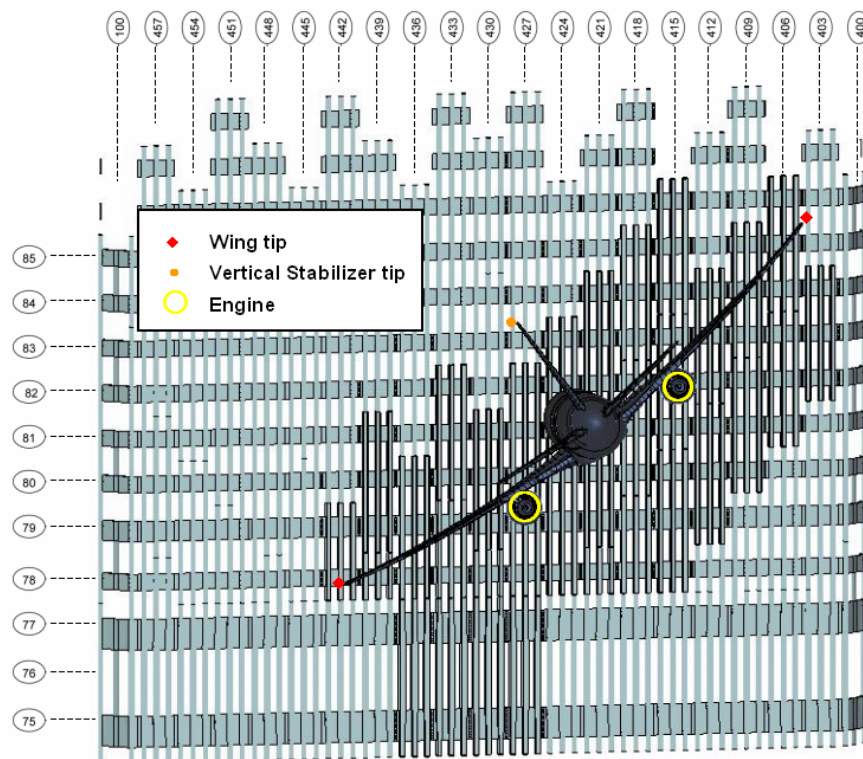
Figure 7-11. An orientation and trajectory of UAL 175 that matches the impact pattern (vertical approach angle = 6°, lateral approach angle = 13°).

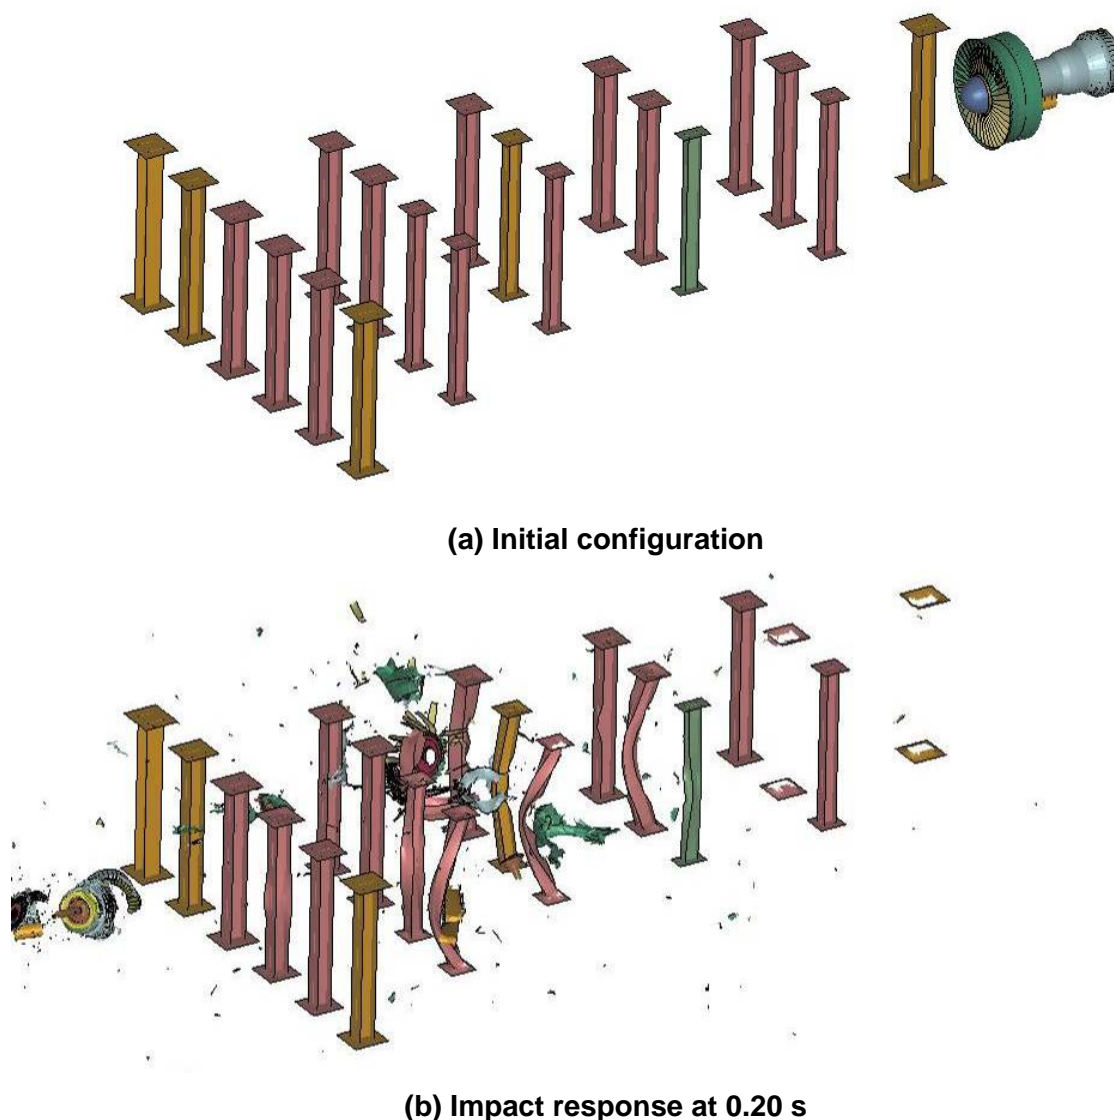
Figure 8–1. Example engine impact into an assembly of core columns.

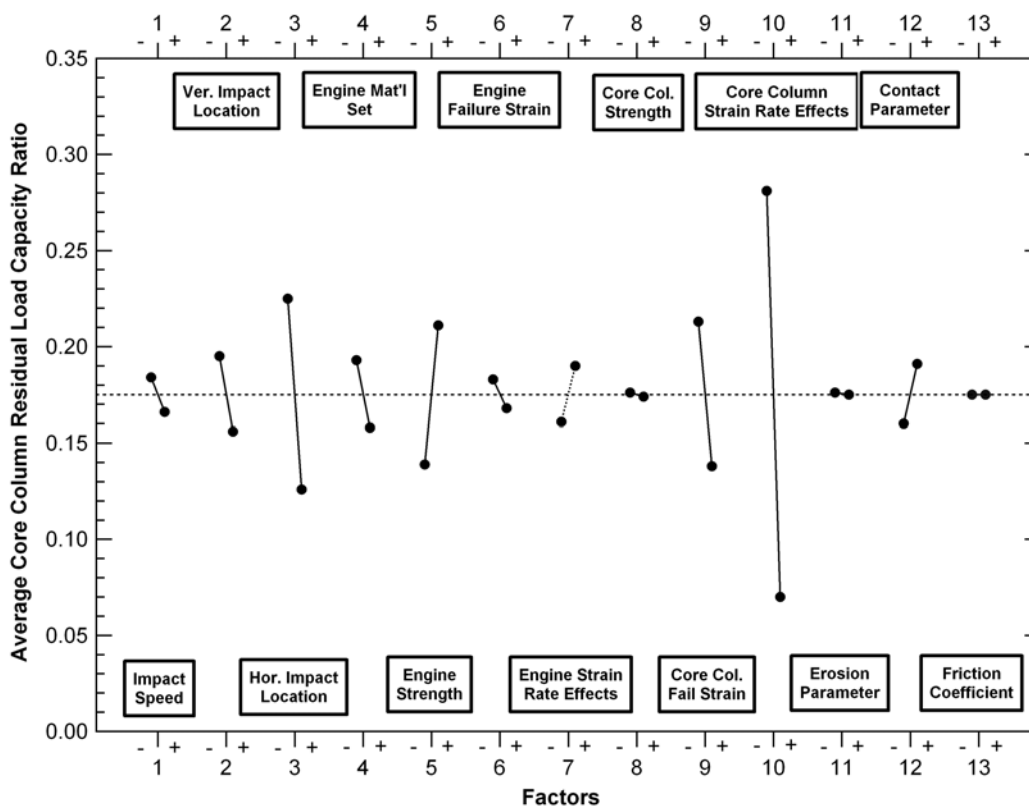
Figure 8-3. Main effects plot for the engine - core column impact analyses.

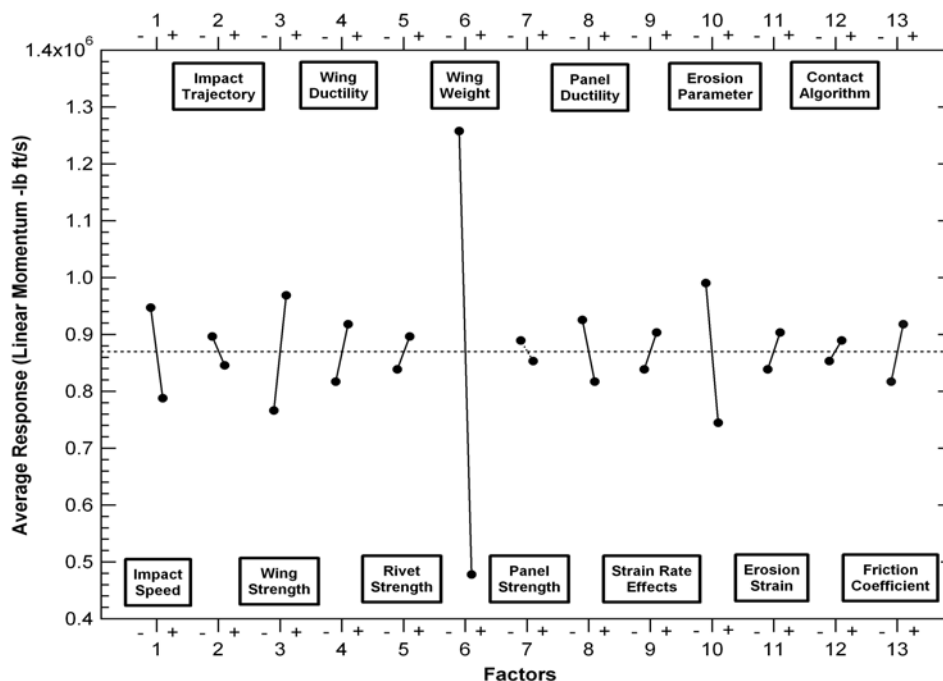
**Figure 8–6. Main effects plot for the wing-panel impact analyses.**
