Transient overvoltage protection: The implications of new techniques

François Martzloff
General Electric Company

Reprinted, with permission, from *Proceedings, 4th Symposium on Electromagnetic Compatibility*, Zürich, 1981
Also appeared as a reprint in *The Electrical Engineer* (Thomson Publications, Johannesburg), October 1991

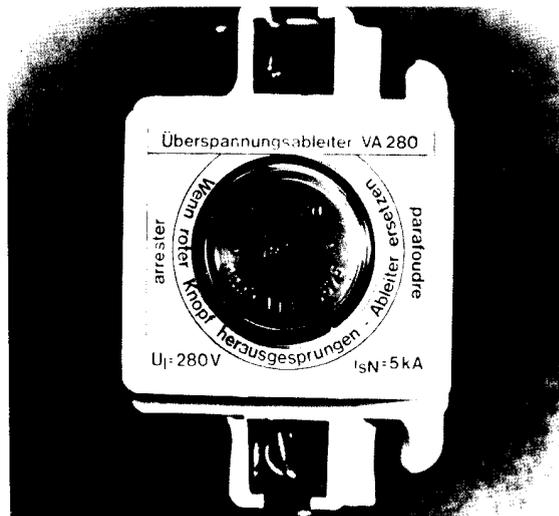
Figure 2: Surge arrester for 220 V circuits, panel installation

Surge arresters, which have sufficient current discharge capacity, consist of a gap in series with a non-linear resistor, usually a silicon carbide block (Figures 1, 2, and 3). These arresters are effective in limiting overvoltages to levels compatible with solid insulation. In recognition of this compatibility, the IEC

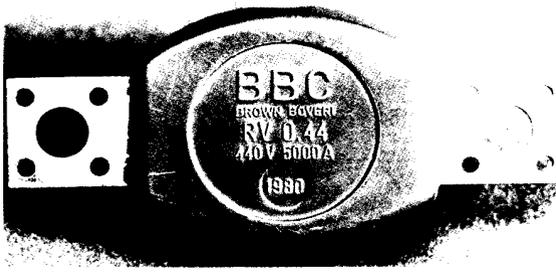
Figure 3: Surge arrester for 220/440 V circuits, service entrance installation

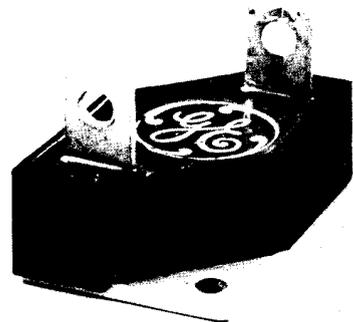
Figure 13: Metal oxide varistor (32 mm) packaged for industrial applications

The 150 V and 250 V varistors (Figure 13) were installed either outside or inside the panel. The installation will be discussed with the test results.
