Surge Voltages in Residential Power Circuits

SURGE VOLTAGES IN RESIDENTIAL POWER CIRCUITS

31 CP 67-430

by
G.J. Hahn and F.D. Martzloff
Research and Development Center
General Electric Company
Schenectady, New York

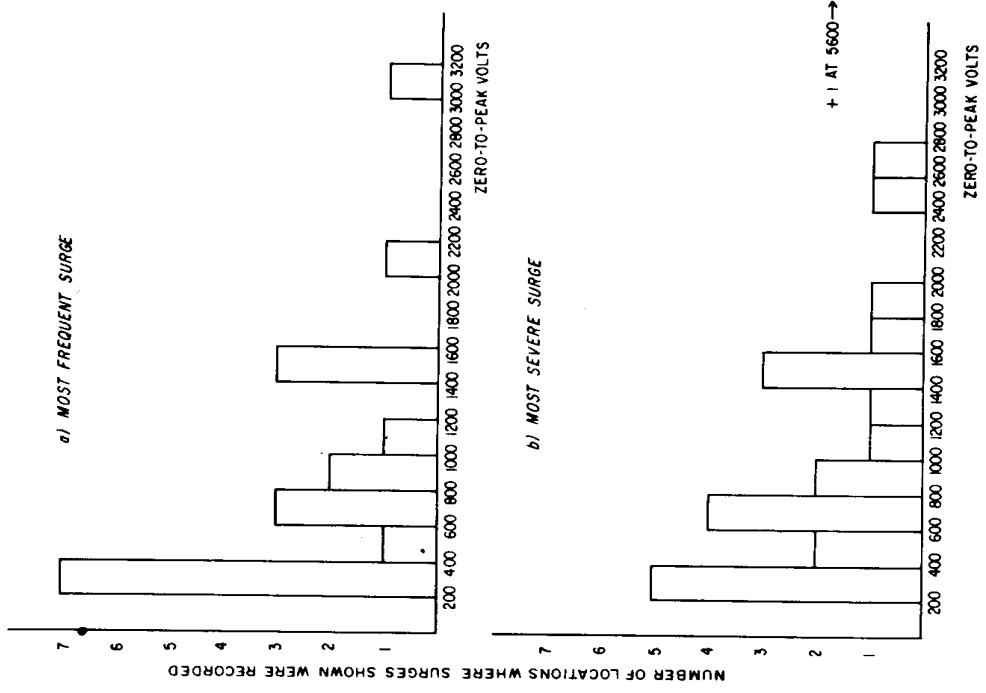
Figure 6a. Distribution of Surges--Most Frequent Surge

Figure 6b. Distribution of Surges--Most Severe Surge

At the conclusion of the recording program, a total of 16 homes and two overhead distribution poles had been monitored for a total of 7000 hours. The peak of the surges was distributed as shown in Figure 6a; the most frequent and severe surges were distributed as shown in Figure 6b.

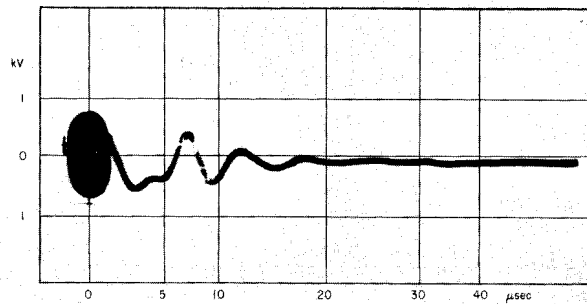
Figure 7a. Internal Switching Transient Recorded at a Farmhouse (15 such transient surges in 1500 hours)

1. Load switching in the house occasionally produced transient surges; these affected only that particular house. For any particular house, these transient surges had a wave shape which was consistently repeated with variations in amplitude along the entire film recording. This probably resulted from combination of switch characteristics and the impedance of the house wiring system; the variations in amplitude were probably caused by variations of the switching angle and/or connected loads. Typical wave shapes of the recorded surges are shown in Figures 7a, 7b, and 7c.

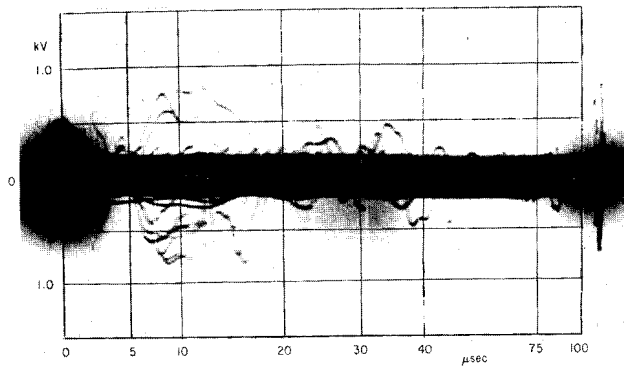
Figure 7b. Composite Record Showing Surges for a 24-hour Period at a Suburban Home. (Oscilloscope is triggered for each surge, plus once every hour, resulting in \pm 165-volt band of steady state 60 Hz voltage. Recordings above 1800 volts are blanked out by the oscilloscope.)

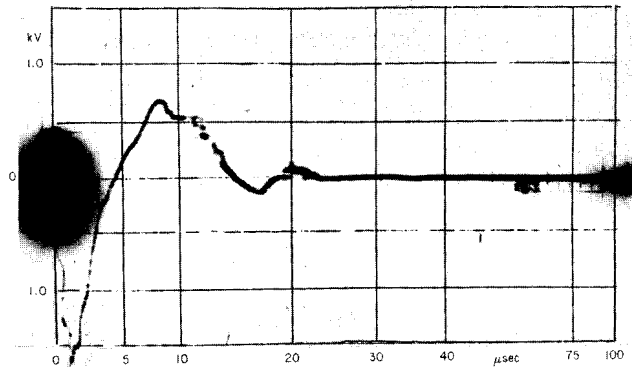
Figure 7c. Single Surge with 1700-volt Peak, Recorded at the Same Location as Figure 7b. (In a 5-day period surges of this wave shape were recorded as follows: 13 above 1000 volts, 18 above 1500 volts, 21 above 2000 volts, and 1 above 2500 volts. Source was determined to be interruption of a high-voltage transformer for an oil furnace.)

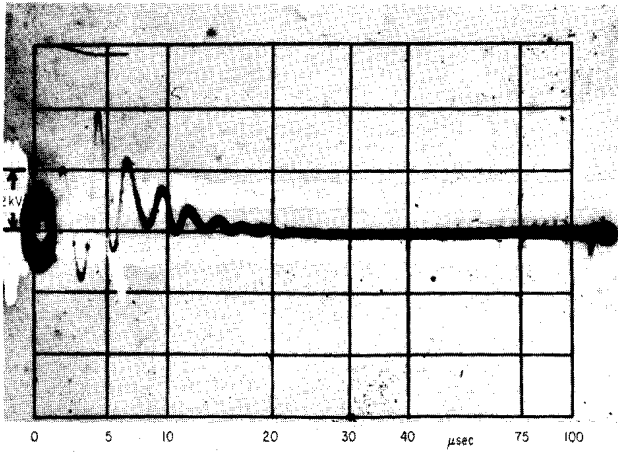
Figure 8a. Transient Surges Recorded on Overhead Distribution Systems in Charleston, South Carolina (3800-volt crest, 300 kHz oscillation.)

2. Surge voltages not associated with load switching within the house were associated with lightning storms. In some cases, the home owner was able to correlate the film advance counts with the storm. Although recorded during lightning storms at two different locations, the surges shown in Figures 8a and 8b present the interesting characteristic of being oscillatory at a frequency in the range of 300 kHz. The surge shown in Figure 8a was recorded at the overhead distribution line (oscilloscope mounted on the pole), while the surge of Figure 8b was recorded at the service entrance in a home. The first exhibits far less damping than the second; this might be explained by the lower damping due to lower resistance of the system at the pole than at the end of a service drop.

Both of these surges, as well as most of the other surges recorded during lightning storms, exhibit this oscillatory characteristic at a frequency which is nearly constant for a particular locality. This constancy suggests that the oscillation of the system followed an excitation caused by the lightning stroke. A number of surges in the range of 800 to 1200 volts were observed during several storms. The maximum surge voltage recorded was 5600 volts; several other surges recorded during the same period were in excess of 4000 volts.¹
