NIST Response to the World Trade Center Disaster

**Federal Building and Fire Safety Investigation
of
the World Trade Center Disaster**

Part IIB – Collapse Sequence

April 5, 2005

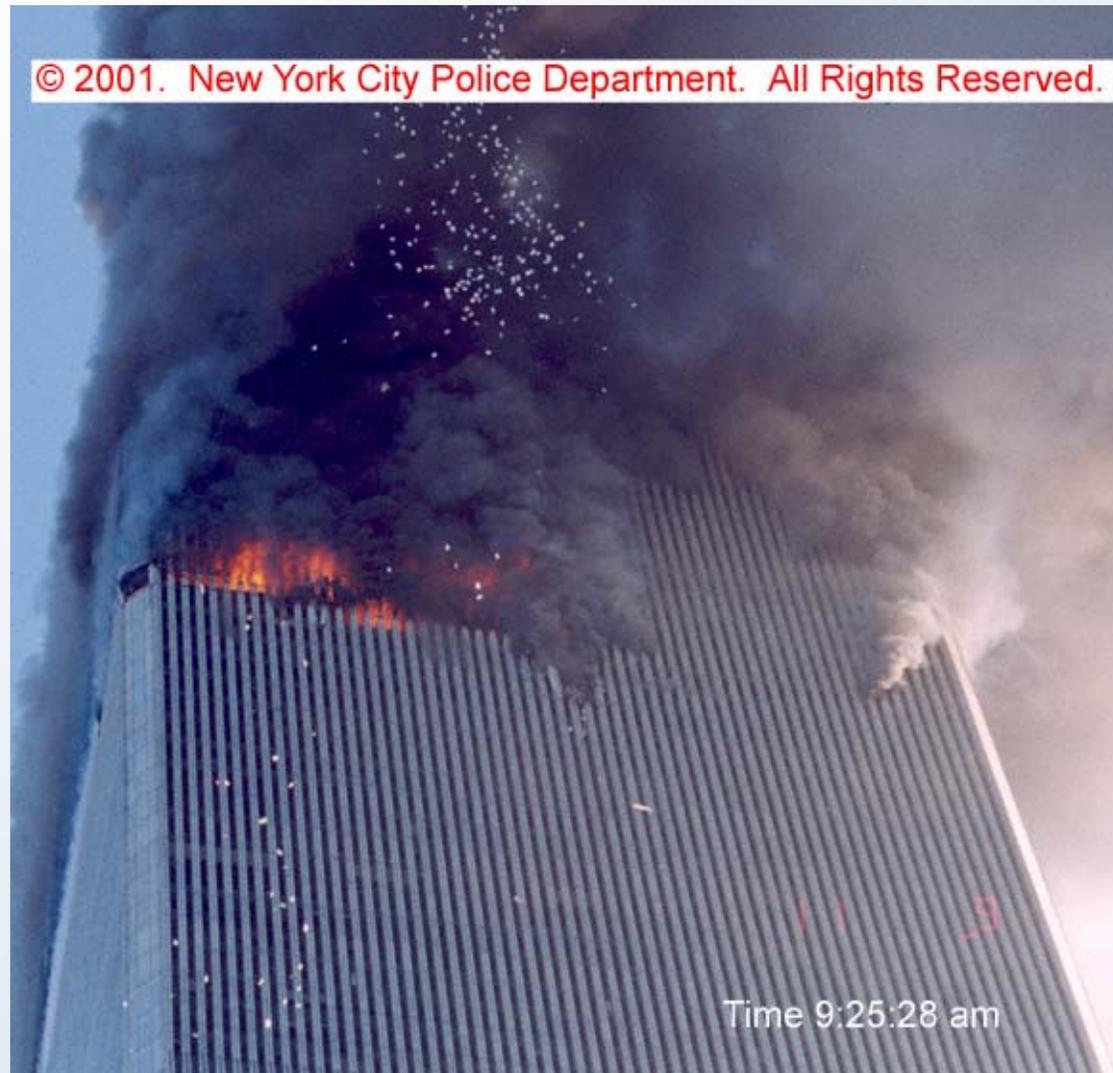
South Face of WTC 1, 9:40 am. No inward bowing

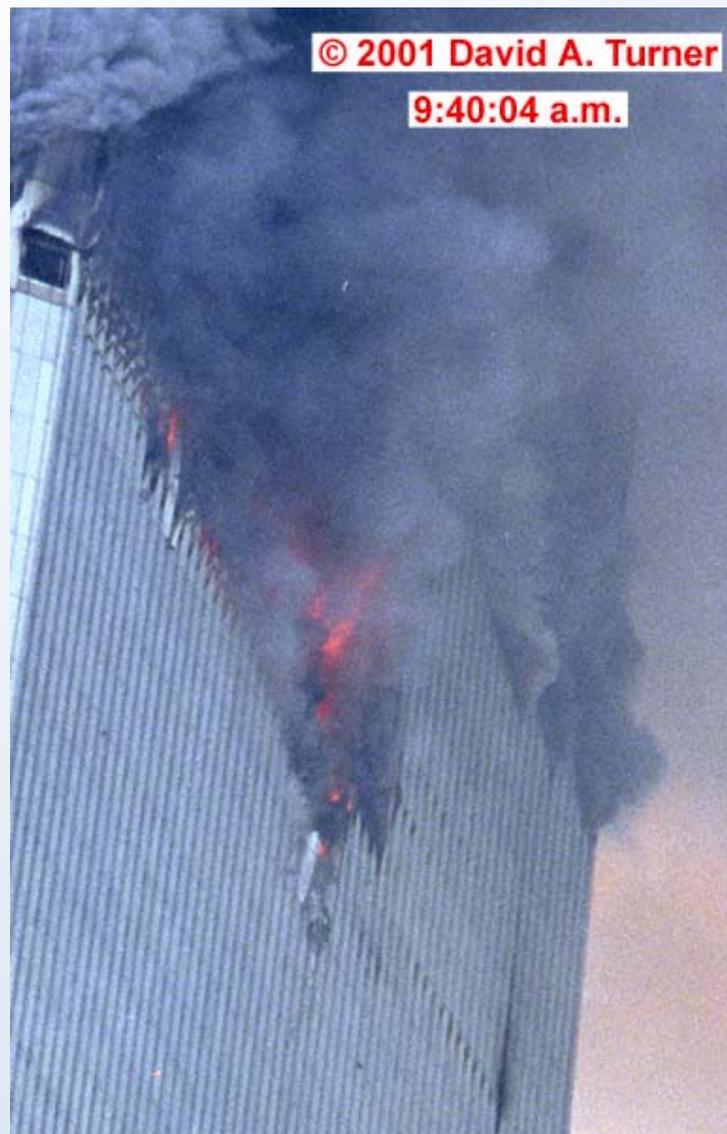
South Face of WTC1

- Time: 10:22 AM
- Measurements of inward bowing (inches)
- **Maximum = 55 inches**
(uncertainty ~ +/- 6 inches)

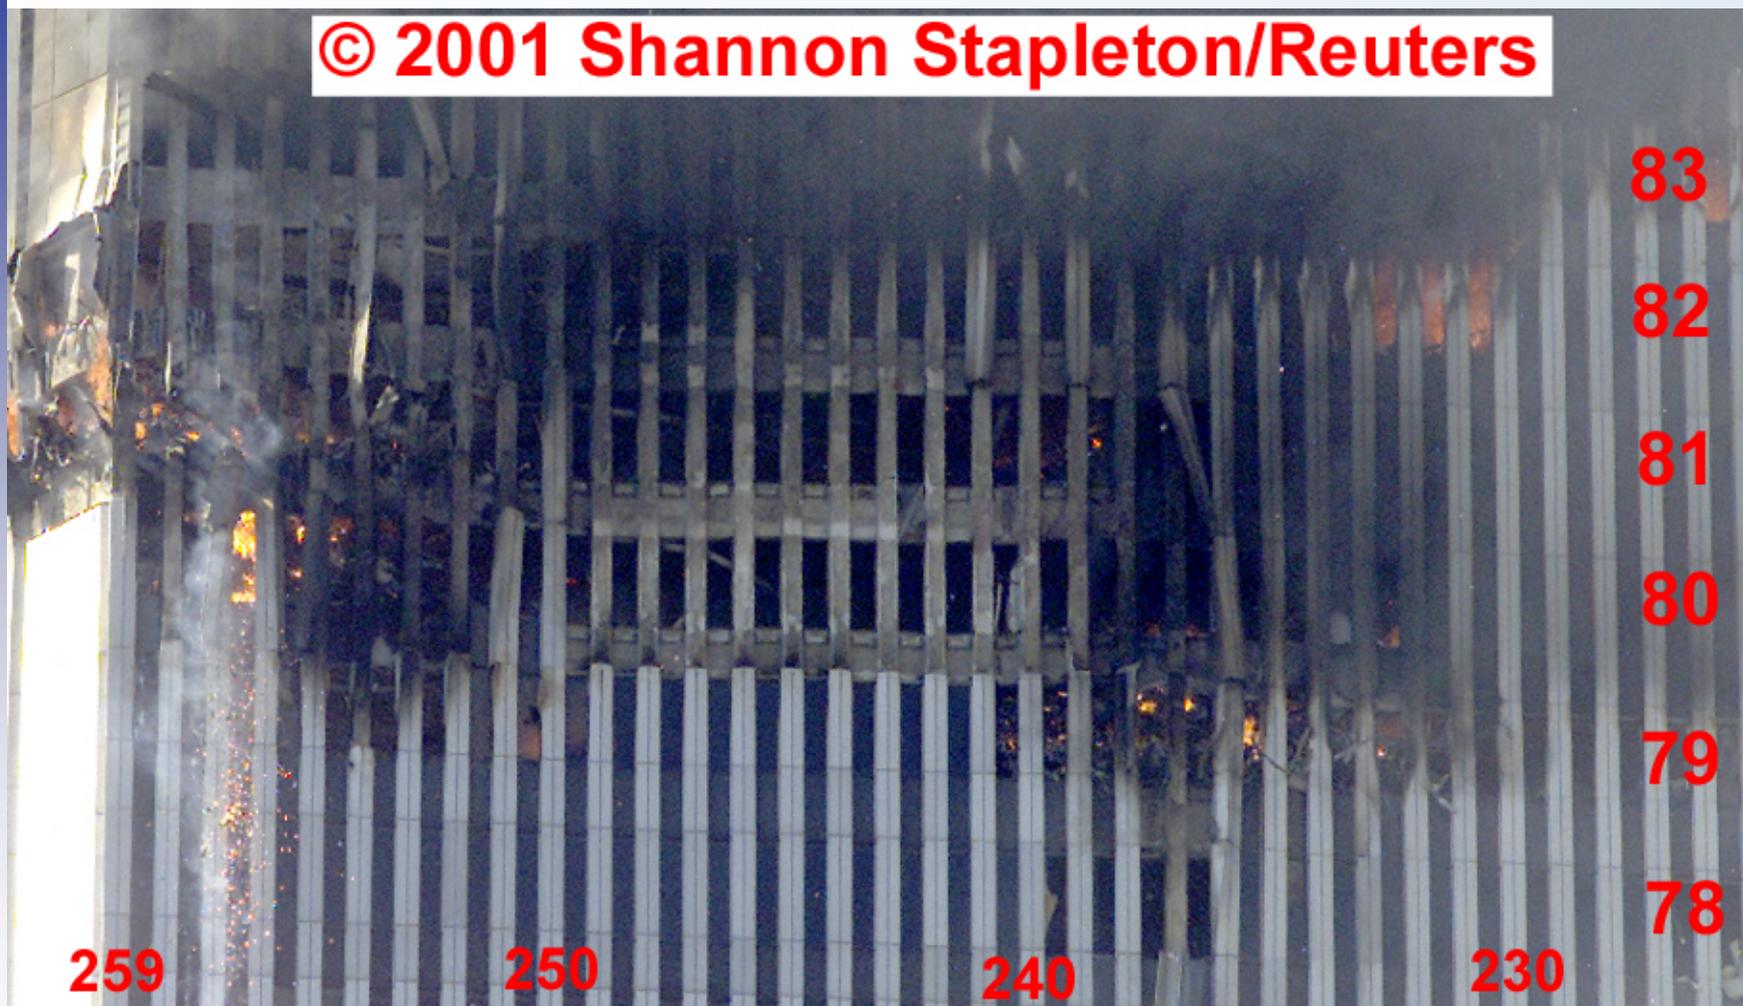
Photographic Evidence of Hanging Floor Slab

North Face of the South Tower. Image shows what appear to be portions of several floor slabs hanging across window openings on Floors 80, 81, and 82

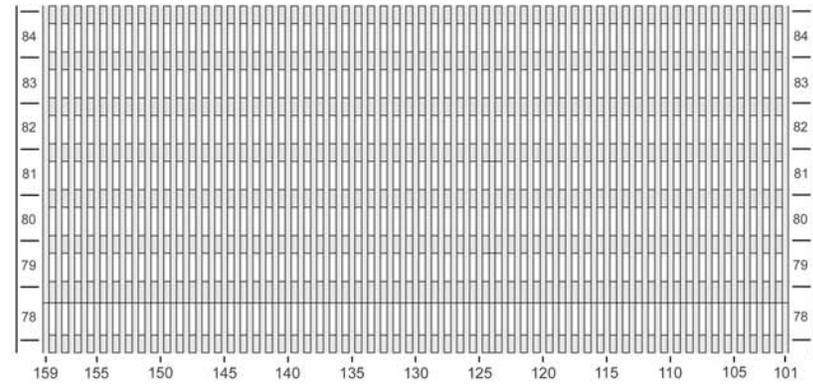
WTC 2, West Face

9:46 a. m. to 9:58 a.m.
